Inspection Photos

Operator: Mustang Resources LLC - #10550

Location Name: Burns-66S94W /35SWSE

Inspection Document #: 702800373

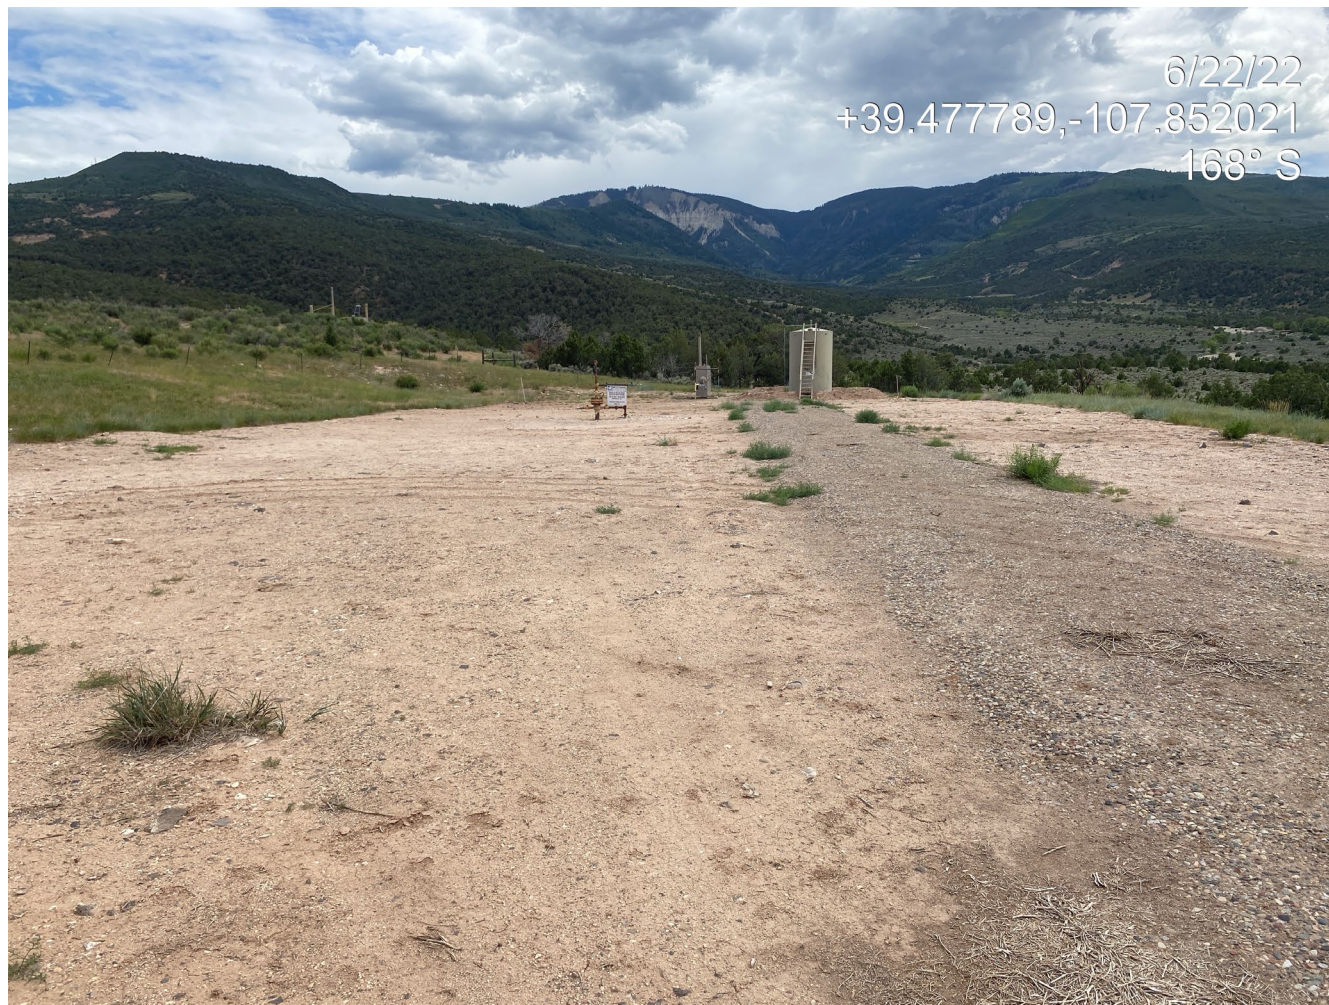
Photo 1. Photo taken from the north shows an overview of the Location.

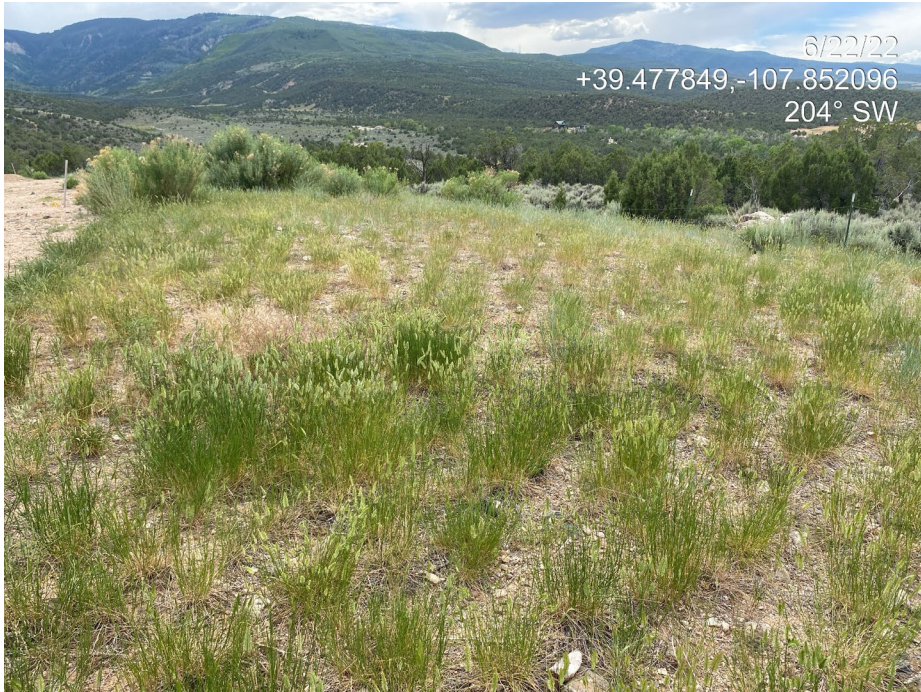
Photo 2. Photo taken from the north of the Location shows western interim areas are well vegetated with crested wheatgrass, a non-native perennial grass.

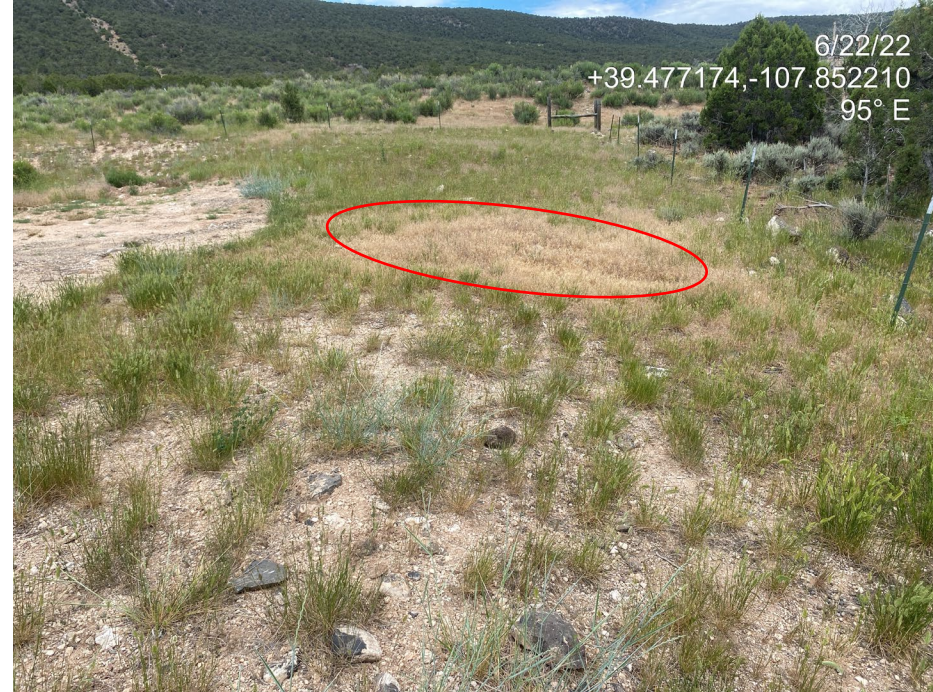
Photo 3. Photo taken from the south of the Location shows southern interim areas are well vegetated with crested wheatgrass, a non-native perennial grass. However, a dense patch of cheatgrass is present.

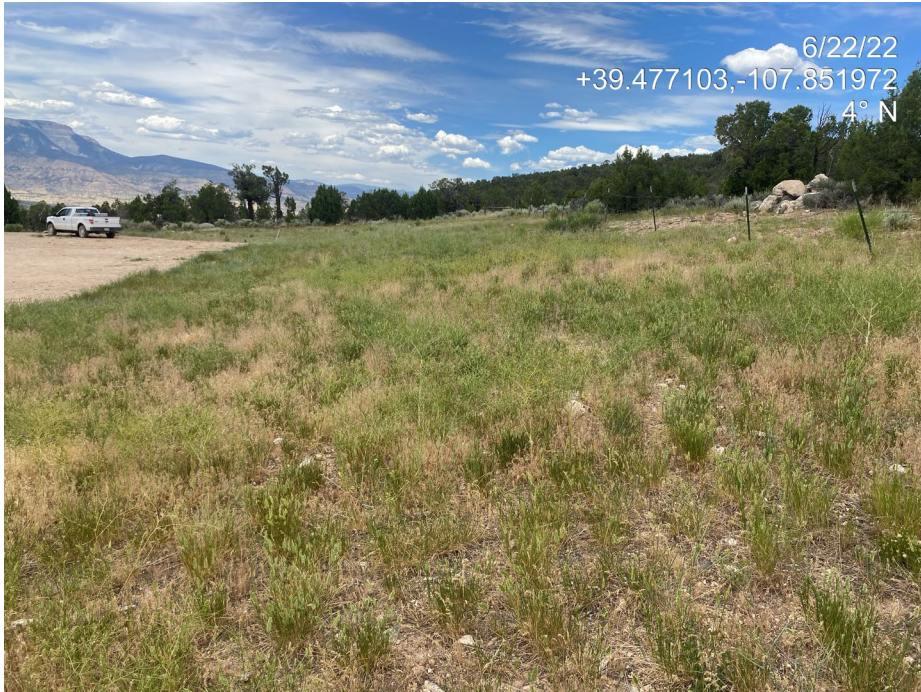
Photo 4. Photo taken from the east of the Location shows eastern interim areas are well vegetated with crested wheatgrass, a non-native perennial grass. Photo also shows cheatgrass is more widespread in the eastern interim areas than in western areas (see Photo 2).

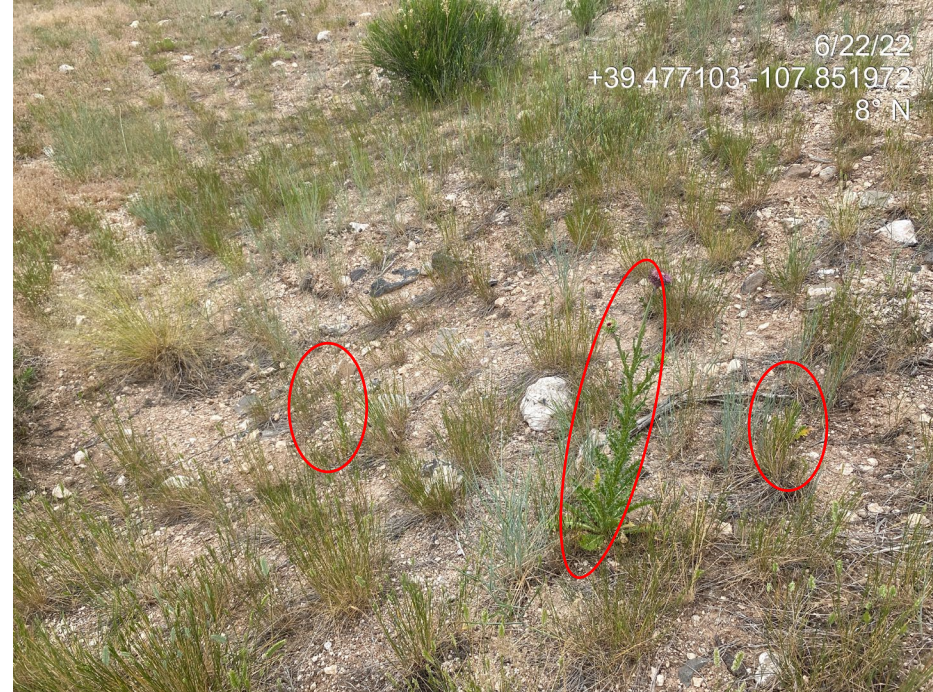
Photo 5. Photo taken from the southeast of the Location shows musk thistle, a Colorado List B noxious weed.

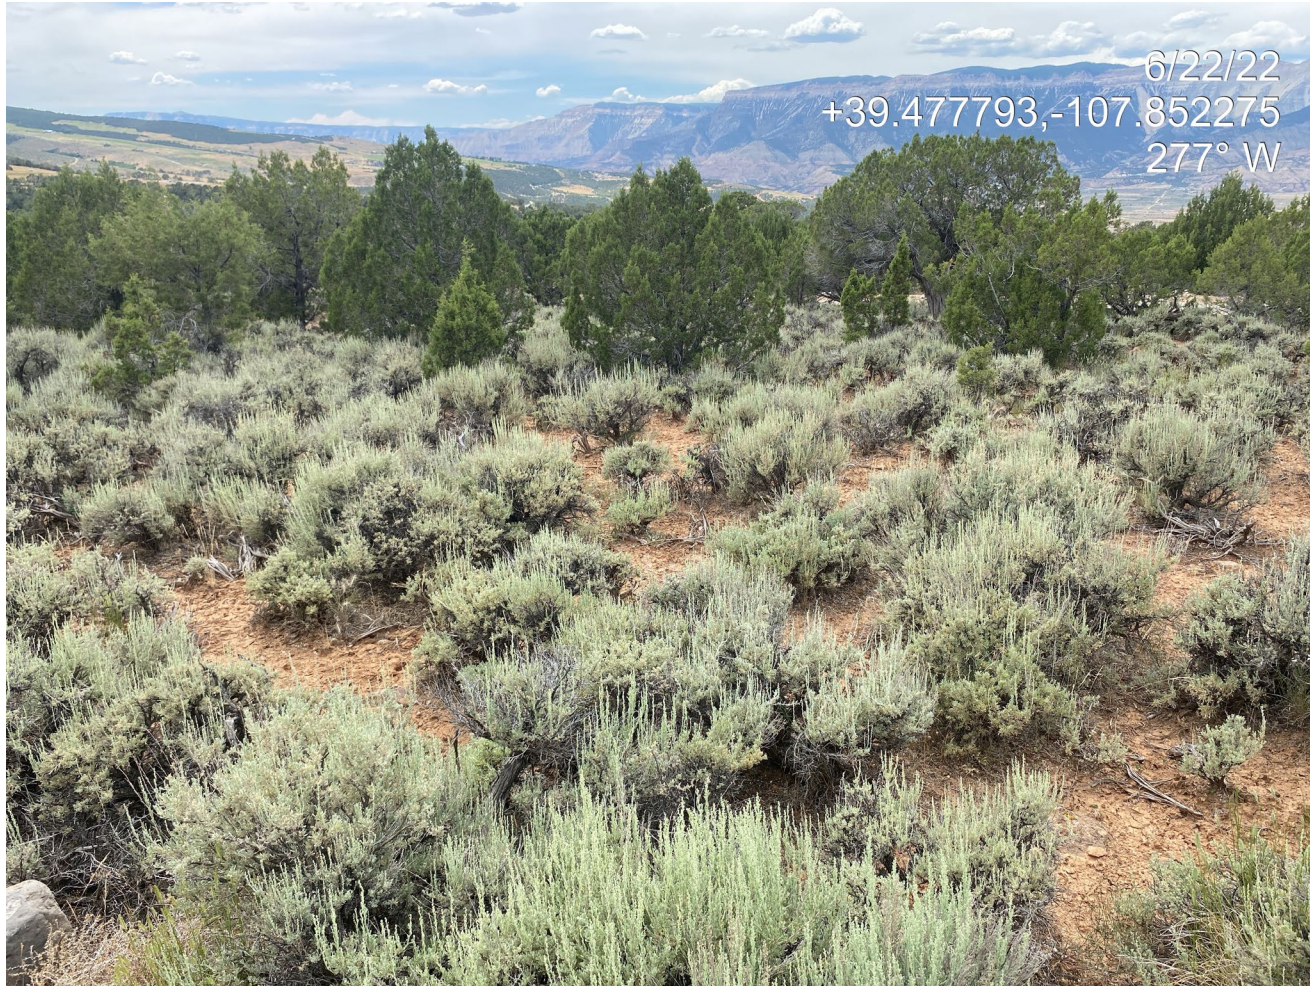
Photo 6. Photo taken to the west of the Location shows the reference area vegetation community is native rangeland. Cheatgrass is uncommon.
