# Inspection Photos and Issue Report

Operator: CAERUS PICEANCE LLC #10456

Location ID: 467272

Rio Blanco County, CO

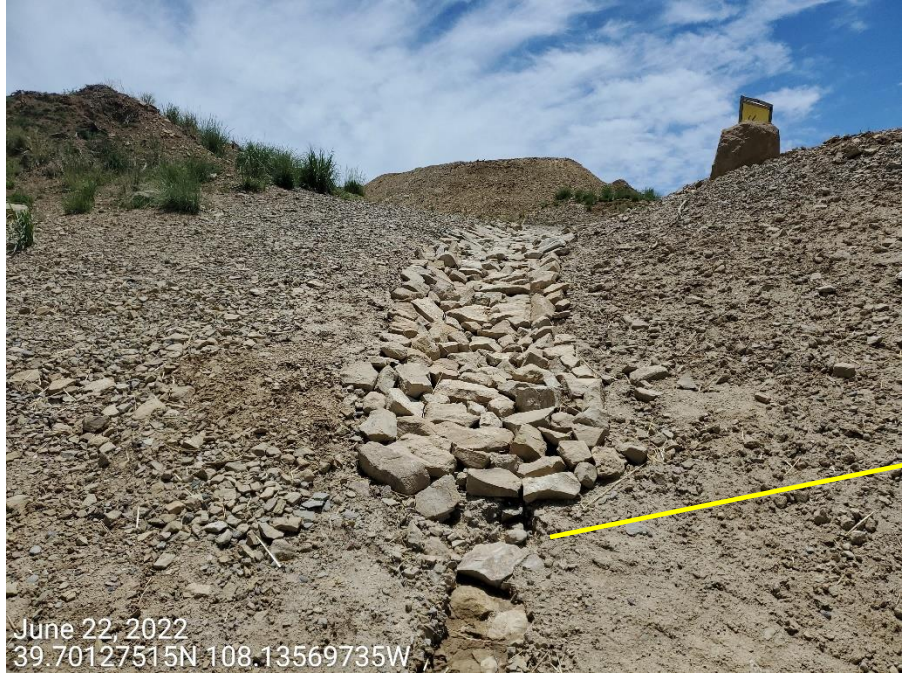
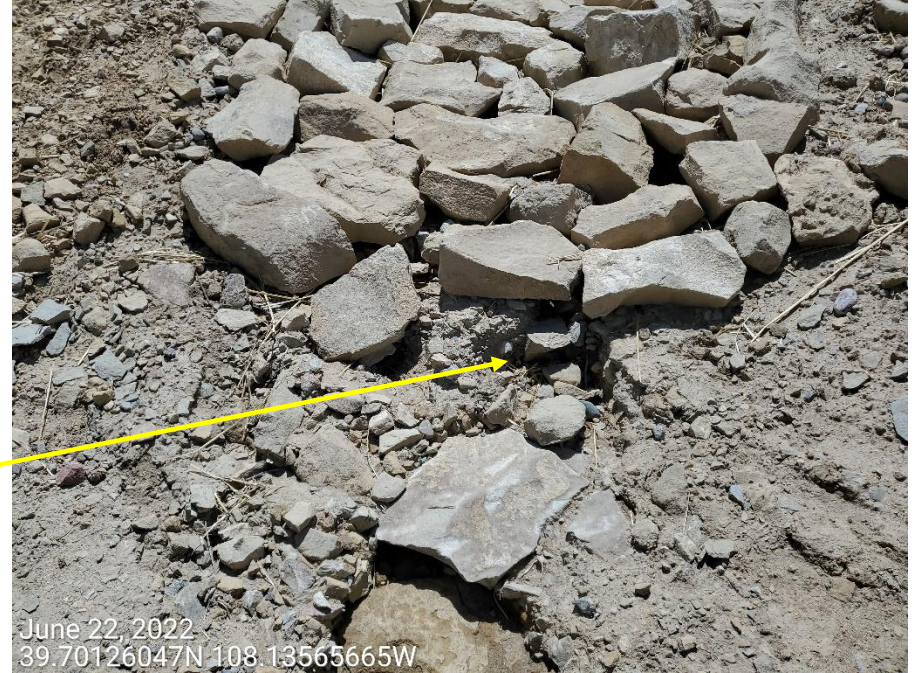
**Photo 1:** Photos taken from the sediment trap on the north end of the Location. Photo shows additional work to the inlet has been performed, however, inlet does not appear to have been constructed with geotextile lining per good engineering practices, and degradation to the control is recurring (arrow).

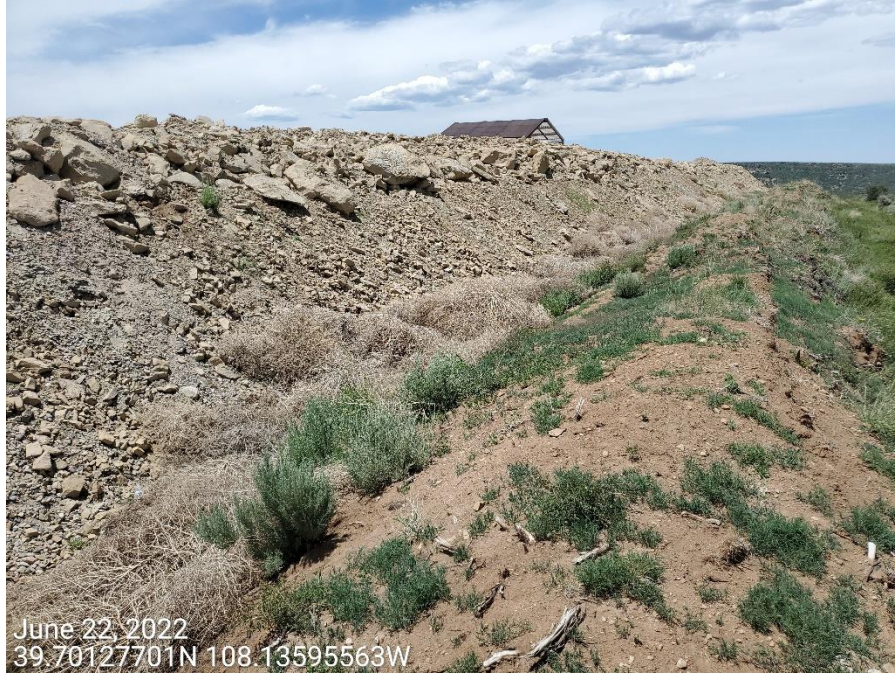
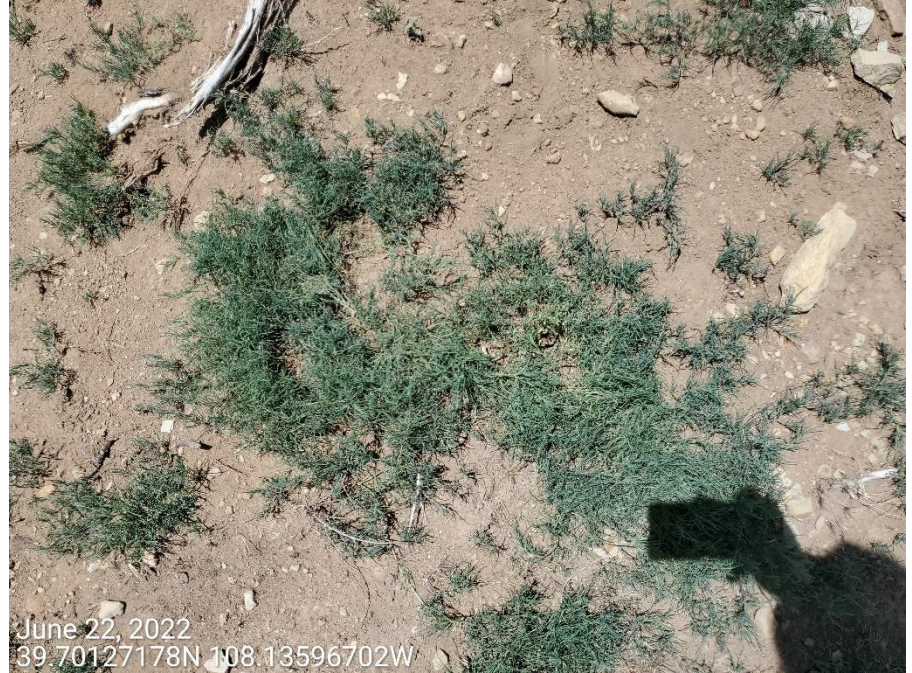
**Photo 2:** Photos taken from the topsoil stockpile along the perimeter of the Location. Photo left shows weed debris along the perimeter of the Location has not been removed and properly disposed per corrective actions. Photos also show BMPs to prevent Undesirable Plant Establishment, and to protect the topsoil stockpiles are inadequate; photo right shows weeds establishing on stockpiles.

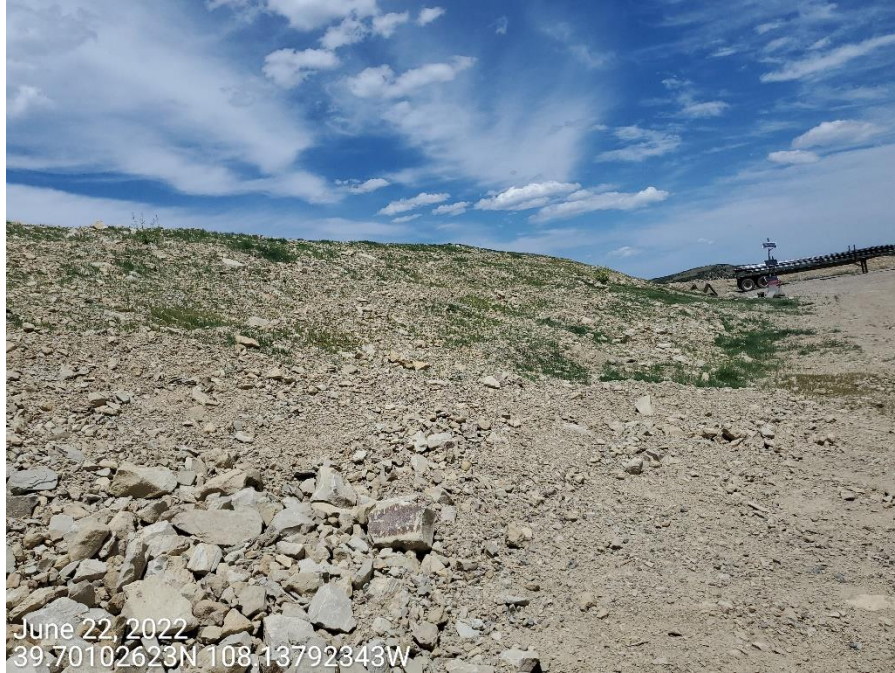
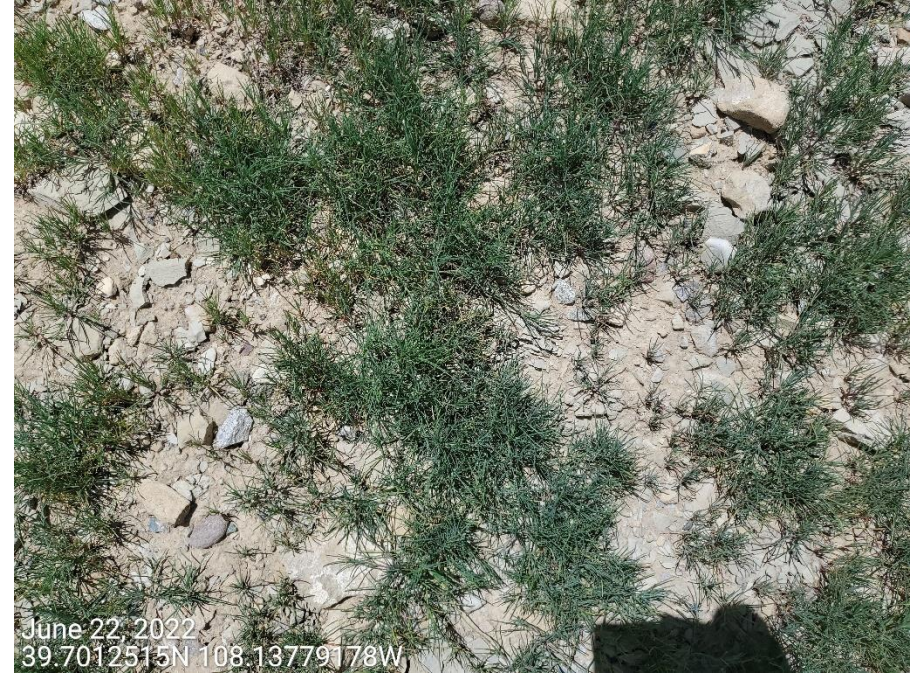
**Photo 3:** Inspection #696203714 notified Operator of Undesirable Plant Species germinating on the Location, and advised maintenance to ensure Location remains free of Undesirable Plant Species pursuant to Rule 606.c. Photos examples showing that proactive measure to prevent weed establishment has not been taken by Operator- Undesirable Plant Species have continued to establish on the Location, as well as on the topsoil stockpiles along the Location's perimeter.

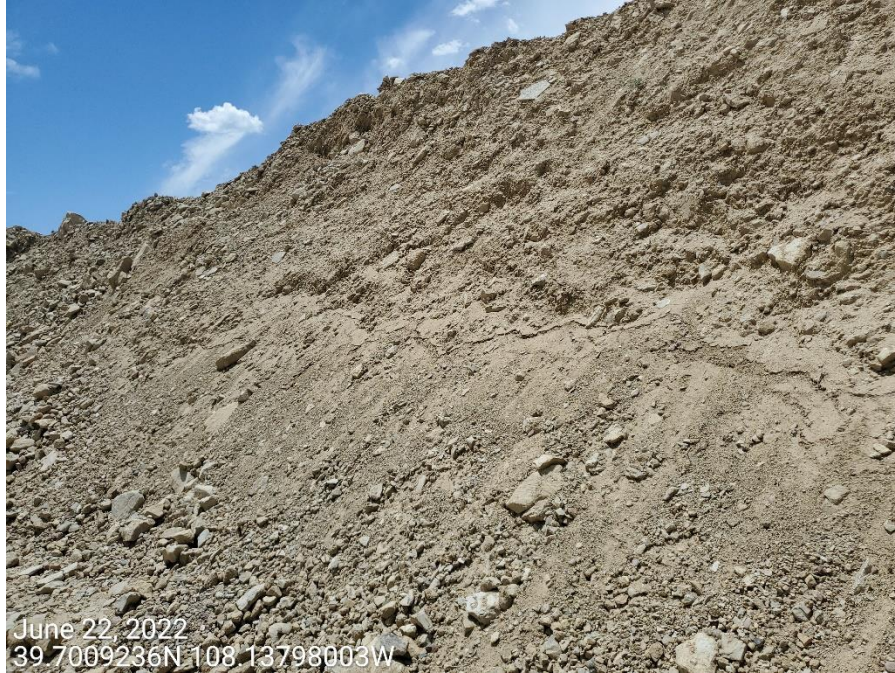
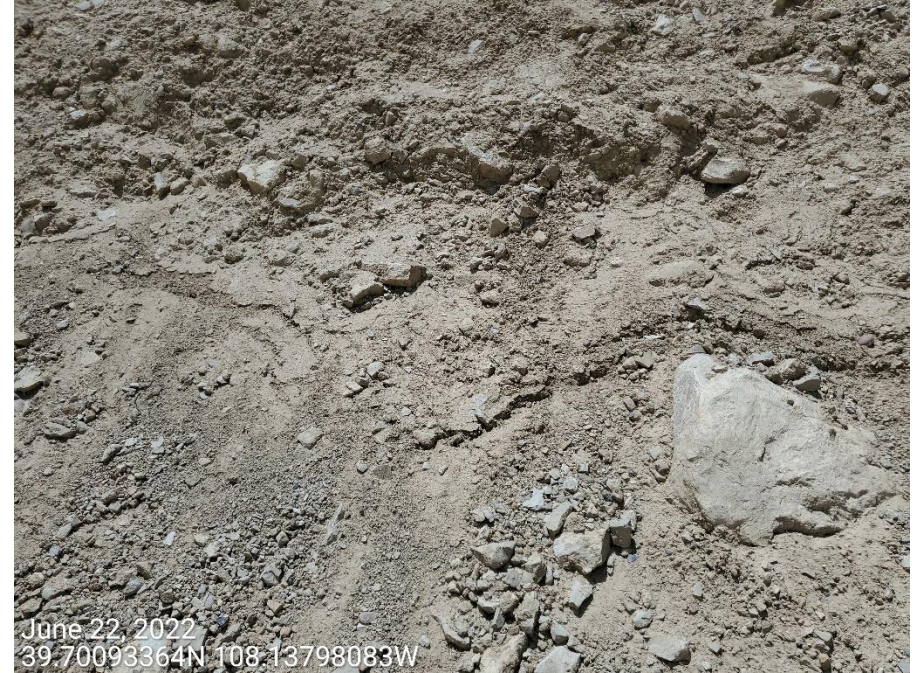
**Photo 4:** Photos example showing BMPs to minimize erosion and degradation on slopes of the Location remain missing or insufficient.

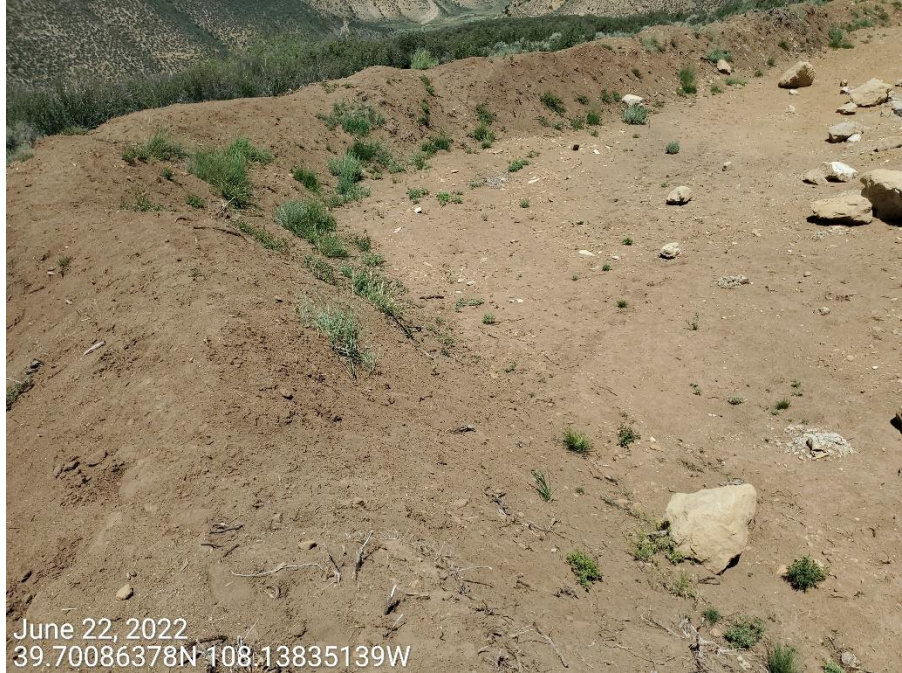
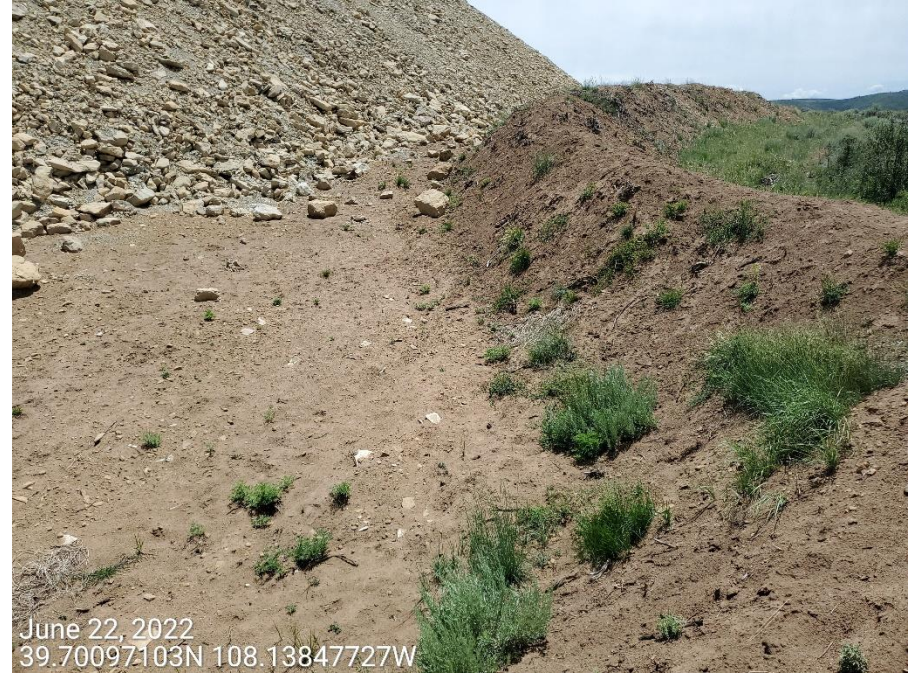
**Photo 5:** Photos taken from the perimeter of the Location. Photos examples showing that topsoil remains in use at the base of the fill slopes/subsoils of the Location as a berm and sediment trap/pond to manage stormwater. Photos also show topsoil stockpiles are larger bare; BMPs to minimize erosion and degradation remain missing or insufficient to protect stockpiled soils.

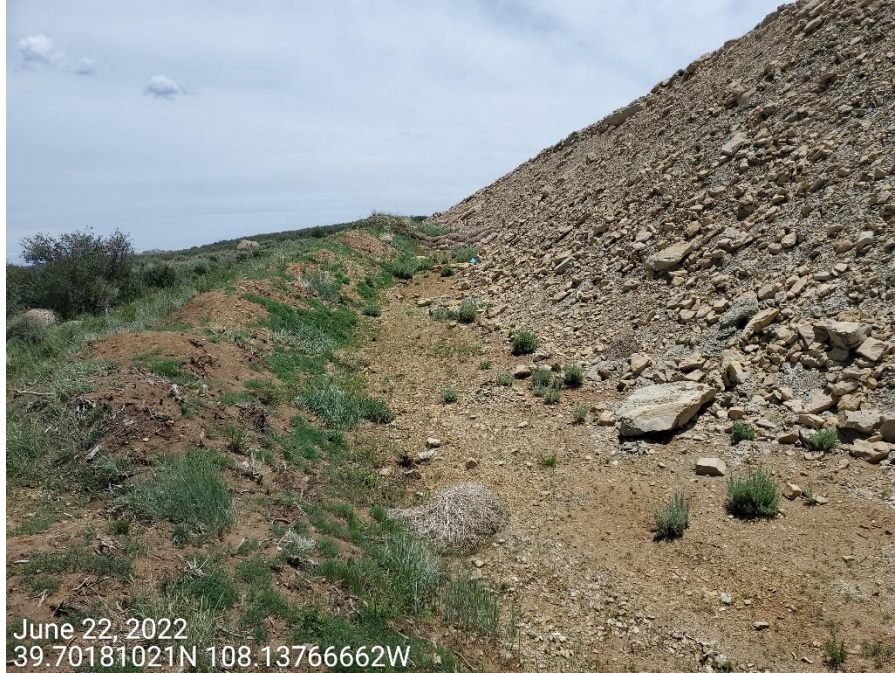
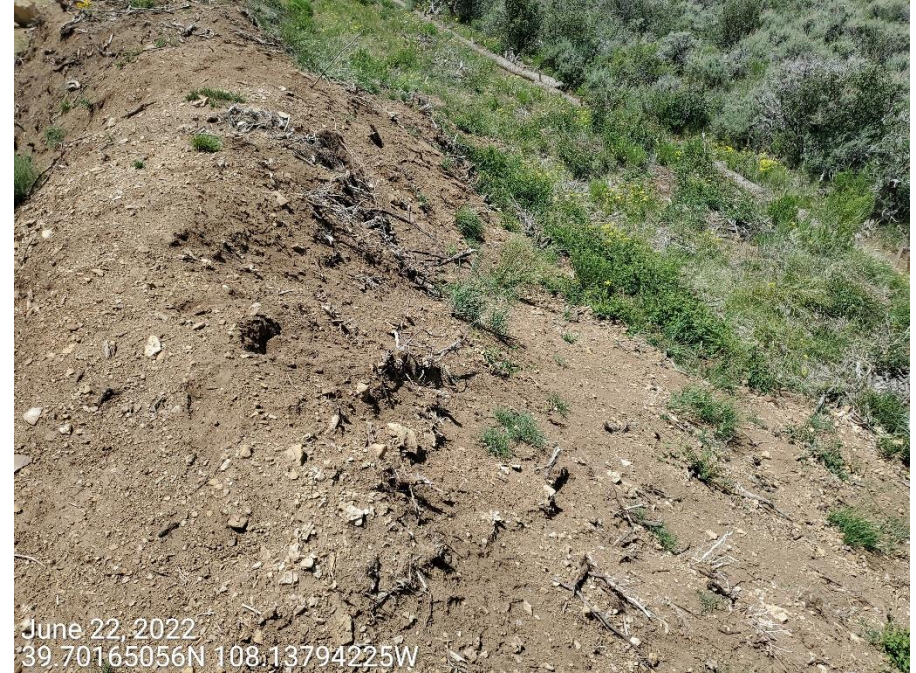
**Photo 6:** See comments under photo 5.

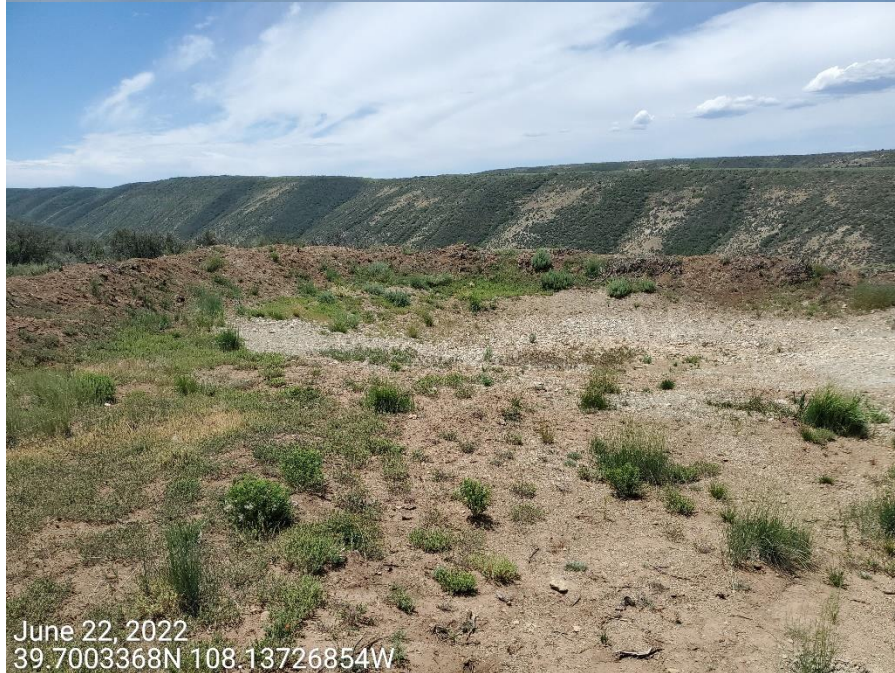
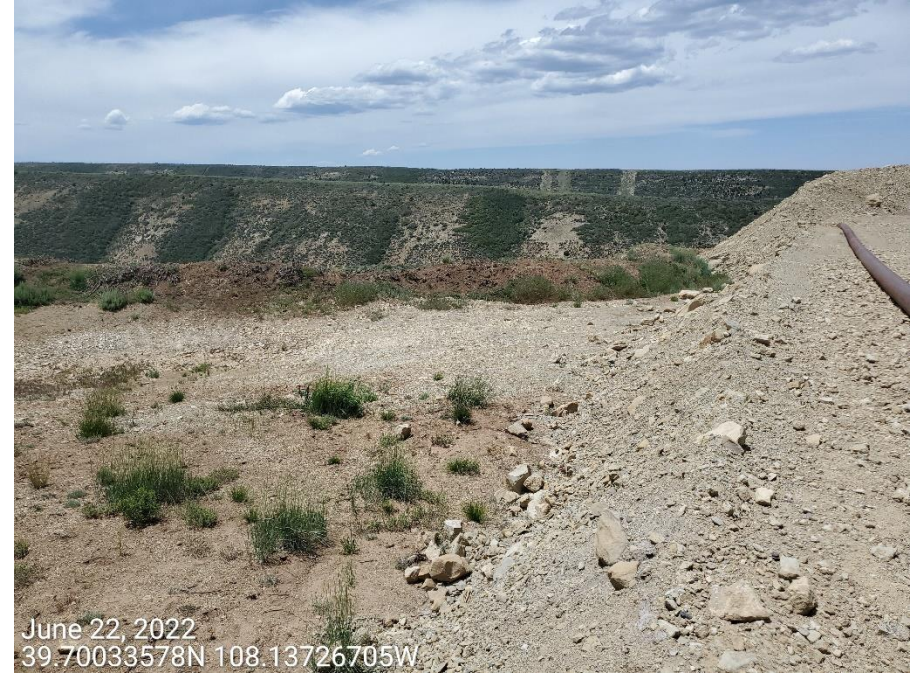
**Photo 7:** See comments under photo 5.

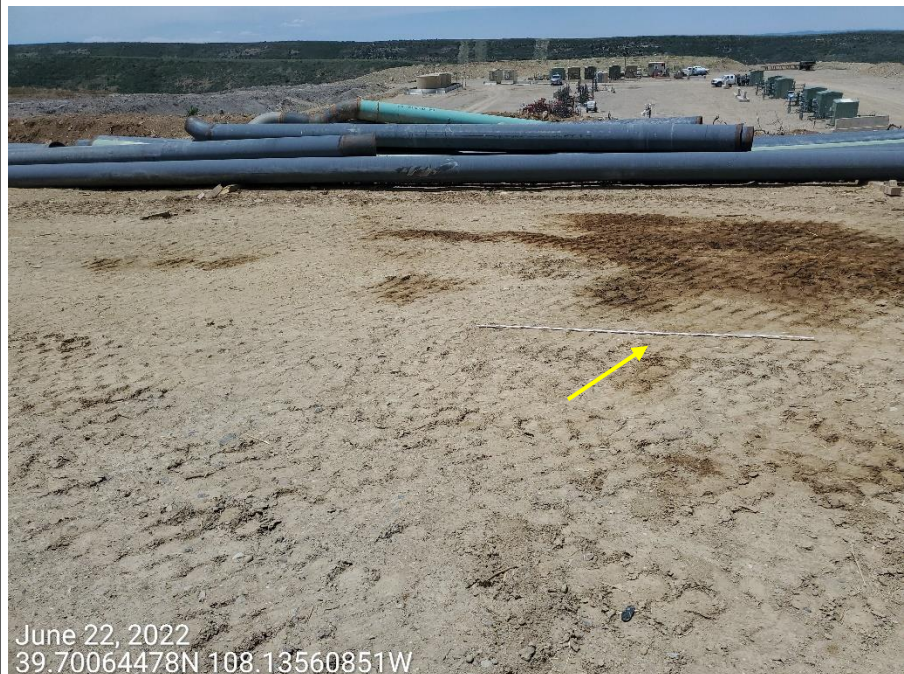
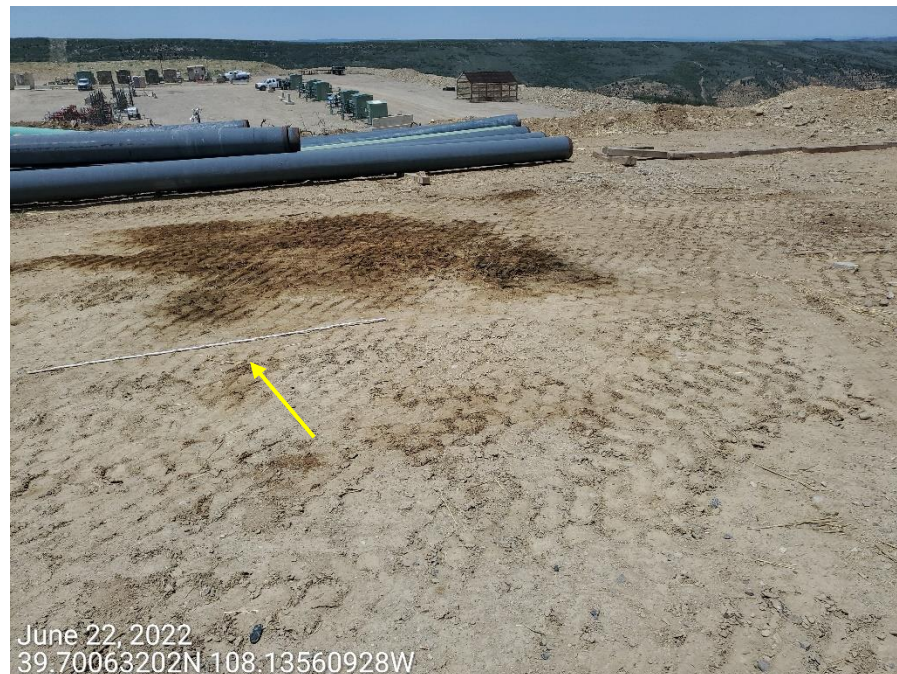
**Photo 8:** Photo shows impacted/stained soils observed on the east end of the Location.

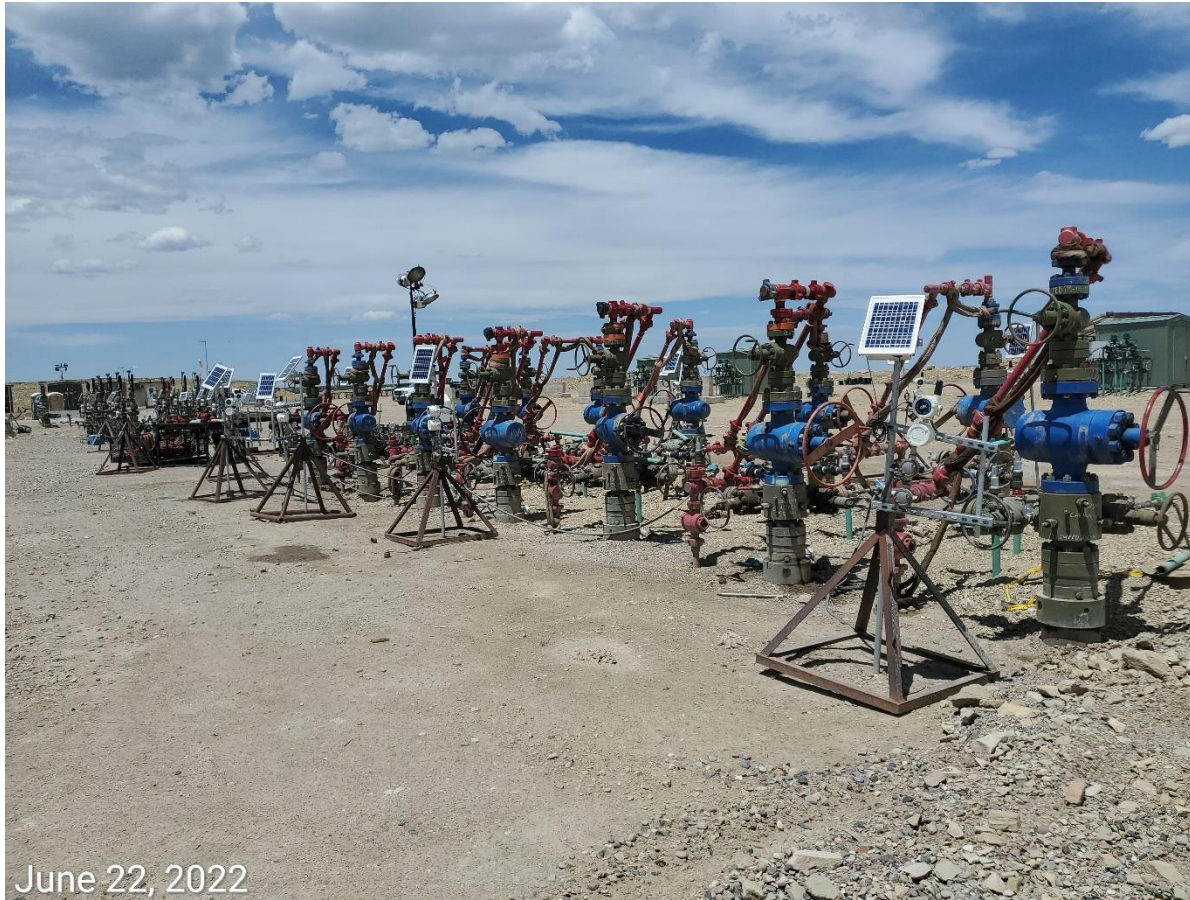
**Photo 9:** Signage missing from wells

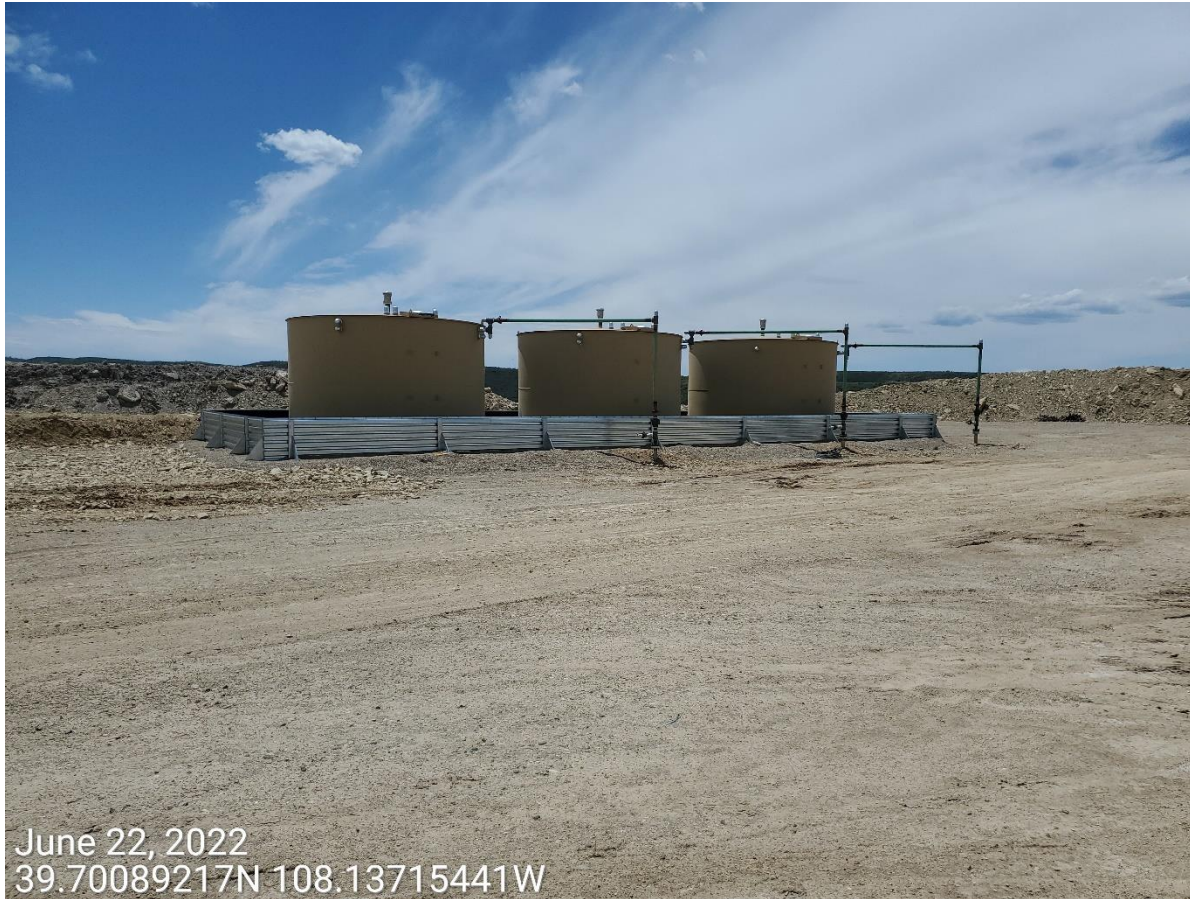
**Photo 10:** Signage and labels missing from battery, and tanks.
