Inspection Photos and Issue Report

6/22/2022

Operator: CAERUS PICEANCE LLC #10456

Location ID: 335699

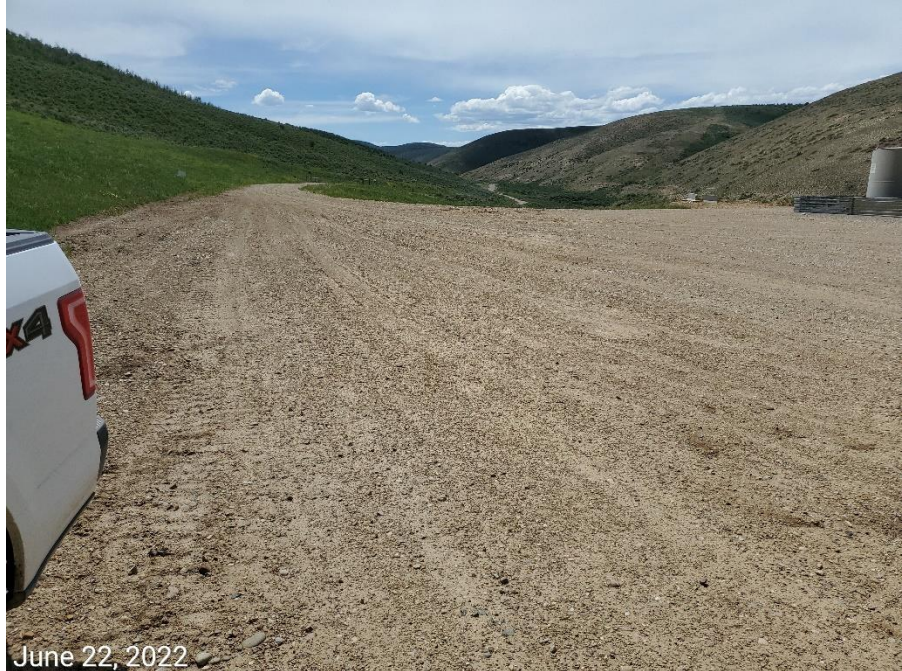
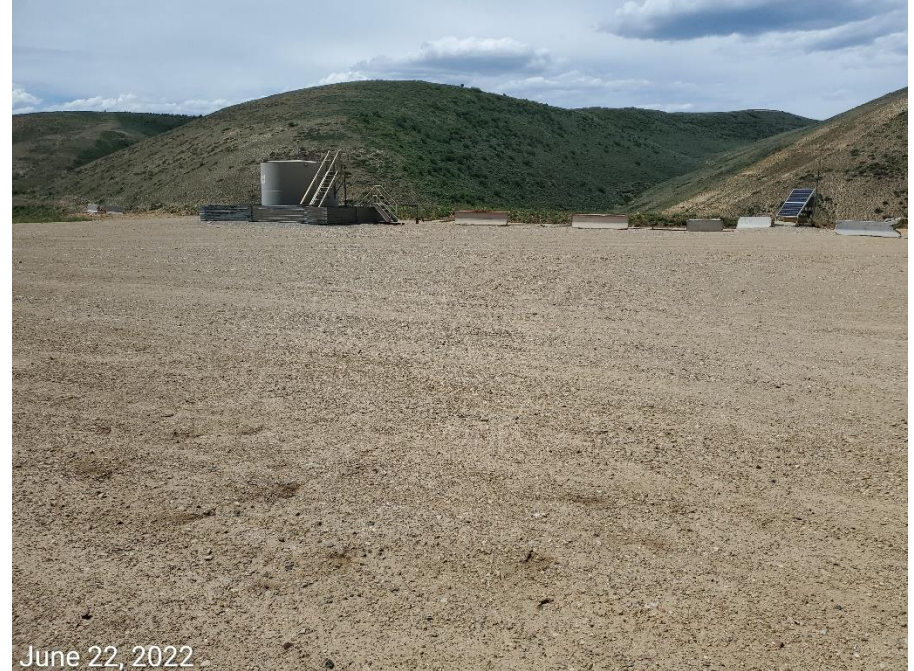
Photo 1: Photos taken from the south end of the production area. Photos 1-2 provide an overview of the Location from west, northwest, northeast to east.

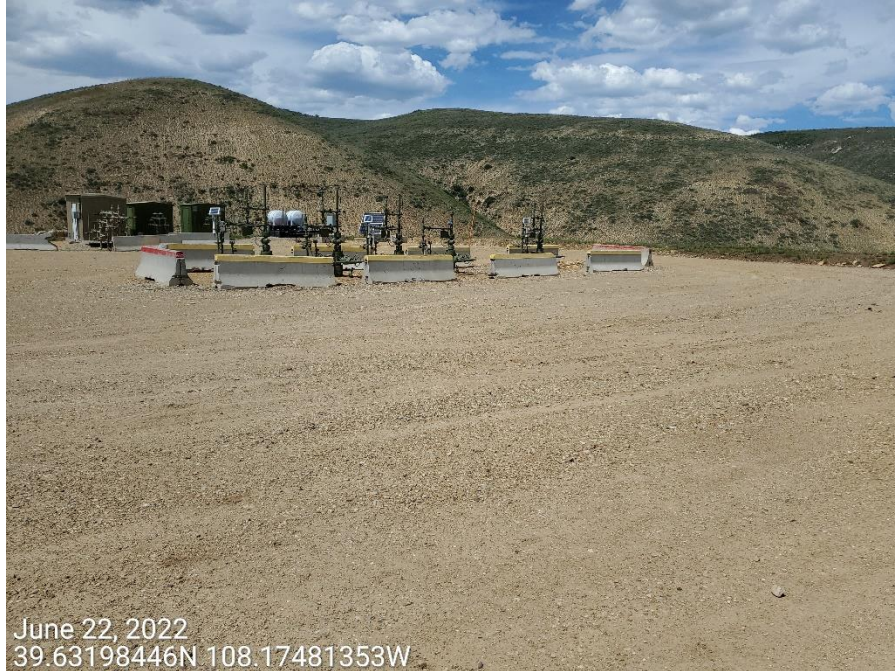
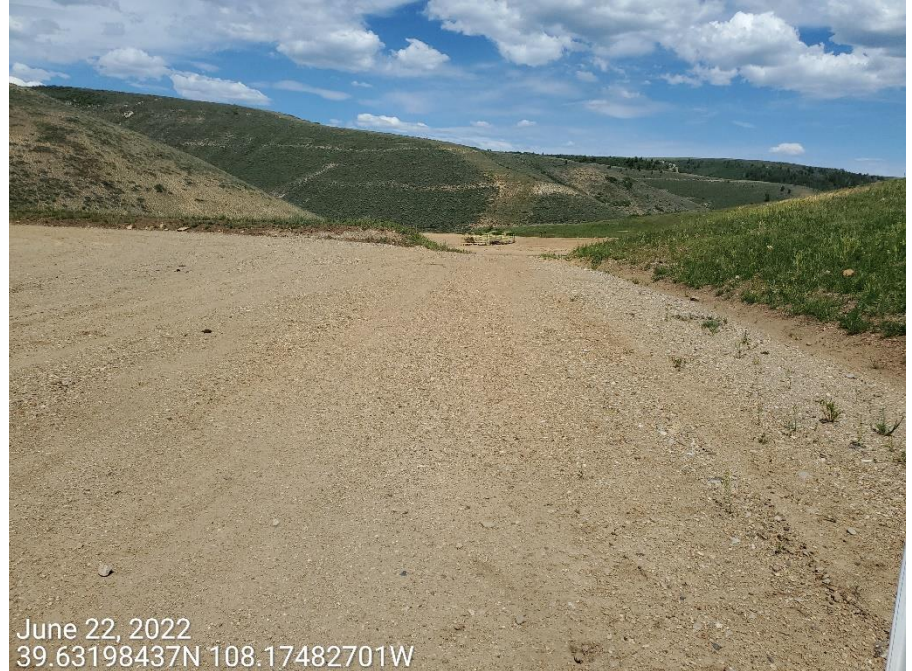
Photo 2: See comments under photo 1.

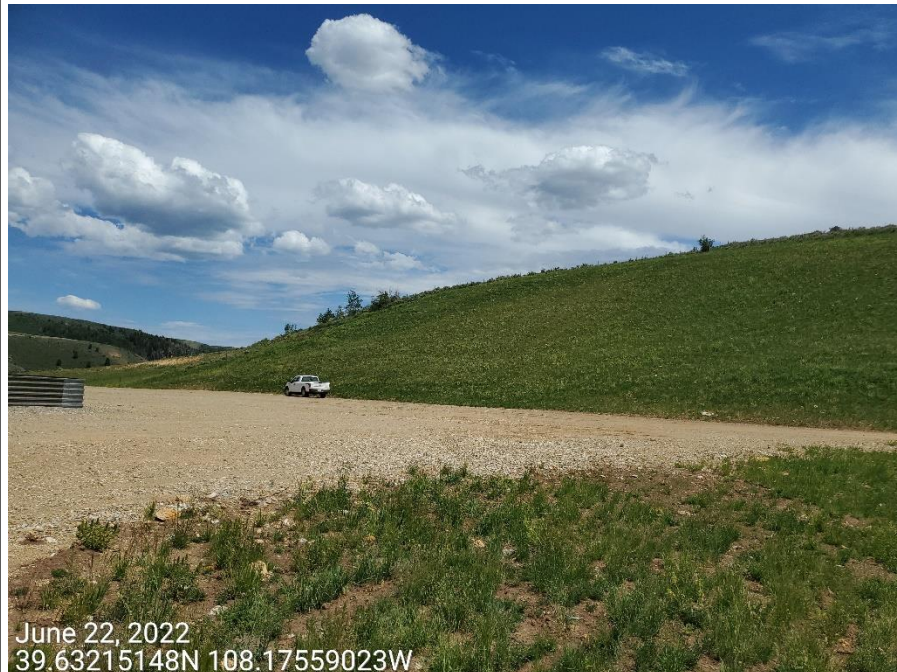
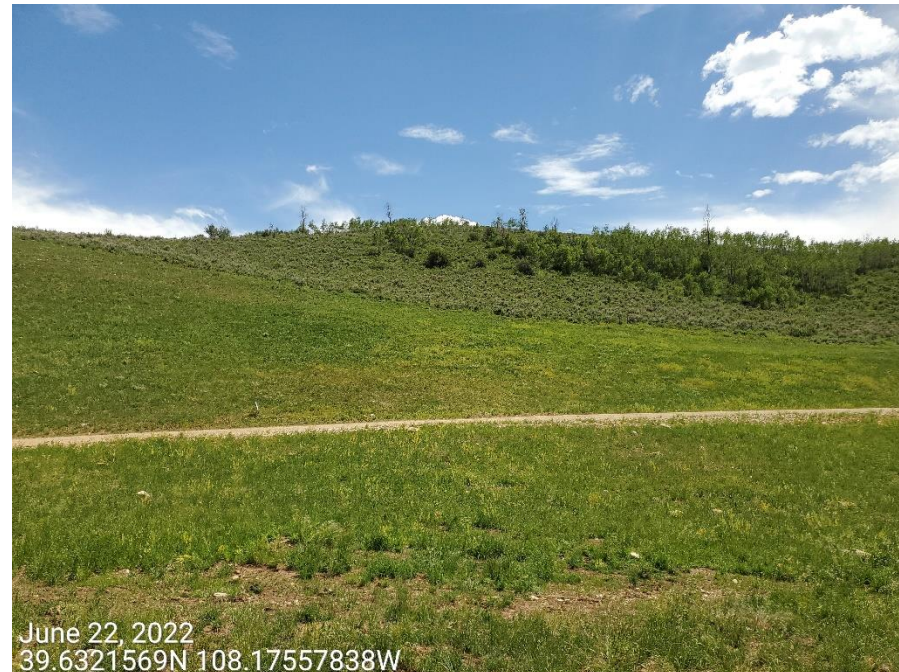
Photo 3: Photos provide example of the interim areas. Interim reclamation is “in-process”, however it is noted Operator has used a seed mixture with species not reflective of the adjacent reference area (Barnyard grass, Alfalfa, etc..)

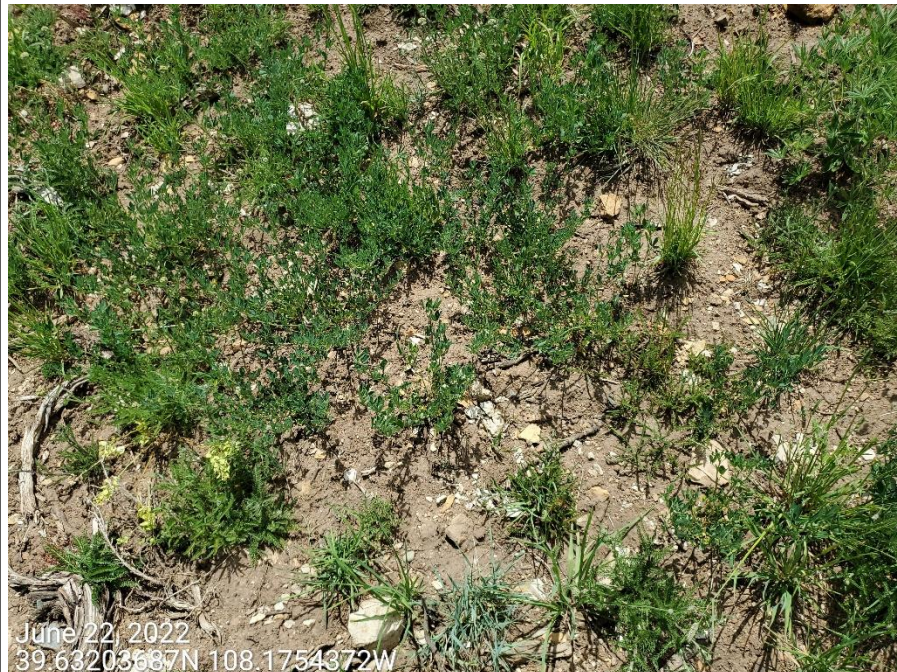
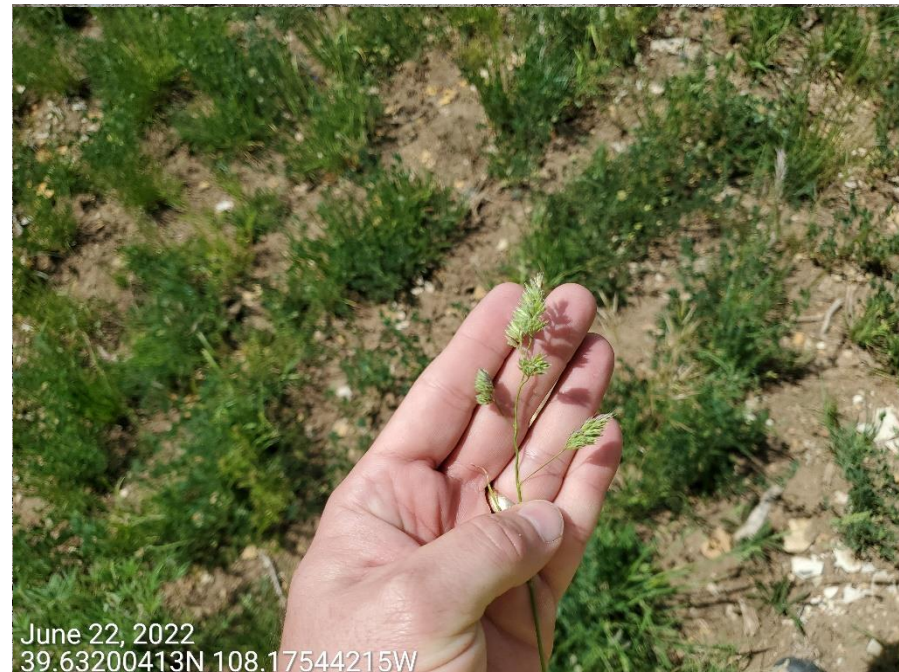
Photo 4: Photos show example of introduced species observed on Location (alfalfa, orchard grass).

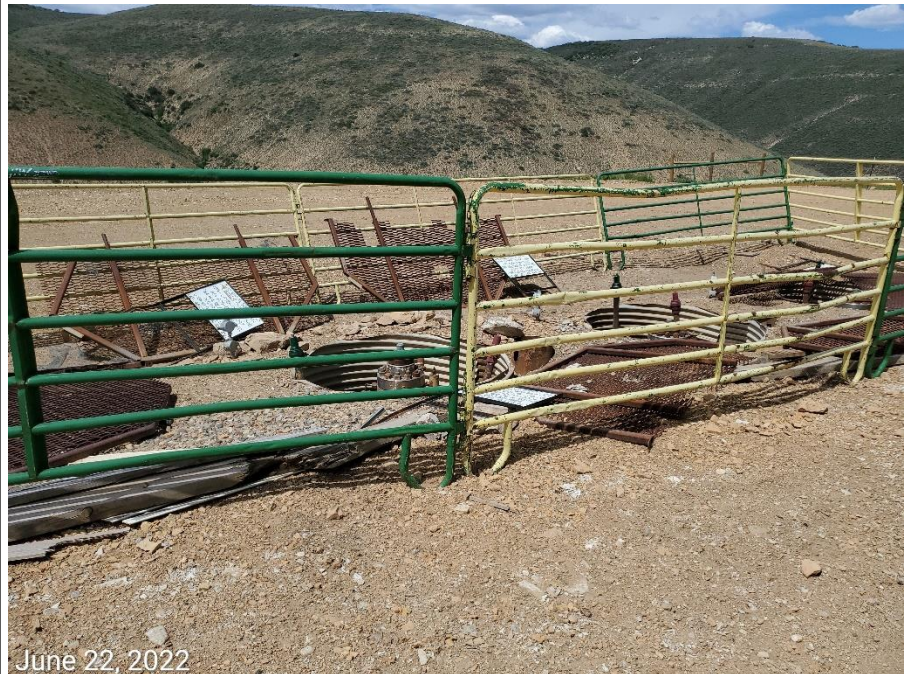
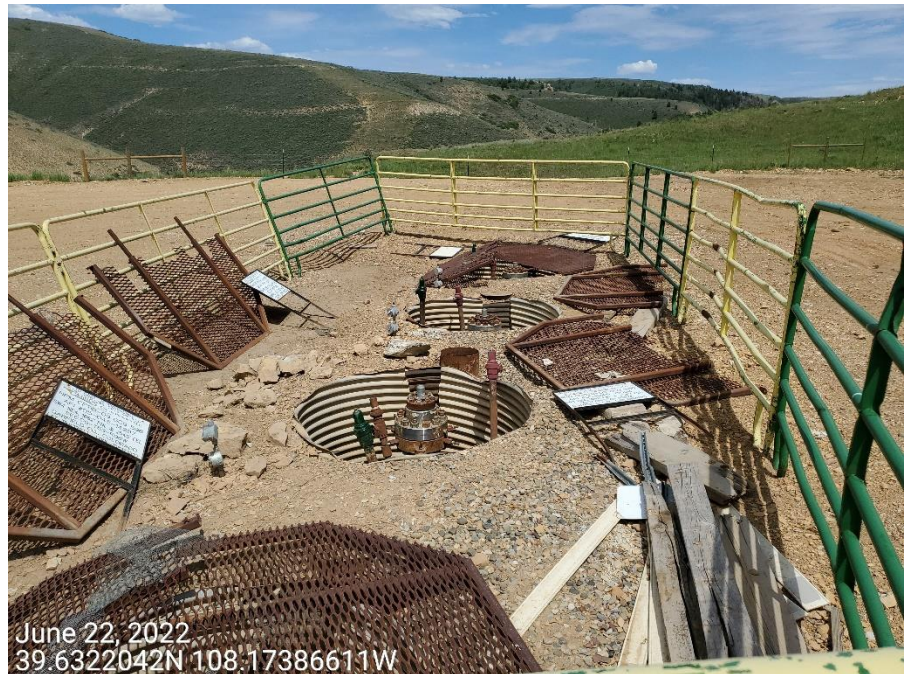
Photo 5: Photos taken from the TA wells on the east end of the Location. Photo shows uncovered cellars/pipes, and well signs in disarray. Photo also shows wood and trash debris

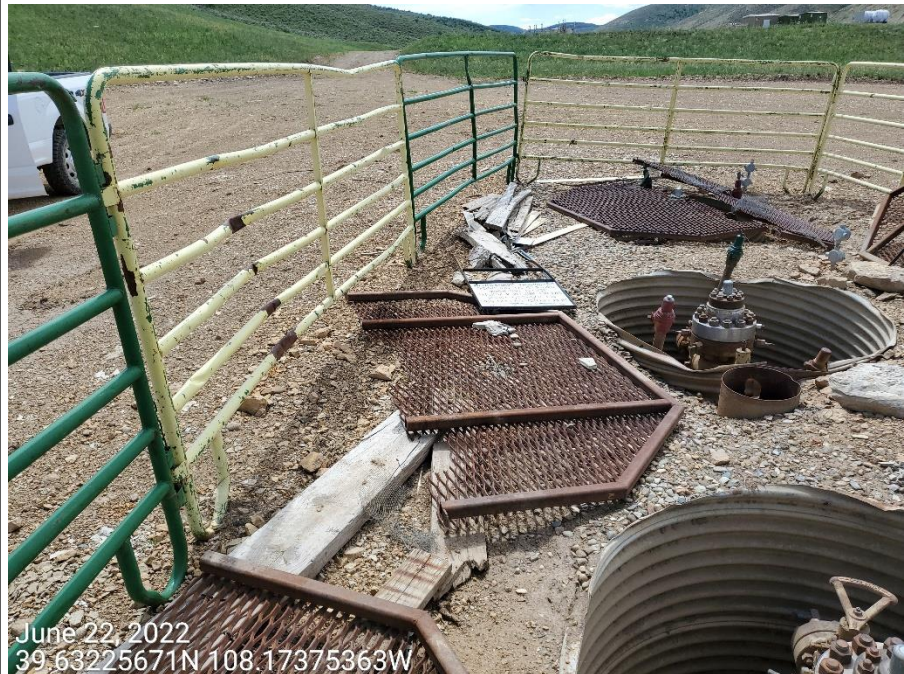
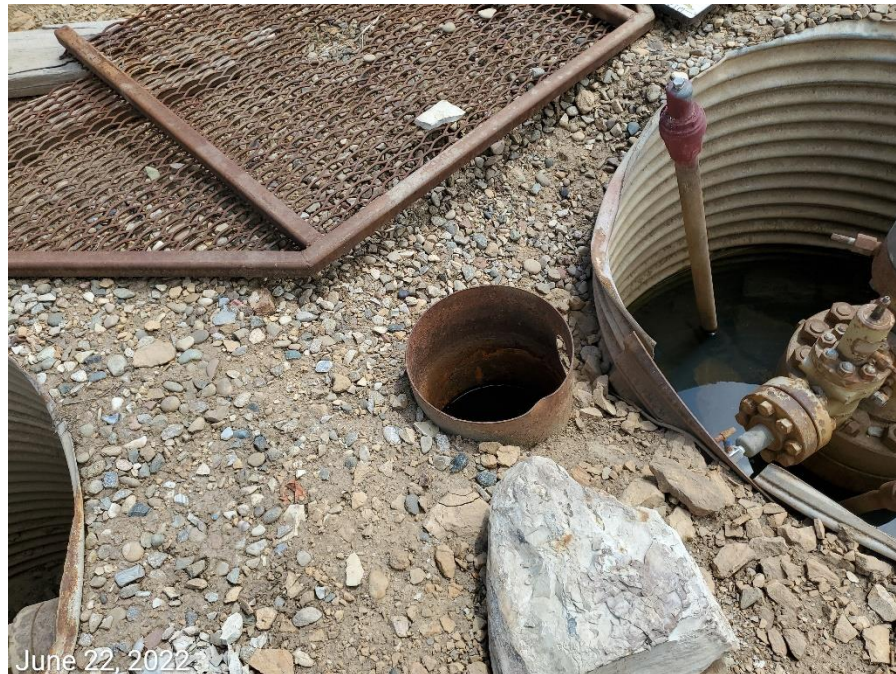
Photo 6: Photos taken from the TA wells on the east end of the Location. Photo shows uncovered cellars/pipes, and well signs in disarray. Photo also shows wood and trash debris

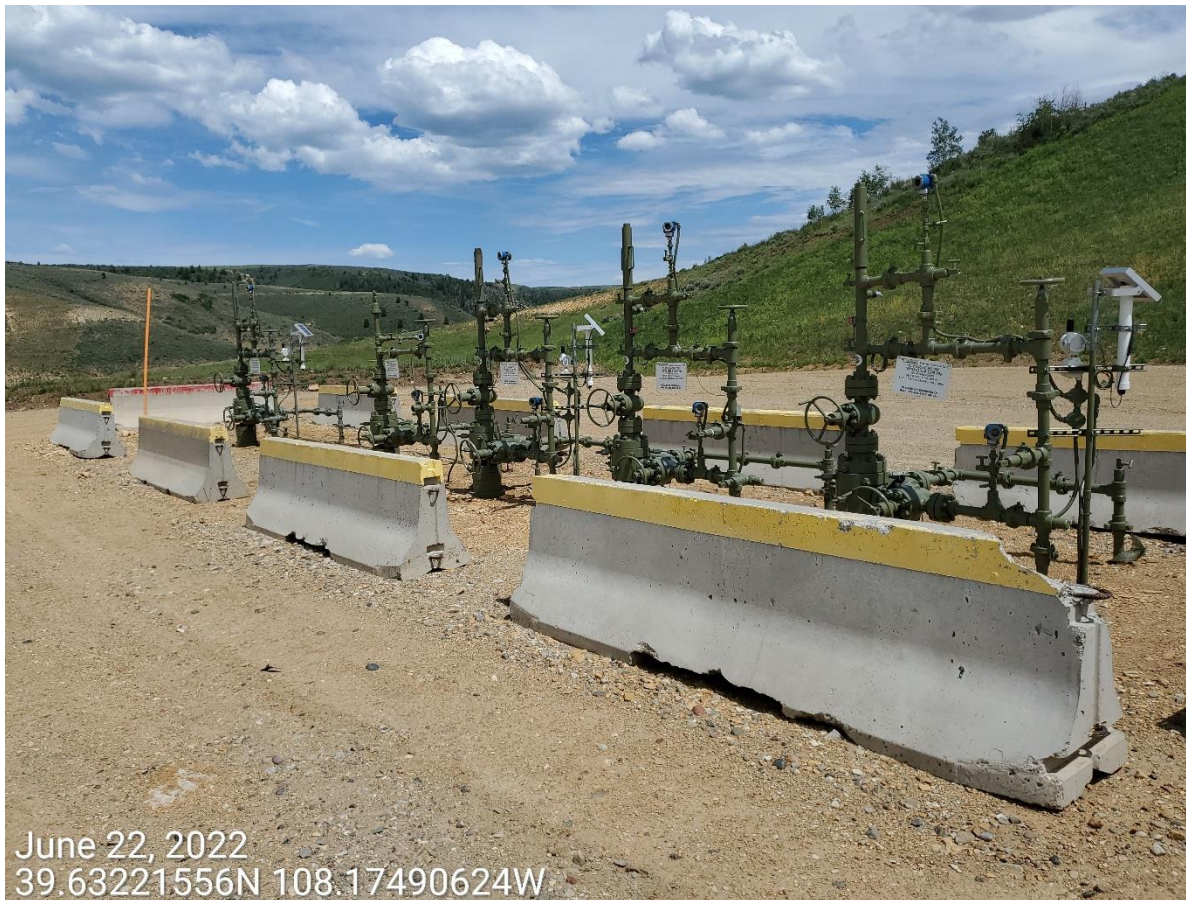
Photo 7: Photo shows string of wells along the upper (wester) section of the working pad. Wells include 045-23878/23874/23873/23876/23881. Unable to find evidence of well 045-23877.
