Attachment B

Field Notes

Former Eckhardt 43-34 Wellhead

(Separator Release)

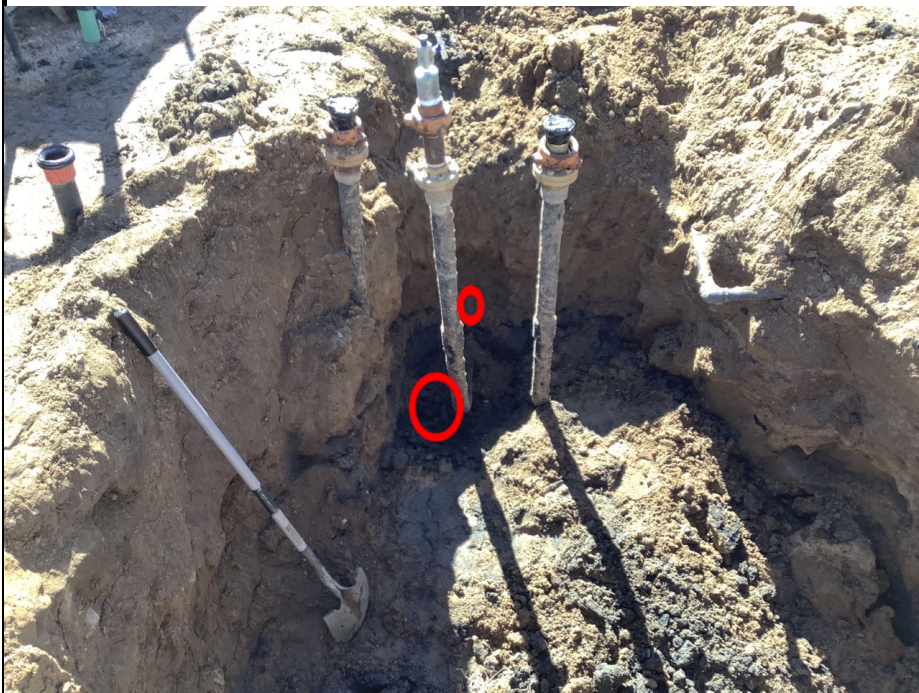
Equipment ID:		Equipment Type:		Equipment ID:		Equipment Type:			
Material:		Volume:		Material:		Volume:		Contents:	
Notes/Conditions: SS06 (4'), SS07 (6') [hole dug to 6']					Notes/Conditions: SS08 (7') (soil filled hole dug to 7')
