Construction and Stormwater Inspection

Operator: EXTRACTION OIL & GAS INC- #10459

Location ID: 460670

Inspection Photos
Location Name: Blue Paintbrush /Pad
Location ID: 460670

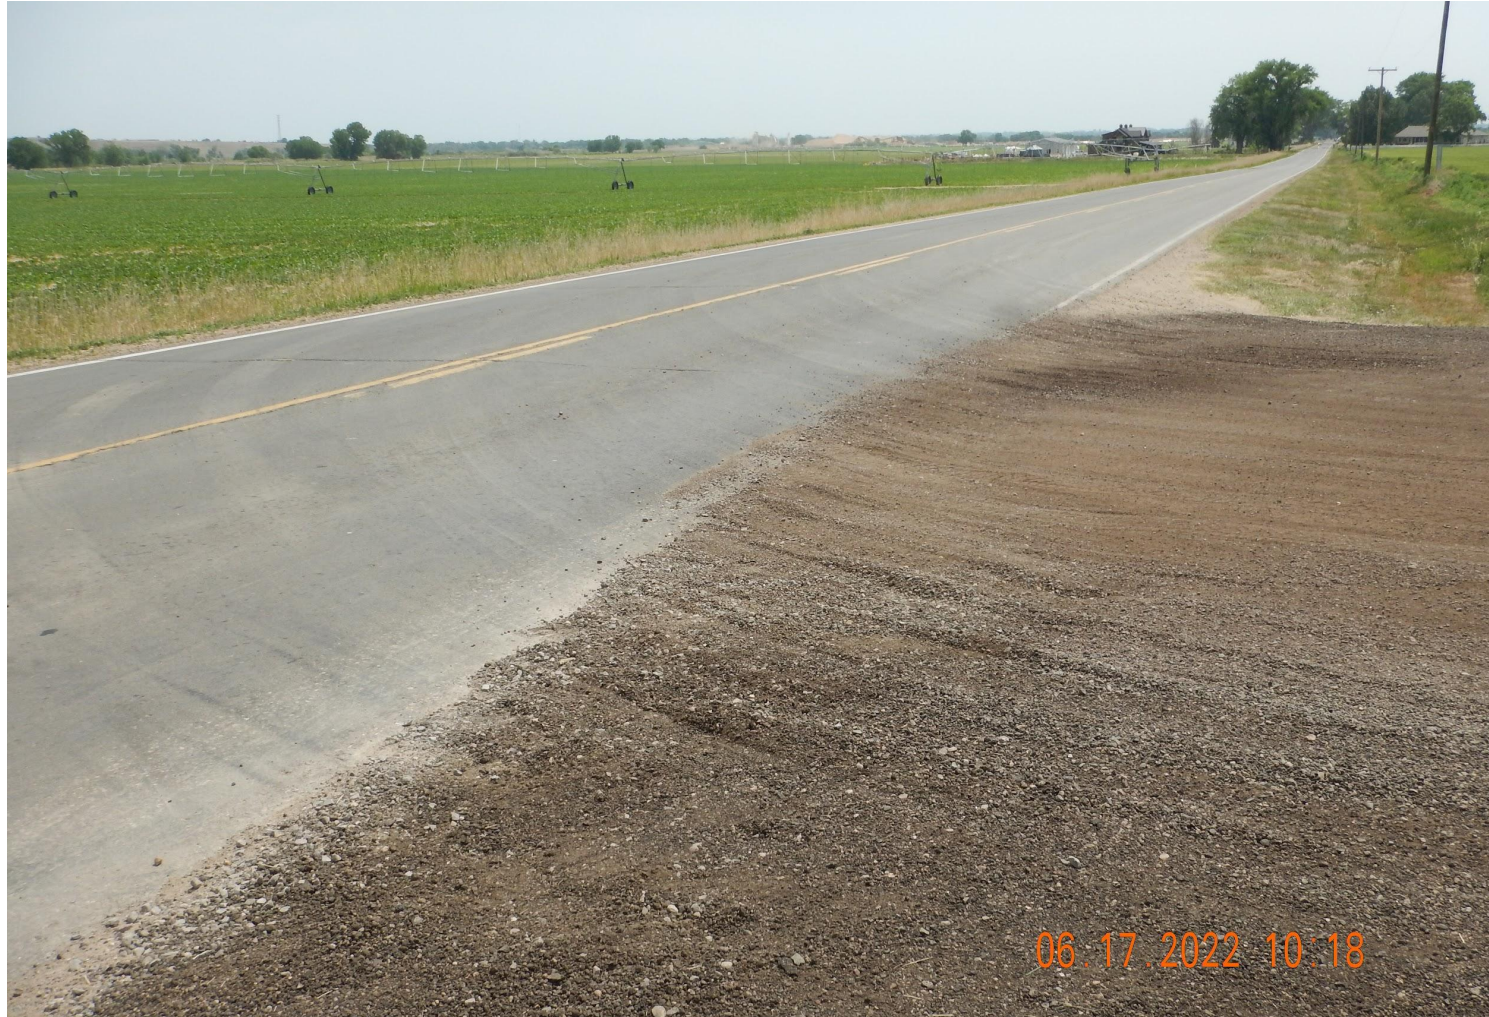
Photo 1. Photo taken from the entrance of location, facing East. Photo illustrates Operator has cleaned up the sediment track out and there were no observed issues during this inspection.

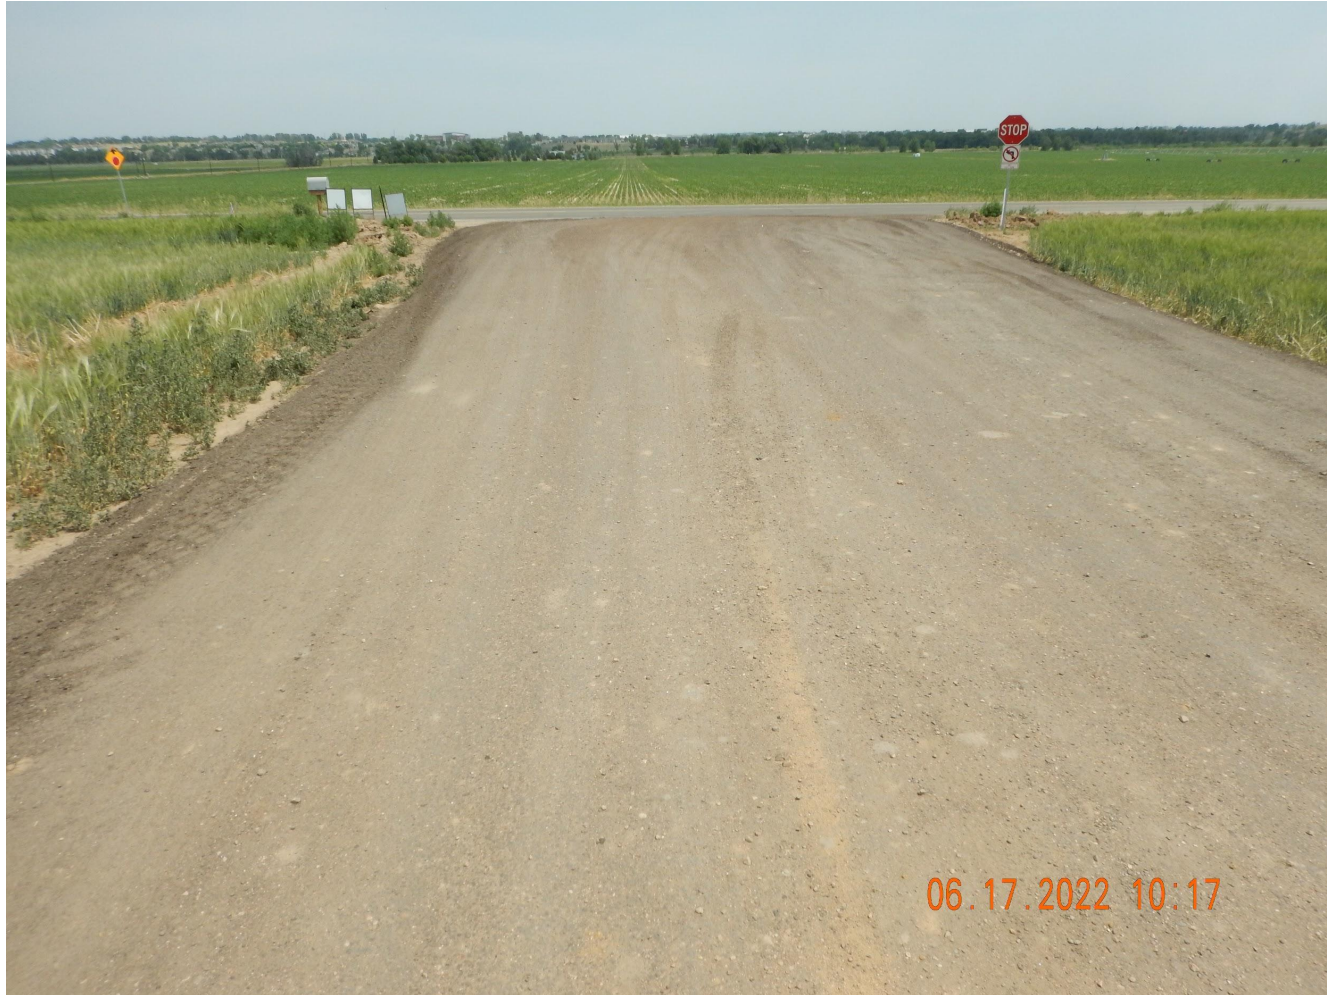
Photo 2. Photo taken from the entrance of location, facing North. Photo illustrates Operator added recycled asphalt as additional BMP.

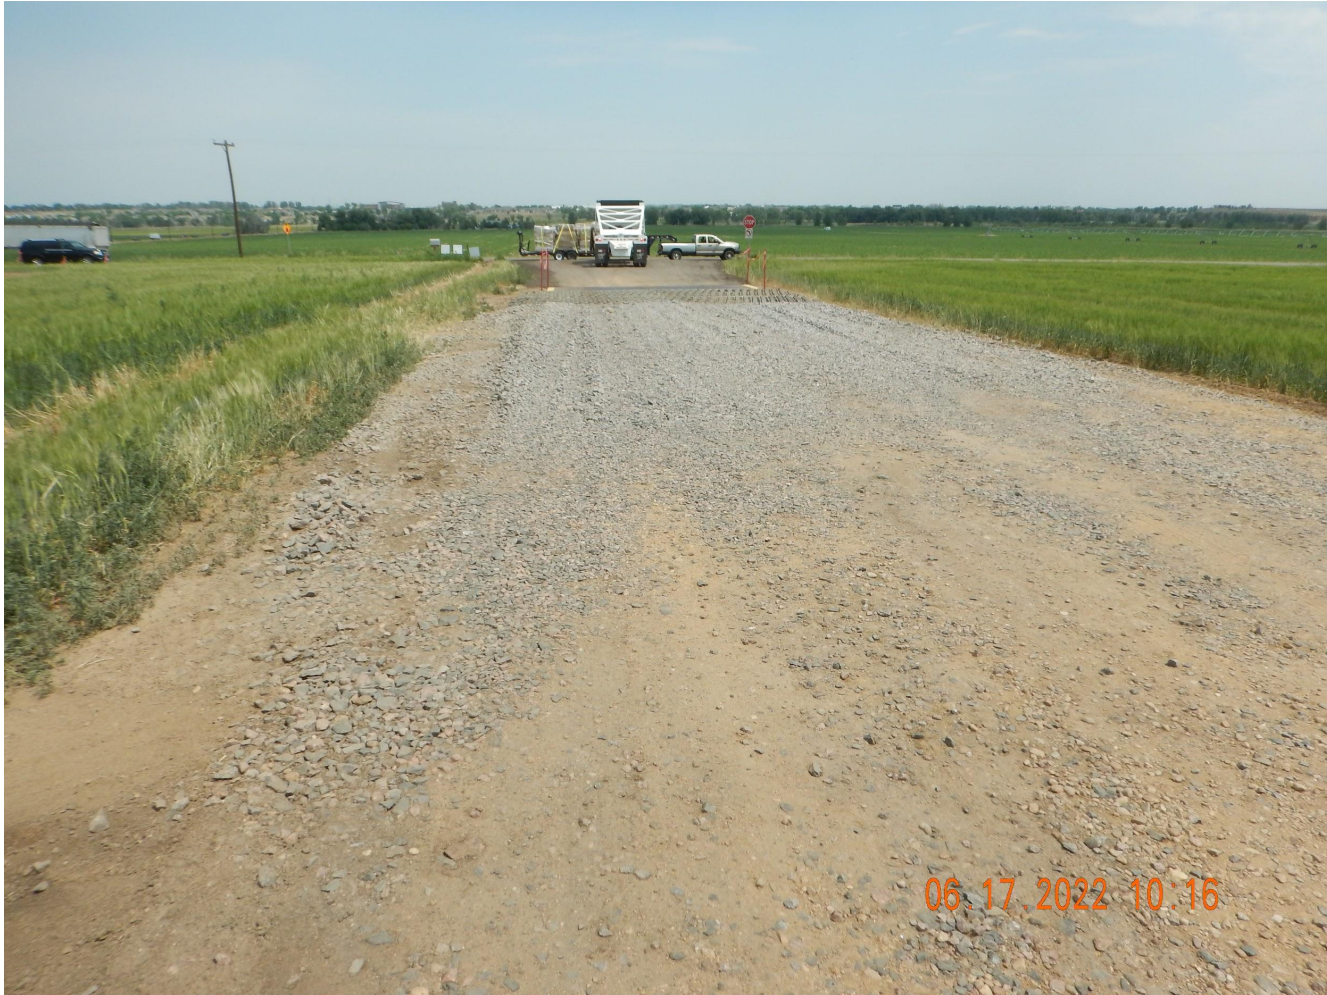
Photo 3. Photo taken south of the entrance, facing North. Photo illustrates additional tracking device BMPs have been added (additional rock, recycled asphalt and additional roadbase was added to the entire access road). Also, Operator performed the required BMP maintenance.

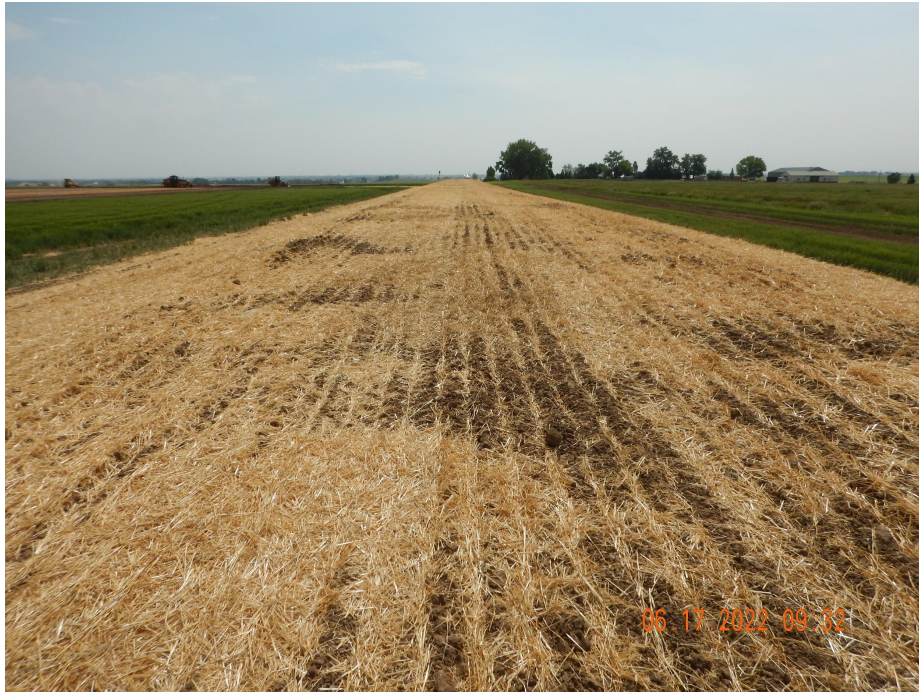
Photo 4. Photo taken from the western topsoil stockpile, facing East. Operator has seeded and straw crimped mulch into the topsoil.

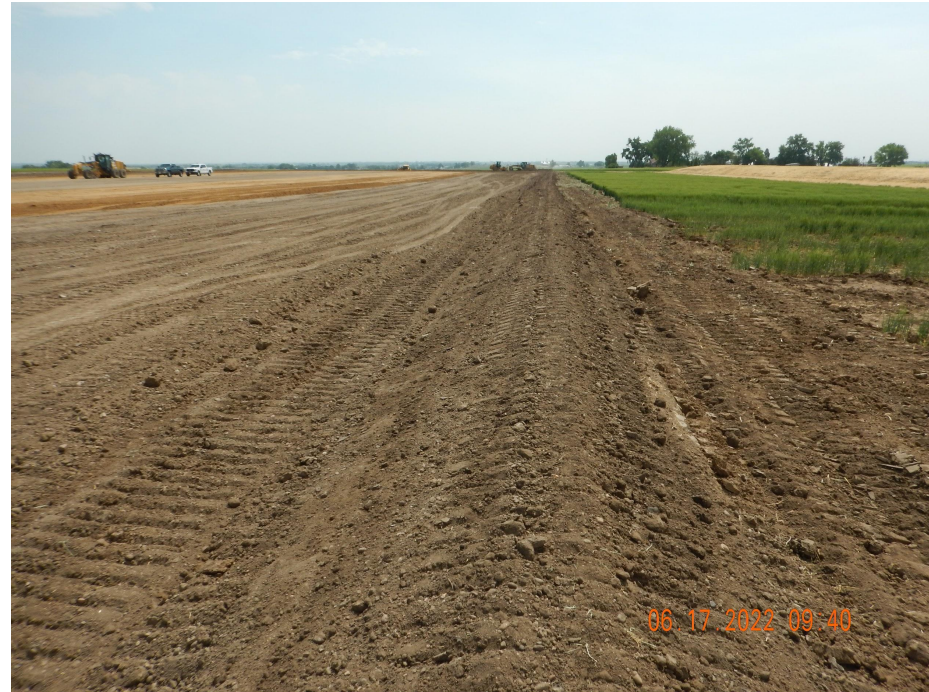
Photo 5. Photo taken from the southwestern well location, facing East. Photo illustrates a graveled berm BMP has been installed as an additional stormwater BMP.
