Inspection Photos

API: 071-09918

Operator: BNL (ENTERPRISE) INC

Inspection Date: 6/29/2022

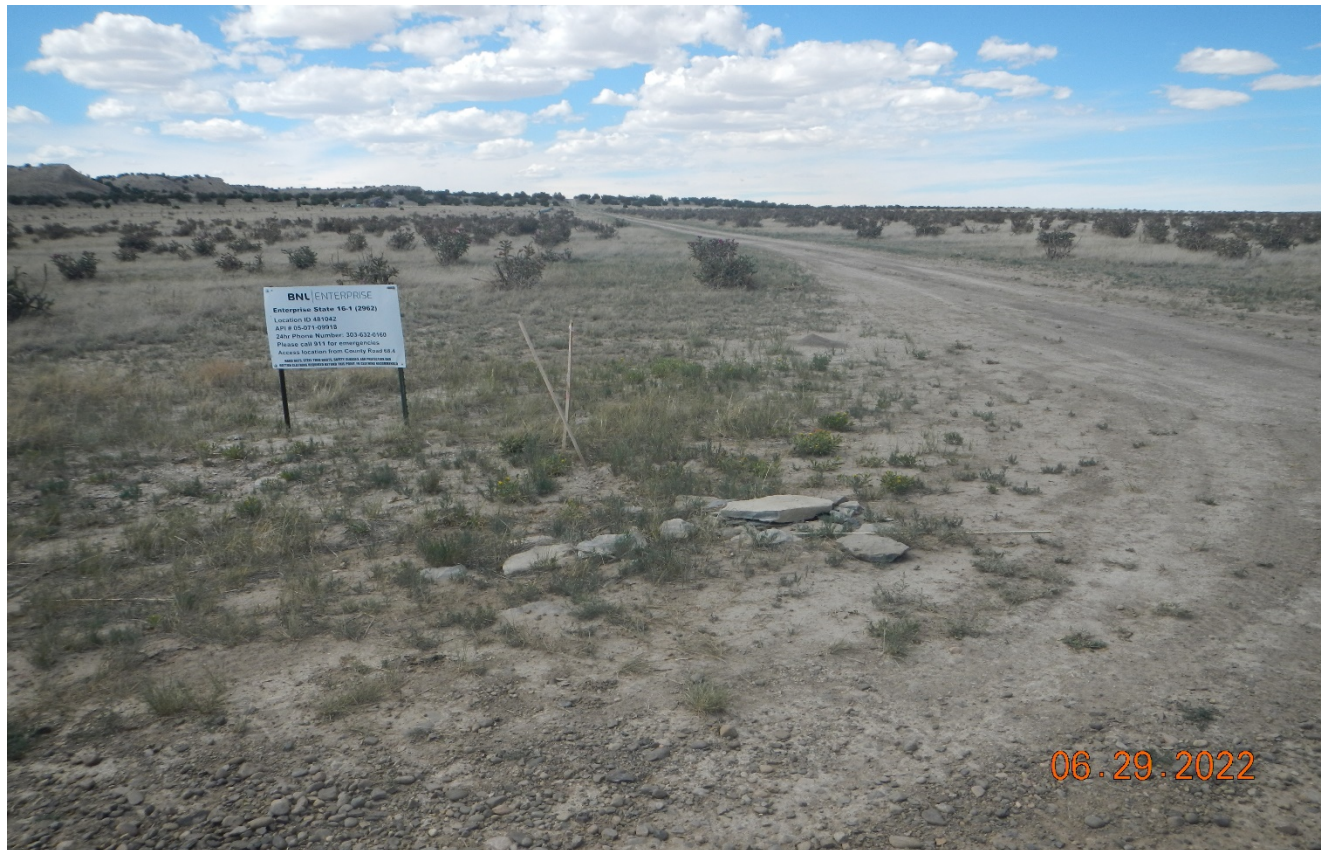
Photo 1. Facing north along the access road. Sign is posted at access road entrance.

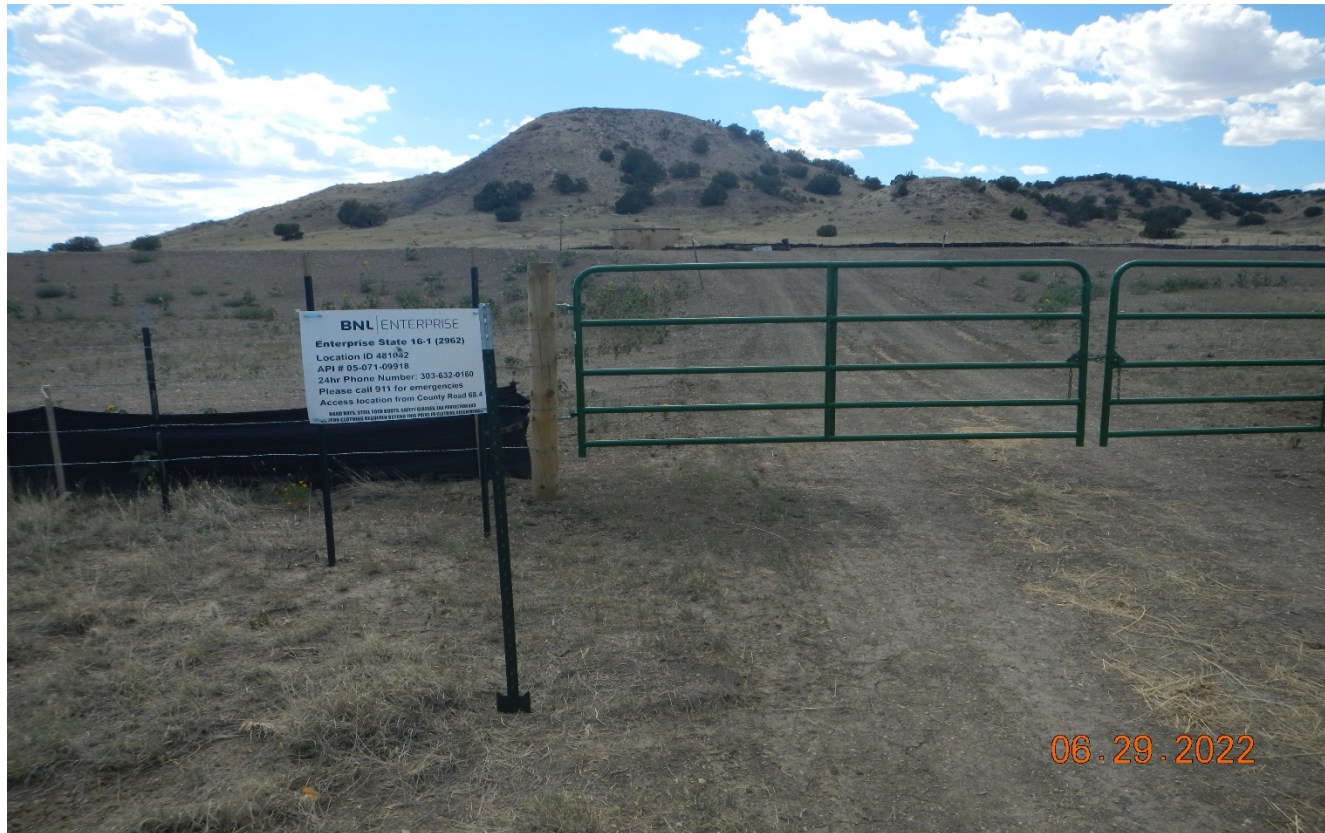
Photo 2. Facing west toward the location. Well sign is posted at the location. The location is fenced and gates have been installed.

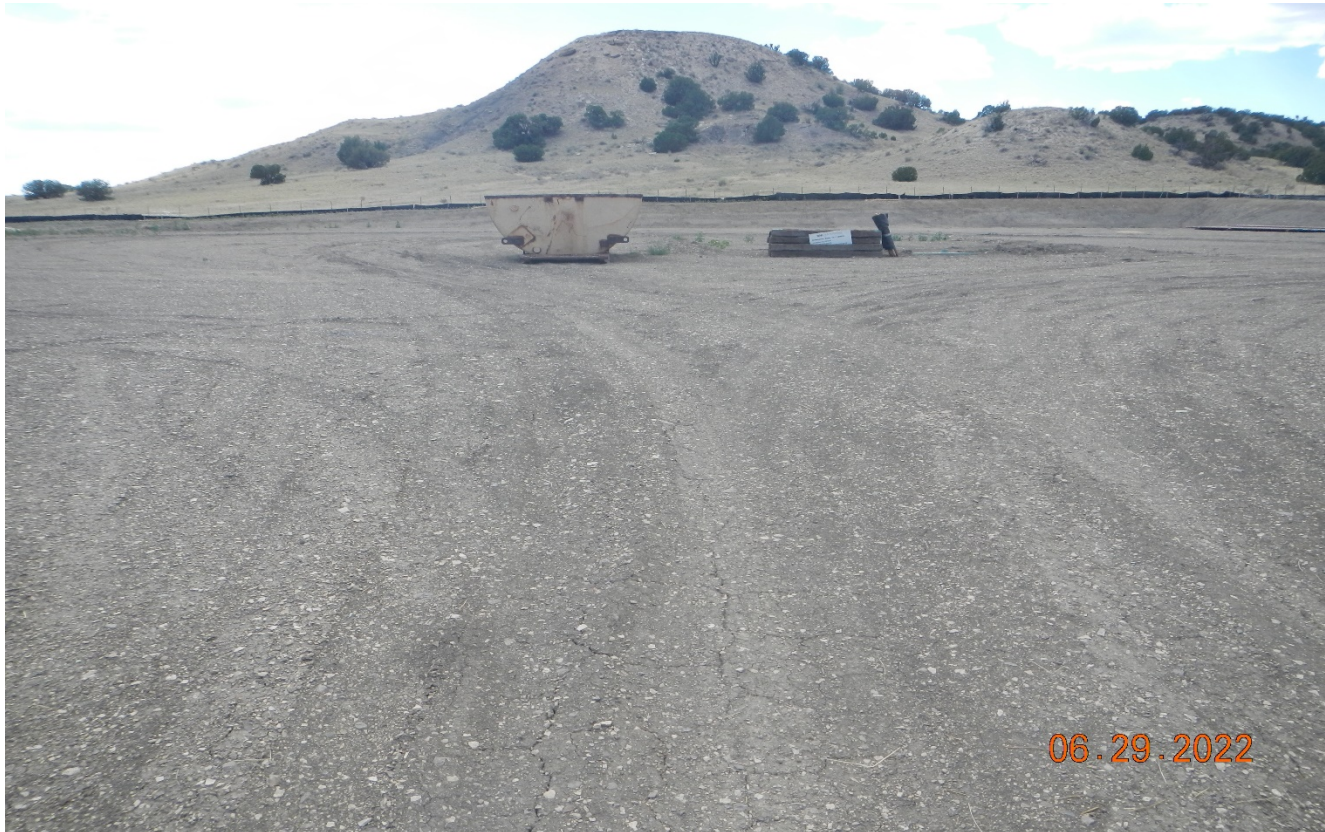
Photo 3. Facing west toward the well site. There is an open top tank near the well that is full of fluid. Secondary containment will need to be installed per 603.o. or the tank and fluids need to be removed.

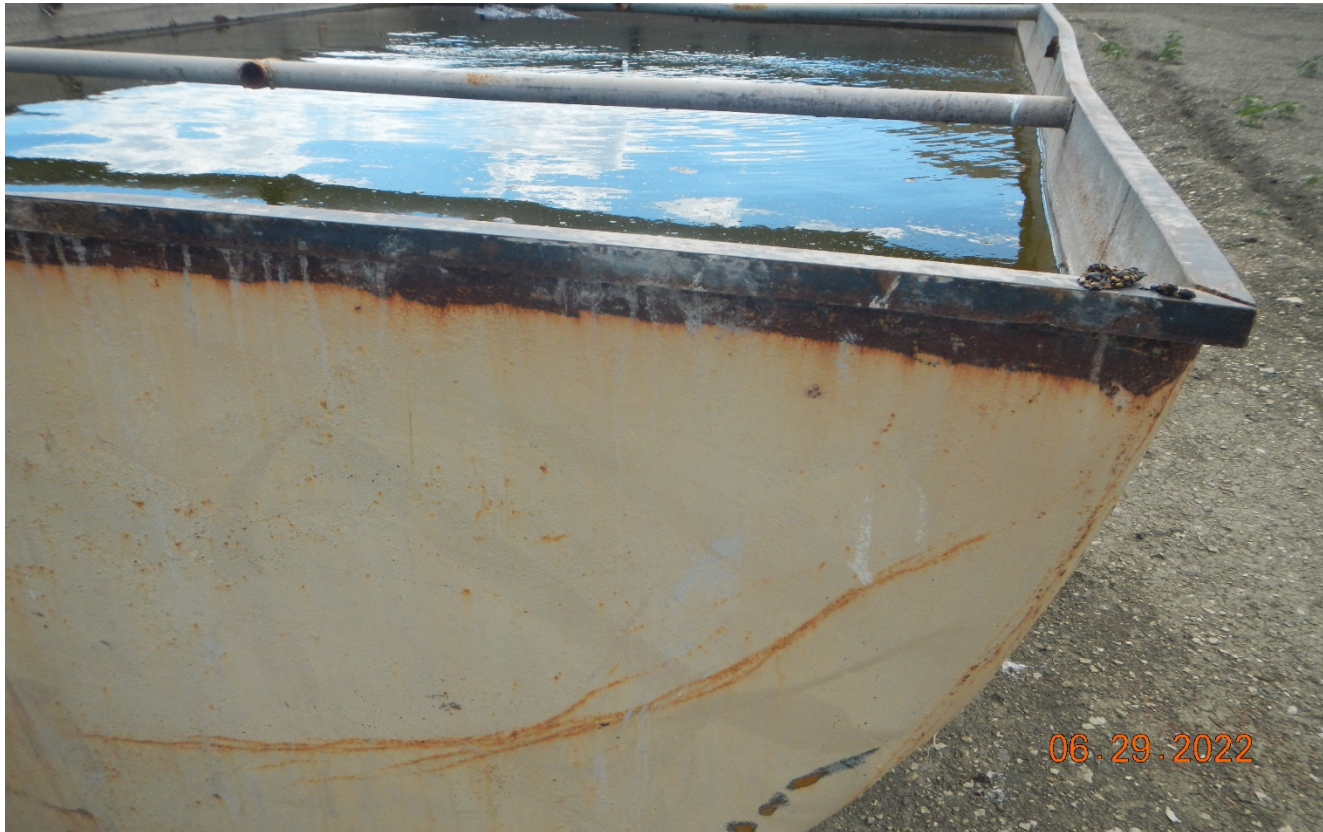
Photo 4. This photo shows the fluid level of the tank No wildlife protection (netting) is installed to prevent entry.

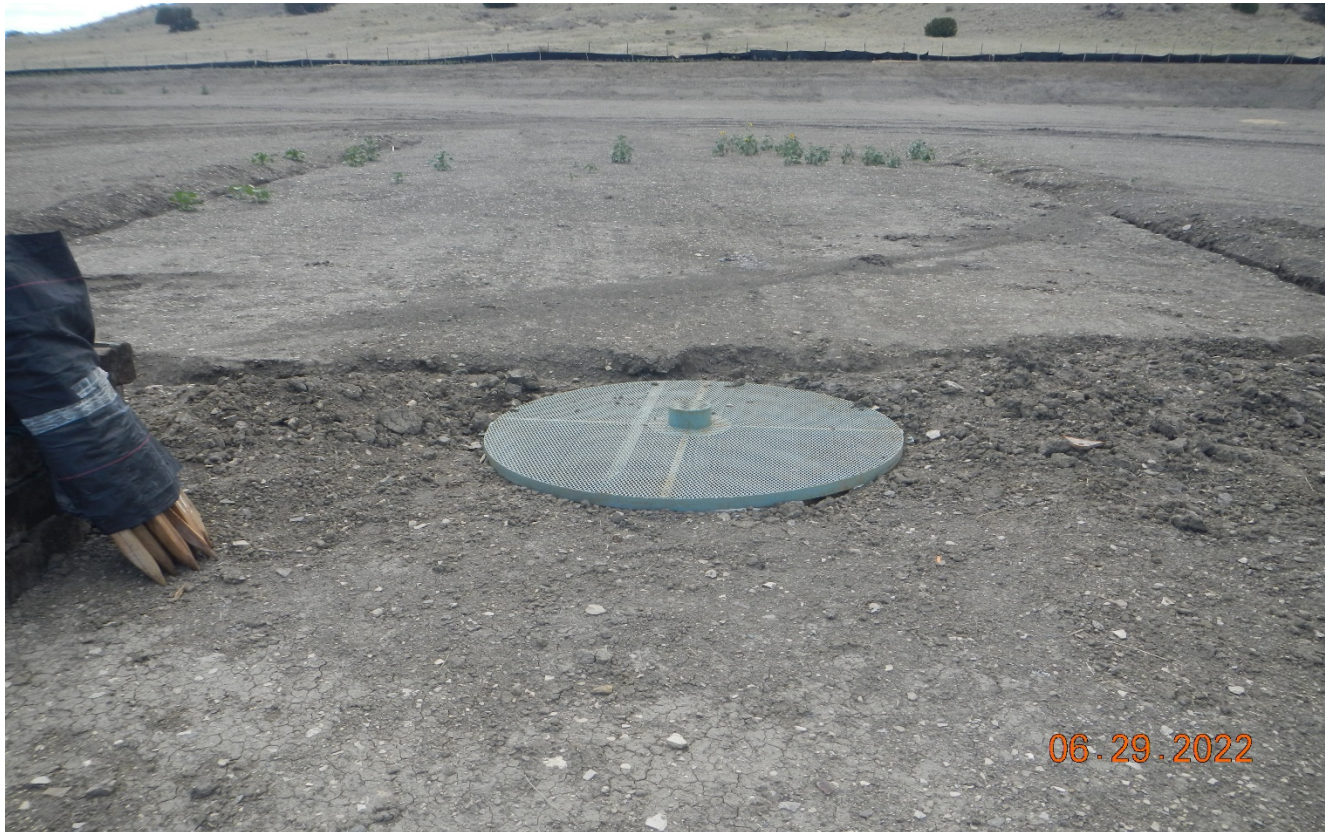
Photo 5. The wellhead has been cover to prevent entry.

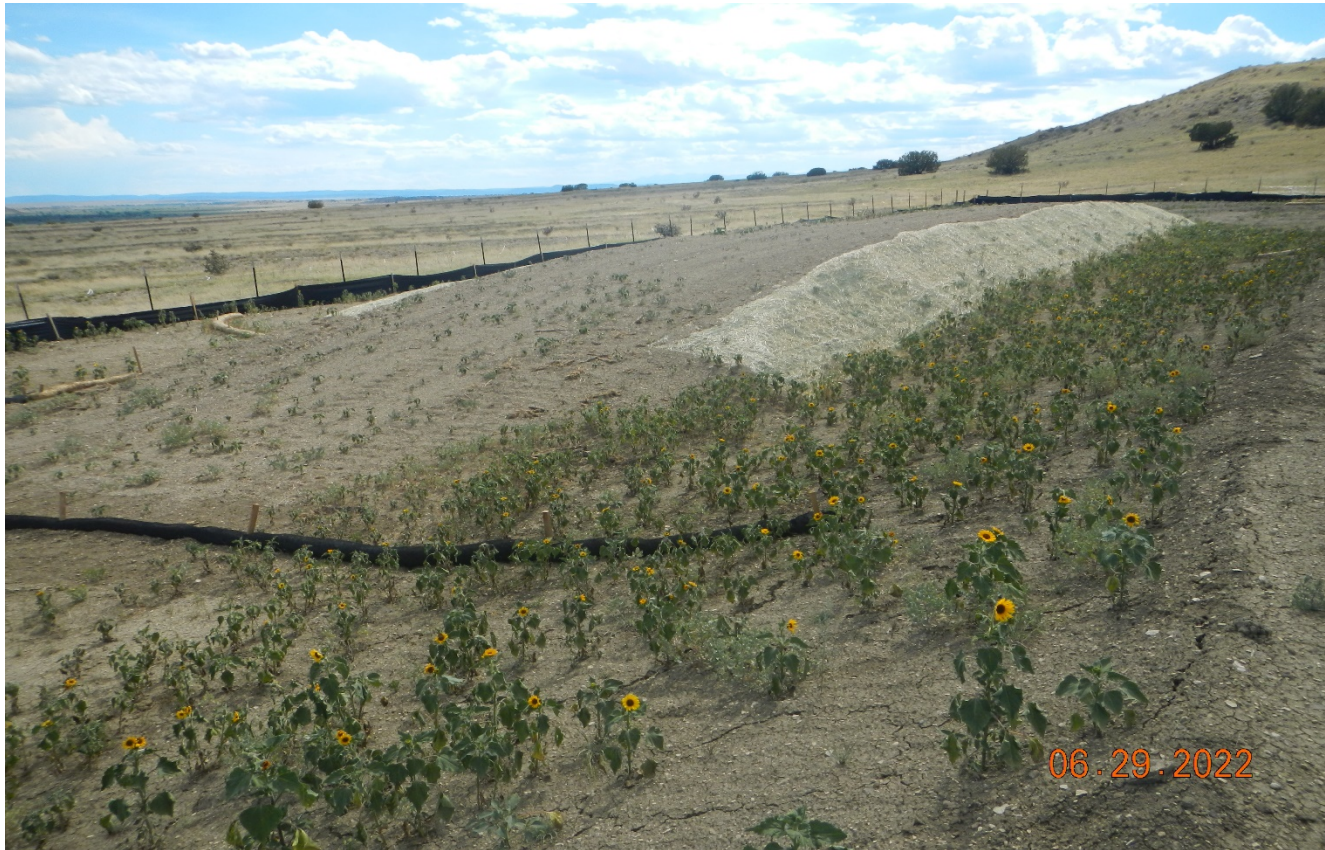
Photo 6. Facing toward the topsoil pile. It does not appear the entire topsoil pile was seeded as vegetation is not establishing. All unused disturbed areas will need to be reclaimed.

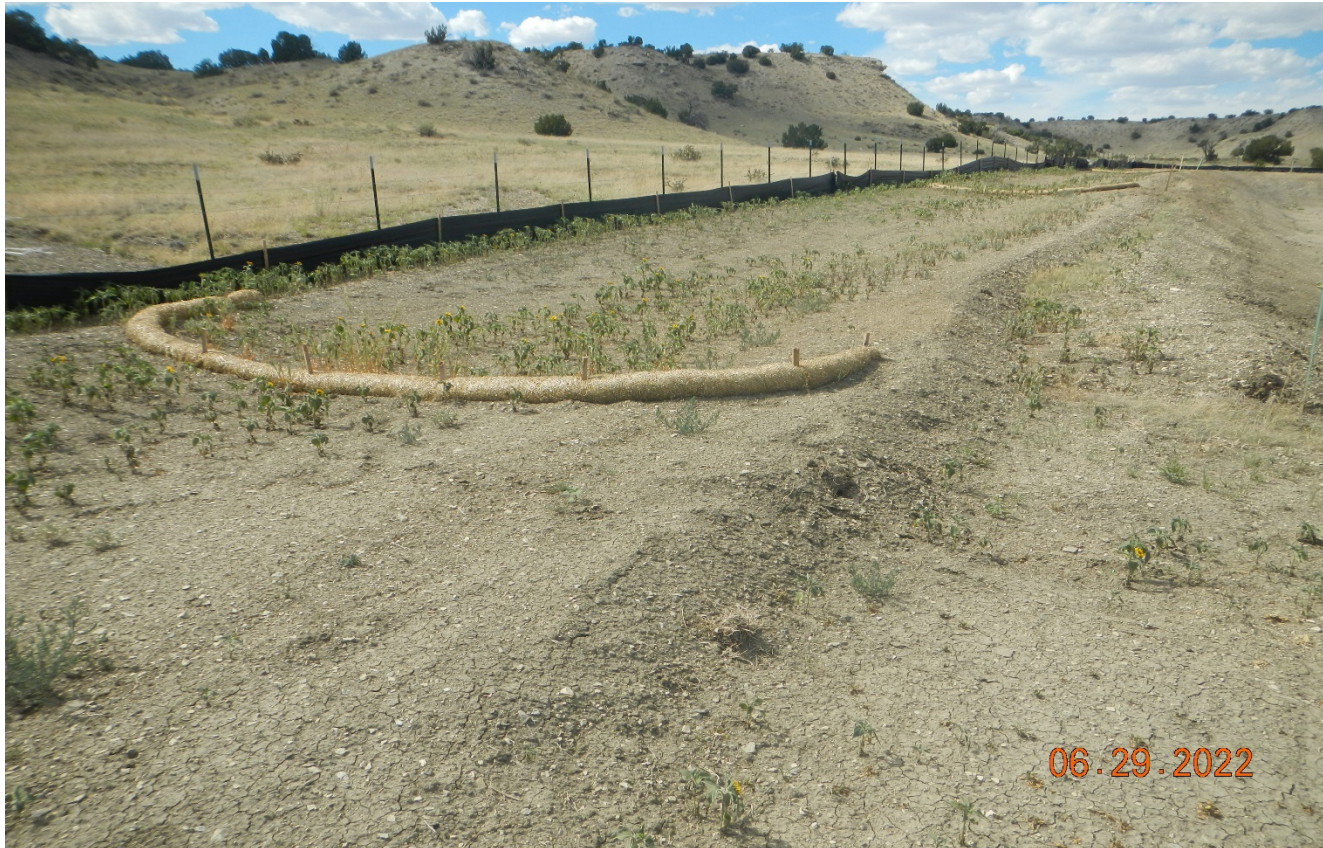
Photo 7. Southwest side of the location facing northwest. There are wattles installed along the perimeter swale. The disturbed soils will need to be reclaimed for long term stabilization.

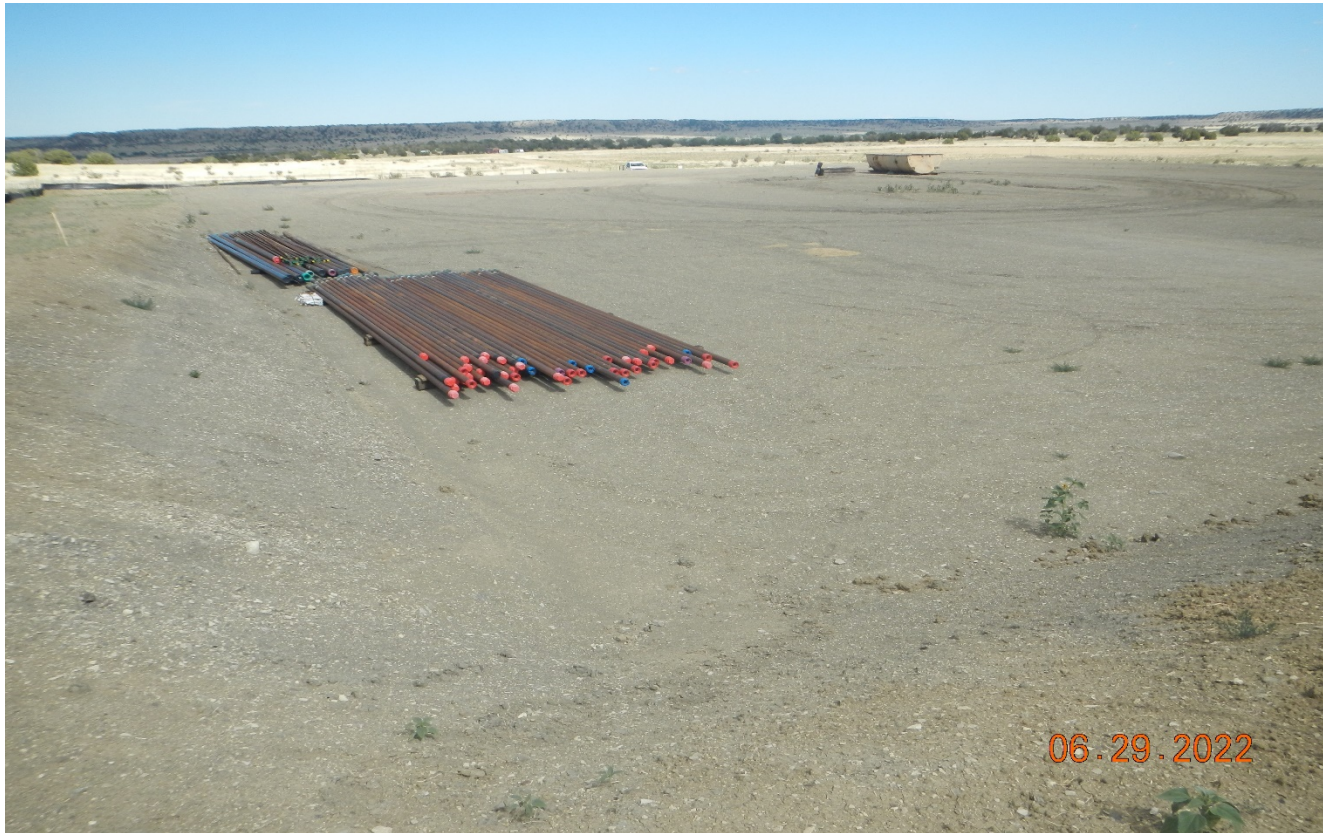
Photo 8. Northwest side of the location facing southeast toward the location.
