Interim Reclamation and Stormwater Inspection

June 16, 2022

Operator: CCRP OPERATING INC - #10665

Location Name: Grynberg Stateline Federal /24-12-65-4 Pad

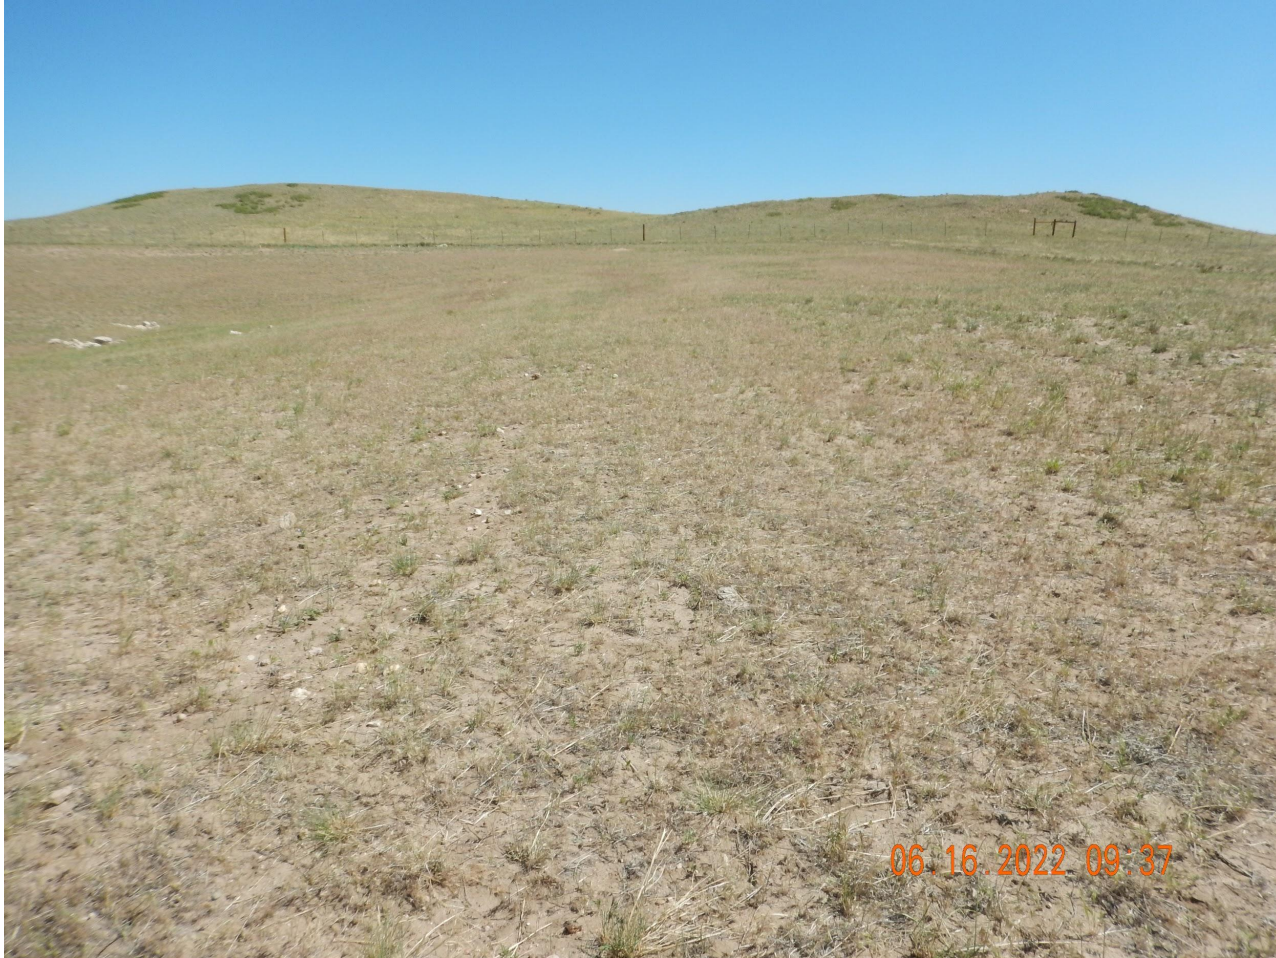
Photo 1. Photo taken from eastern interim reclamation area, facing North. Photo illustrates the establishment of desirable plant species; however, the plant cover is not reflective of reference areas and the establishment of cheatgrass has increased since the previous inspection.

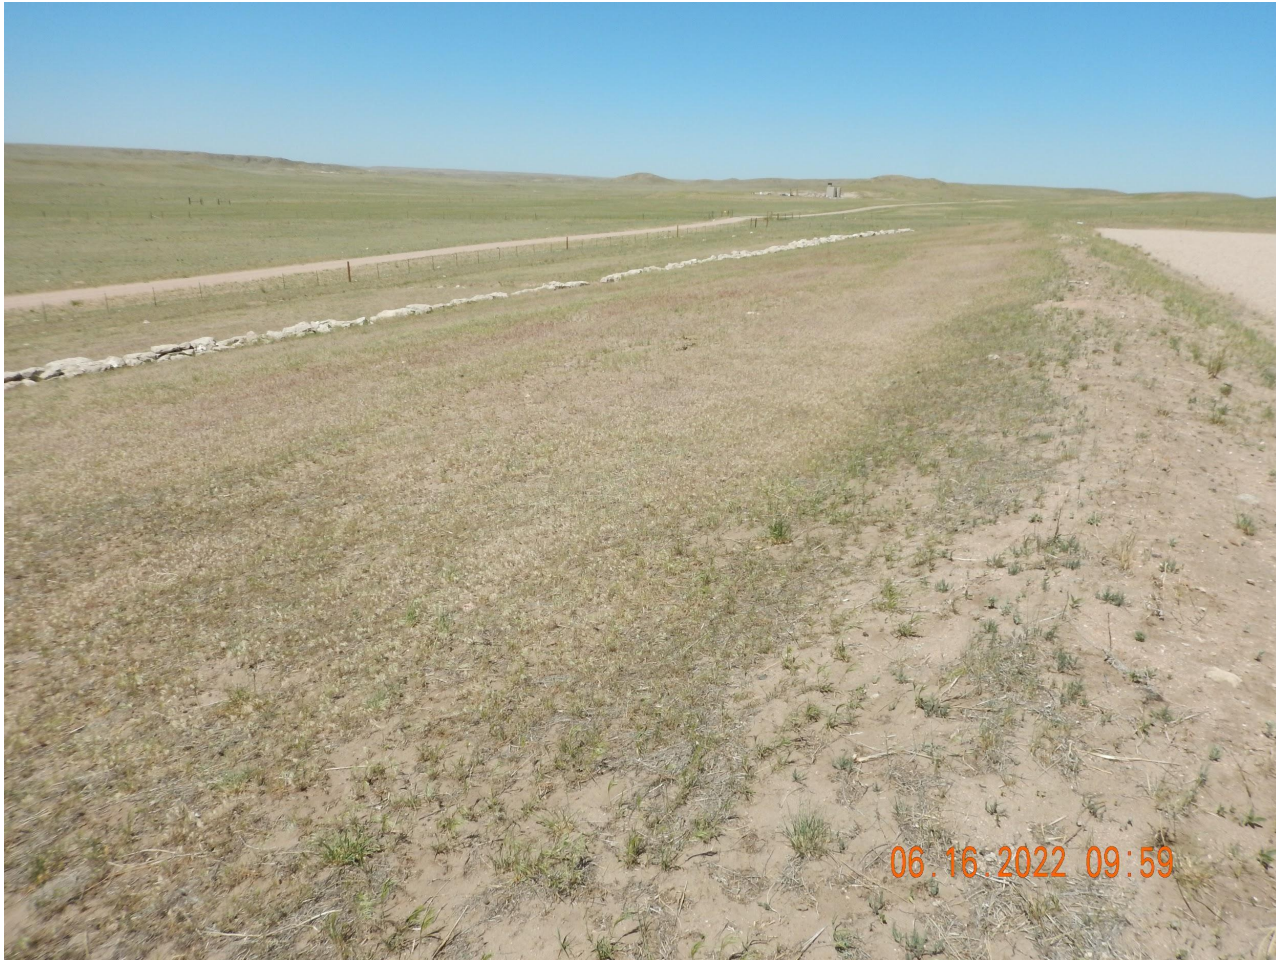
Photo 2. Photo taken from southeastern interim reclamation area, facing West. Photo illustrates cheatgrass is the dominant vegetative cover along the southern fill slope with some desirable vegetation.

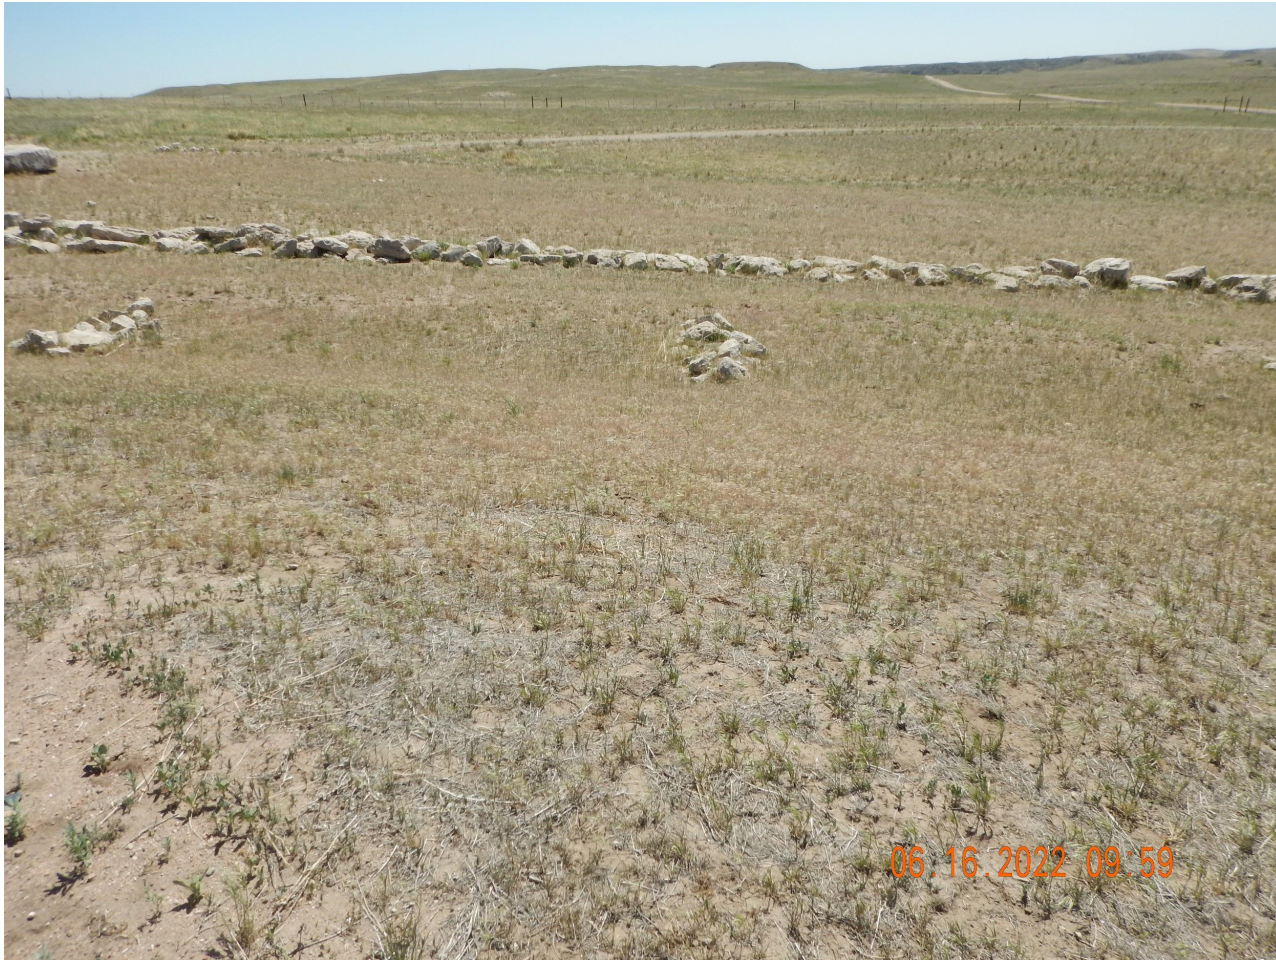
Photo 3. Photo taken from southeastern interim reclamation area, facing East. Photo illustrates cheatgrass is the dominant vegetative cover along the southeastern interim area.

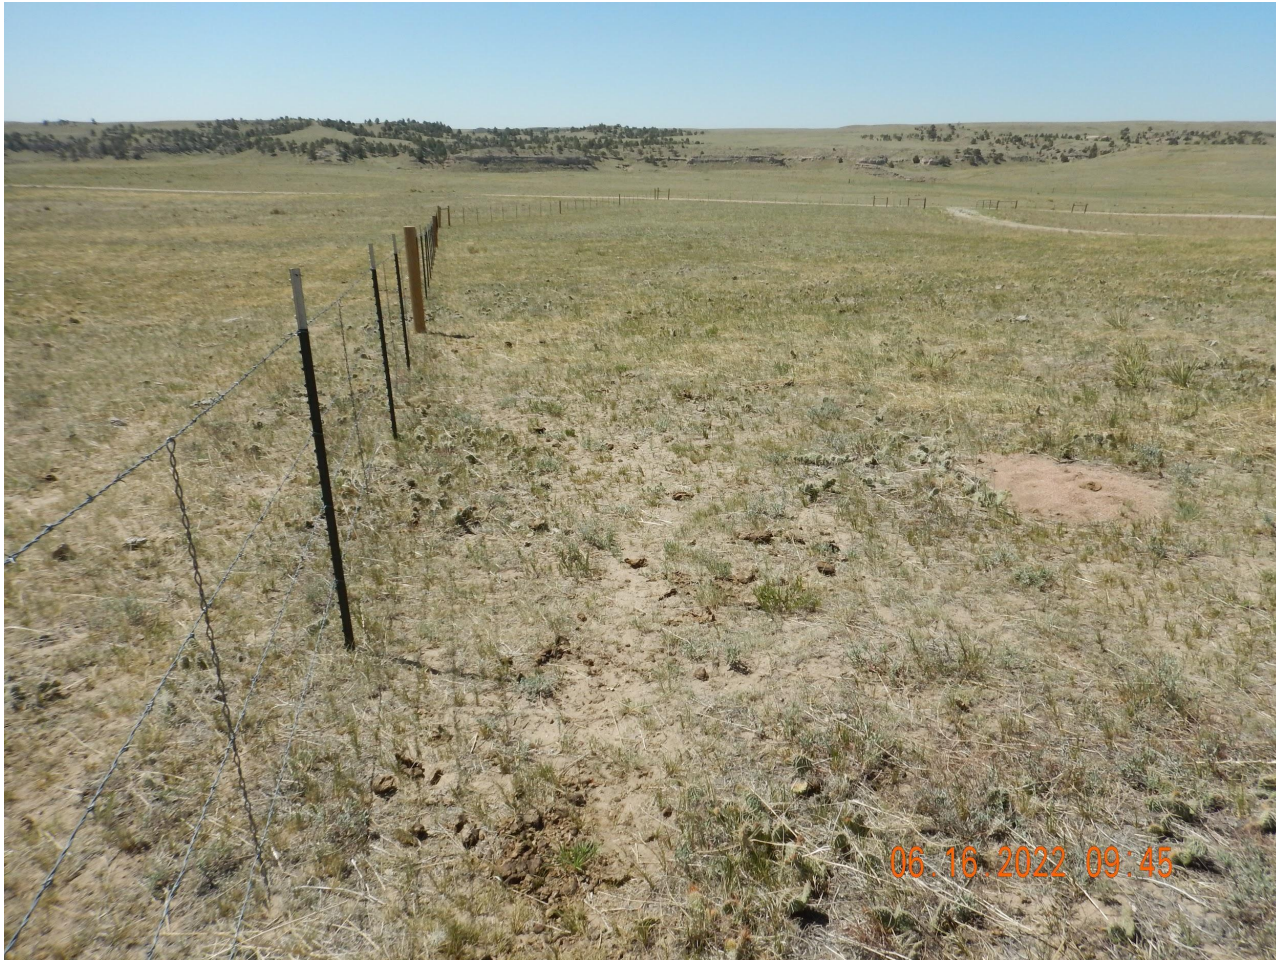
Photo 4. Photo taken from eastern perimeter of location, facing South. Photo illustrates cheatgrass was not observed.

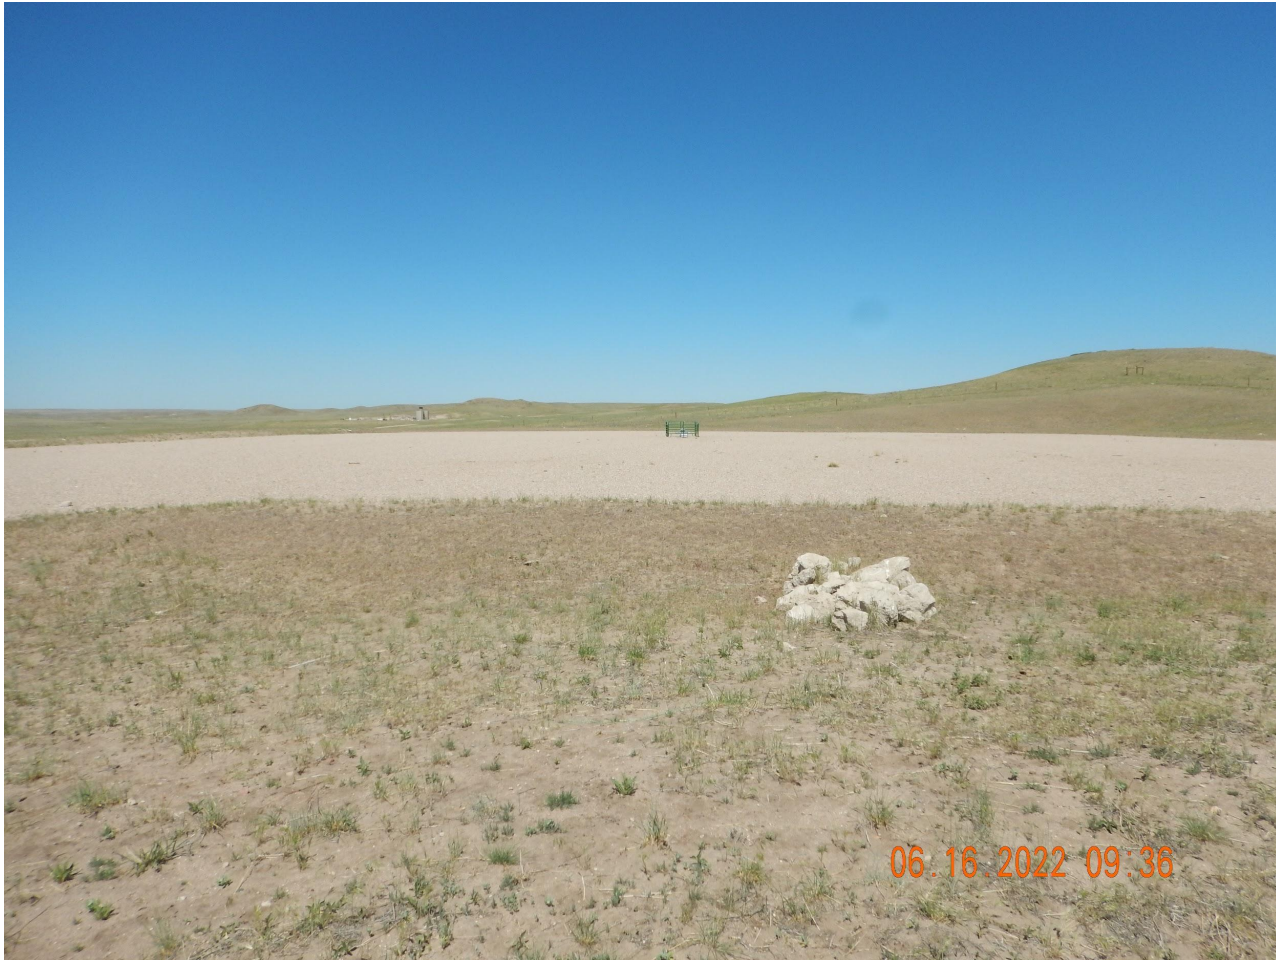
Photo 5. Photo taken from eastern interim reclamation area, facing West. Photo the well pad has been stabilized and there does not appear to be any sediment movement via wind erosion.
