Inspection Photos and Issue Report

Operator: CAERUS PICEANCE LLC # 10456

Location ID: 334752

Garfield County, CO

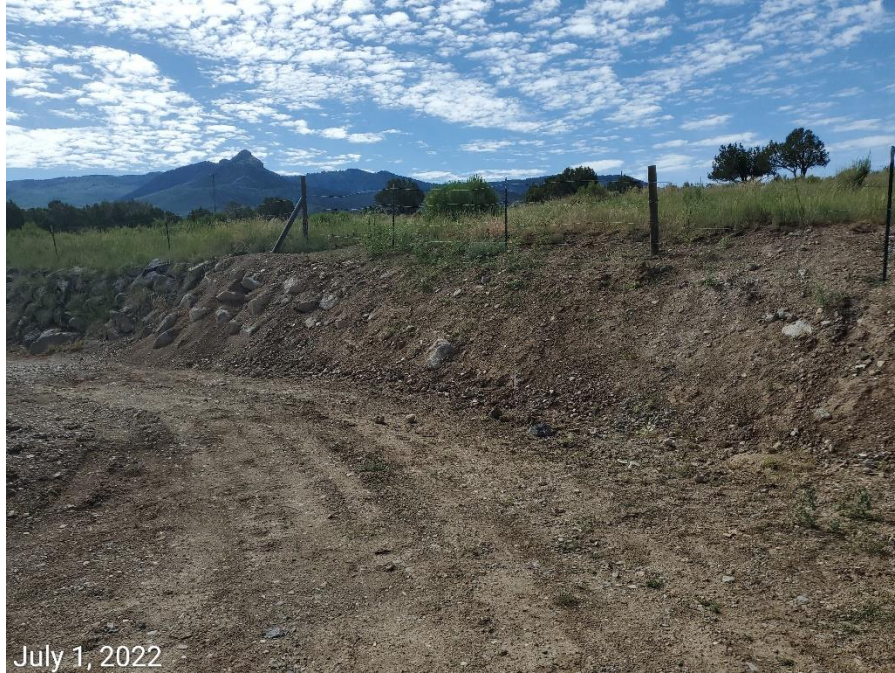
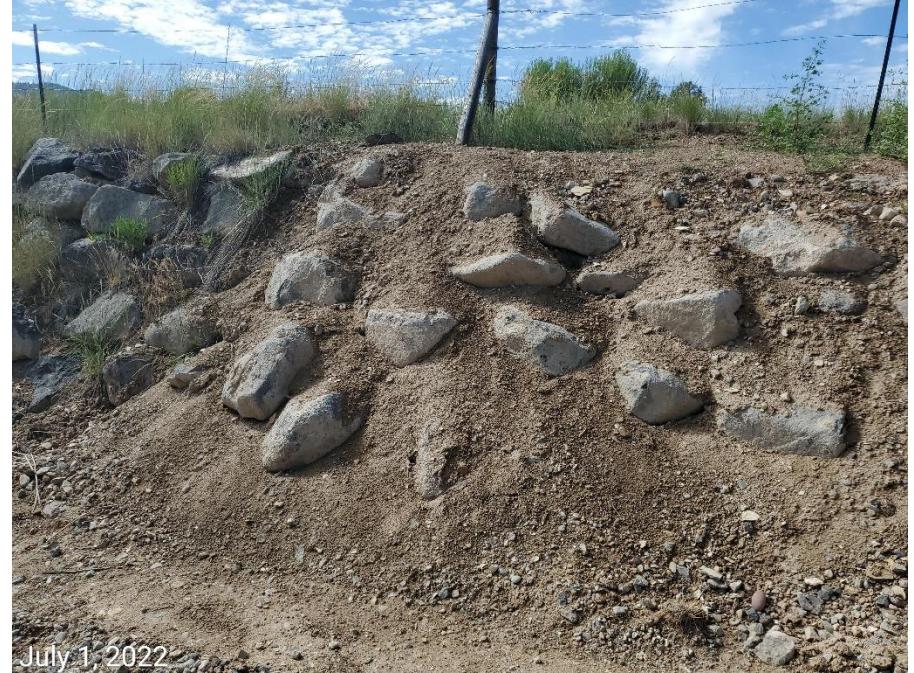
Photo 1: Photos show cut slopes on the south end of the Location. Photo shows Operator appears to have placed additional soils to repair the erosion degradation, however control measures remain missing or insufficient to minimize erosion and degradation.

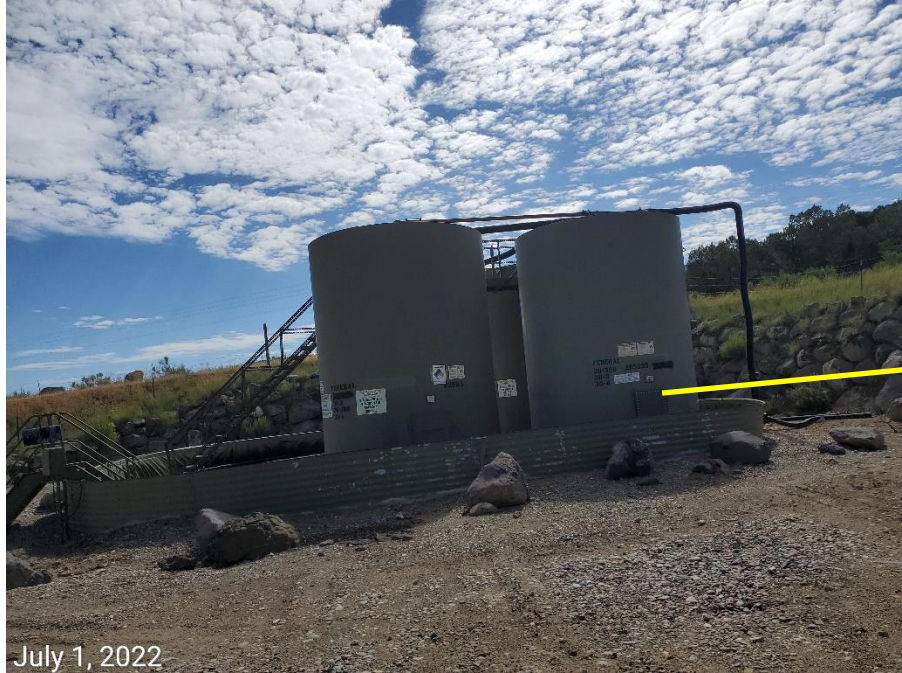
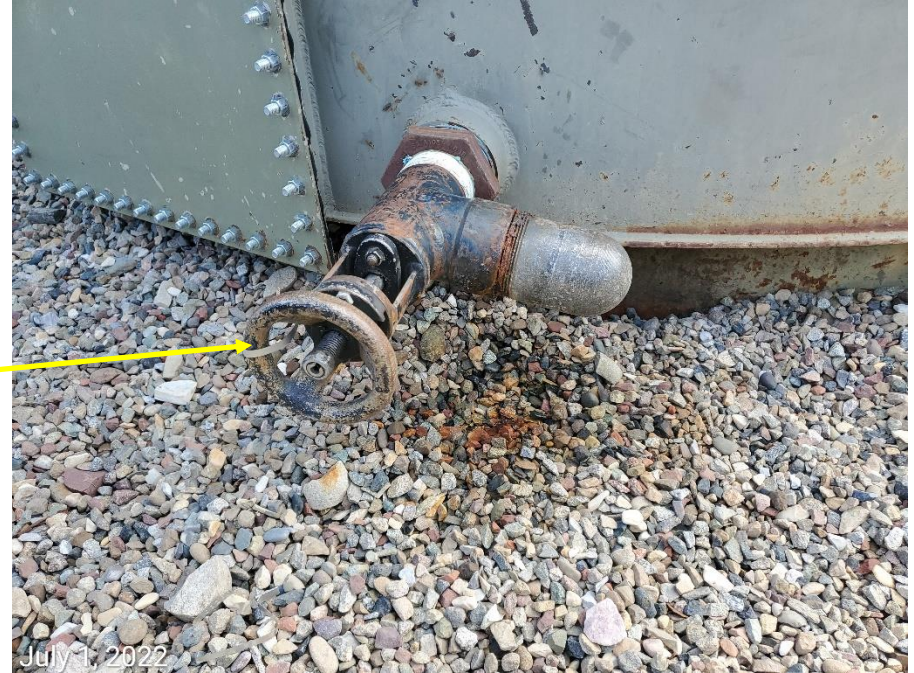
Photo 2: Photo shows tank and bull plug where fluids have continued to leak from.
