Inspection Photos and Issue Report

Operator: CAERUS PICEANCE LLC # 10456

Location ID: 334682

Aaron Trujillo
NW Reclamation Specialist
COGCC

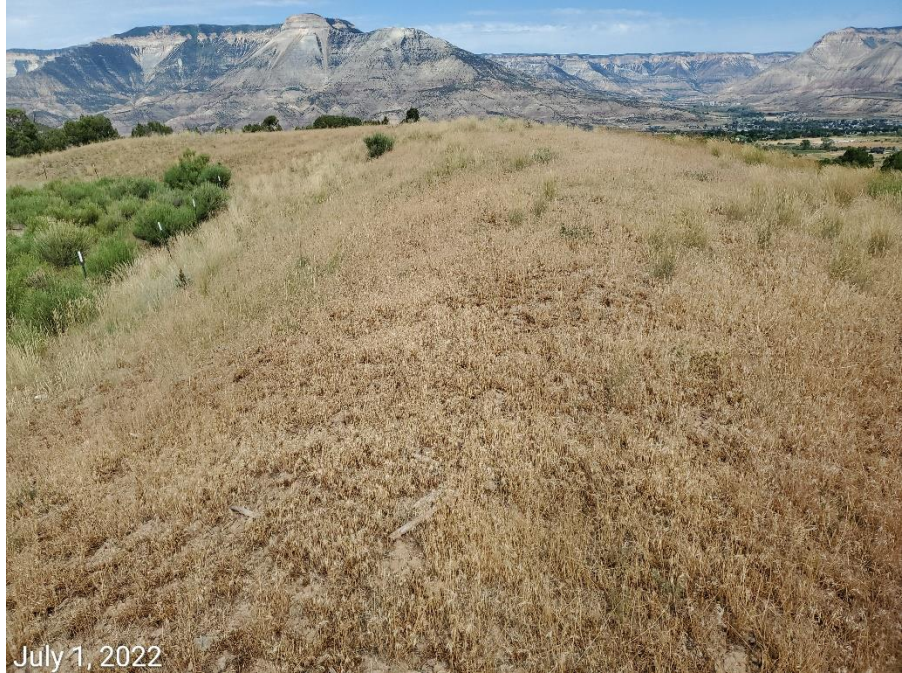
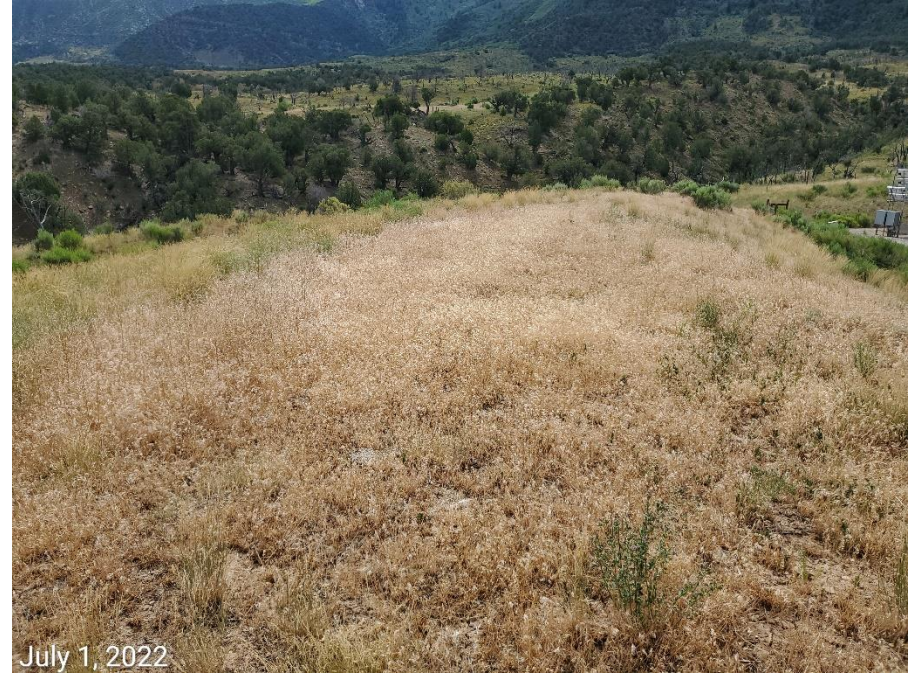
Photo 1: Photos taken from the topsoil stockpiles. Photos examples showing areas that are predominantly cheat grass, and not progressing towards reclamation standards; unable to find evidence of additional reclamation work per corrective actions.

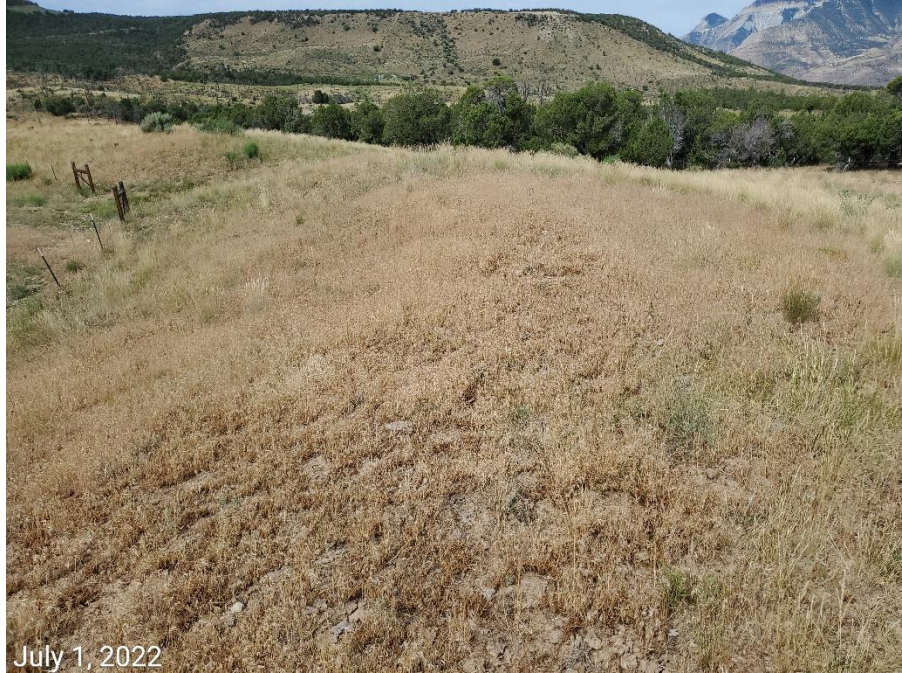
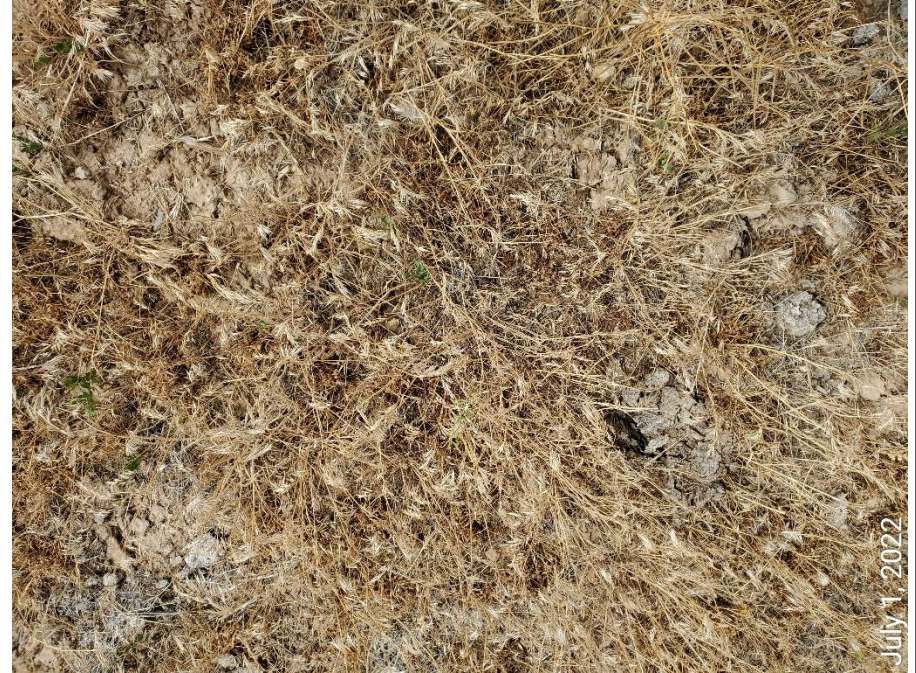
July 1, 2022

Photo 2: Photos taken from the topsoil stockpiles. Photos examples showing areas that are predominantly cheat grass, and not progressing towards reclamation standards; unable to find evidence of additional reclamation work per corrective actions.

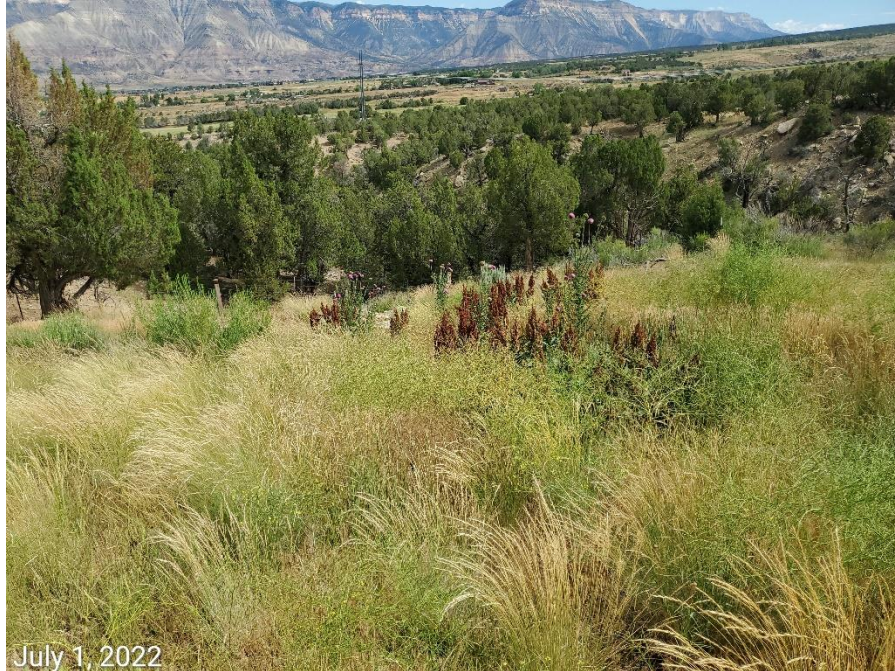
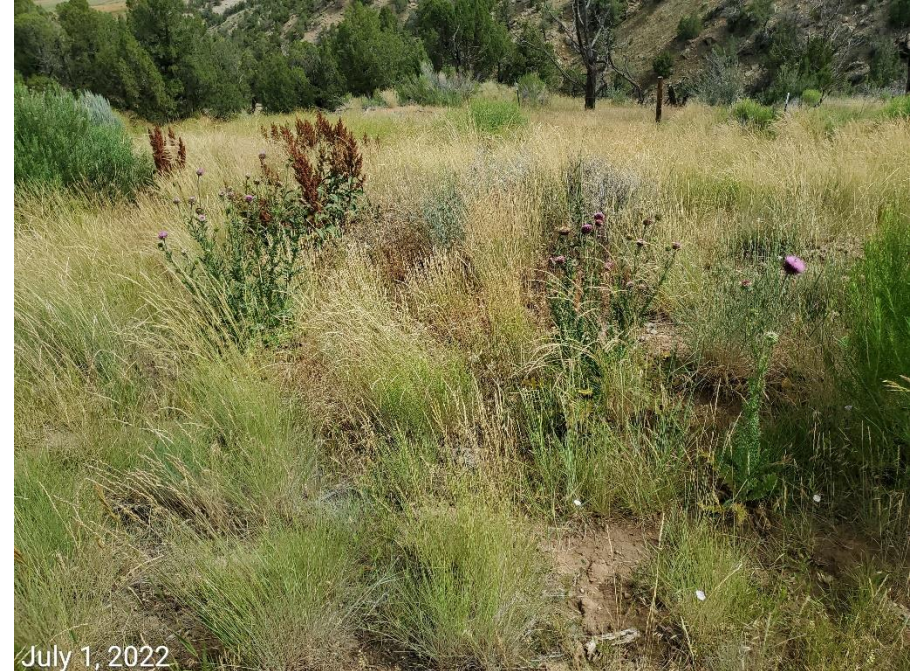
Photo 3: Photos examples showing noxious weeds (musk thistle) established on the interim areas of the Location.

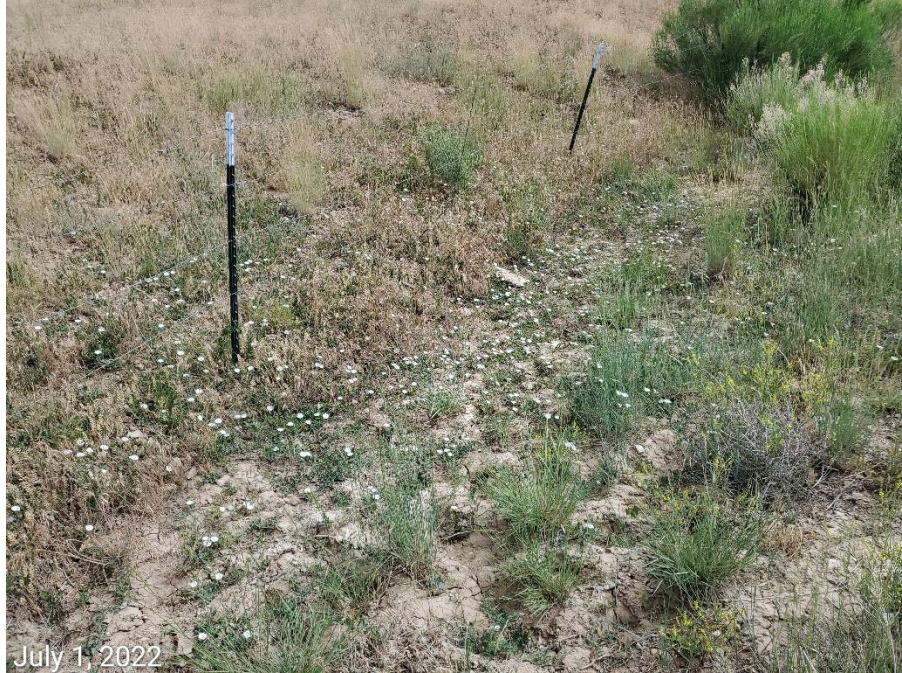
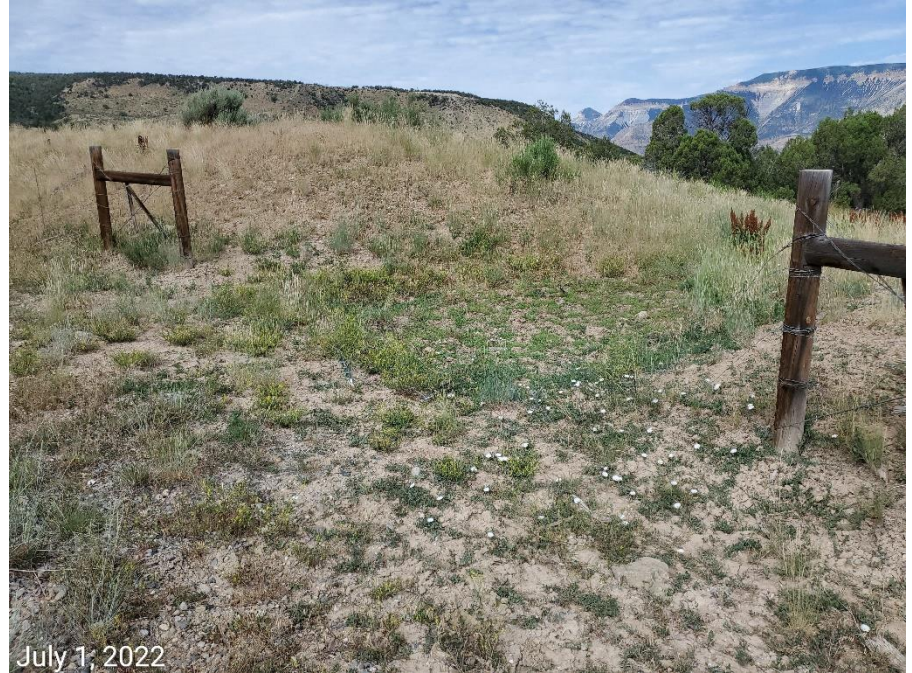
Photo 4: Photos examples showing noxious weeds (Field bindweed- white flowers) established on the location.
