# Inspection Photos and Issue Report

Operator: CAERUS PICEANCE LLC # 10456

Location ID: 334983

Garfield County, CO

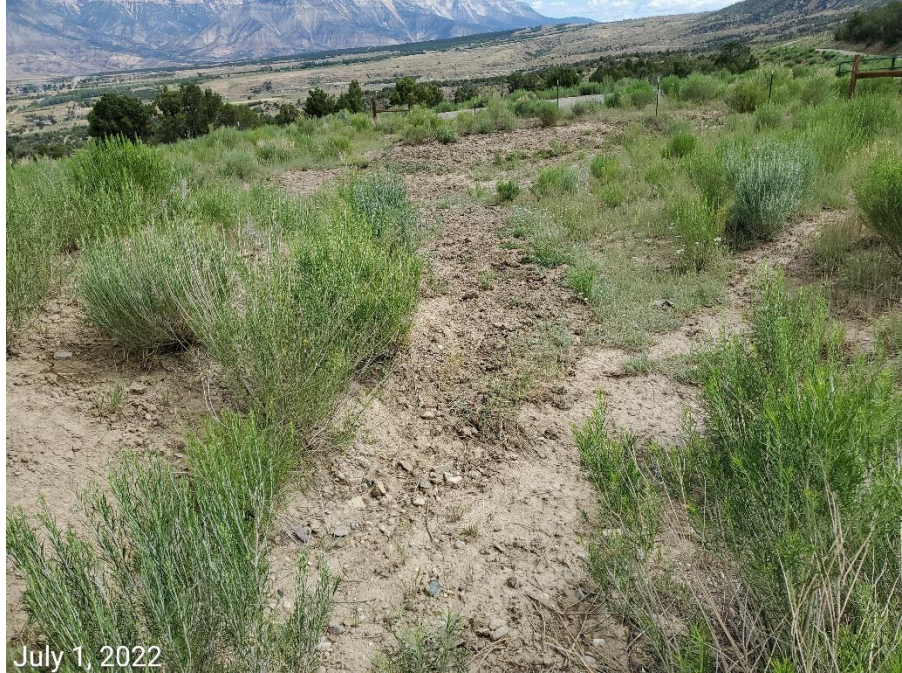
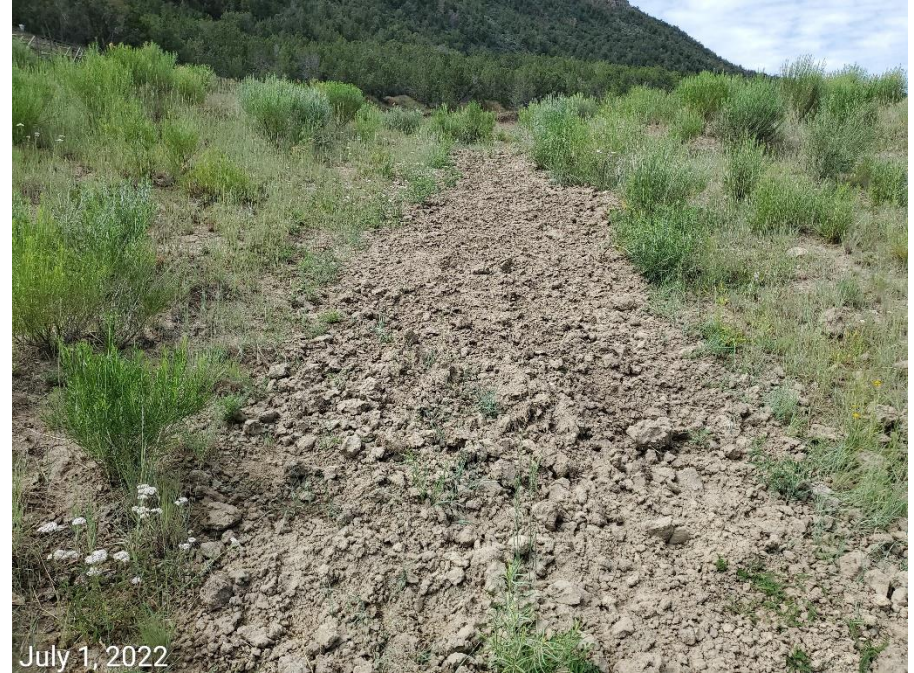
**Photo 1:** Photos show the inlet to the sediment trap on the north end of the Location. Photo shows control measure has not been installed per good engineering practices; gully erosion has been repaired, however soils have been left unconsolidated, and the inlet has not been properly engineered and armored.
