Inspection Photos and Issue Report

Operator: CAERUS PICEANCE LLC # 10456

Location ID: 311692

Garfield County, CO

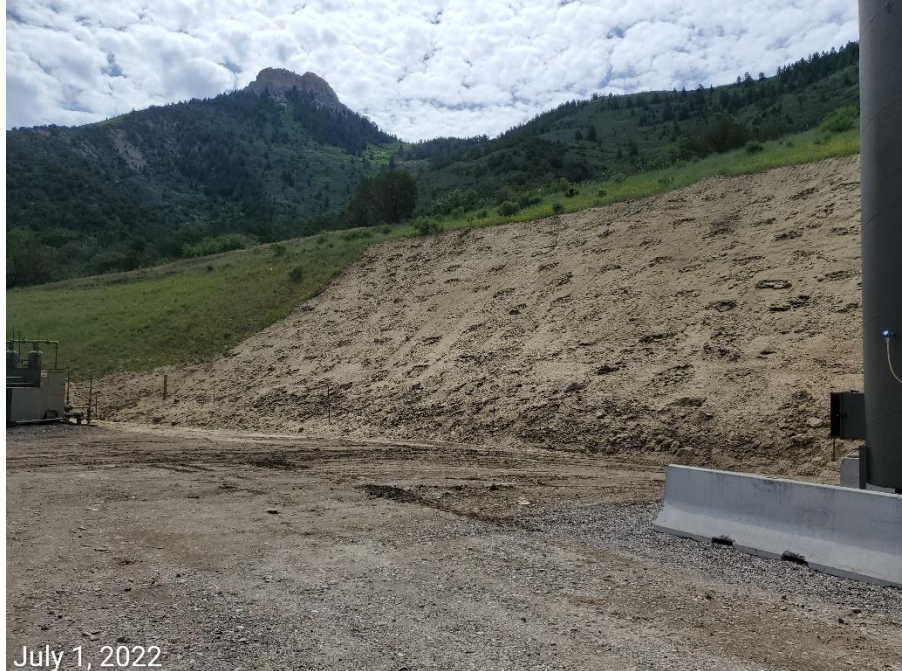
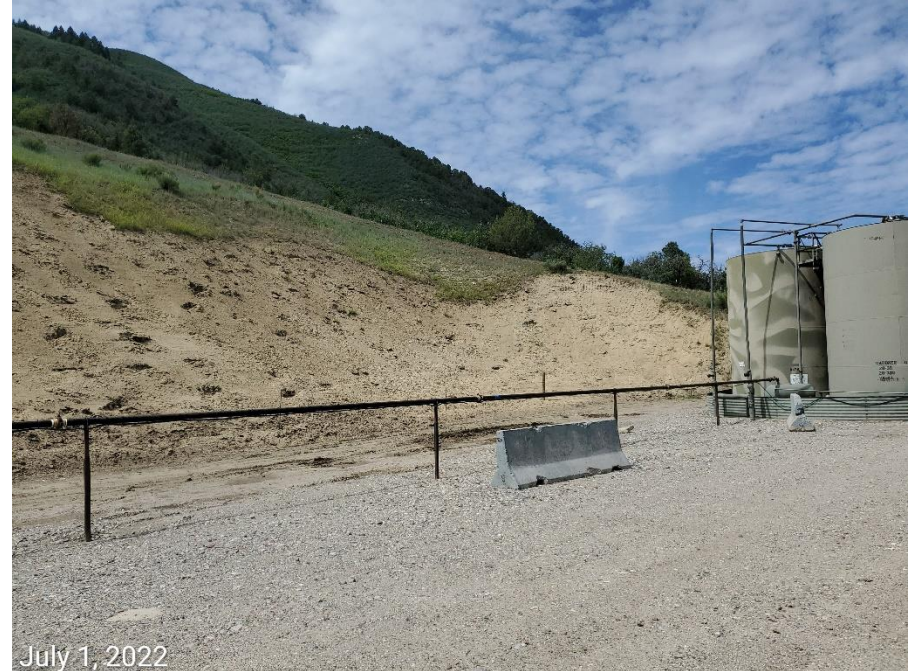
Photo 1: Photos shows the degradation has been repaired, and a hydromulch applied to the slope; it is noted that hydromulch is considered a temporary control. Pot-holes also appear to have been implemented on sections of the slope, though it is unclear if this is adequate or appropriate to stabilize the slopes.

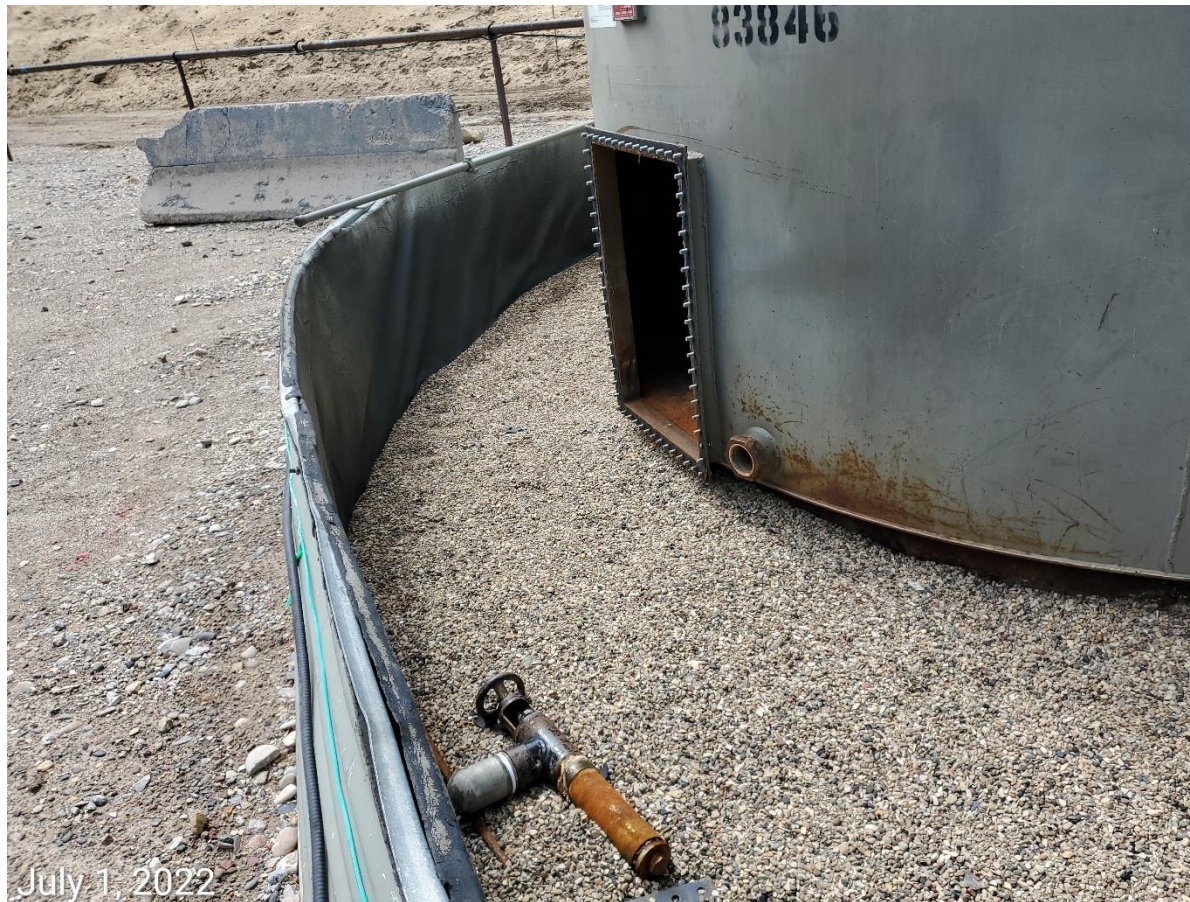
Photo 2: Photo taken from the northeastern-most tank. Stained soils appear to have been cleaned and Work at tank appears to be in process, however it is unclear if corrective actions have been addressed in its entirety; manway cover removed, pipes leading to tank have been disconnected; liner integrity beneath tank unknown.
