Inspection Photos
Location Name: UPRR 43 Pan Am I #26
Location ID: 318445

Photo 1 loc pic. Stained soil

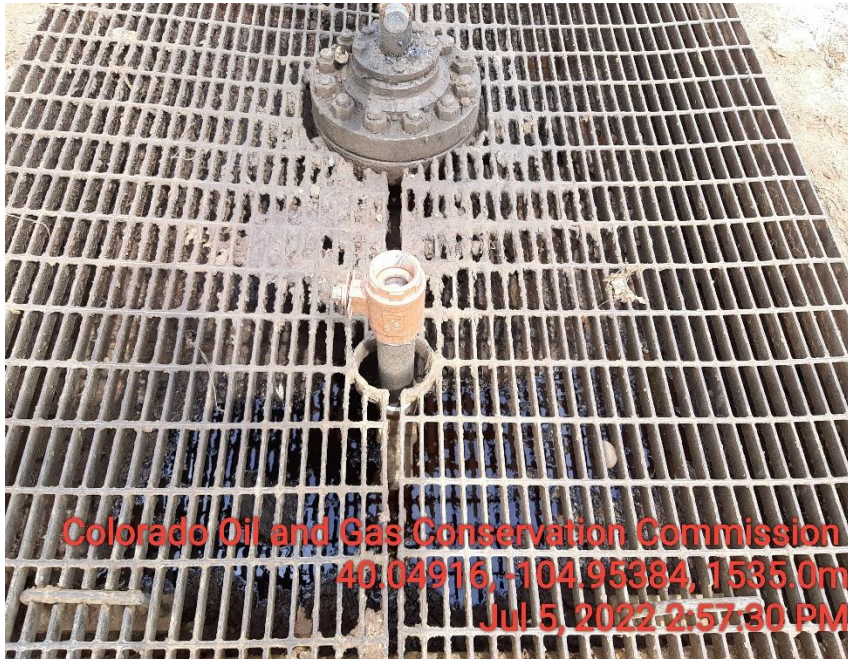
Colorado Oil and Gas Conservation Commission
40.04916, -104.95384, 1535.0m
Jul 5, 2022 2:57:30 PM

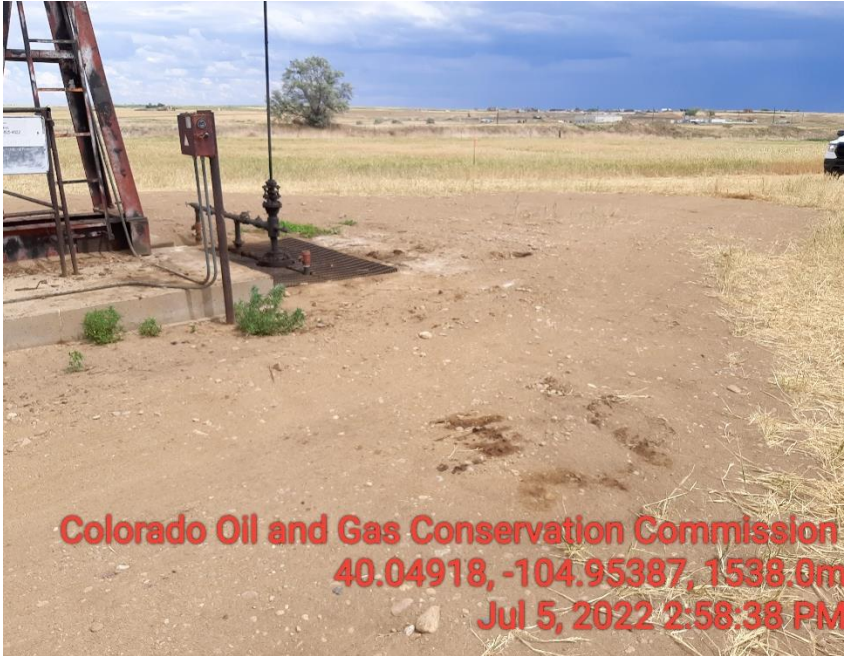
Photo 5 Stained soil around well head and on location left by workover rig.
