Inspection Photos

Operator: Caerus Piceance LLC - #10456

Location Name: Benzel Disposal-66S93W /36NWNE

Inspection Document #: 702800410

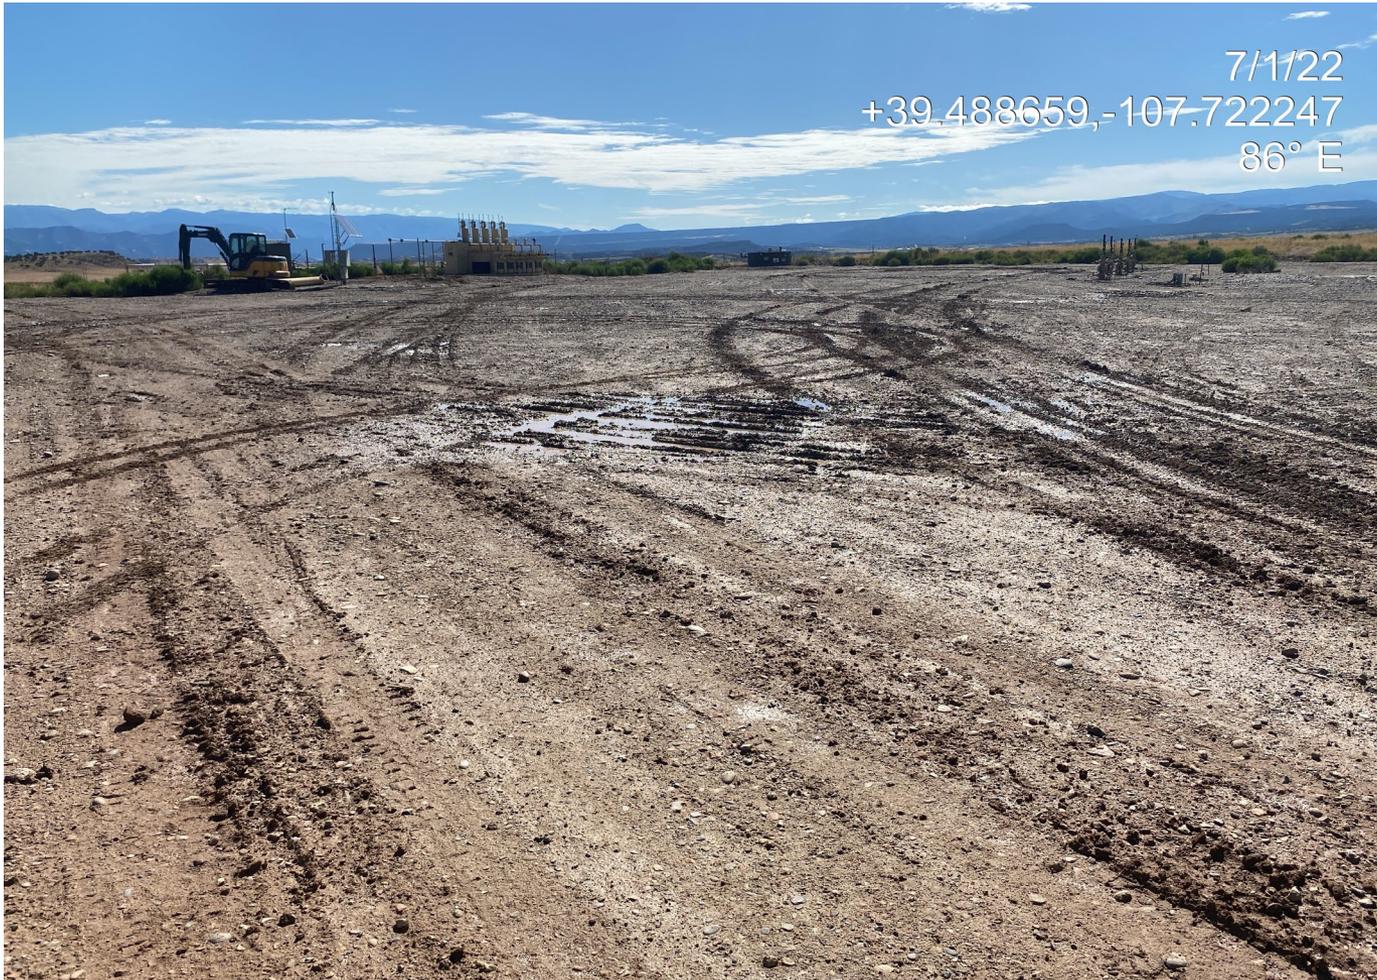
Photo 1. Photo taken from the west of the Location shows an overview of the working pad area.

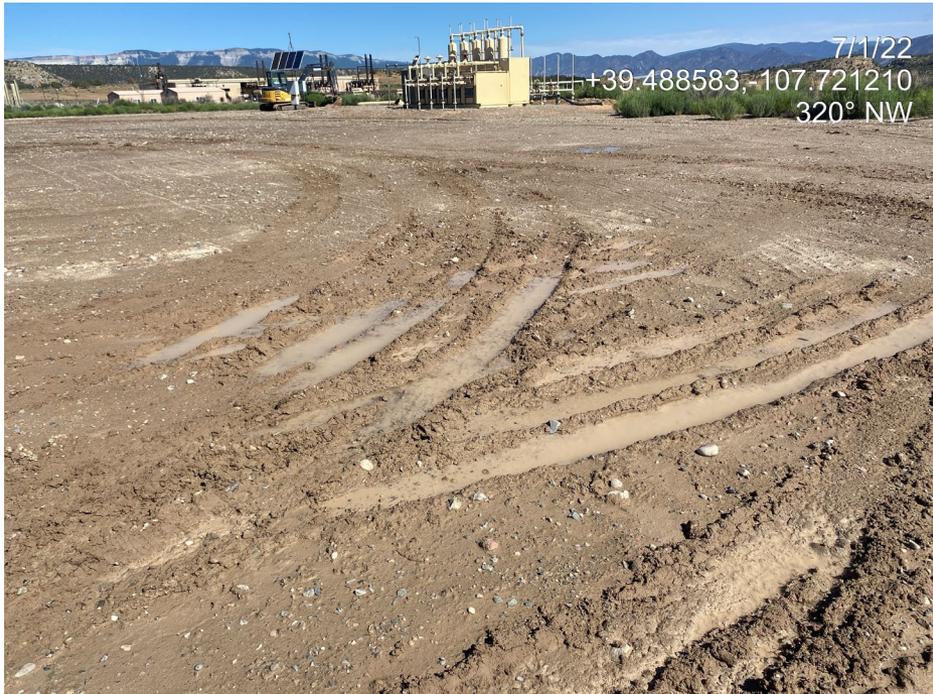
Photo 2. Photo taken from the east of the Location shows a lack of stabilization/compaction degradation of the pad surface.

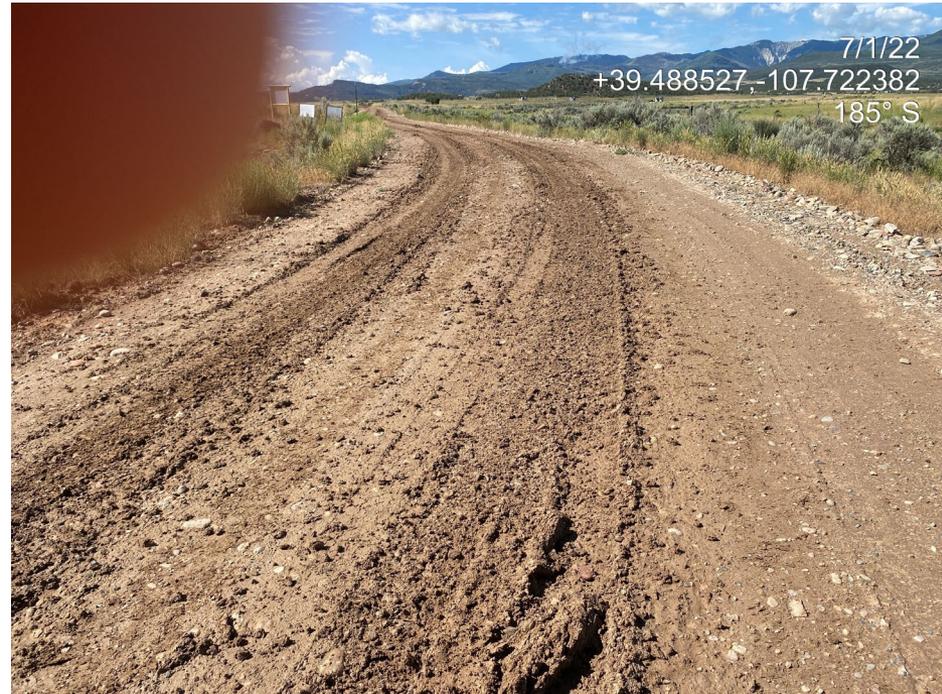
Photo 3. Photo taken from the southwest of the Location shows a lack of stabilization/compaction degradation of the access road.

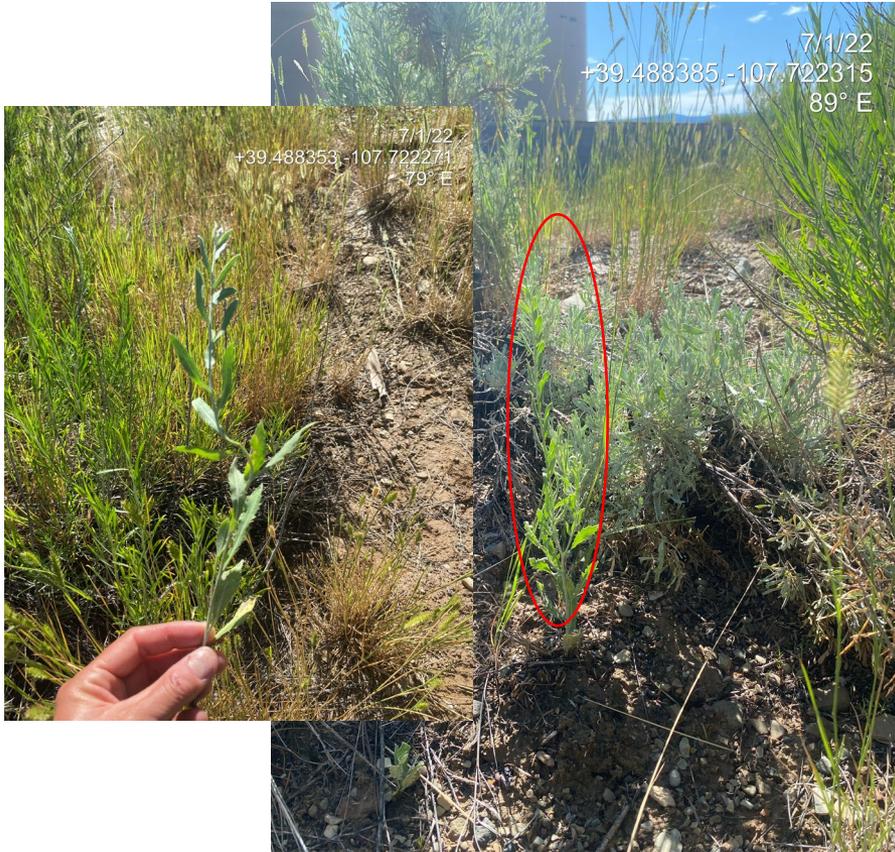
Photo 4. Photos taken from the southwest of the Location shows untreated Russian knapweed remaining in an area previously identified and recently treated.

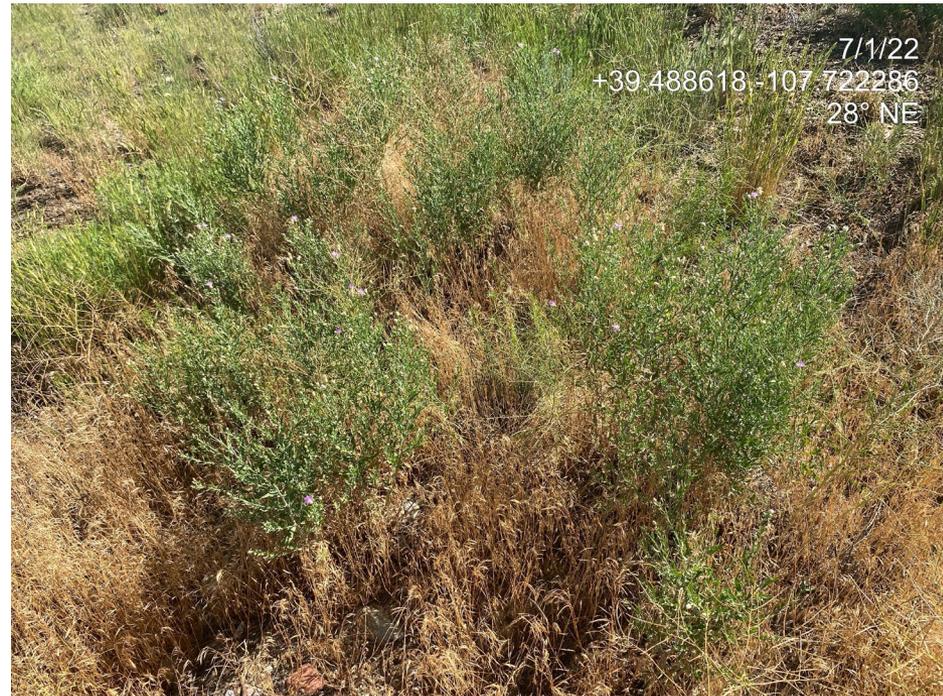
Photo 5. Photo taken from the northwest of the Location shows a previously unidentified and untreated patch of Russian knapweed.

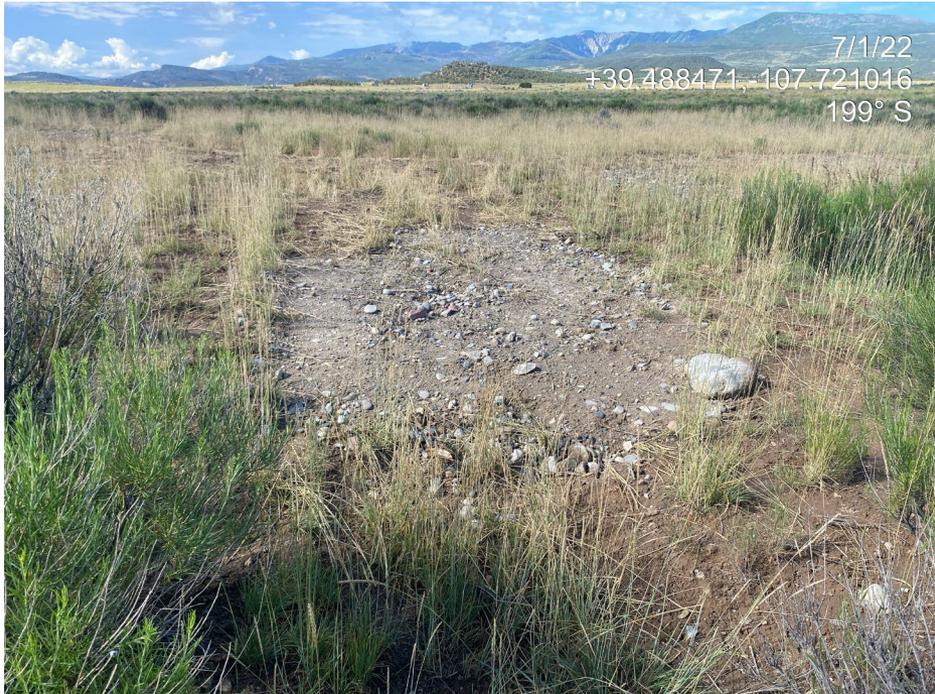
Photo 6. Photo taken from the east of the Location shows an example of an area where subsidence has been filled.

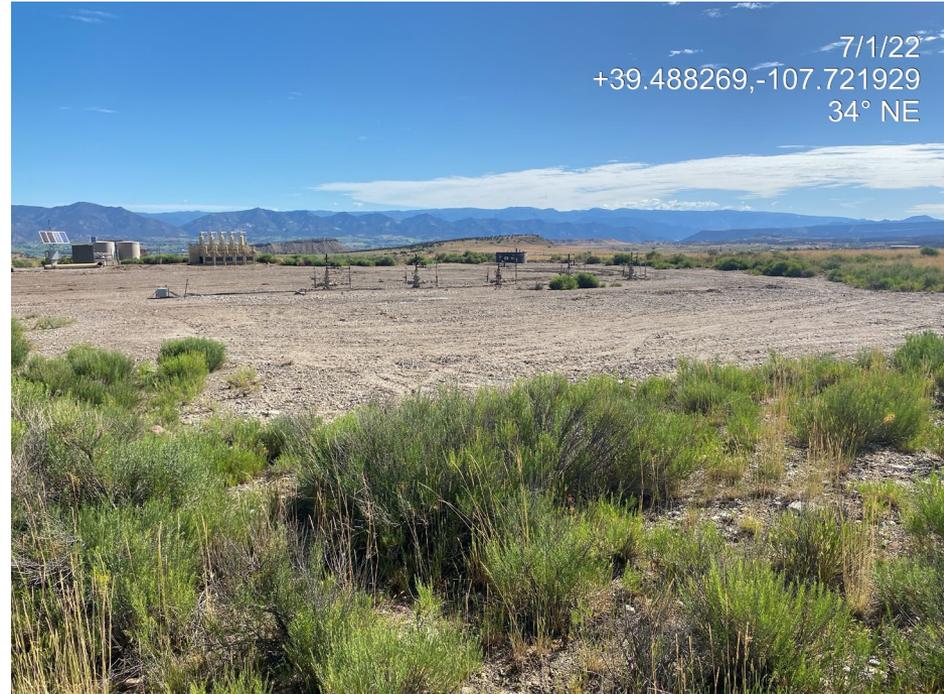
Photo 7. Photo taken from the south of the Location shows where concrete forms have been removed.
