Inspection Photos

Operator: TEP Rocky Mountain- #96850

Location Name: Youberg /SR 43-12

Inspection Document #: 702800421

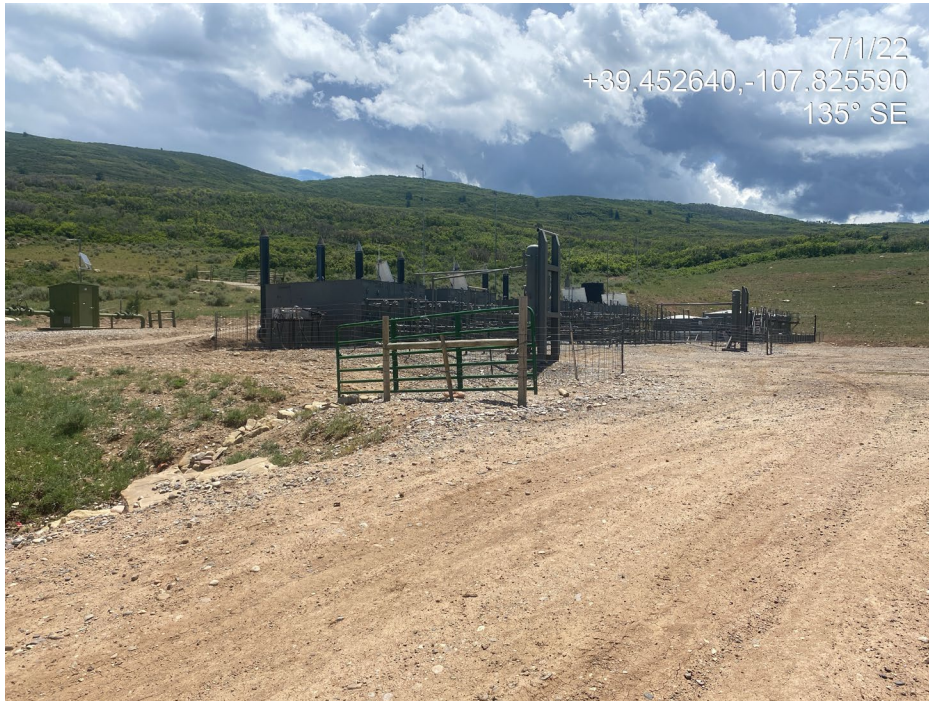
Photo 1. Photo taken from the north shows an overview of the Location production area.

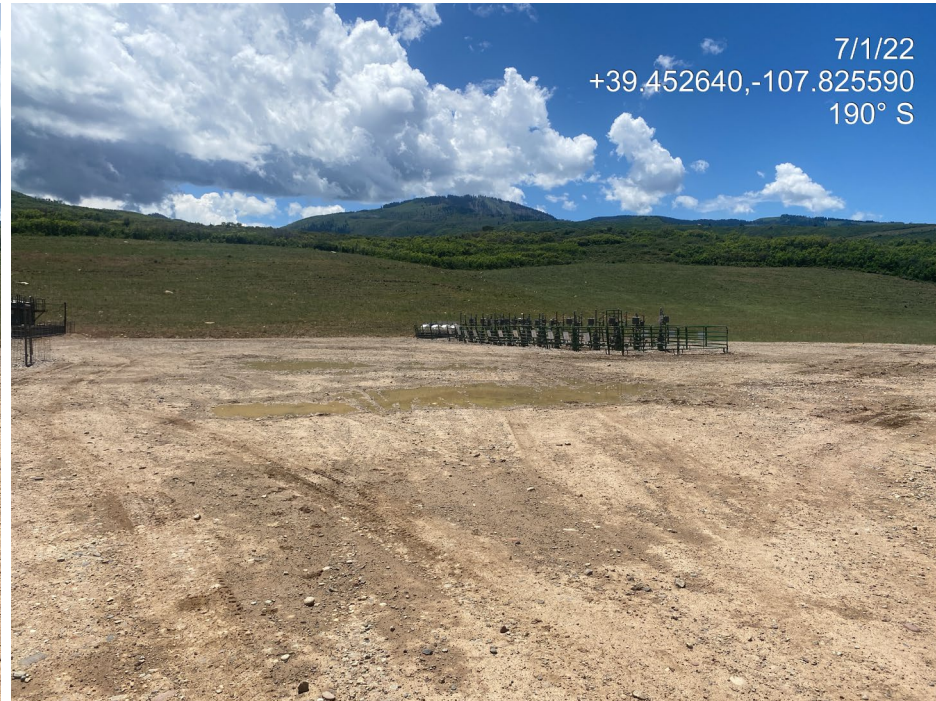
Photo 2. Photo taken from the north shows an overview of the Location production area.

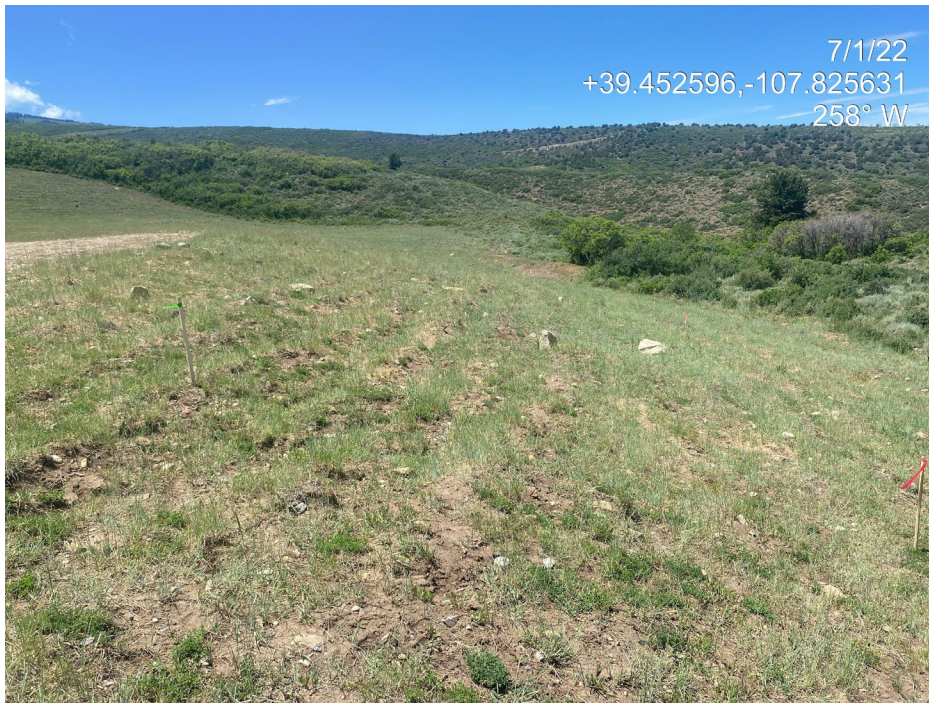
Photo 3. Photo taken from the north shows the fill slope is well vegetated with perennial grasses. Stakes are present indicating areas of partial pad reconstruction.

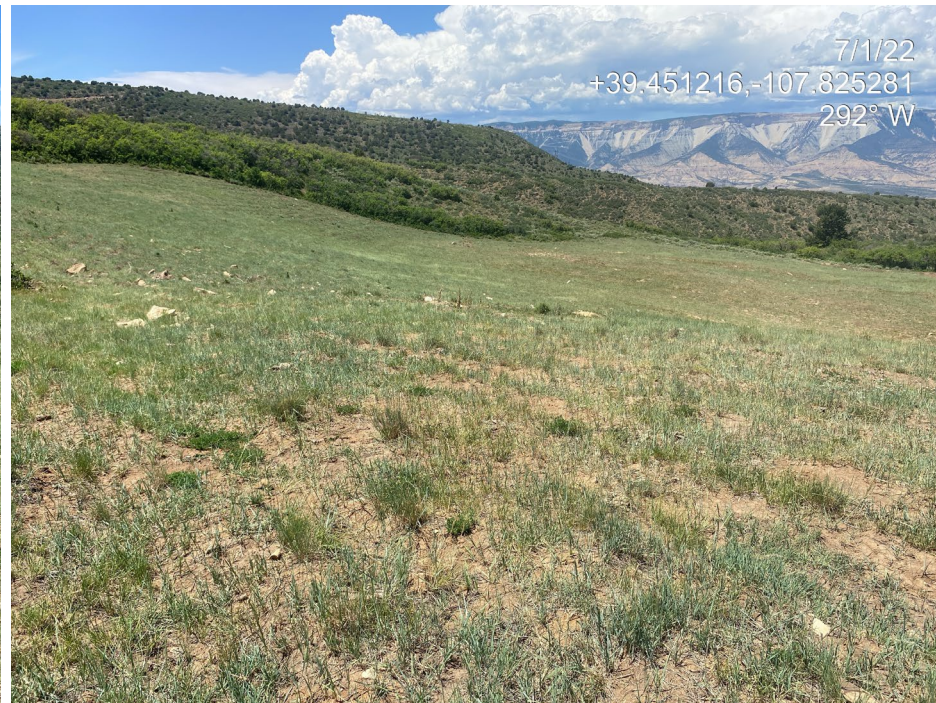
Photo 4. Photo taken from the south shows the cut slope is well vegetated with perennial grasses.

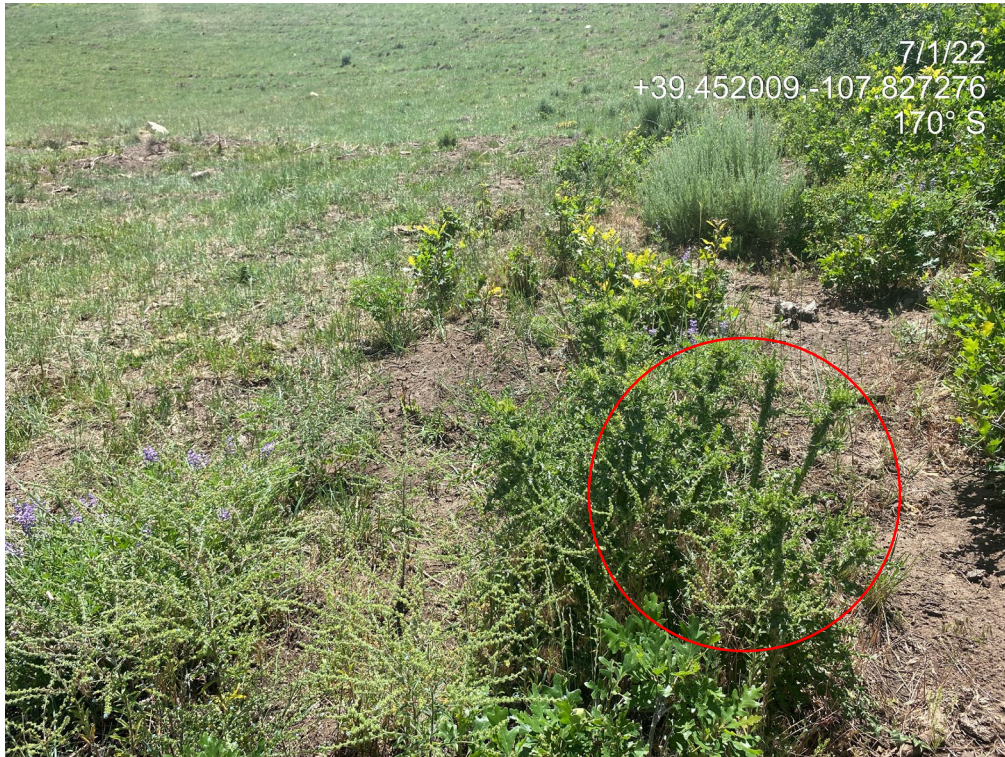
Photo 5. Photo taken from the western interim area shows an example of bull thistle, a list B Noxious Weed present throughout the interim areas.

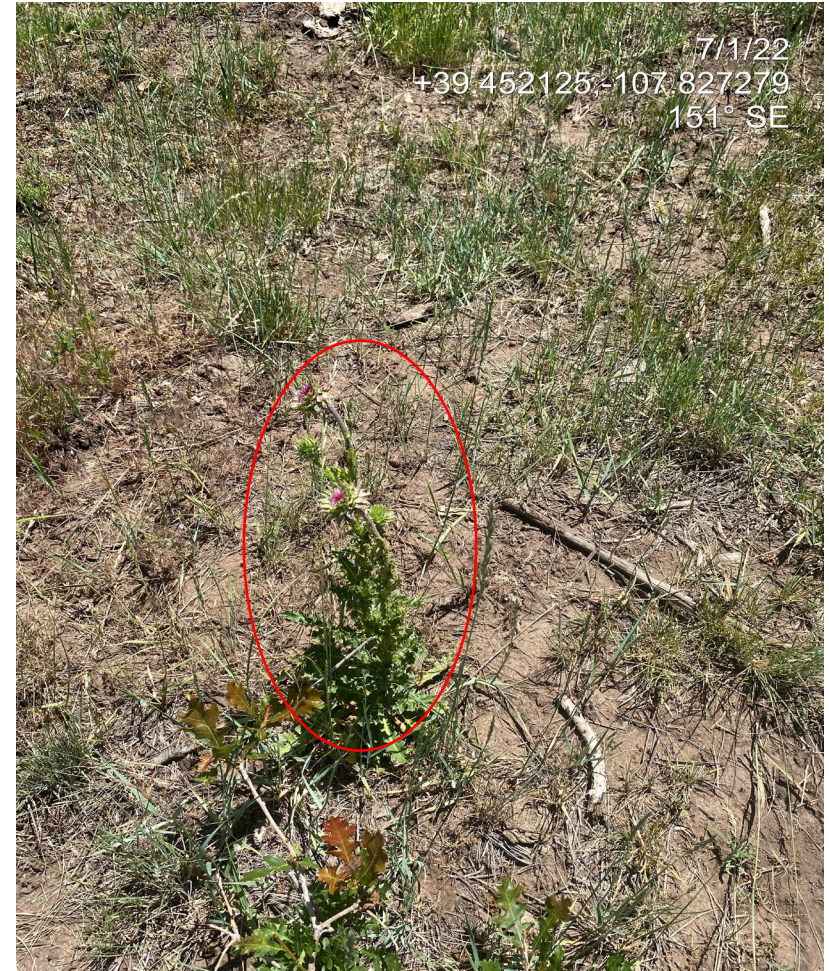
Photo 6. Photo taken from the western interim area shows an example of musk thistle, a list B Noxious Weed present throughout the interim areas.

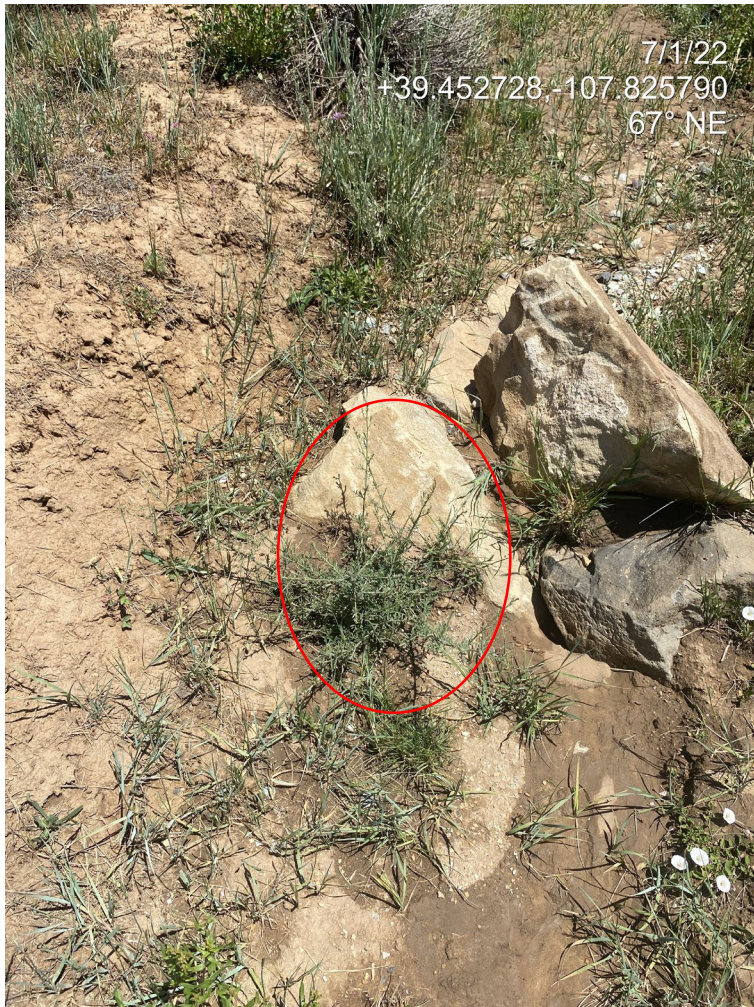
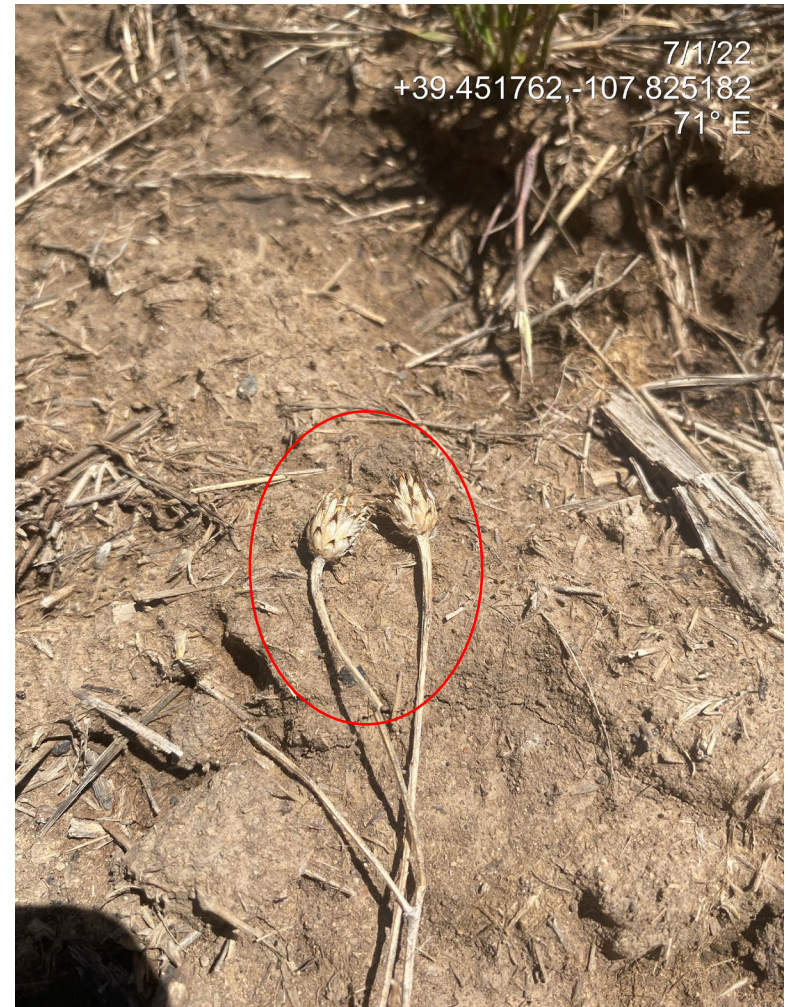
Photo 7. Photos taken from the northern and southern interim area shows an example of spotted knapweed, a list B Noxious Weed present throughout the interim areas.

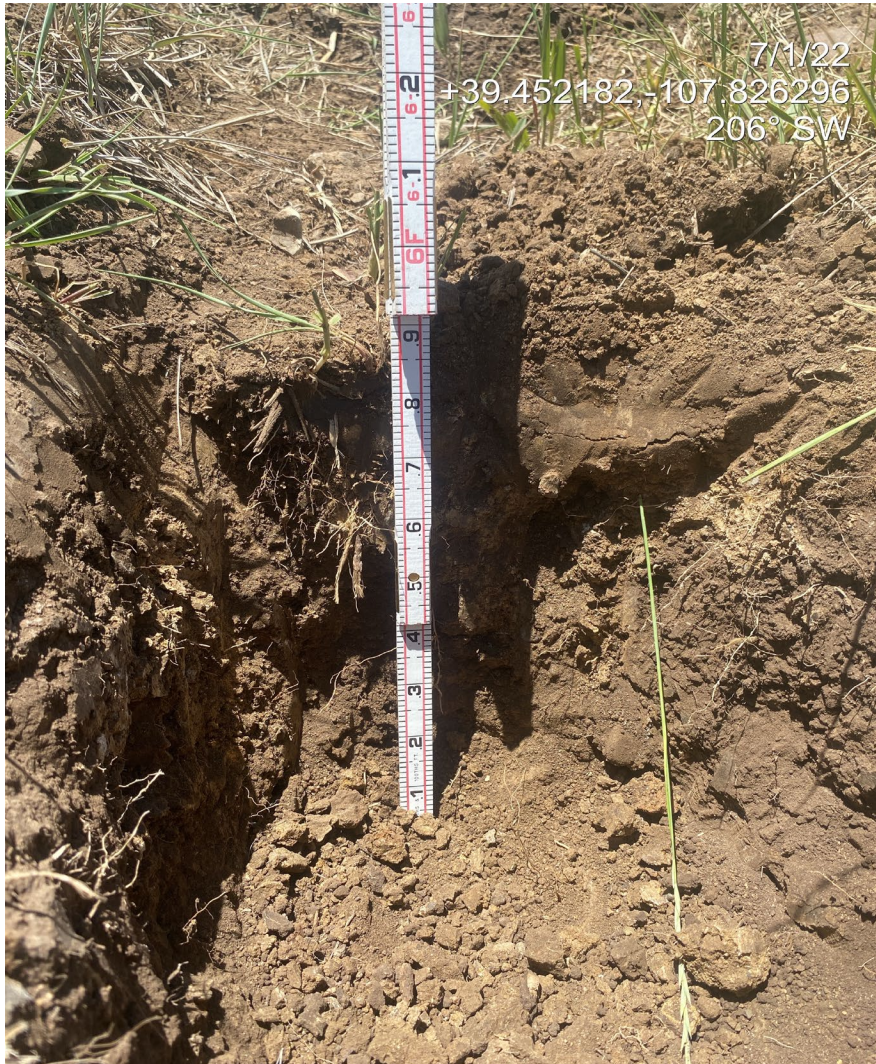
Photo 8. Photo taken at the west of the Location where pad reconstruction is planned shows the soil profile in a pit.
