Inspection Photos and Issue Report

Operator: CHEVRON USA INC - 16700

Location ID: 314941

Rio Blanco County, CO

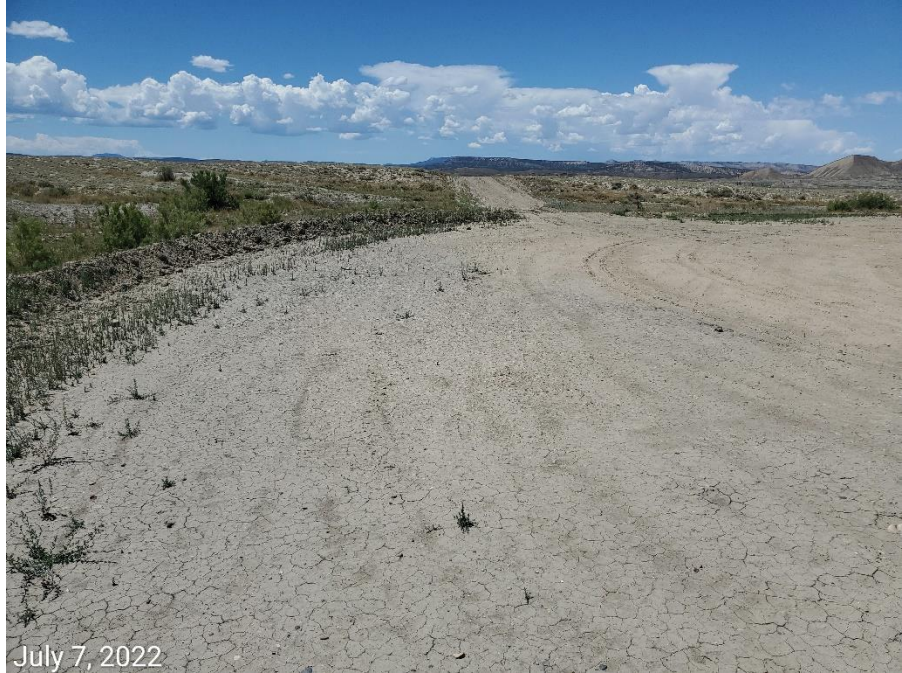
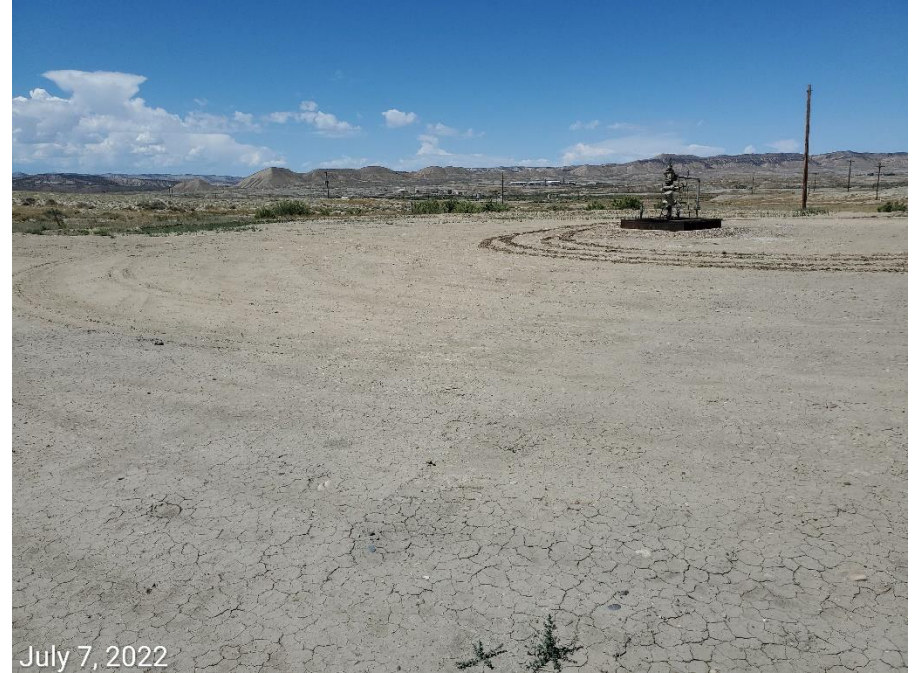
Photo 1: Photos 1-2 provide an overview of the Location from south, southwest, west, northwest.

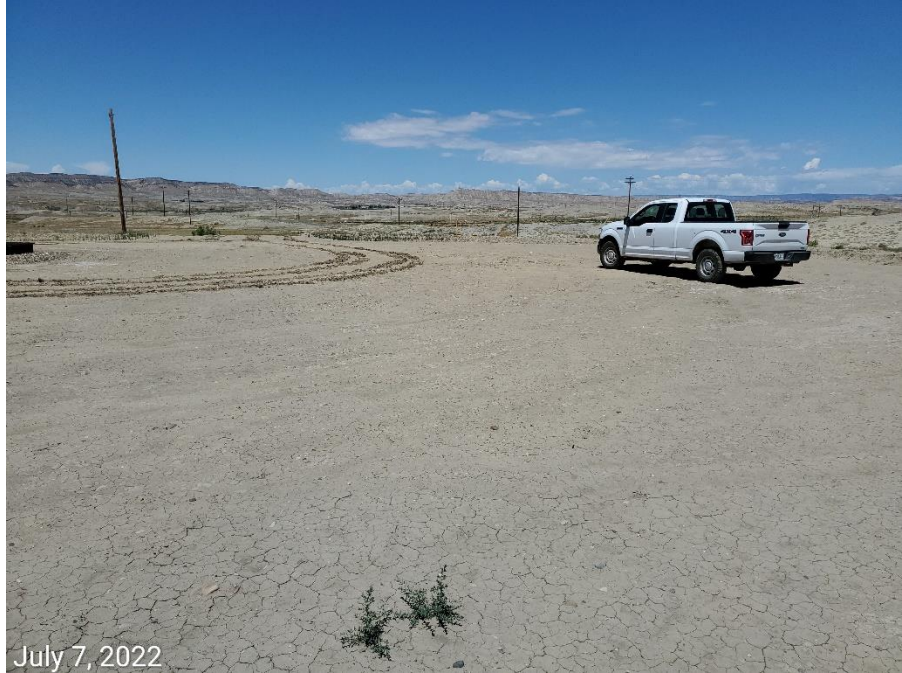
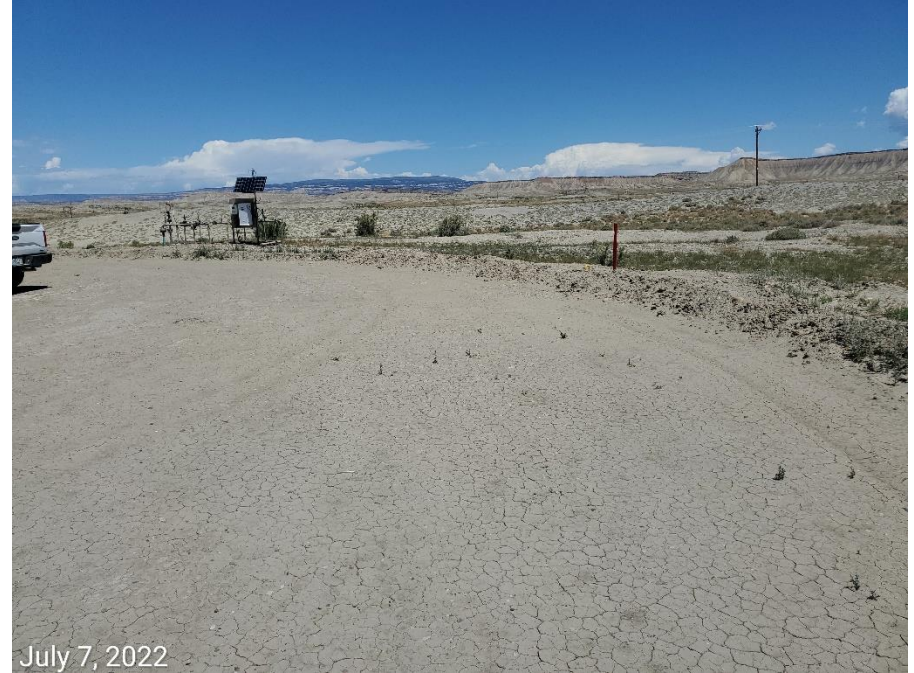
Photo 2: See comments under photo 1.

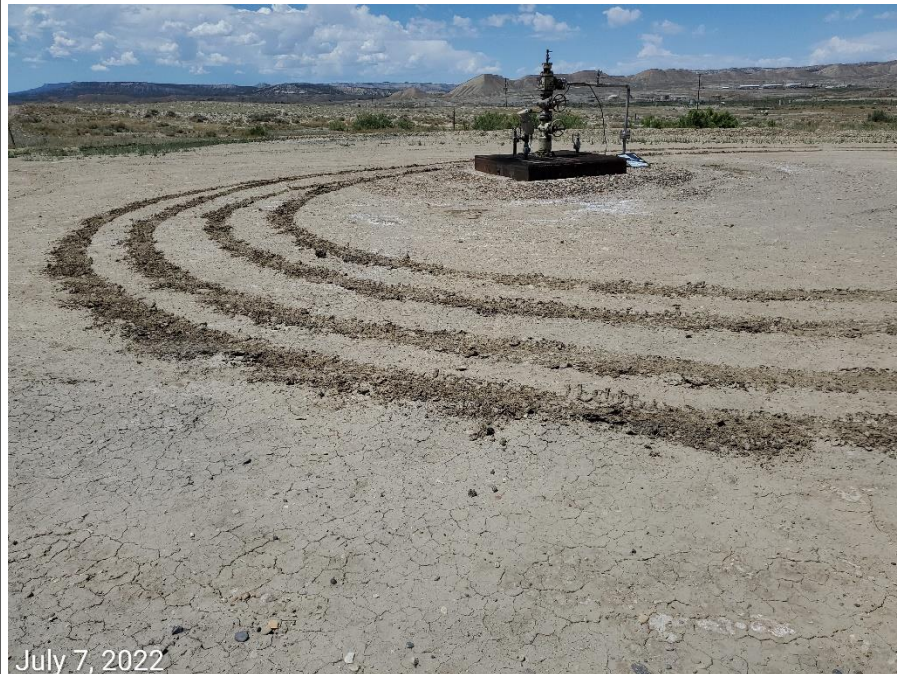
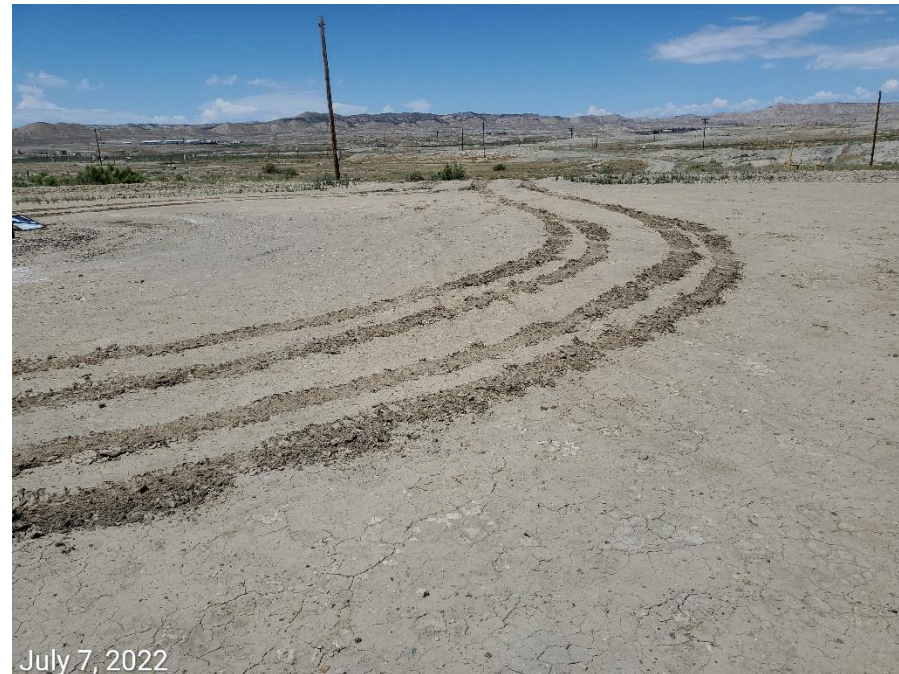
Photo 3: Photo shows vehicle tracking/rutting evident on the pad. Control measures to minimize degradation and sediment transport are missing or insufficient at the Location, and the two access roads leading south and west from the Location

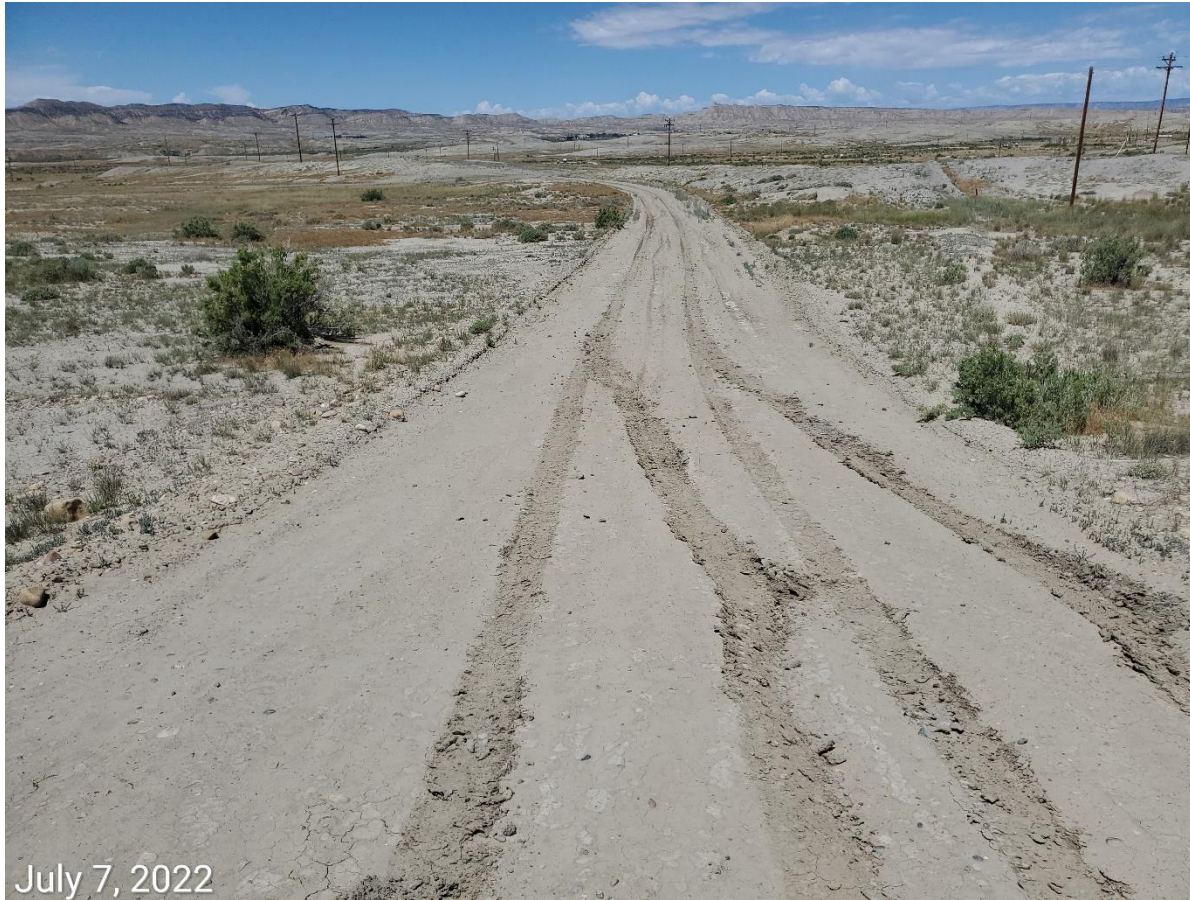
Photo 4: Photo example showing stabilization issues resulting in vehicle tracking and sediment transport on the access road(s).

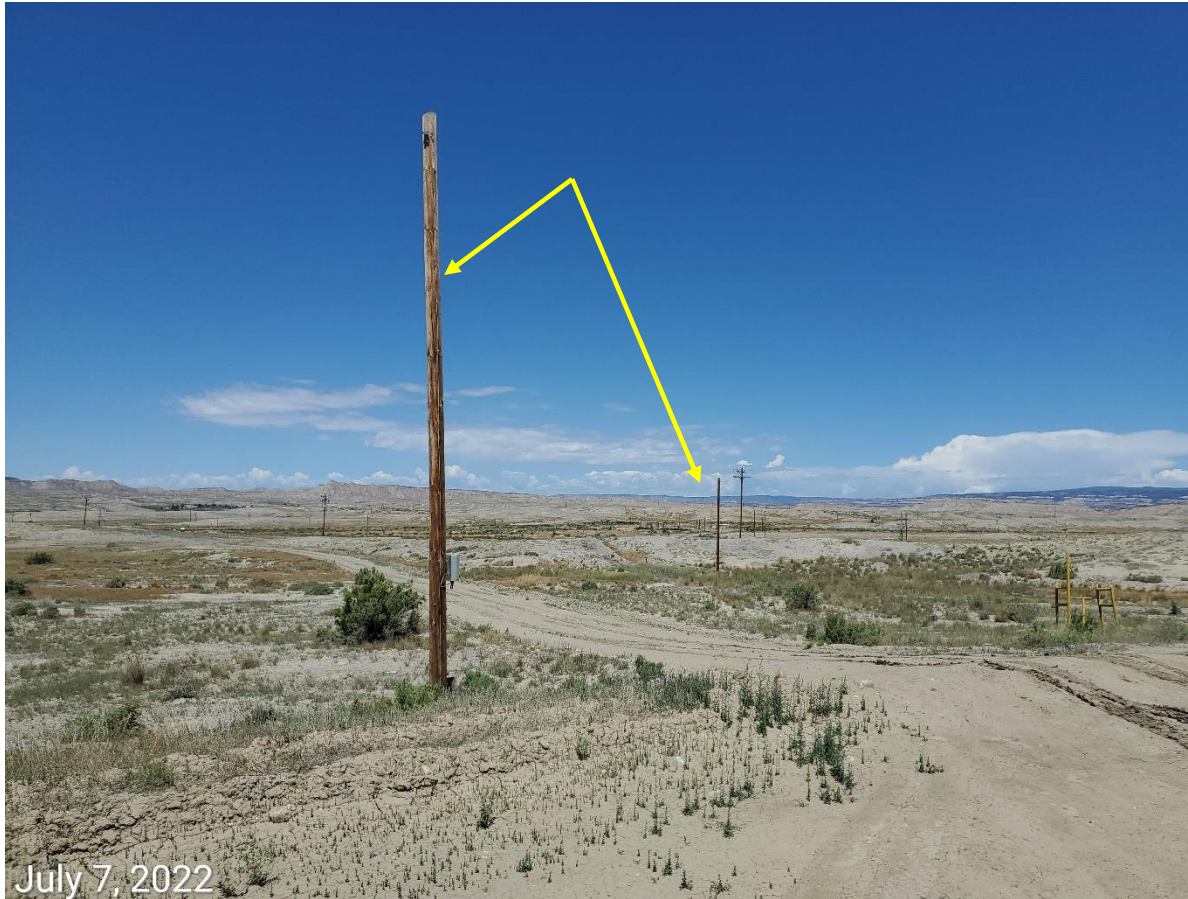
Photo 5: Photo shows unused utility pole equipment leading two the Location; lines have been removed and poles have been left behind
