Interim Reclamation and Stormwater Inspection

June 16, 2022

Operator: LONGS PEAK RESOURCES LLC- #10611

Location ID: 452516

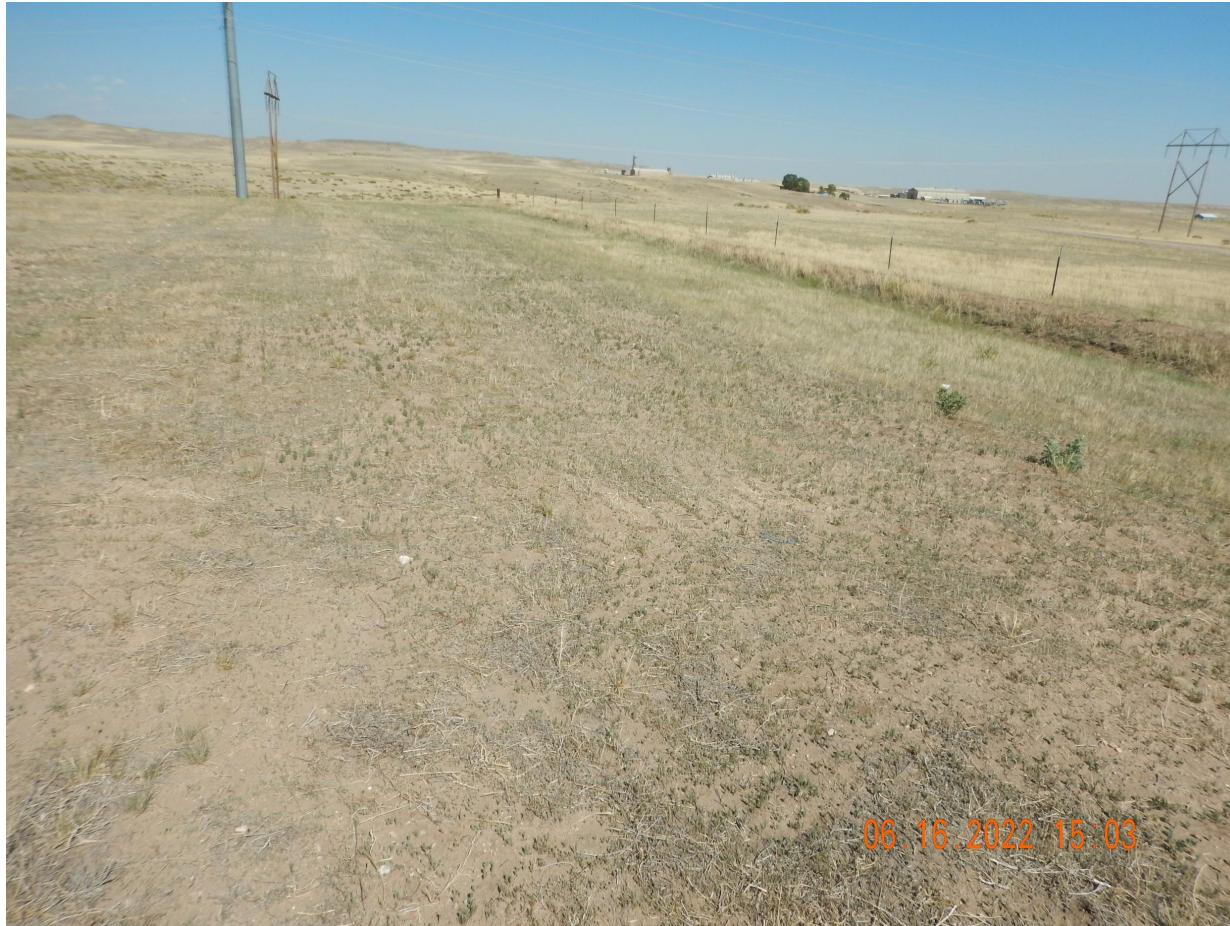
Photo 1. Photo taken from the southeastern interim reclamation area, facing East. Photo illustrates Operator has responded to the previous corrective action to perform additional interim reclamation activities; however, there was little to no germination throughout the interim reclamation area.

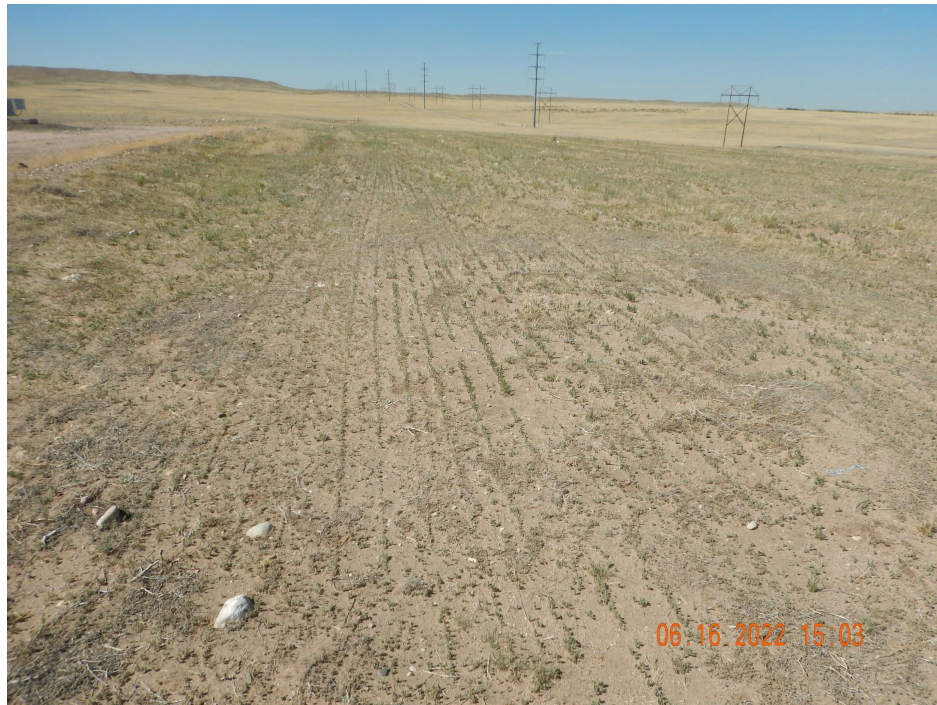
Photo 2. Photo taken from the southeastern interim reclamation area, facing North. See comments under Photo 1.

Note: the Kochia seedlings are coming up in the drill rows, which is not desirable vegetation.

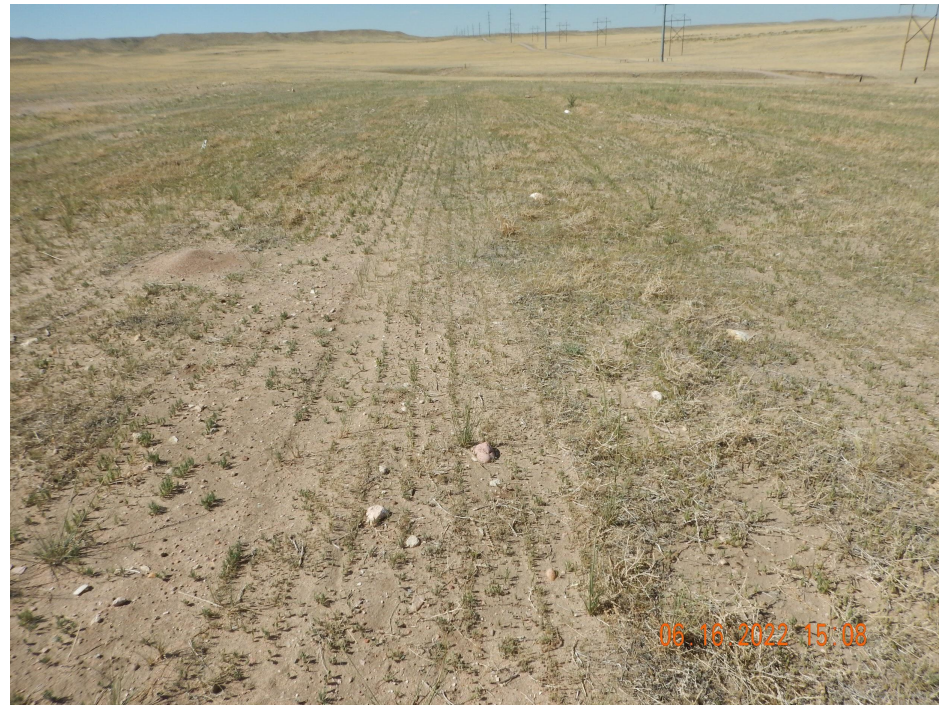
Photo 3. Photo taken from the eastern interim reclamation area, facing North. See comments under Photo 1.

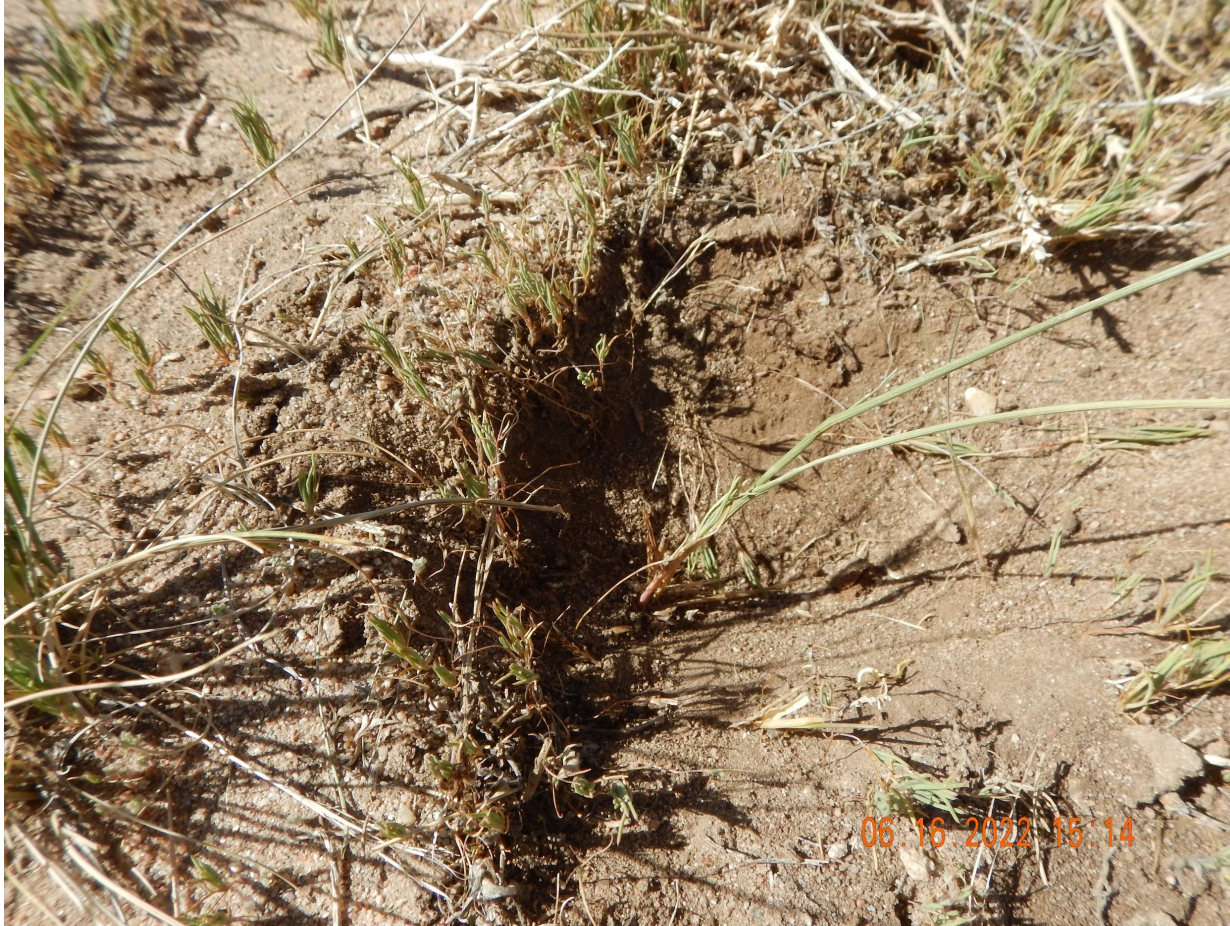
Photo 4. Photo taken from the interim reclamation area. Photo illustrates that one of the desirable grass species was planted deeper than 1.5 inches. Native seeds should not be planted that deep and maybe why this attempt failed.

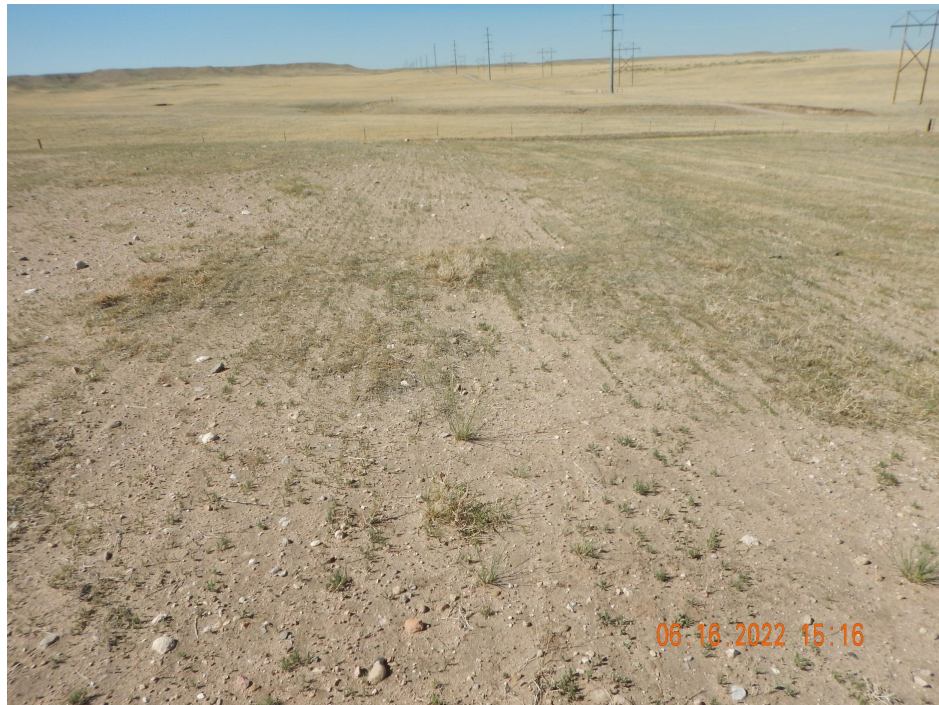
Photo 5. Photo taken from the northeastern interim reclamation area, facing North. See comments under Photo 1.

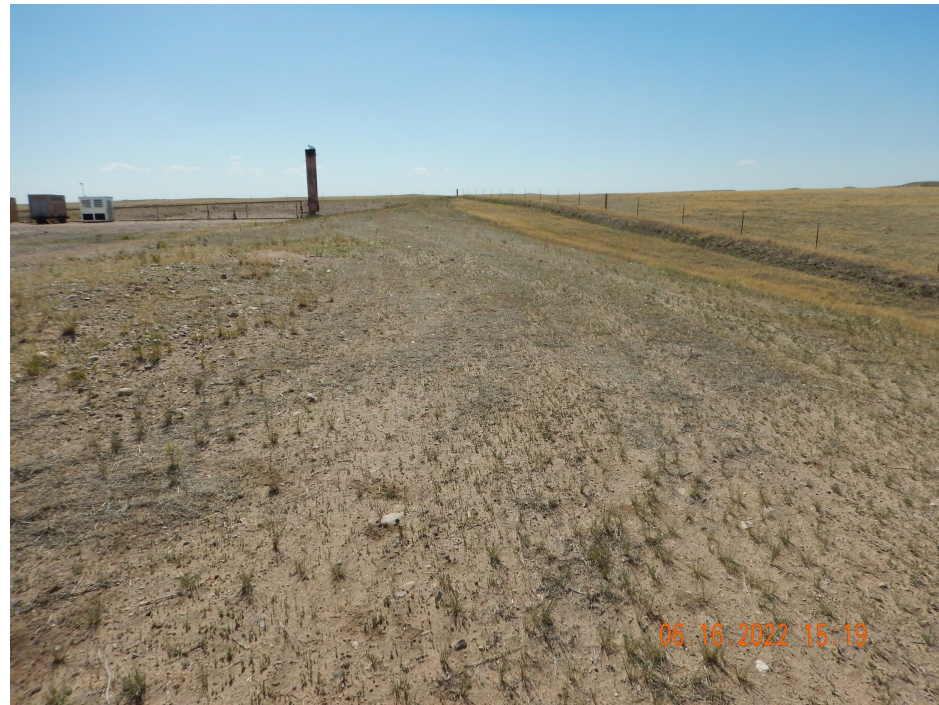
Photo 6. Photo taken from the northeastern interim reclamation area, facing West. See comments under Photo 1.
