# Final Reclamation Inspection

Operator: PDC ENERGY INC - 69175

Location ID: 336611

Weld County, CO

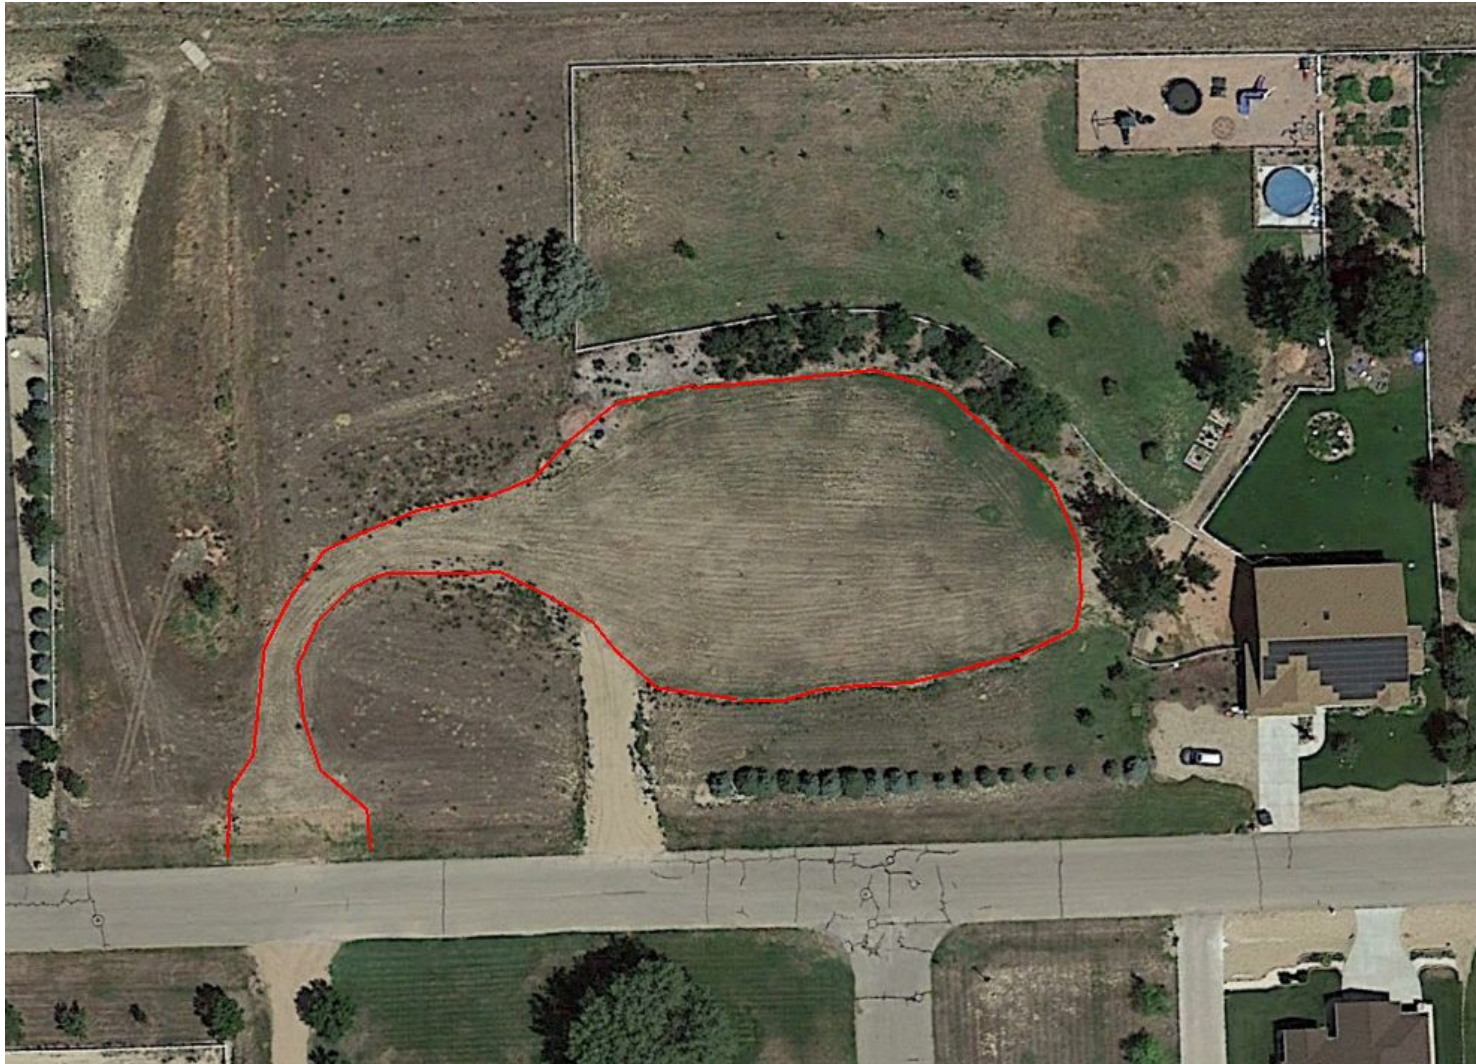
**Photo 1.** Google Earth aerial imagery taken 7/17/2019 after reclamation has been performed. An access road point with a culvert has been left at the request of the surface owner. The perimeter of the reclaimed area is highlighted in red.

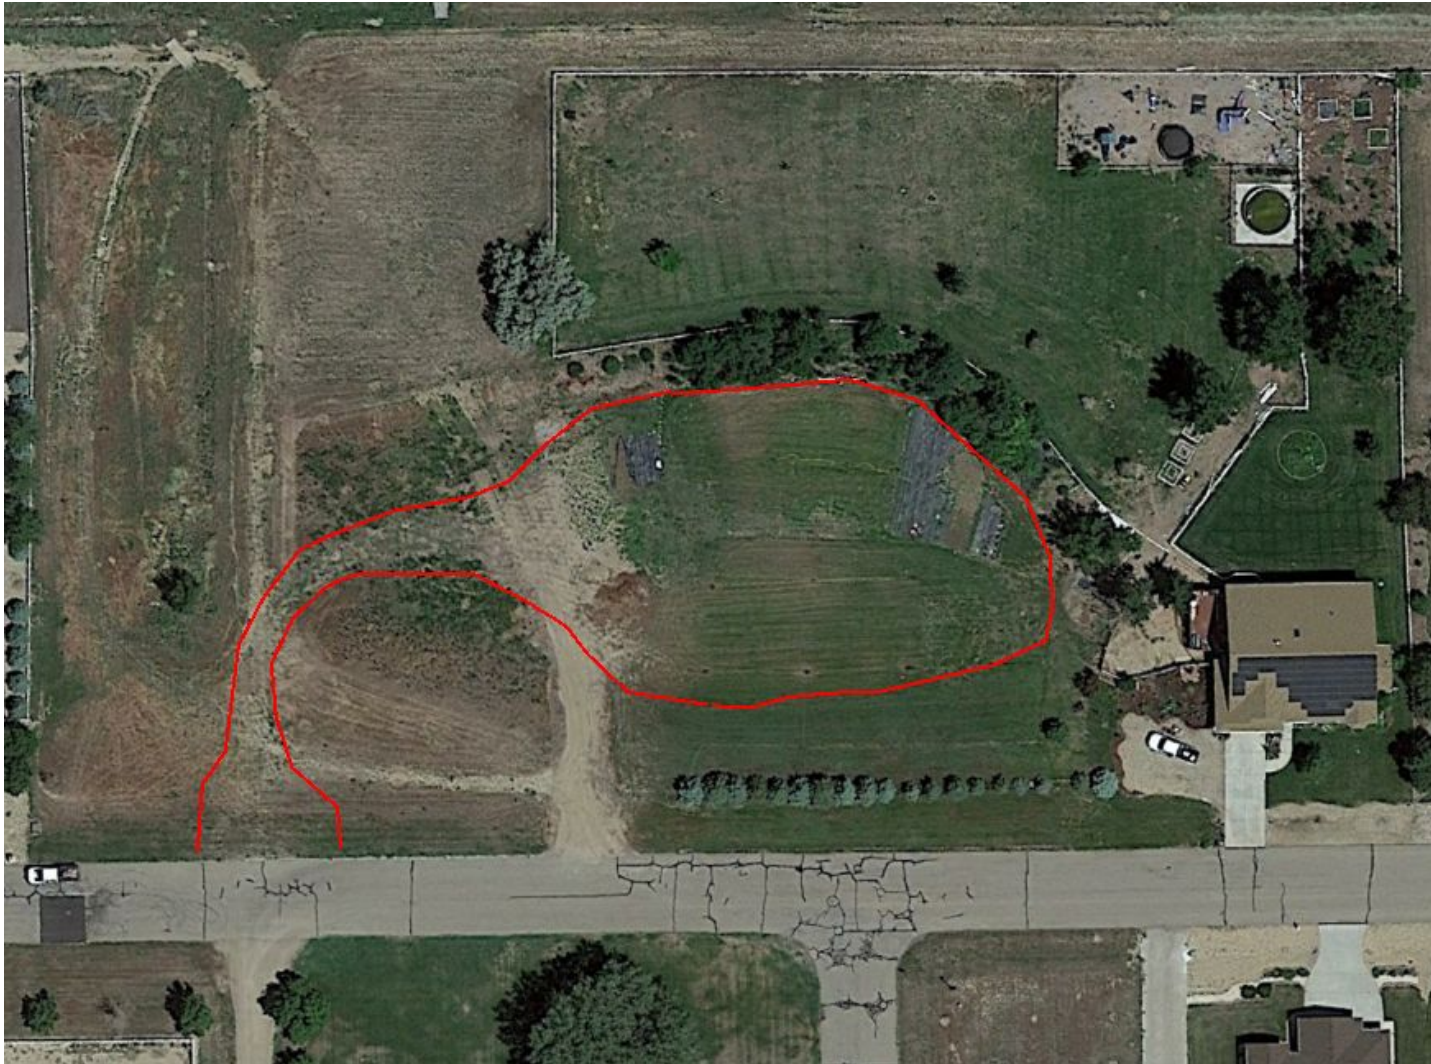
**Photo 2.** Google Earth aerial imagery taken 6/11/2021. Photo illustrates changes in the reclaimed area (garden areas to the north) and some disturbances by the surface owner along the central/western portion- see Photo 3.

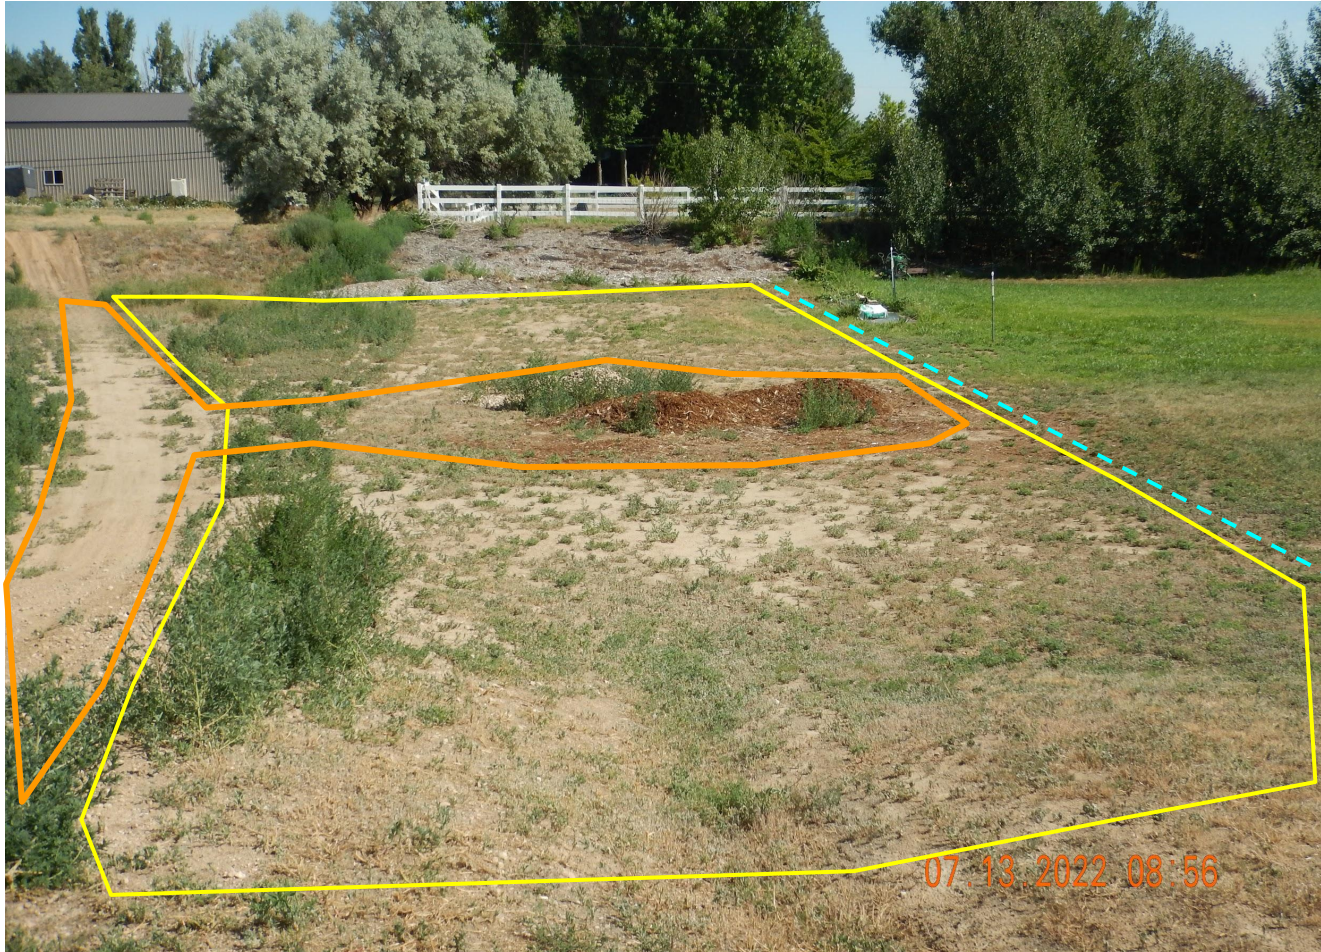
**Photo 3.** Photo taken from central/western portion, facing North. The orange polygon illustrates the approximate portion that has been disturbed by the surface owner/neighborhood dirt bikes. The yellow area is the approximate area that needs to be reclaimed. Note: everything to the right of the blue-dashed line is being irrigated.

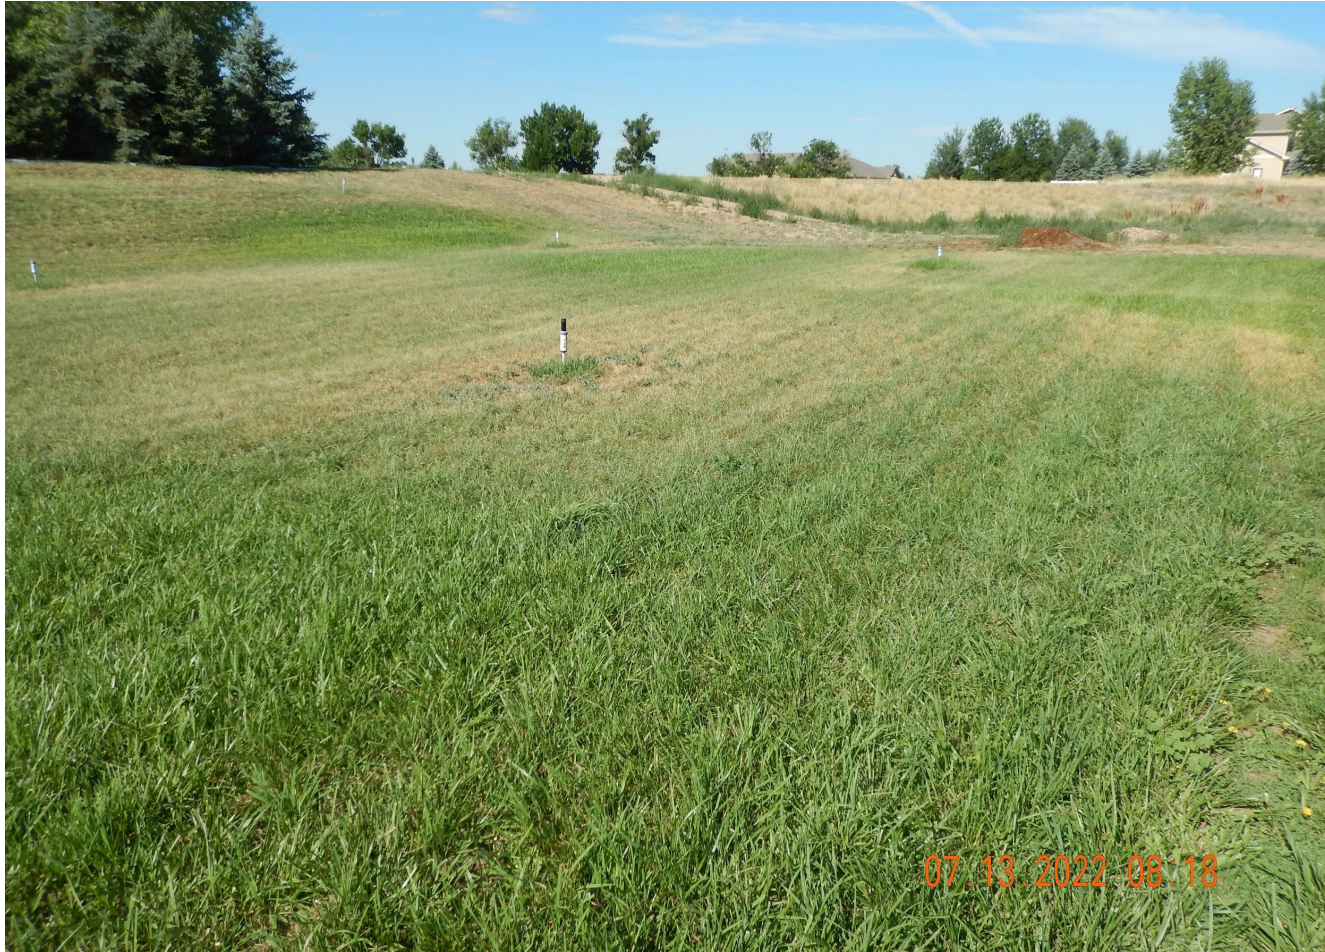
**Photo 4.** Photo taken from the eastern location, facing West. Photo illustrates that the location is reflective of reference areas.

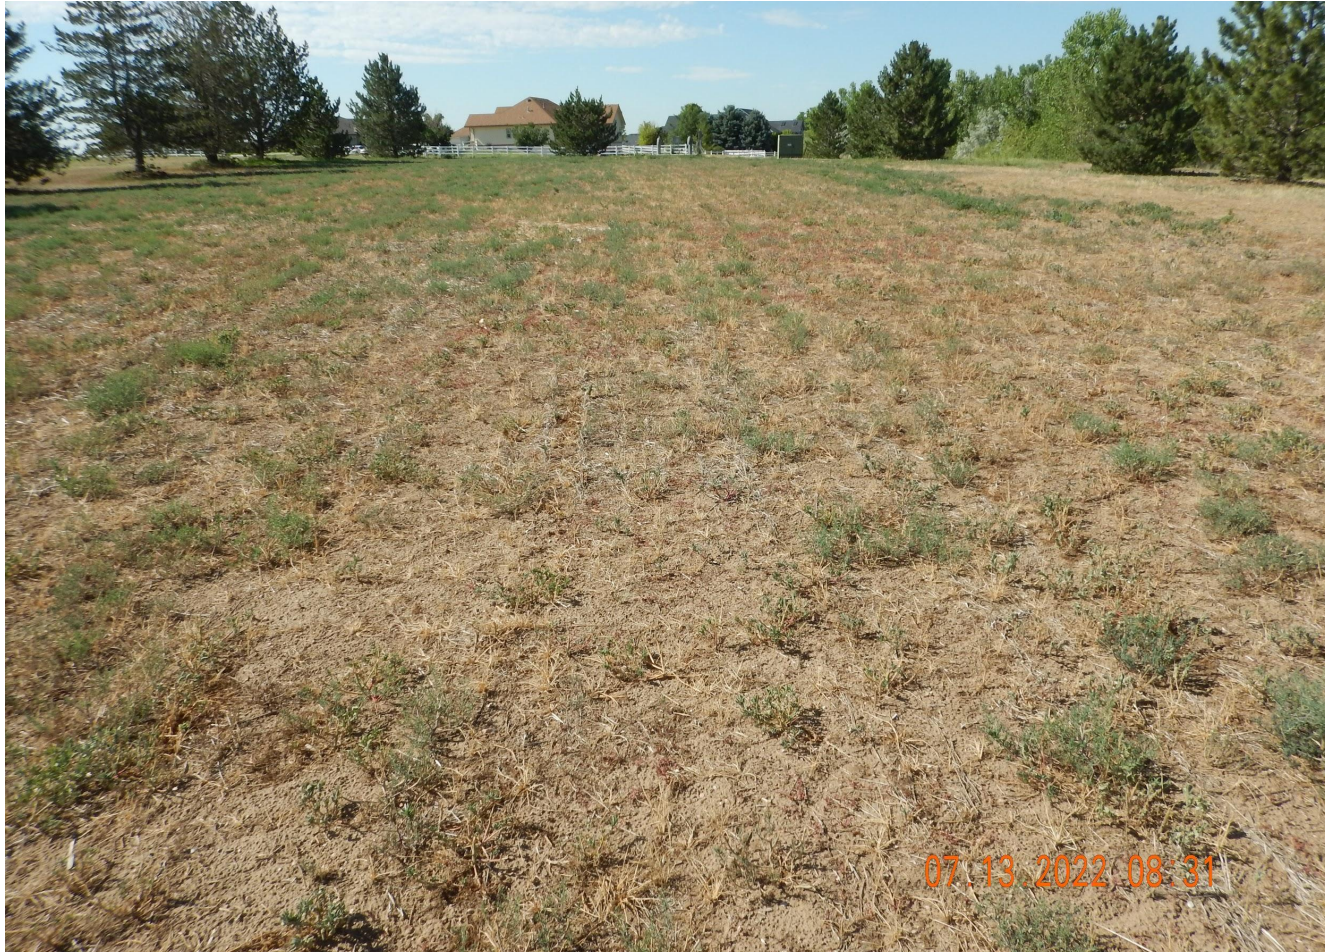
**Photo 5.** Photo taken from the northern associated offsite tank battery, facing South. Photo illustrates Operator has performed final reclamation activities and desirable vegetation was observed. It appears the area is being managed for weeds as the location appears to have been mowed recently.

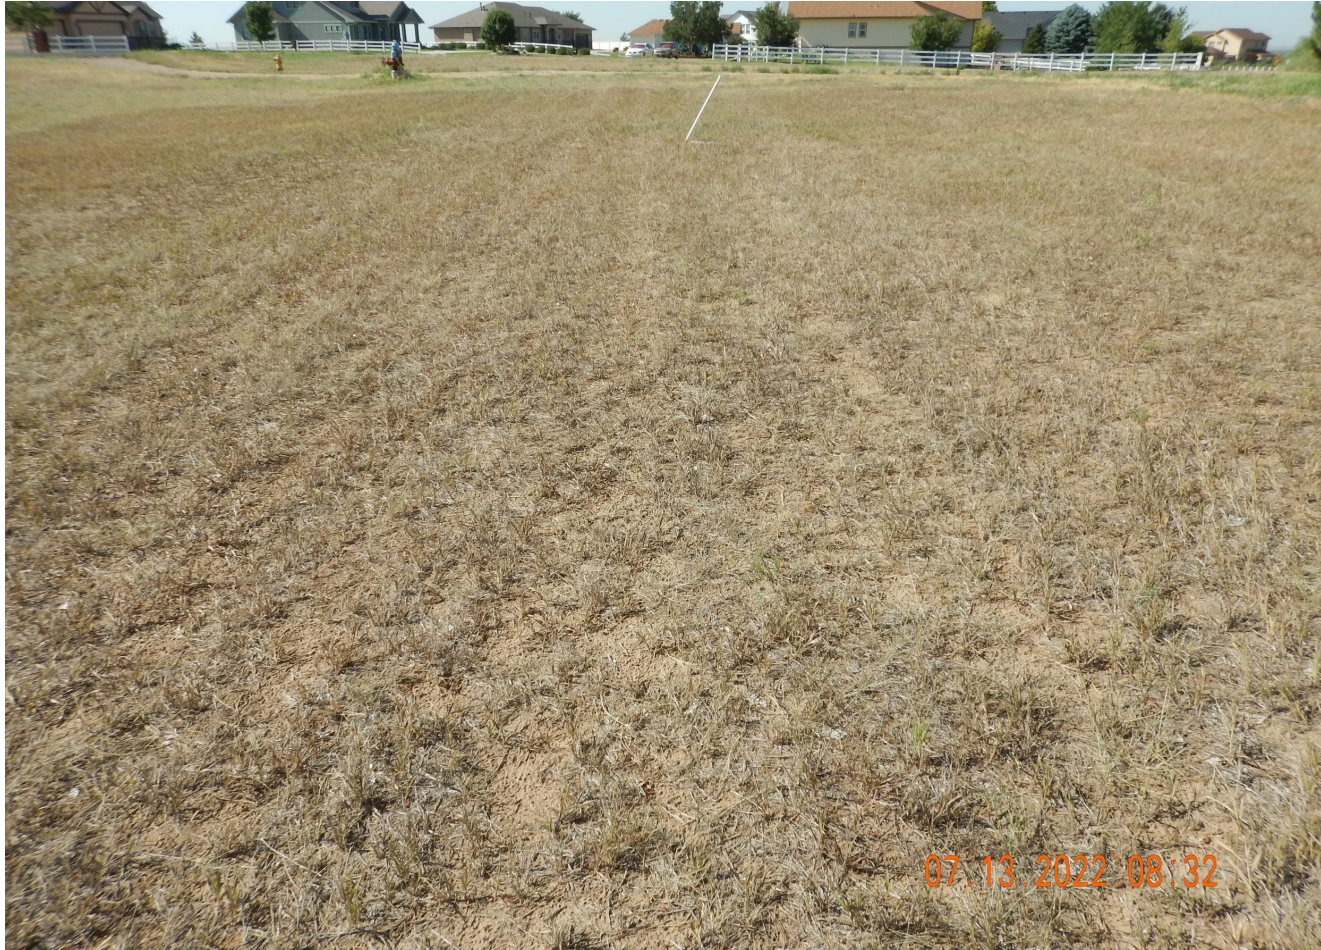
**Photo 6.** Reference photo taken southeast of the tank battery, facing South.
