FLOWLINE ABANDONMENT FORM

SITE NAME: Miller 4-20J							DATE: 6/10/2022	REM. PROJECT #:	WEATHER: Partly cloudy 77(F)
SITE DIRECTIONS: HWY 85 & CR 30, E. 1.2 miles, N. 0.2 miles, E. INTO							CLIENT: CIVITAS		
LEGALS AND LAT/LONG: 40.206753, -104.796379							TASMAN PERSONNEL: Sierra Kyrlo		
SOIL TYPES: Clayey Sand - SC							SURFACE GRADIENT: West		
SOIL SAMPLING							FACILITY INFRASTRUCTURE		
Date/Time	Soil Sample ID	PID (ppm)	Visual	Olfactory	Photo?	Grab or Lab Sample?	EQUIPMENT	Quantity	
							Above Ground Storage Tank (AST)		
6/10/2022 10:00	FL-B01@2'	1.0	No Staining	No Odor	Yes	Lab	Buried or Partially Buried Vessel		
6/29/2022 13:30	FL-B02@4'	329.2	HC Staining	HC Odor	Yes	Lab	Separator		
							Emission Control Device (ECD)		
							Dump Line		
							Wellhead		
							Flowline	1	
							Other:		
							Soil Loads Removed		
							IMPACTED SOIL IDENTIFIED?		
							ESTIMATED VOLUME OF IMPACTS:		
							Date	Number	CY
							Total Removed	0	0

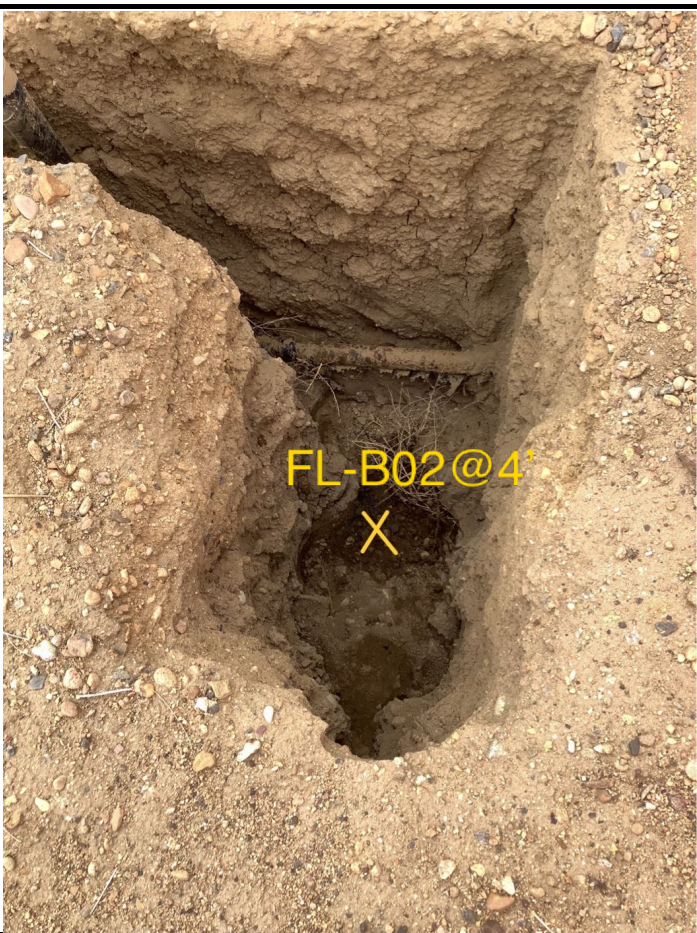
<p>FL-B02@4' X</p>																								
<table border="1"> <tr> <td colspan="2">Equipment ID:</td> <td colspan="2">Equipment Type:</td> </tr> <tr> <td>Material:</td> <td>Volume:</td> <td colspan="2">Contents:</td> </tr> <tr> <td colspan="4">Notes/Conditions: Facing south</td> </tr> </table>	Equipment ID:		Equipment Type:		Material:	Volume:	Contents:		Notes/Conditions: Facing south				<table border="1"> <tr> <td colspan="2">Equipment ID:</td> <td colspan="2">Equipment Type:</td> </tr> <tr> <td>Material:</td> <td>Volume:</td> <td colspan="2">Contents:</td> </tr> <tr> <td colspan="4">Notes/Conditions: Sample at flowline riser</td> </tr> </table>	Equipment ID:		Equipment Type:		Material:	Volume:	Contents:		Notes/Conditions: Sample at flowline riser			
Equipment ID:		Equipment Type:																							
Material:	Volume:	Contents:																							
Notes/Conditions: Facing south
