Inspection Photos and Issue Report

Operator: EL PASO NATURAL GAS COMPANY -
26600

Location #382671
Garfield County, CO

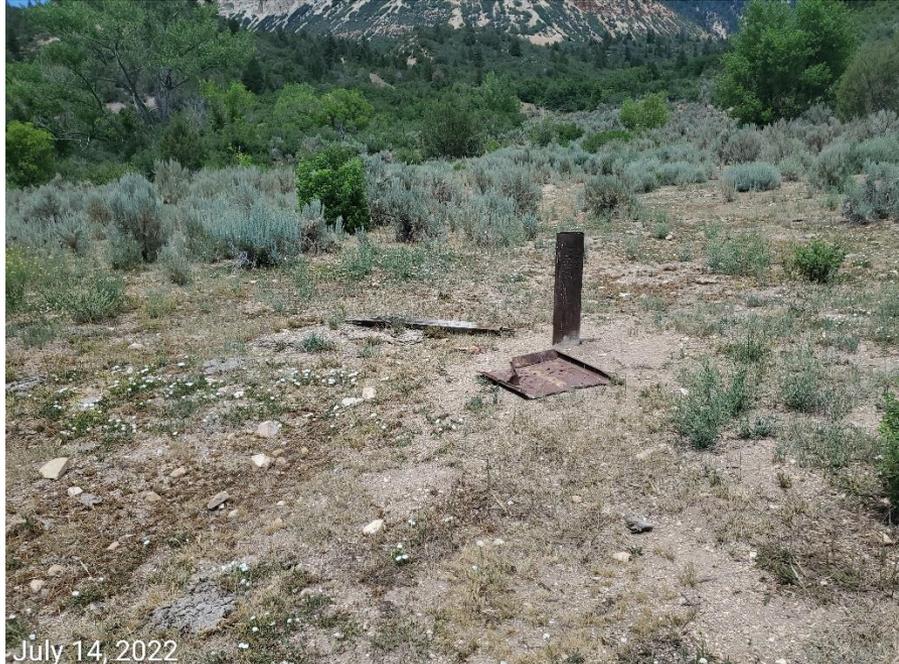
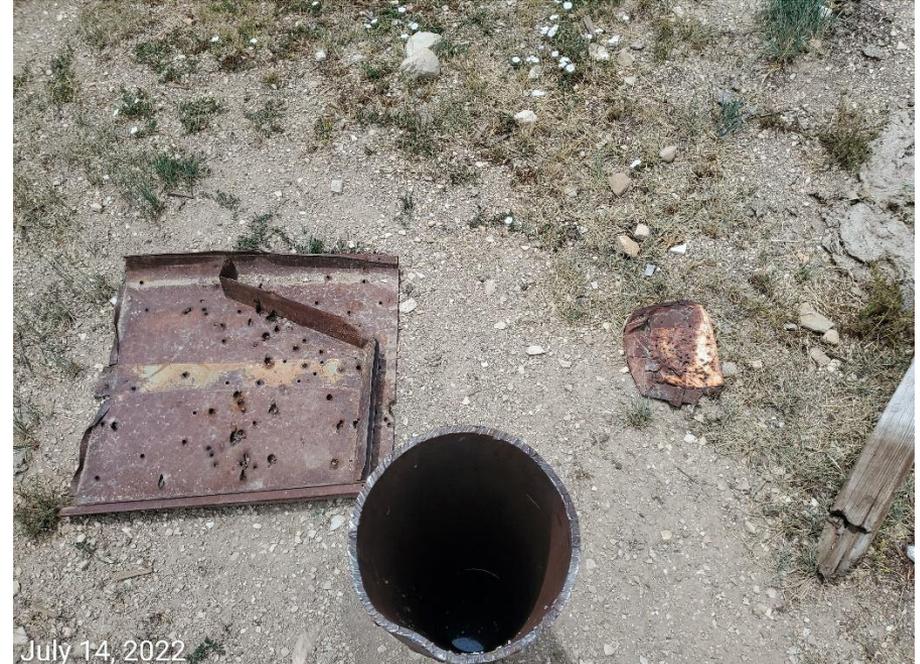
Photo 1: Photos shows well marker has not been installed per (pre-1/15/2021 rule change) Rule 319.a.(5). Pipe has missing welded plate at top, and is currently open.

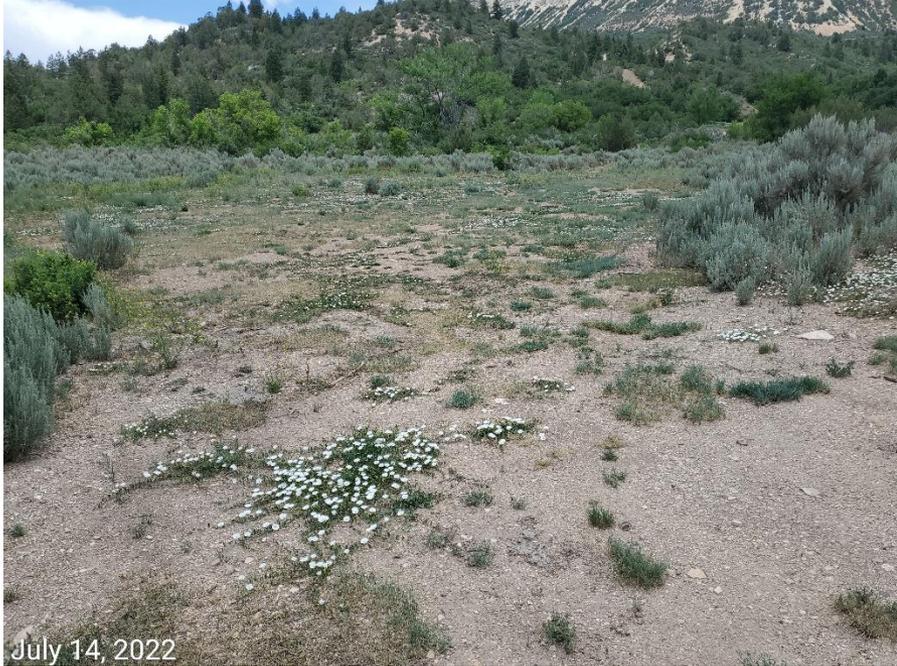
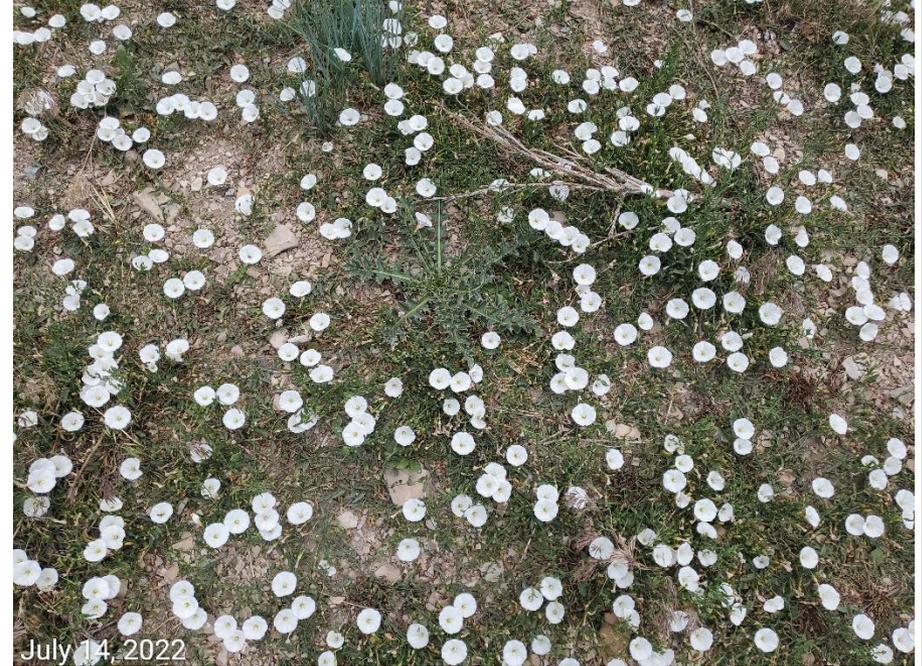
Photo 2: Photos example showing noxious weed establishment observed on the Location, including Field Bindweed, Scotch thistle, Knapweed

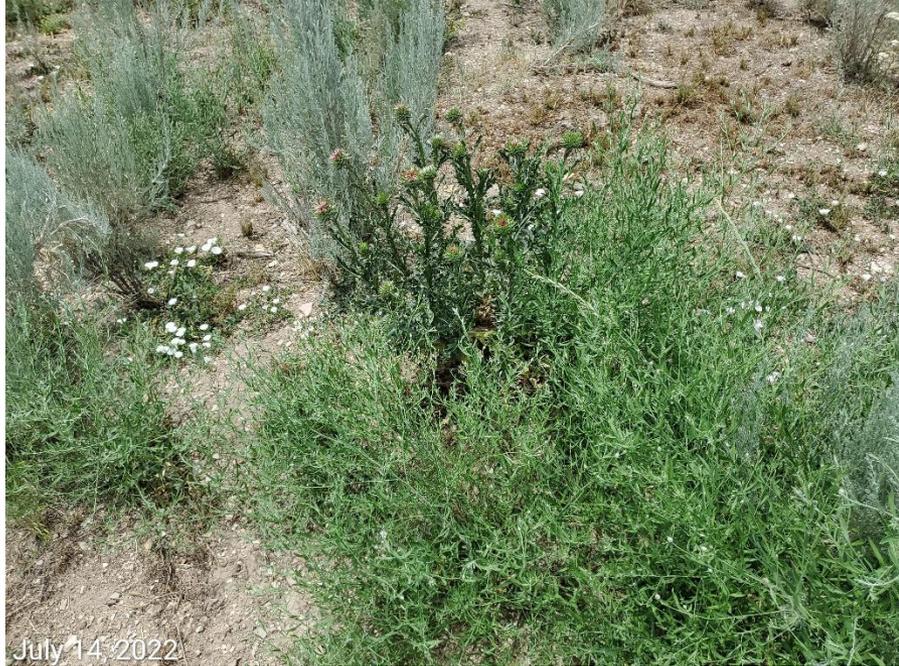
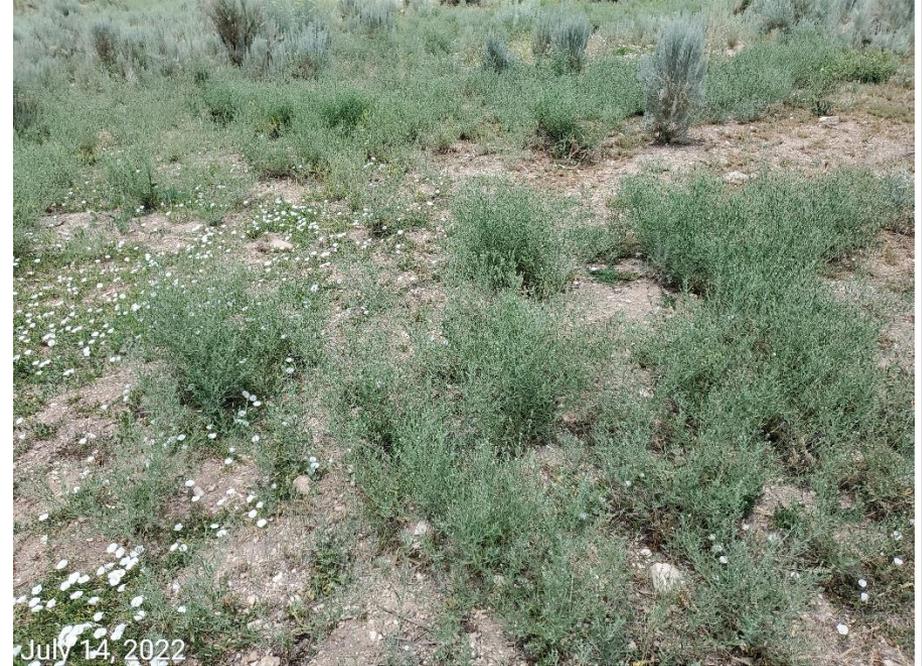
Photo 3: Photos example showing noxious weed establishment observed on the Location, including Field Bindweed, Scotch thistle, Knapweed
