Inspection Photos and Issue Report

Operator: LARAMIE ENERGY LLC # 10433

Location #334550

Mesa County, CO

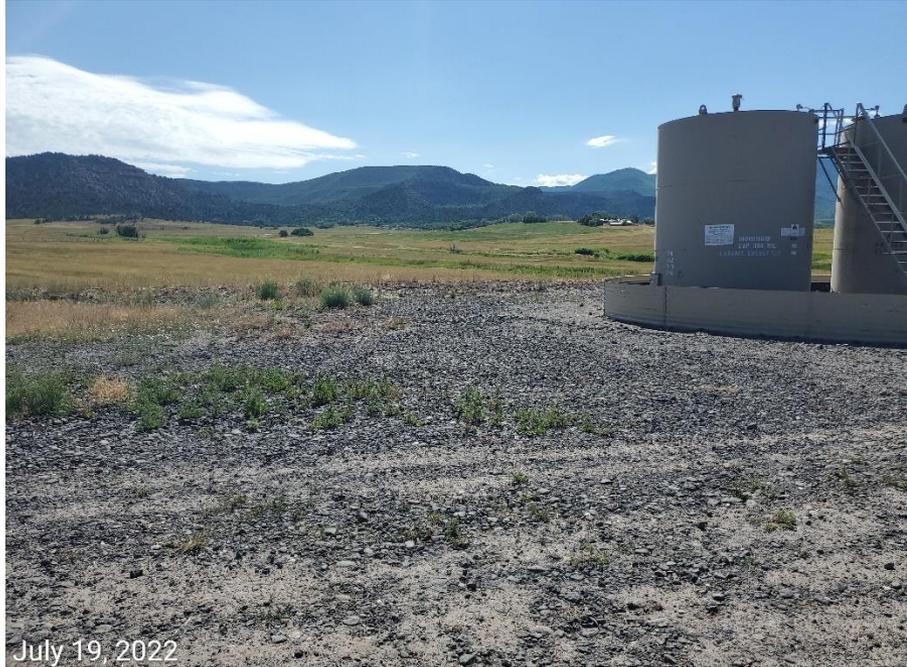
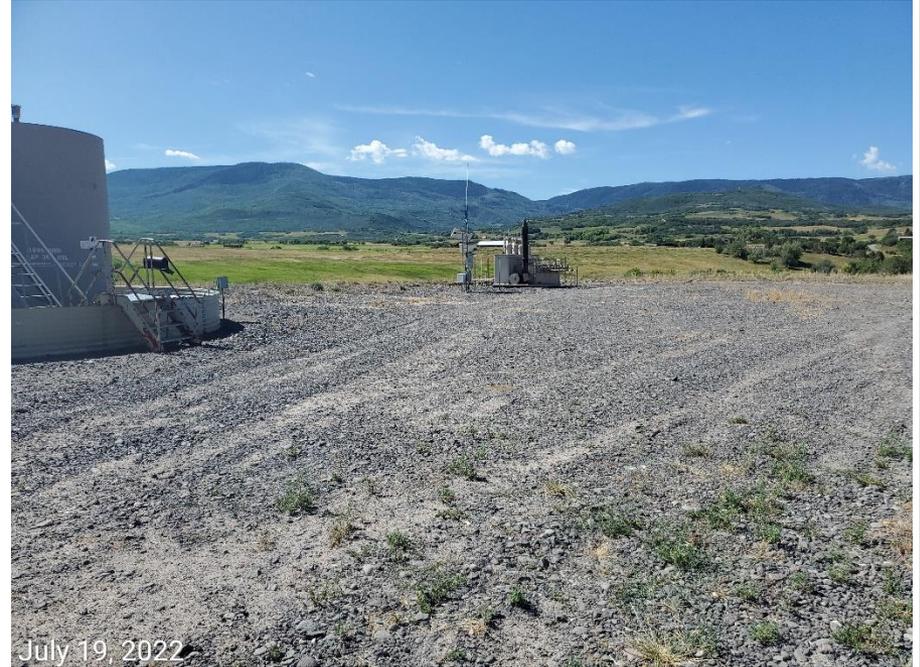
Photo 1: Photos 1-2 taken from the north end of the Location. Photos provide an overview of the Location facing east, southeast, southwest to west.

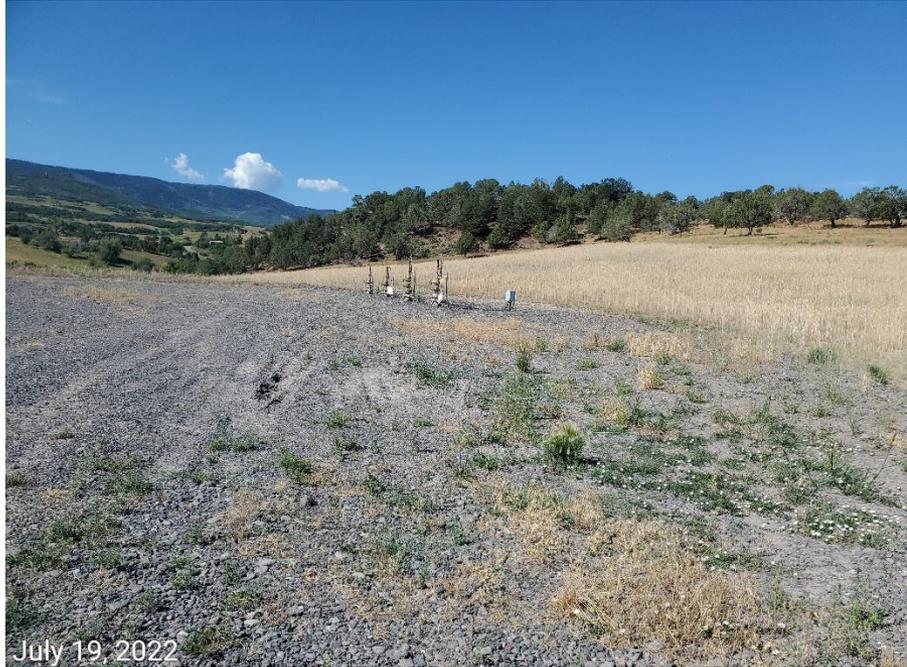
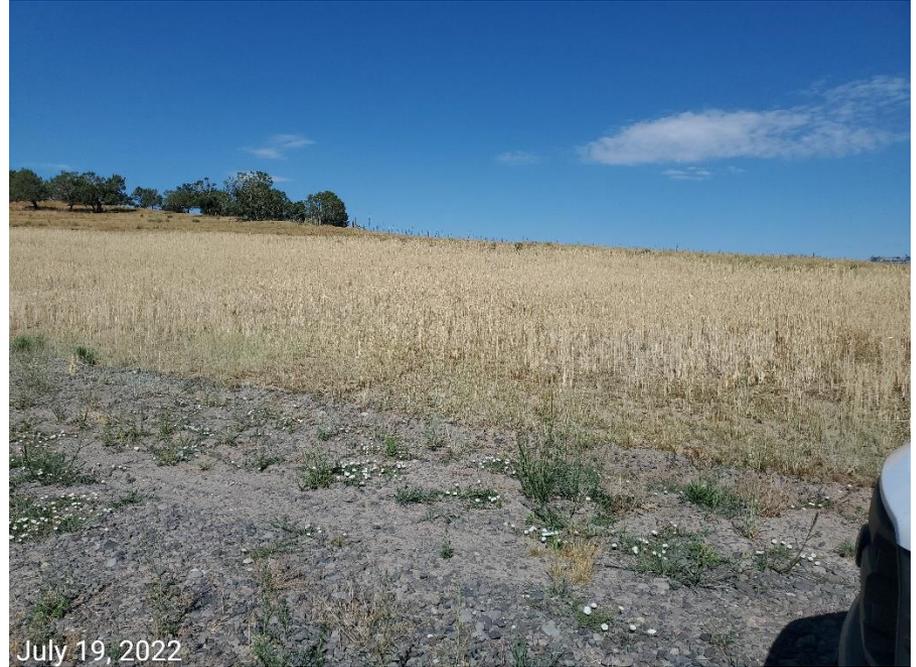
Photo 2: See comments under photo 1.

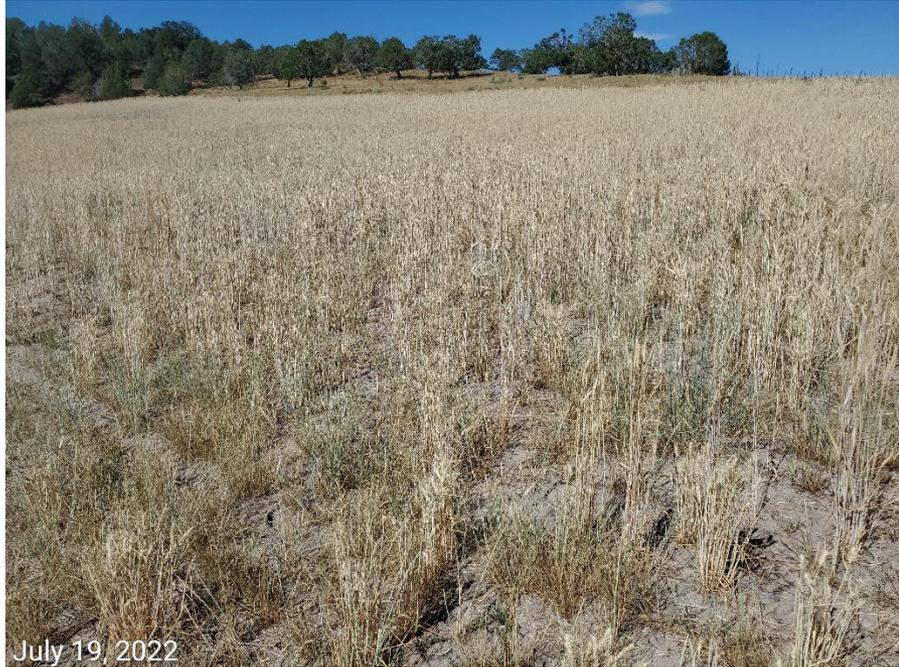
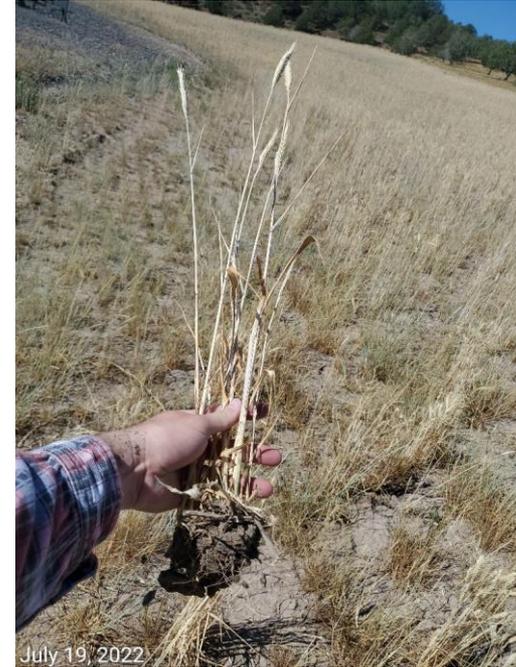
Photo 3: Photos show examples of vegetation observed on the interim areas; though desirable perennial vegetative establishment was observed within interim areas, vegetation established on the interim areas are predominantly annual grass species that do not comport with, or contribute to Rule 1003.e standards and requirements. Annual grass species also do not provide long term stabilization and competes with desirable plant species.

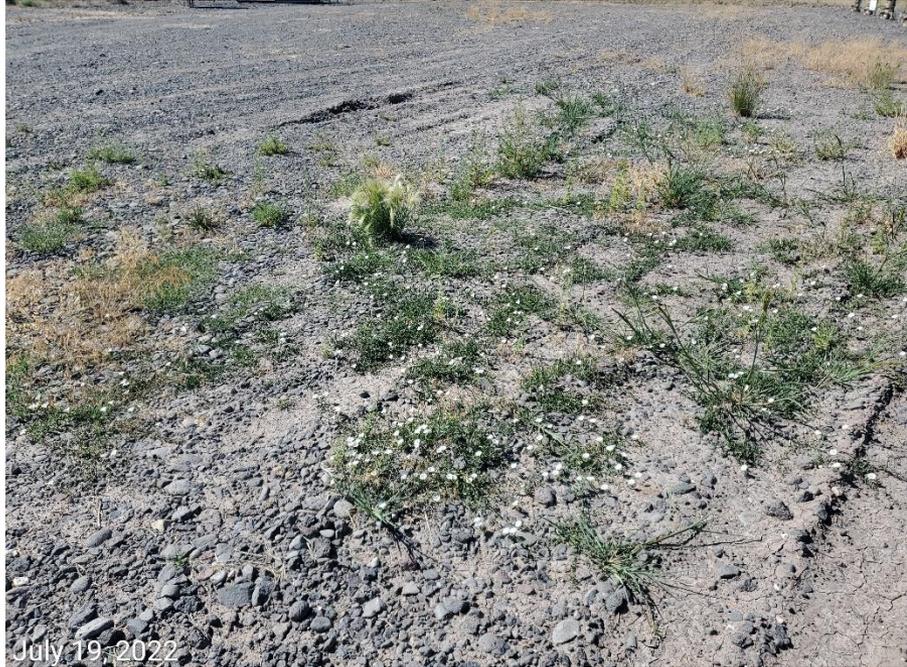
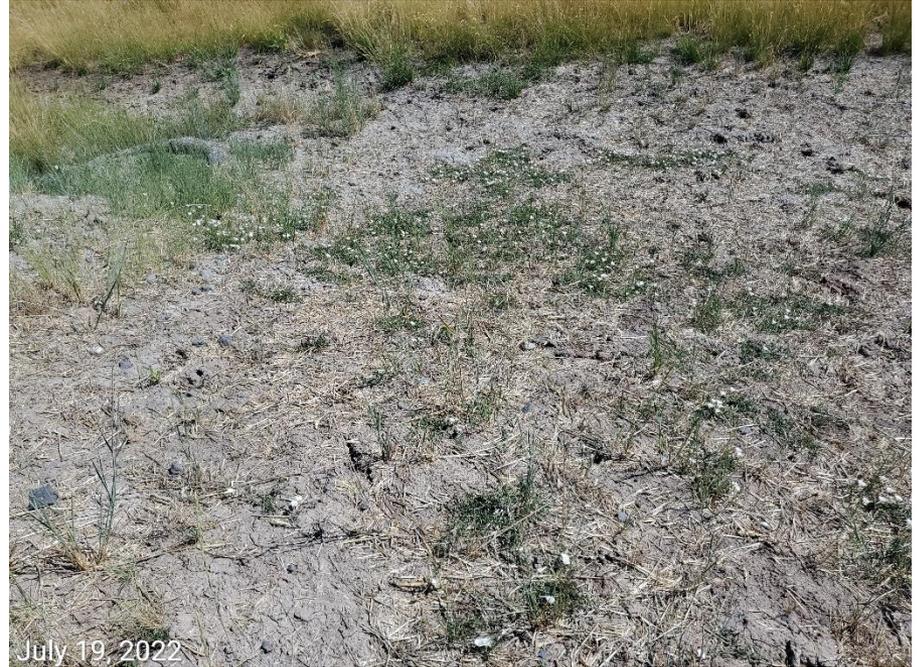
Photo 4: Photos examples showing Undesirable and Noxious plants (bind weed) establishing on the production and interim areas

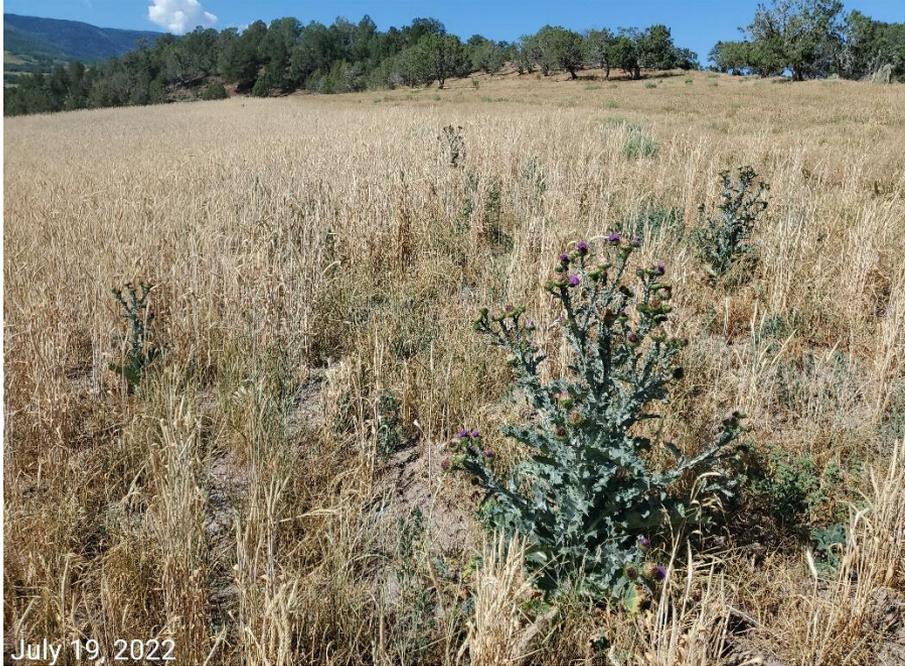
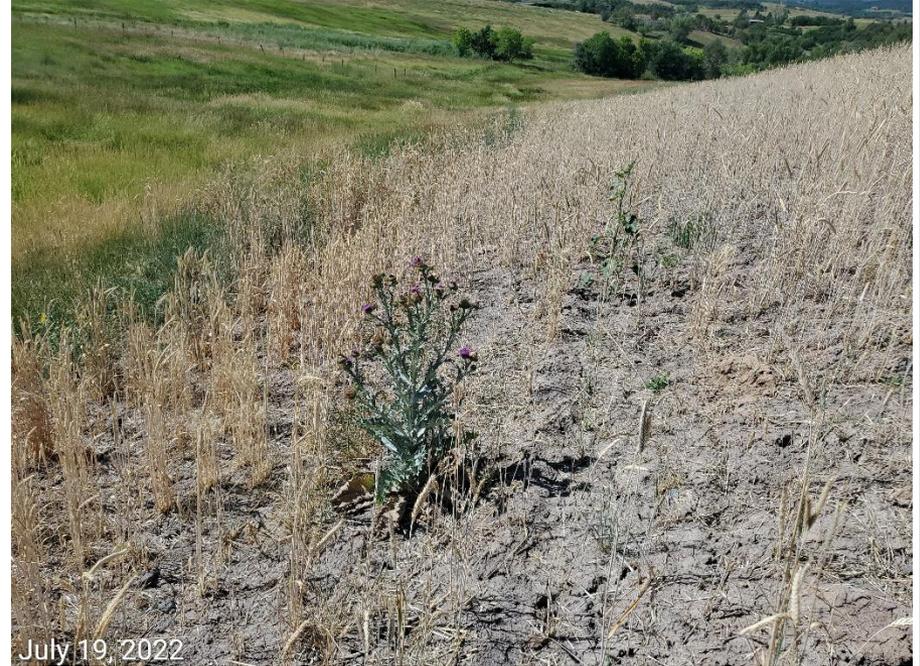
Photo 5: Photos examples showing Undesirable and Noxious plants (scotch thistle) establishing on the production and interim areas

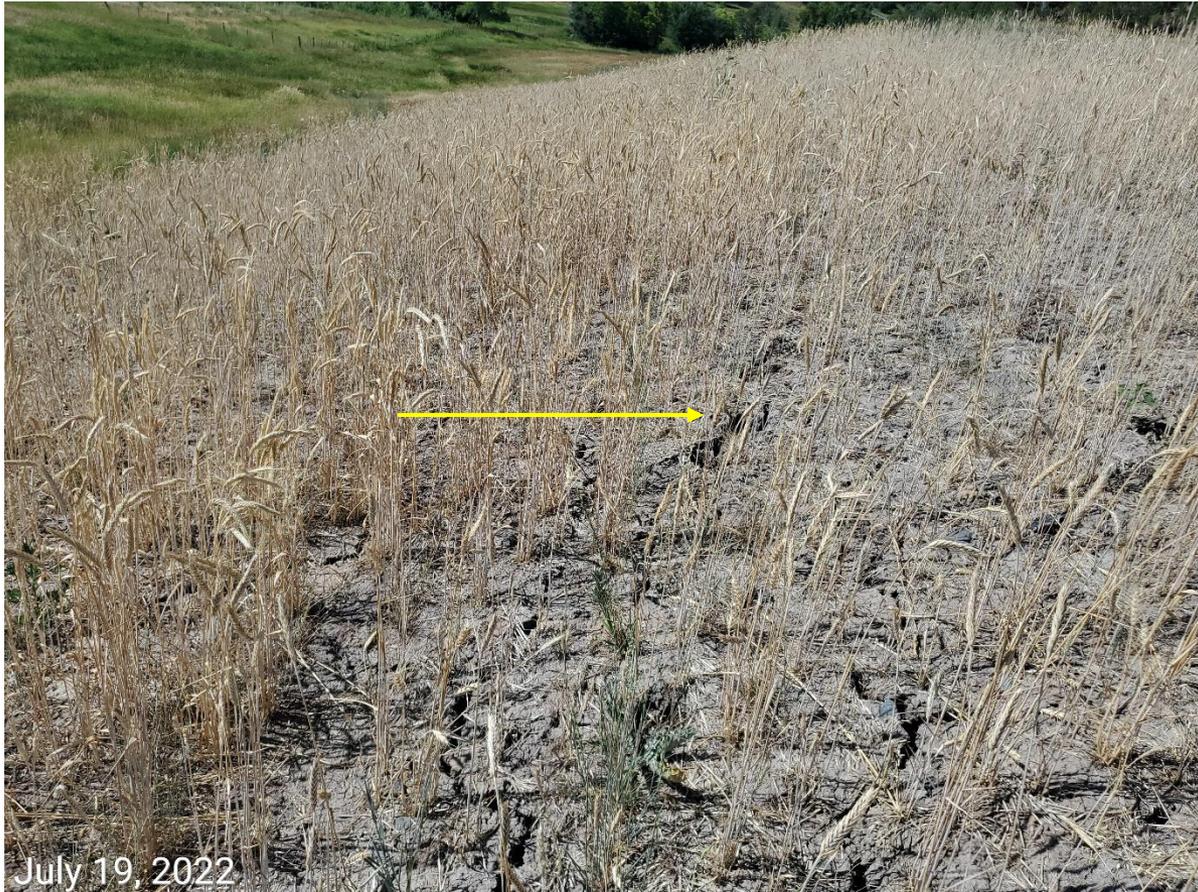
Photo 6: Photo taken from the eastern interim areas; photo provides example of cracks forming on the slopes, suggesting potential stability concerns.
