# Inspection Photos

Operator: Beeman Oil & Gas Inc- #7125

Location Name: Dawson Creek /1-25

Inspection Document #: 702800461

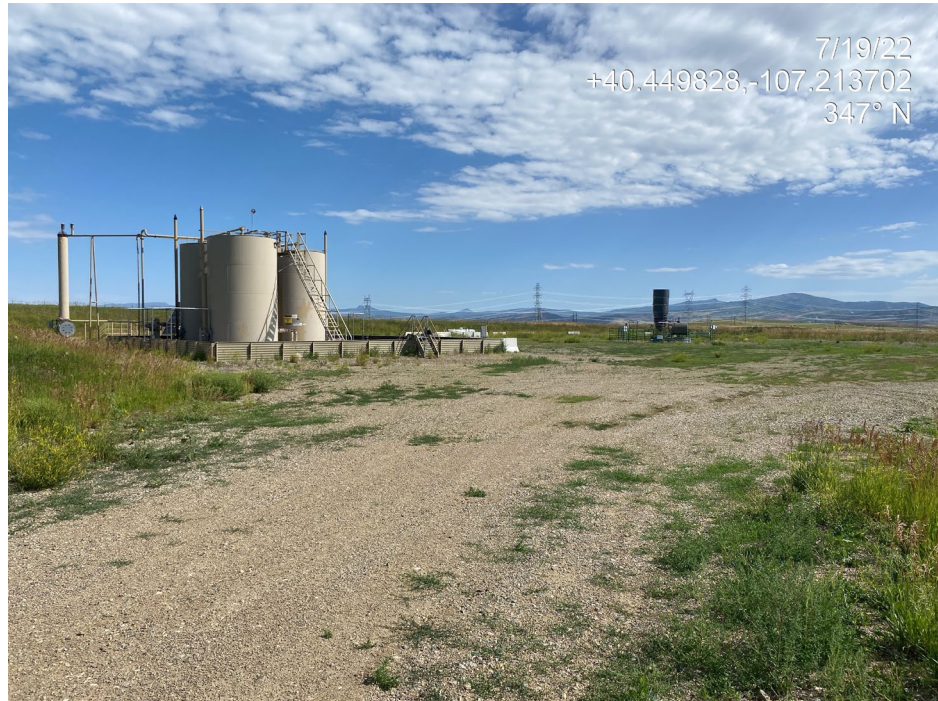
**Photo 1.** Photo taken from the Location entrance shows an overview of the western portion of the Location.

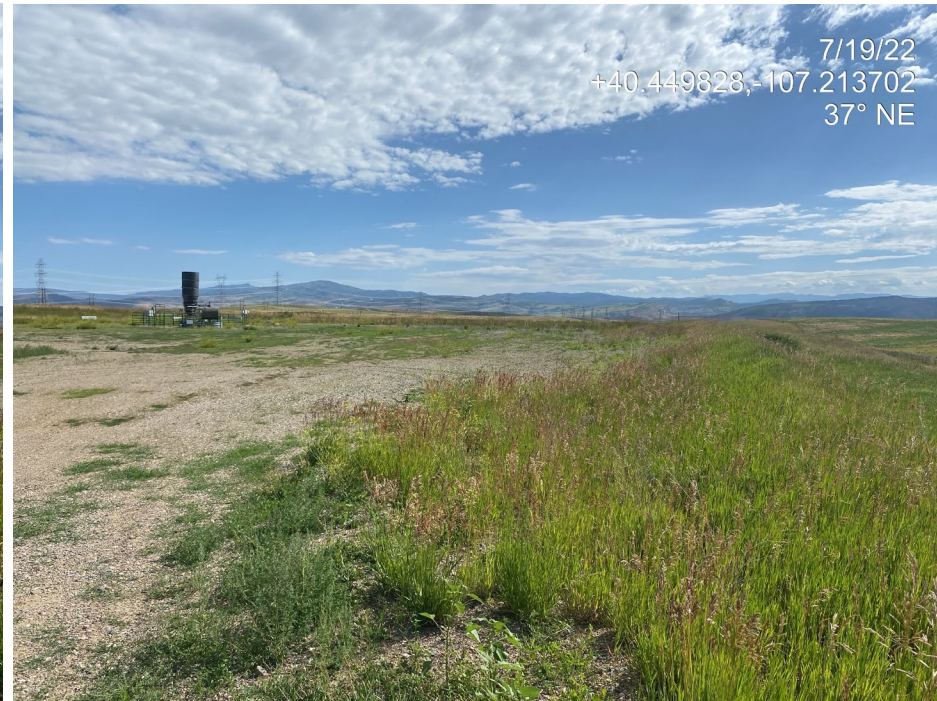
**Photo 2.** Photo taken from the Location entrance shows an overview of the eastern portion of the Location. Photo shows a portion of the pad not necessary for production operations where interim reclamation is required.

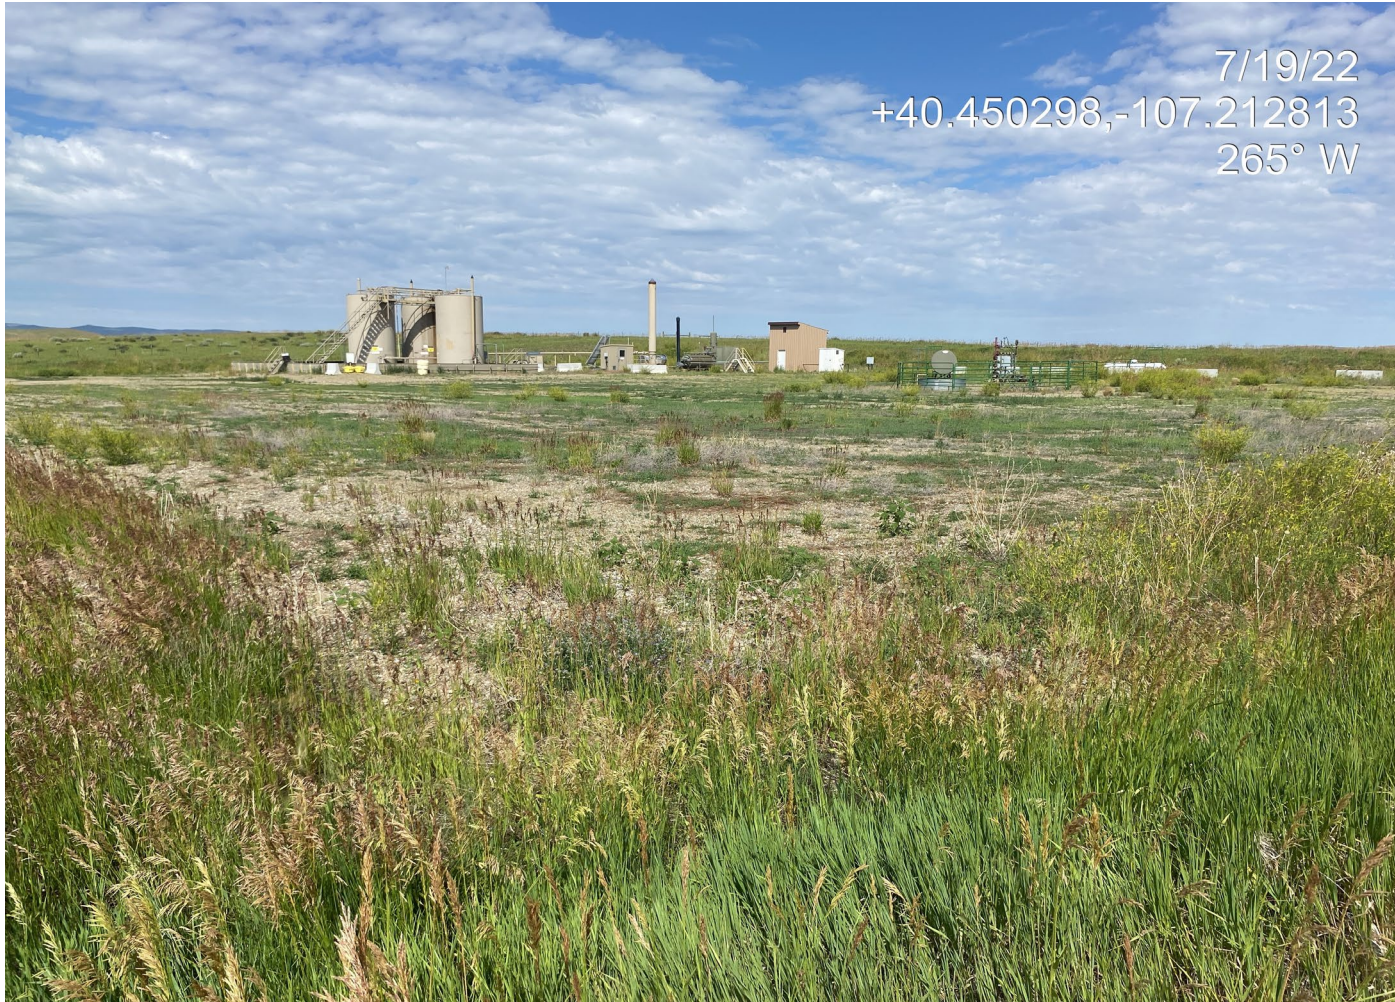
**Photo 3.** Photo taken from the east of the Location shows areas at the east and southeast of the pad which do not appear necessary for production operations where interim reclamation has not been performed.

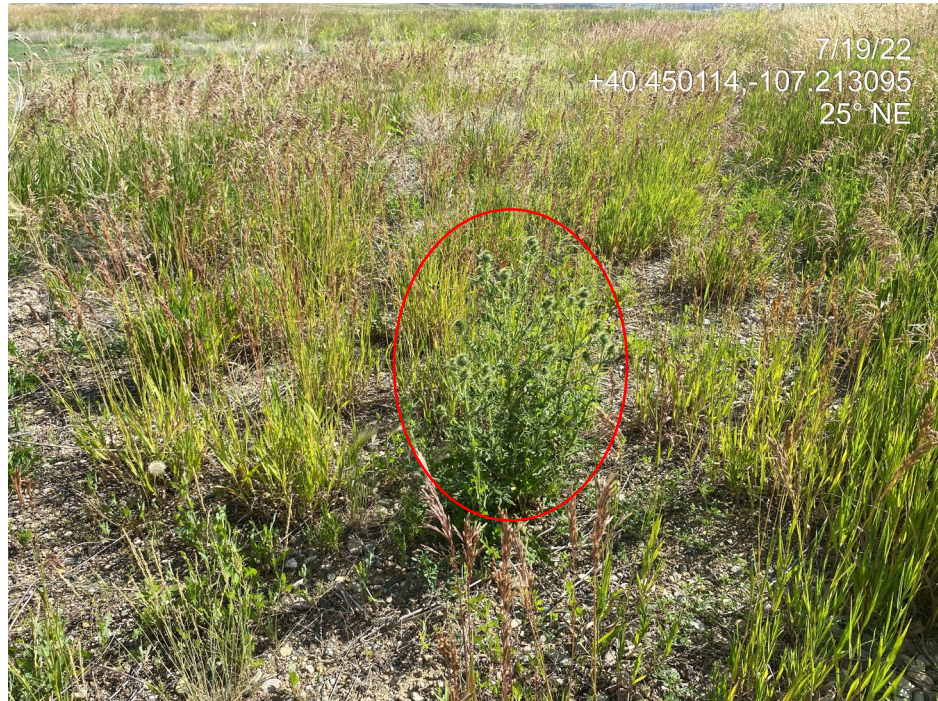
**Photo 4.** Photo taken from the southeast of the Location shows an example of bull thistle, a CO List B Noxious Weed found throughout the Location.

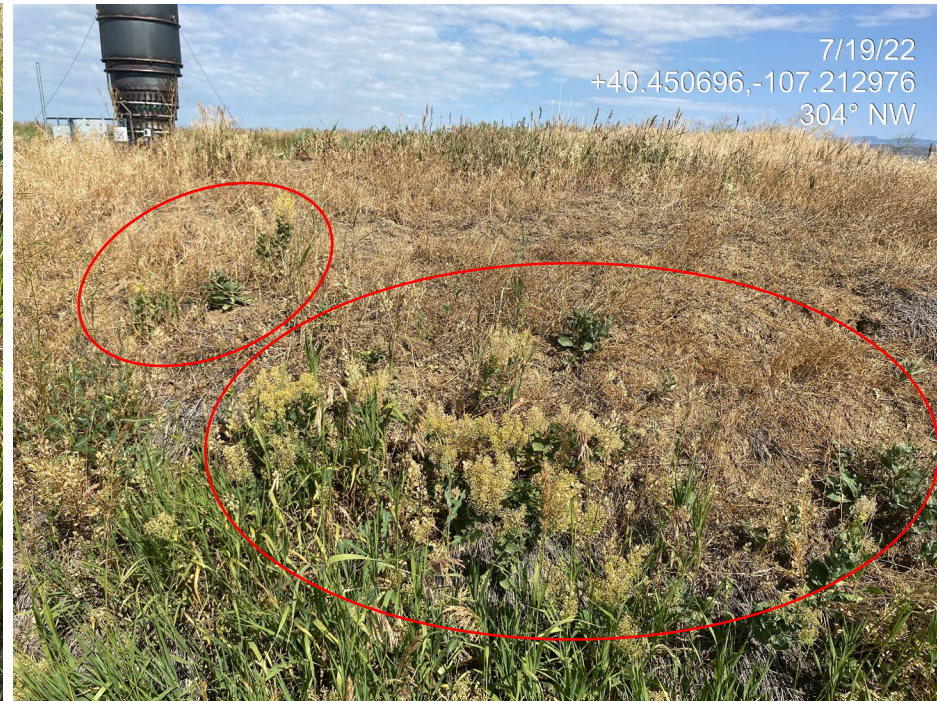
**Photo 5.** Photo taken from the northeast of the Location shows whitetop, a CO List B Noxious Weed.

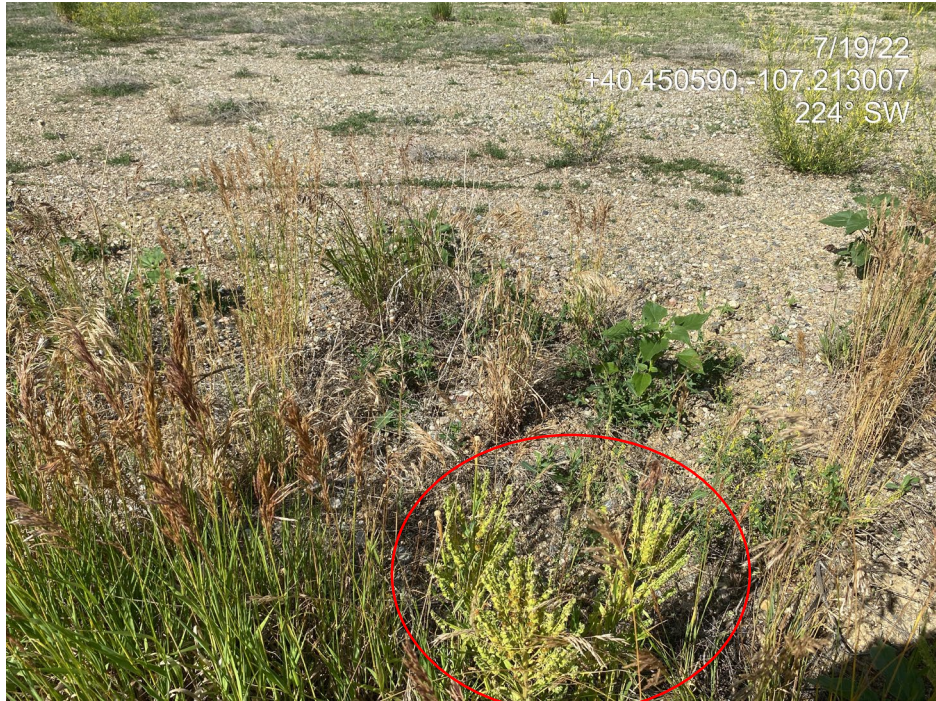
**Photo 6.** Photo taken from the northeast of the Location shows an example of houndstongue, a CO List B Noxious Weed found throughout the Location.

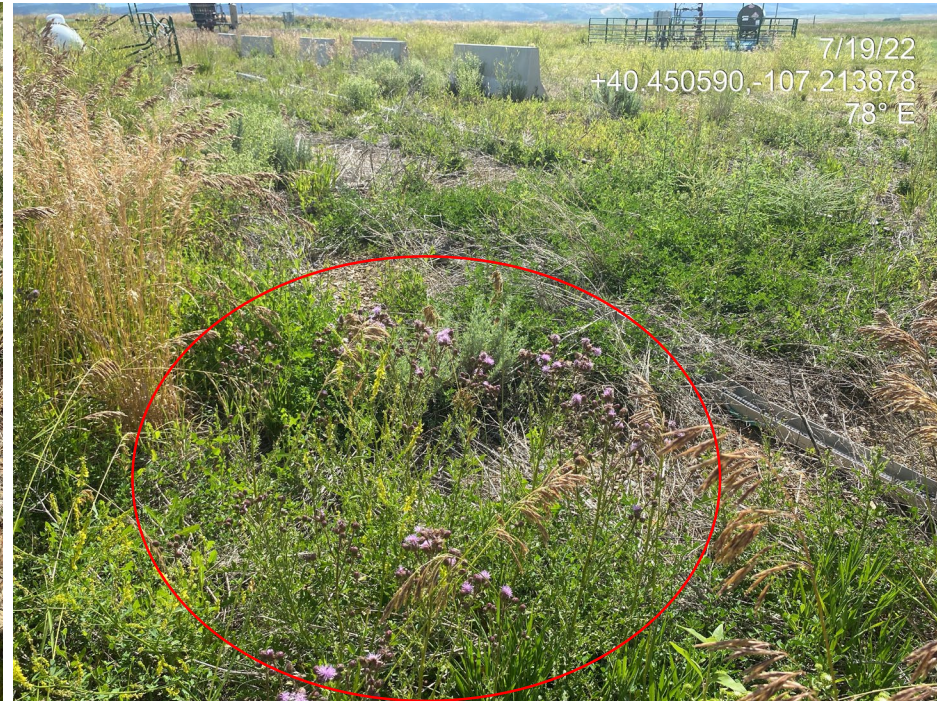
**Photo 7.** Photo taken from the northwest of the Location shows an example of Canada thistle, a CO List B Noxious Weed found throughout the Location.

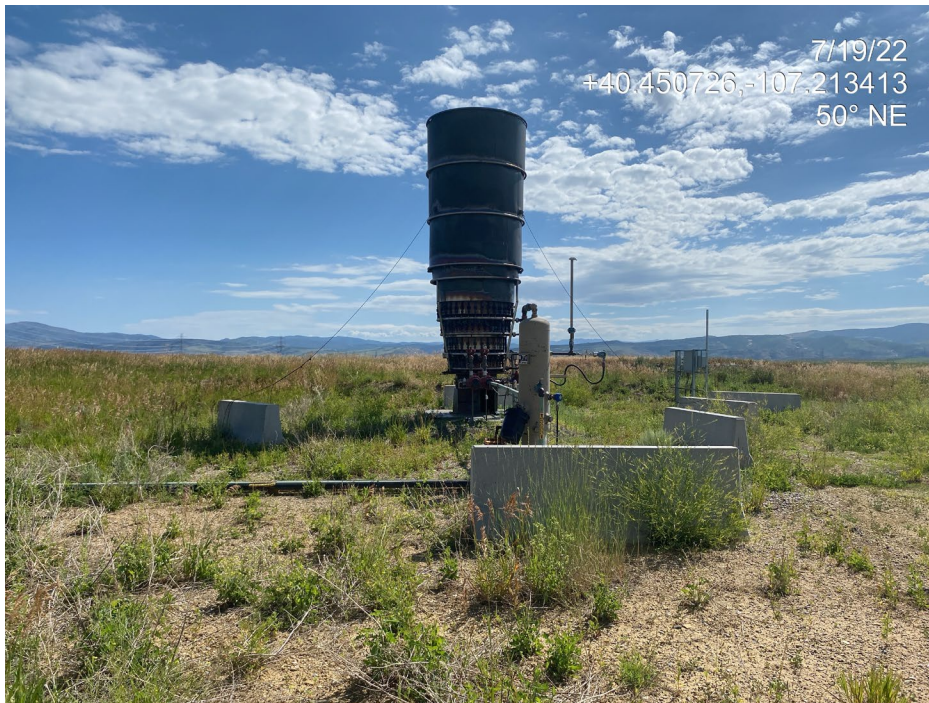
7/19/22  
+40.450726,-107.213413  
50° NE

**Photo 8.** Photo taken from the north of the Location shows the working pad area is overgrown with vegetation, including around production equipment.

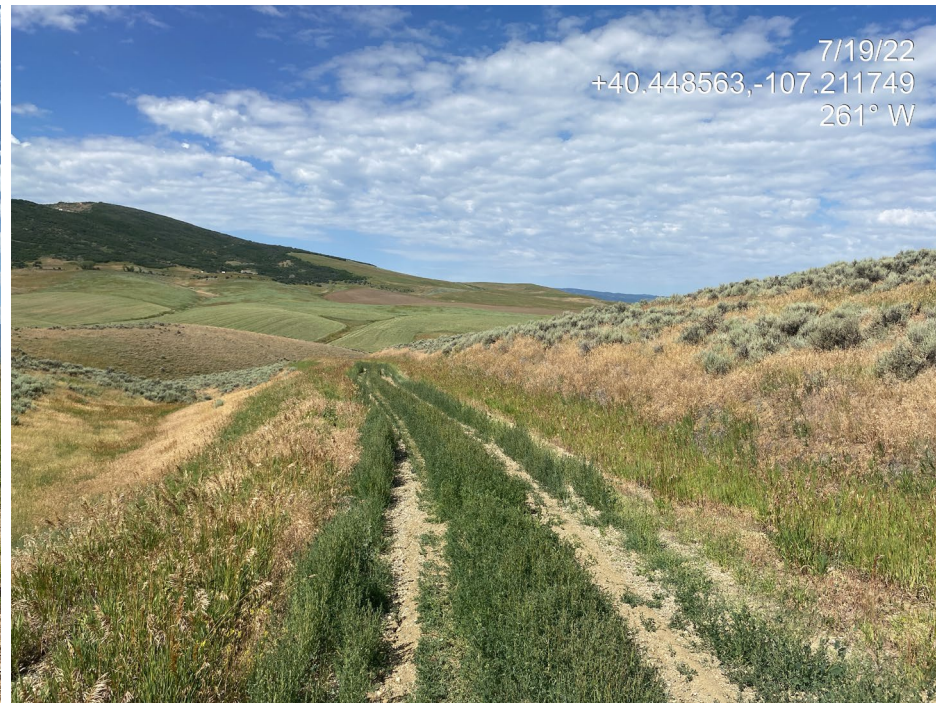
7/19/22  
+40.448563,-107.211749  
261° W

**Photo 9.** Photo taken from the Location access road shows the road is overgrown.

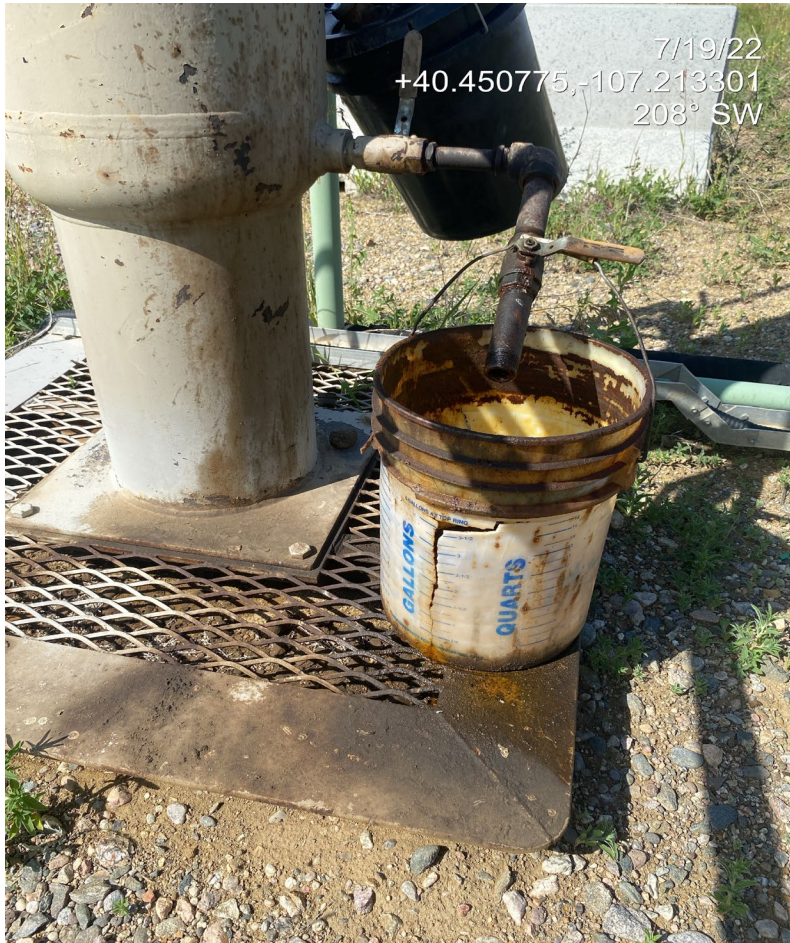
**Photo 10.** Photo taken from the north of the Location shows fluid dripping from production equipment into an inadequate container. Impacted/stained soils were present beneath the container.

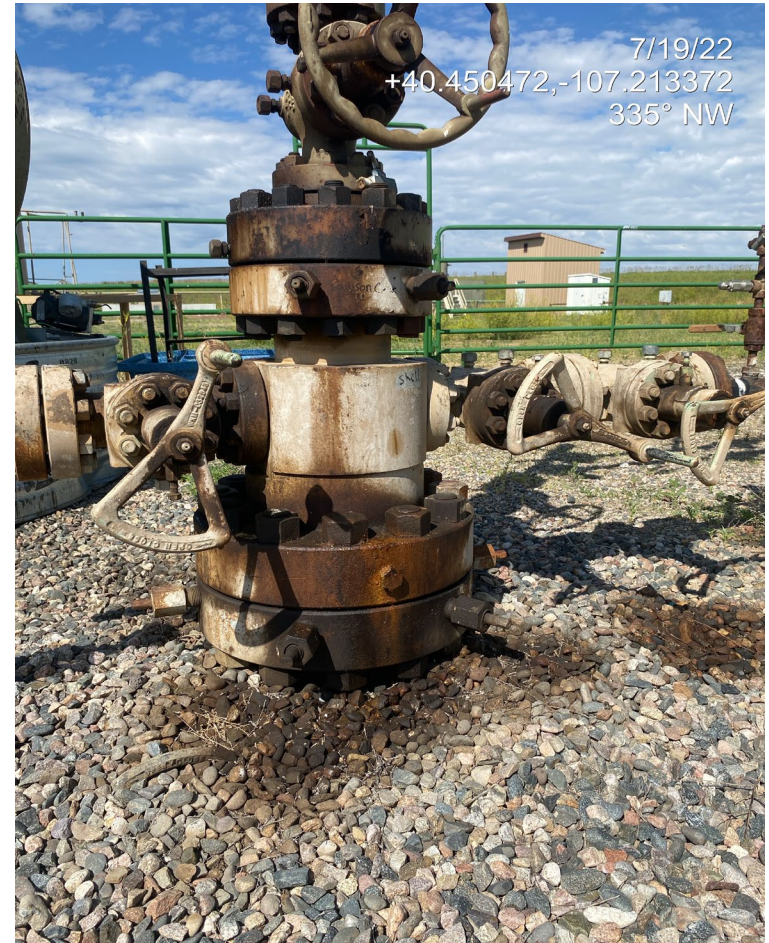
**Photo 11.** Photo taken from the well area shows impacted soils around the wellhead.

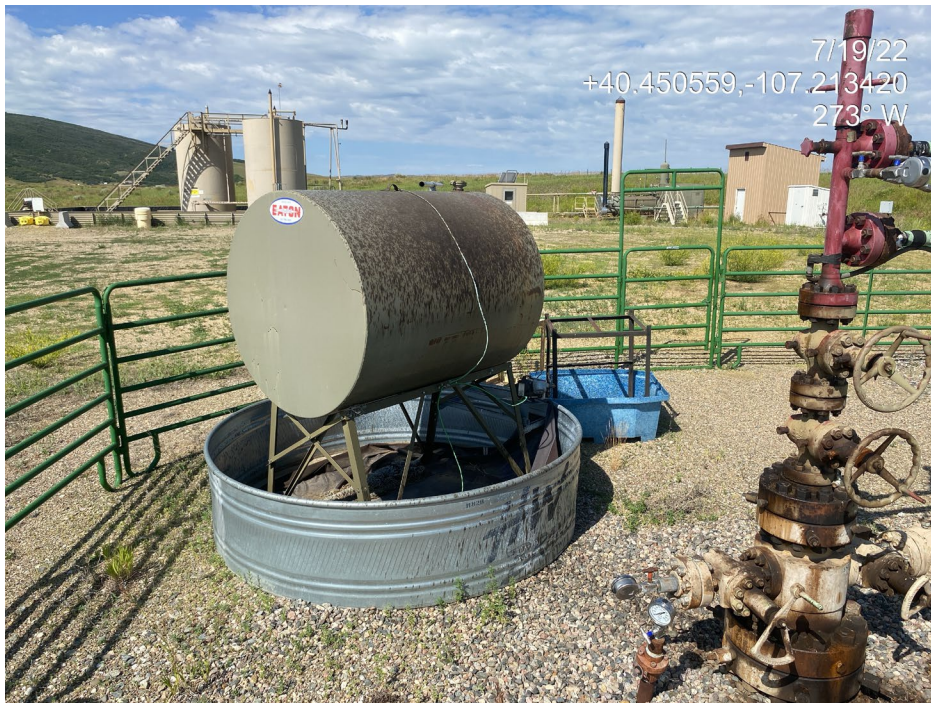
**Photo 12.** Photo shows a methanol tank adjacent to the well with missing/insufficient wildlife protection BMPs on the secondary containment stock tank.

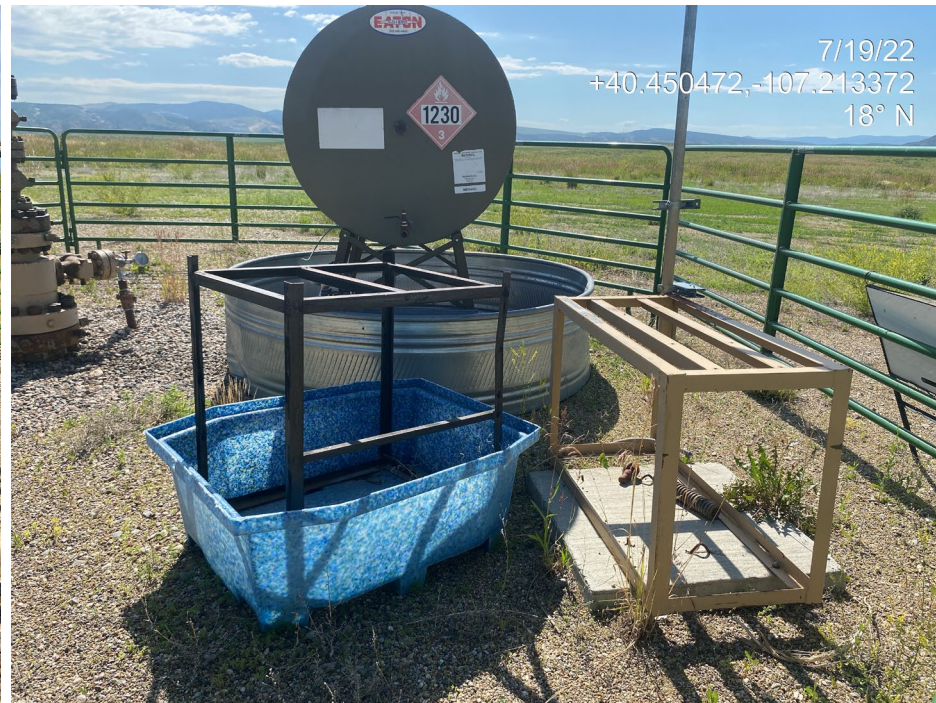
**Photo 13.** Photo taken adjacent to the well shows unused/unnecessary equipment stored on Location.
