Inspection Photos

Operator: Beeman Oil & Gas Inc- #7125

Location Name: Dill Gulch /1-22

Inspection Document #: 702800463

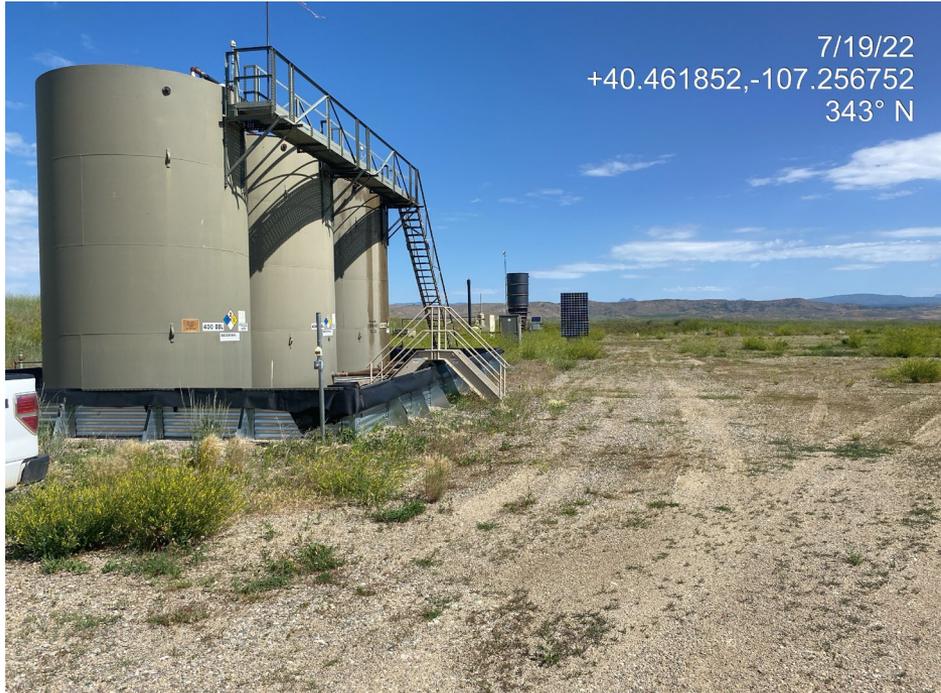
Photo 1. Photo taken from the Location entrance shows an overview of the western portion of the Location.

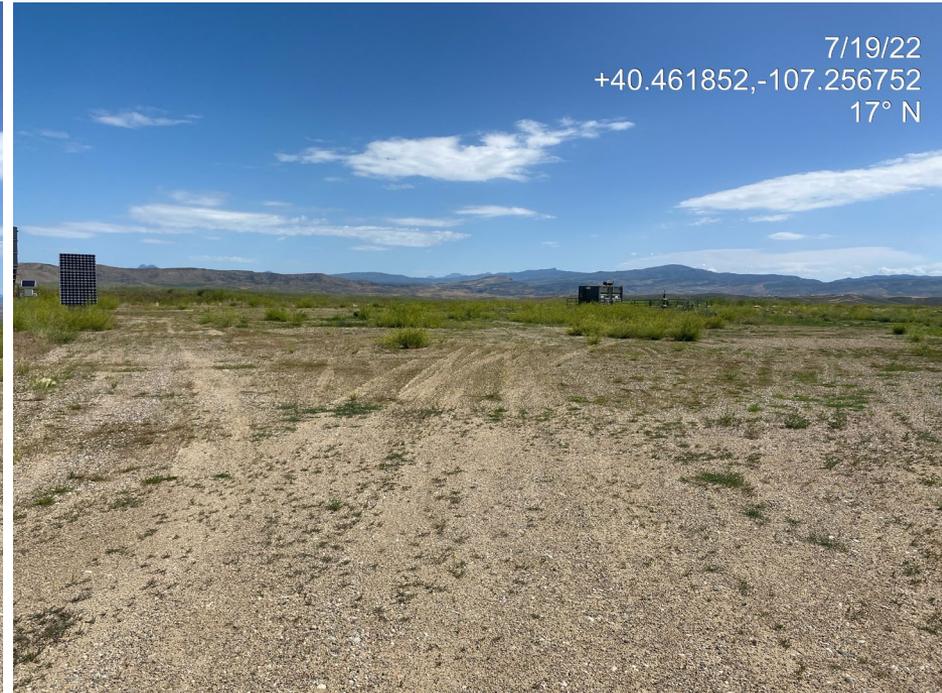
Photo 2. Photo taken from the Location entrance shows an overview of the center of the Location.

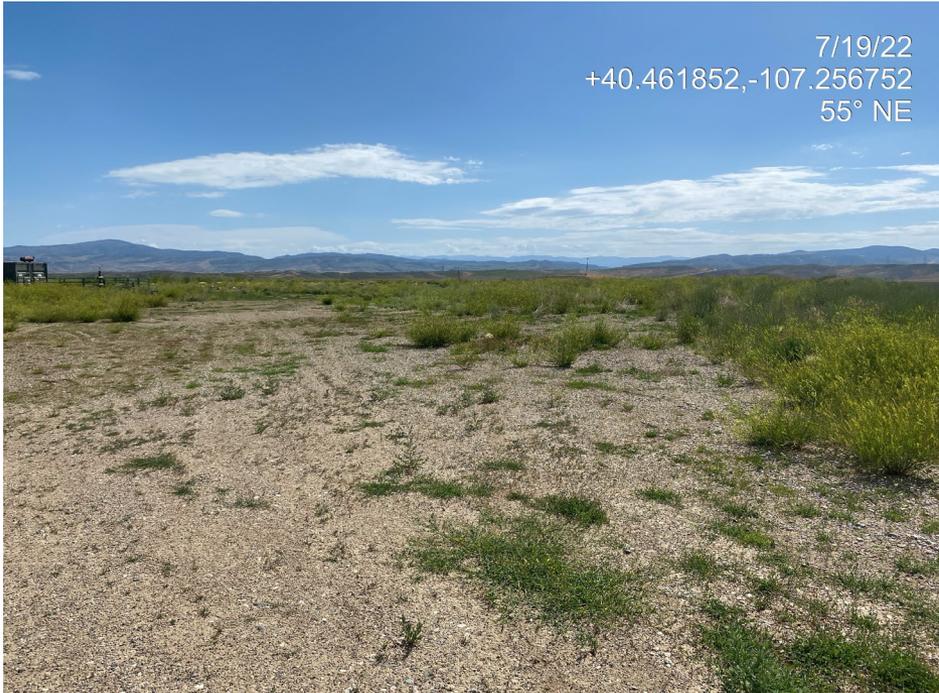
Photo 3. Photo taken from the Location entrance shows an overview of the southern portion of the Location which does not appear necessary for production operations. Interim reclamation has not been performed.

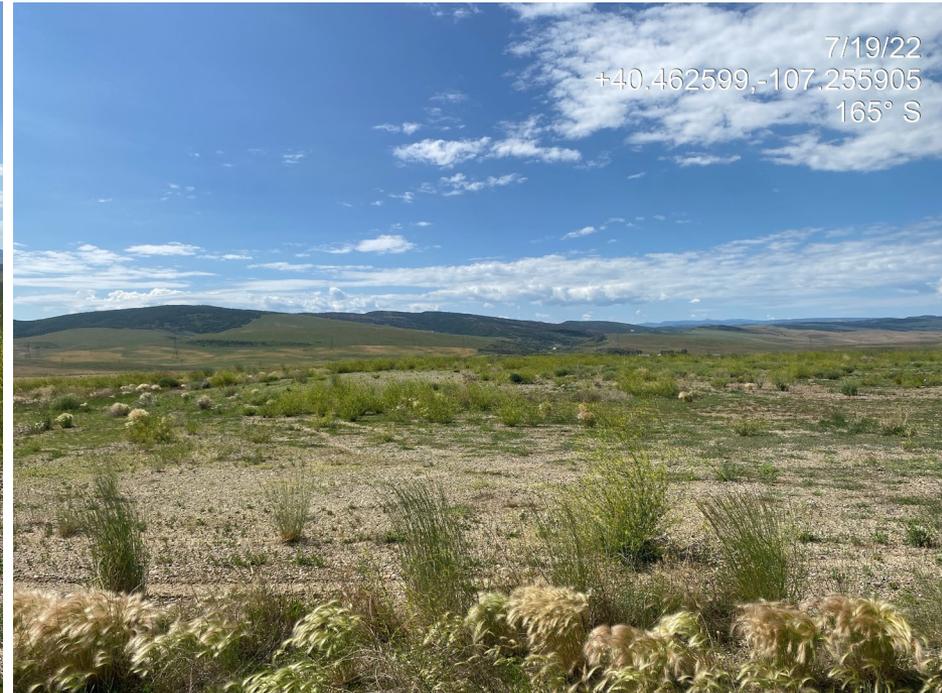
Photo 4. Photo taken from the north of the Location shows the eastern portion of the Location which does not appear necessary for production operations. Interim reclamation has not been performed.

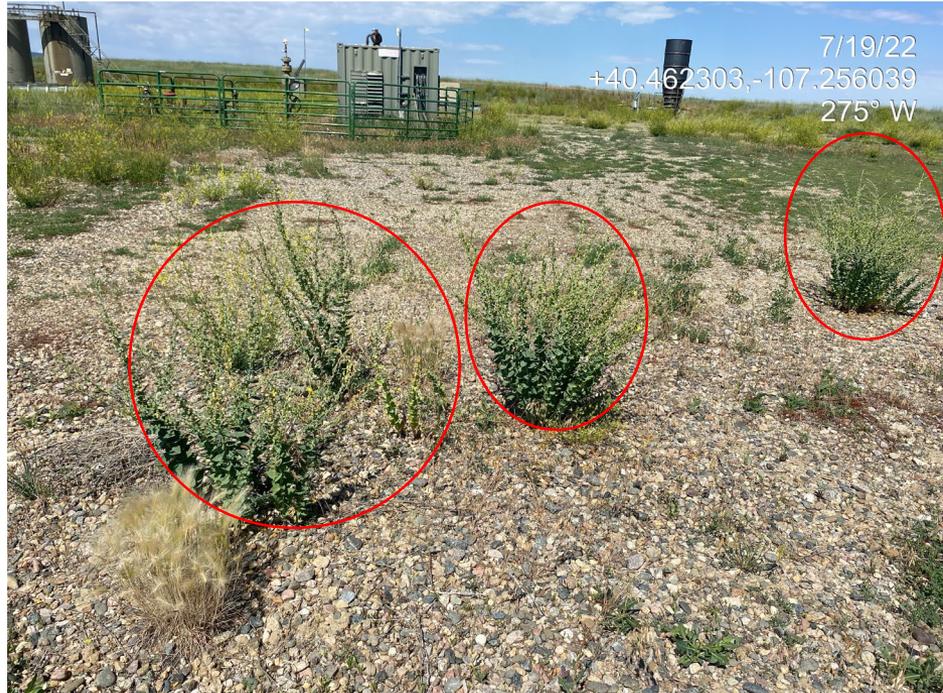
Photo 5. Photo taken from the center of the Location shows an example of Dalmatian toadflax, a CO List B Noxious Weed found throughout the Location.

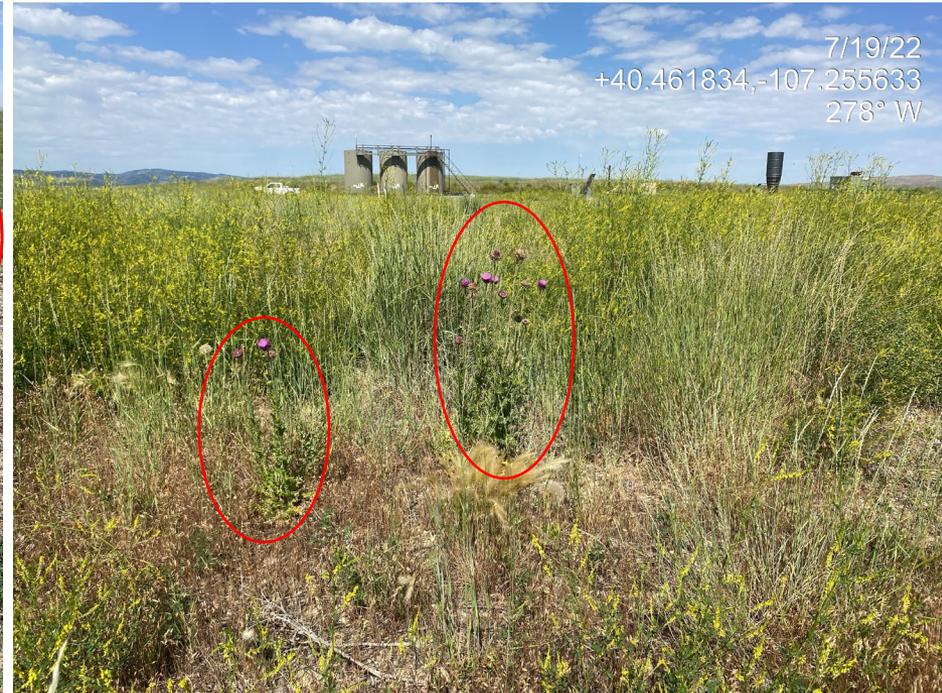
Photo 6. Photo taken from the southeast of the Location shows an example of musk thistle, a CO List B Noxious Weed found throughout the Location.

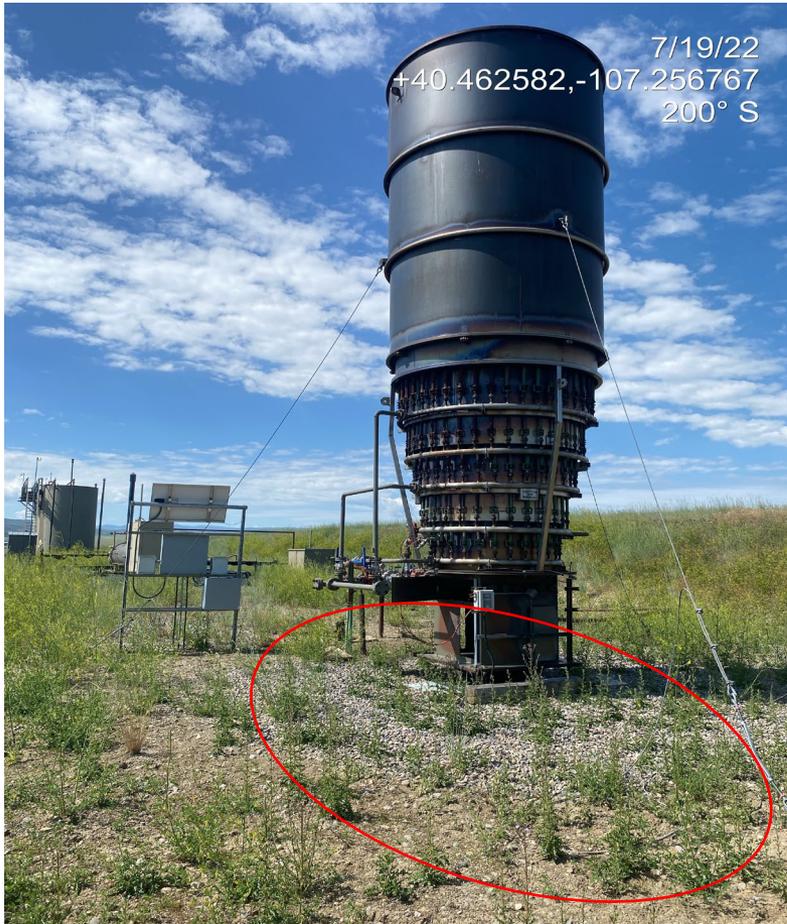
Photo 7. Photo taken from the northwest of the Location shows an example of Canada thistle, a CO List B Noxious Weed found throughout the Location. Photo also shows the working pad area is overgrown.

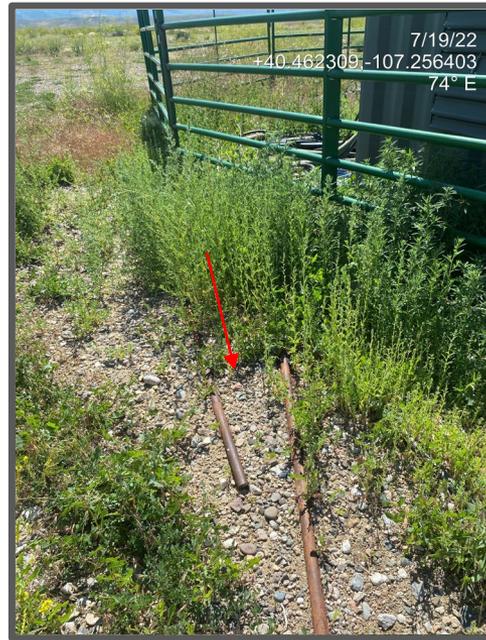
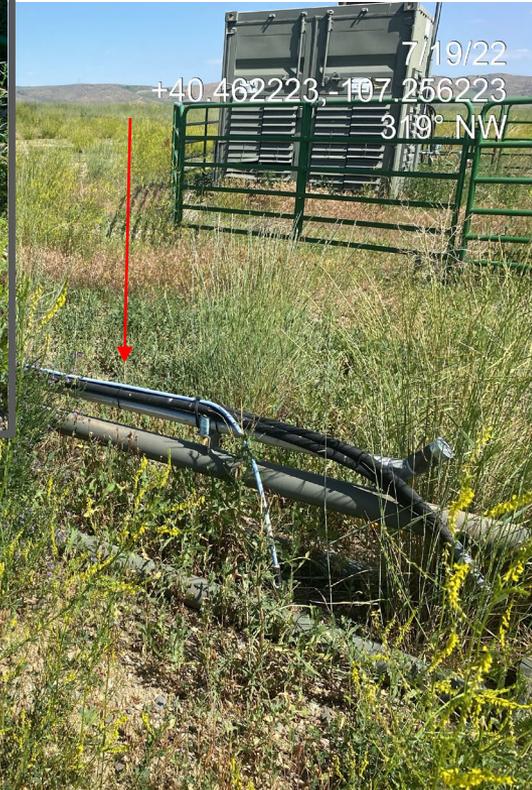
Photo 8. Photos taken from the well area shows unused equipment and the Location is overgrown, including around production equipment.

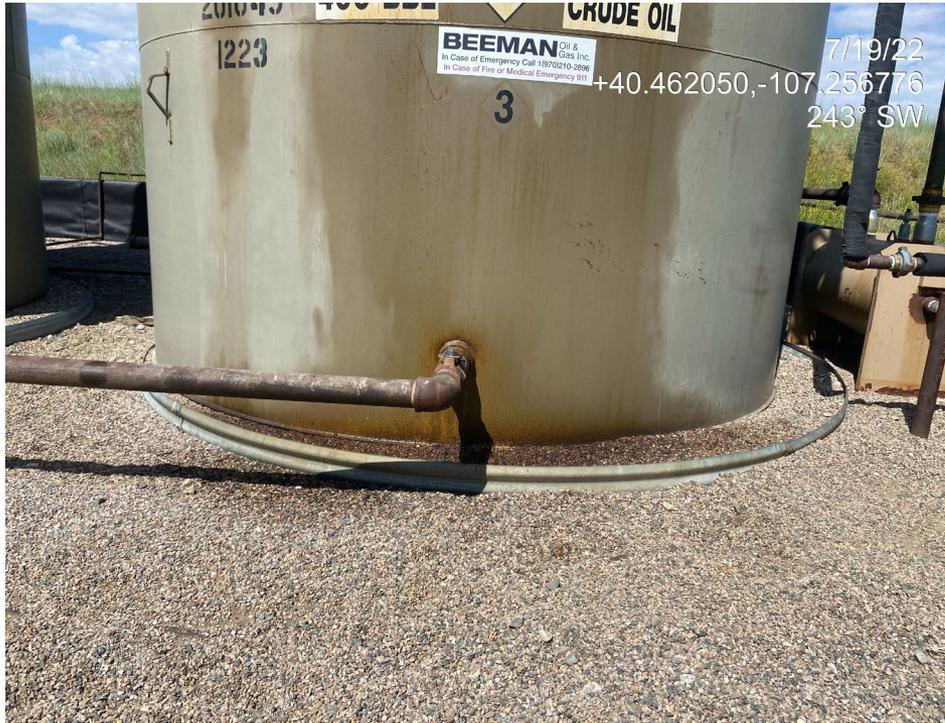
Photo 9. Photo taken from the tank battery at the west of the Location shows the northernmost tank appears to have spilled from the top of the tank. Impacted soils are present within secondary containment.

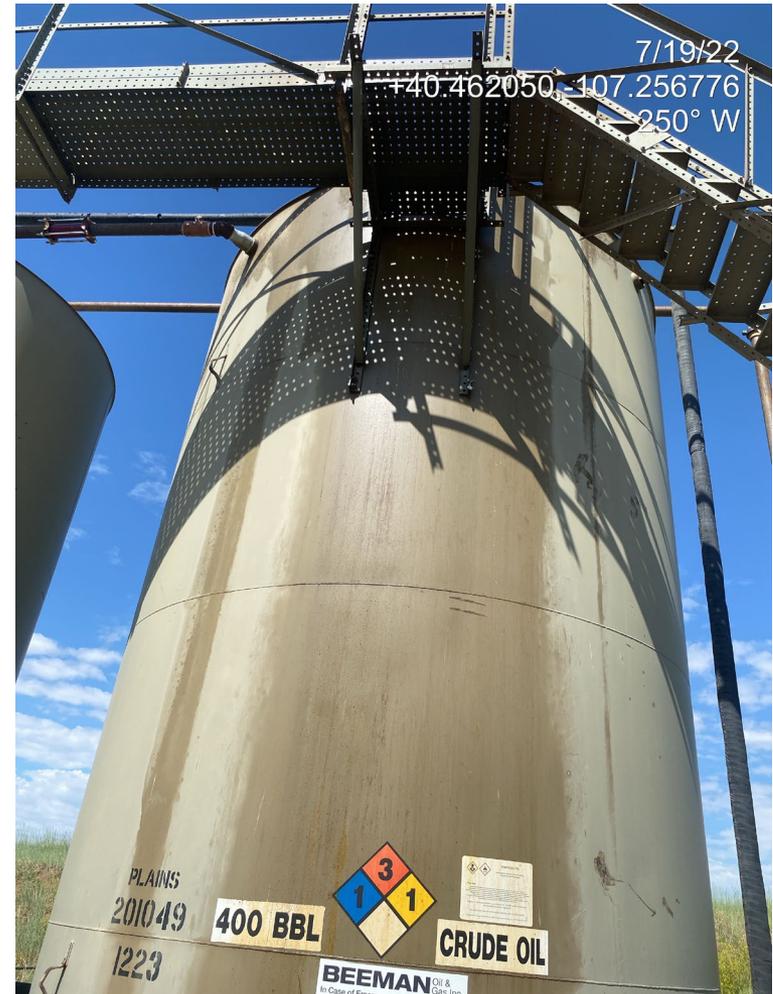
Photo 10. Refer to Photo 9 comment.
