# Inspection Photos and Issue Report

Operator: LARAMIE ENERGY LLC # 10433

Location #312452

Mesa County, CO

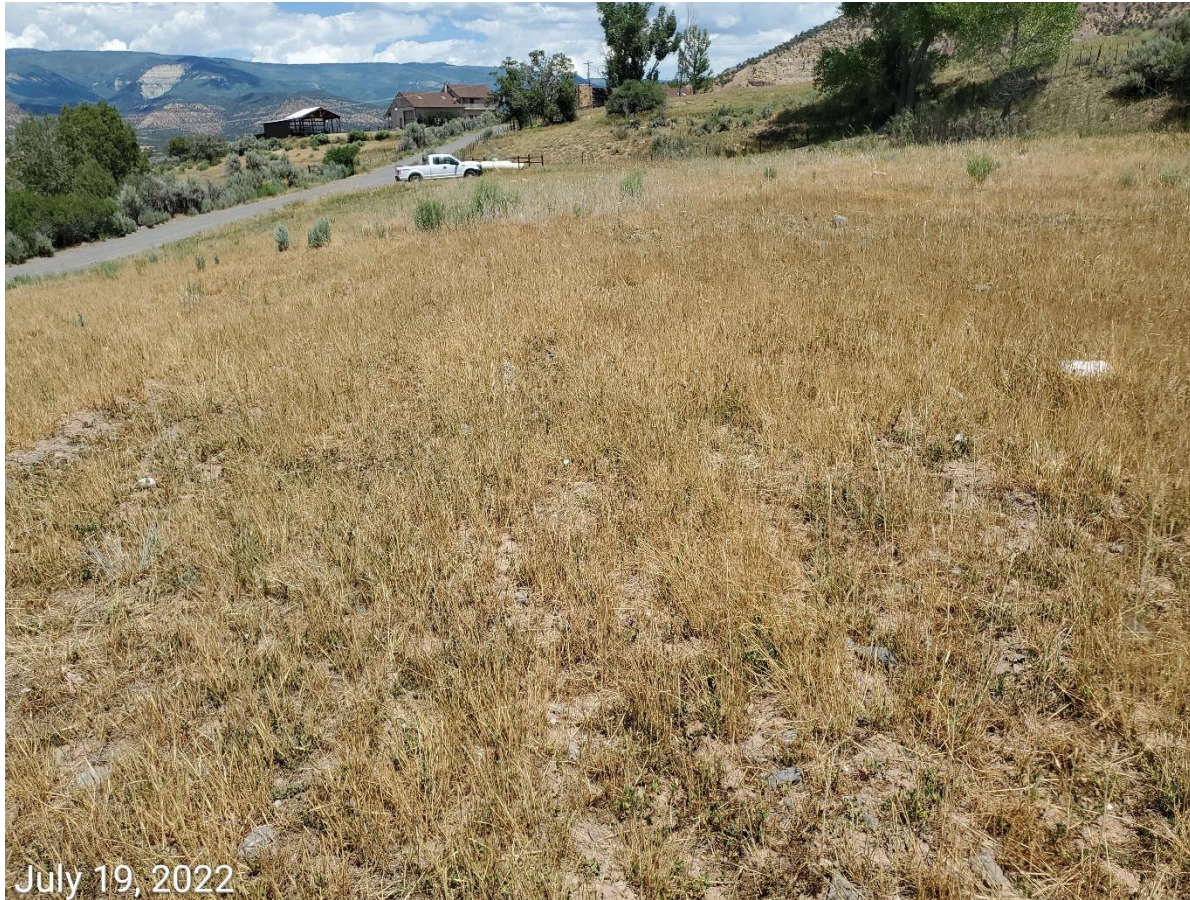
**Photo 1:** Photo taken from the Location. Photo shows vegetative establishment throughout the Location is predominantly a Noxious Weeds (brown vegetation, Jointed Goatgrass). Ongoing noxious weed monitoring/management has been inadequate; weeds have established throughout the majority of the Location, creating an invasive monoculture outcompeting desirable plant establishment; location is not progressing towards an 80% desirable perennial revegetation standard.

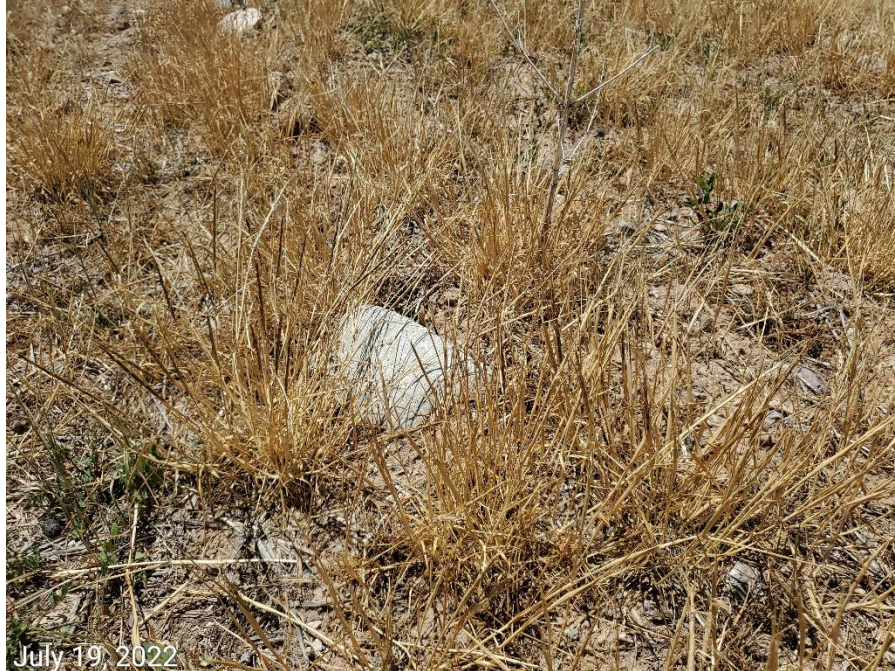
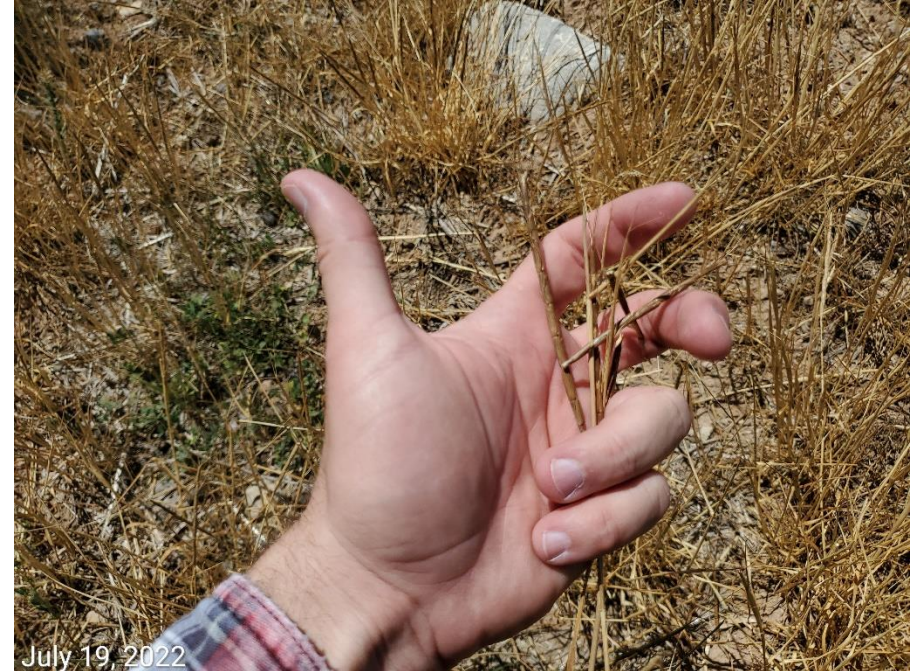
**Photo 2:** Photos show Jointed Goatgrass establishment on the Location.
