Inspection Photos and Issue Report

Operator: LARAMIE ENERGY LLC # 10433

Location #312512

Mesa County, CO

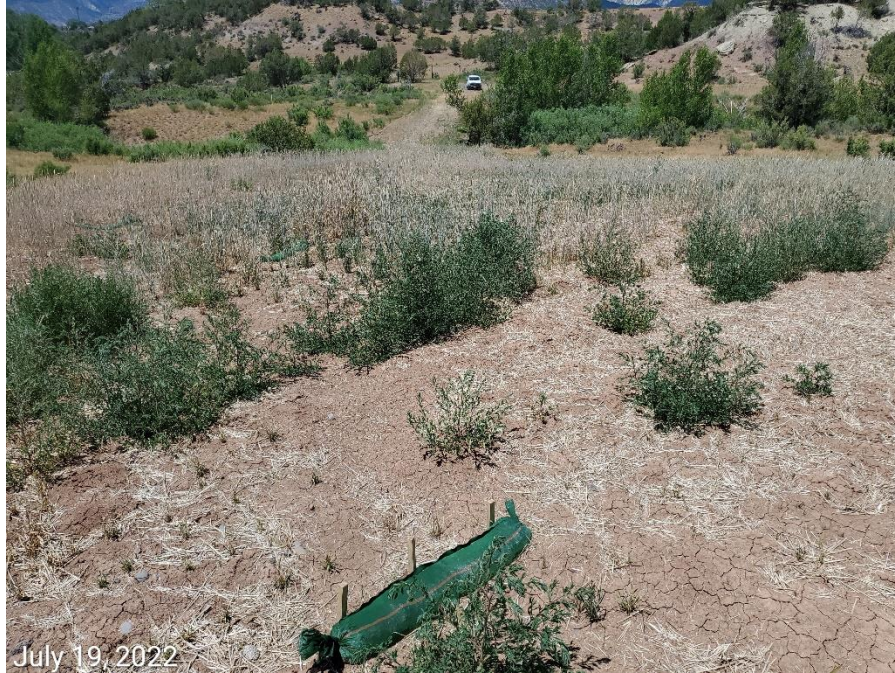
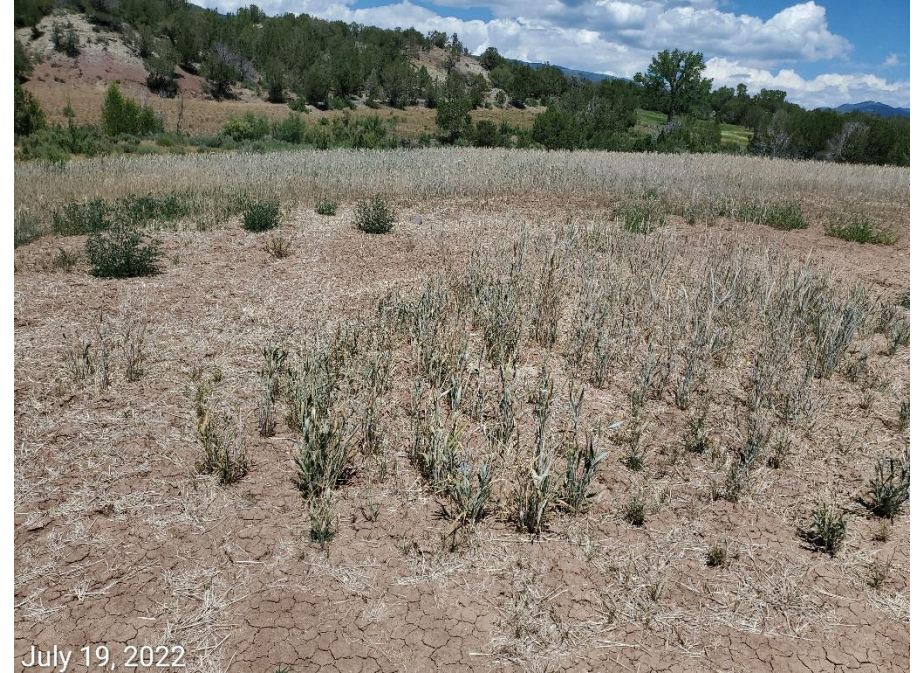
Photo 1: Photos 1-2 taken from the southwestern end of the Location. Photos provide an overview of the Location from northwest, north, northeast to east. Additional reclamation work has been conducted, however desirable perennial plant germination does not appear uniform; vegetation in photos are predominantly annual wheat/rye grasses, noxious weeds (Jointed Goatgrass) or other Undesirable Plant Species such as Kochia and Salsola.

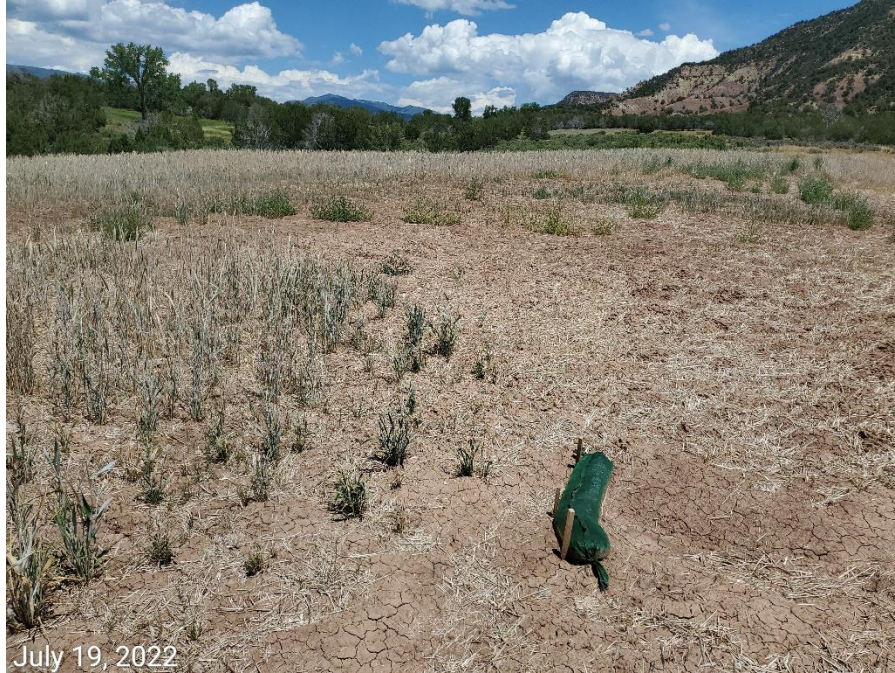
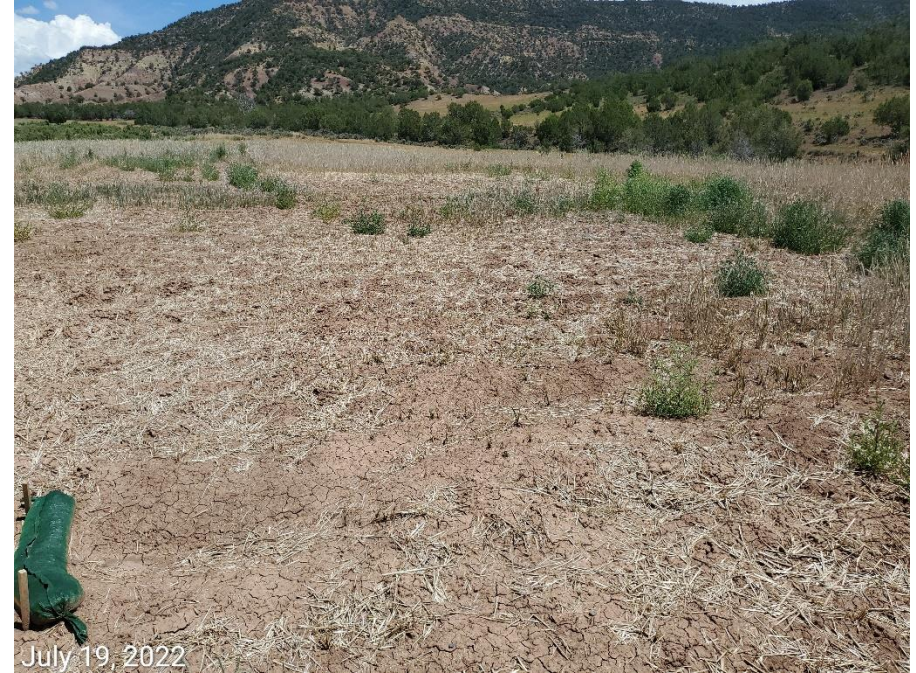
Photo 2: See comments under photo 1.

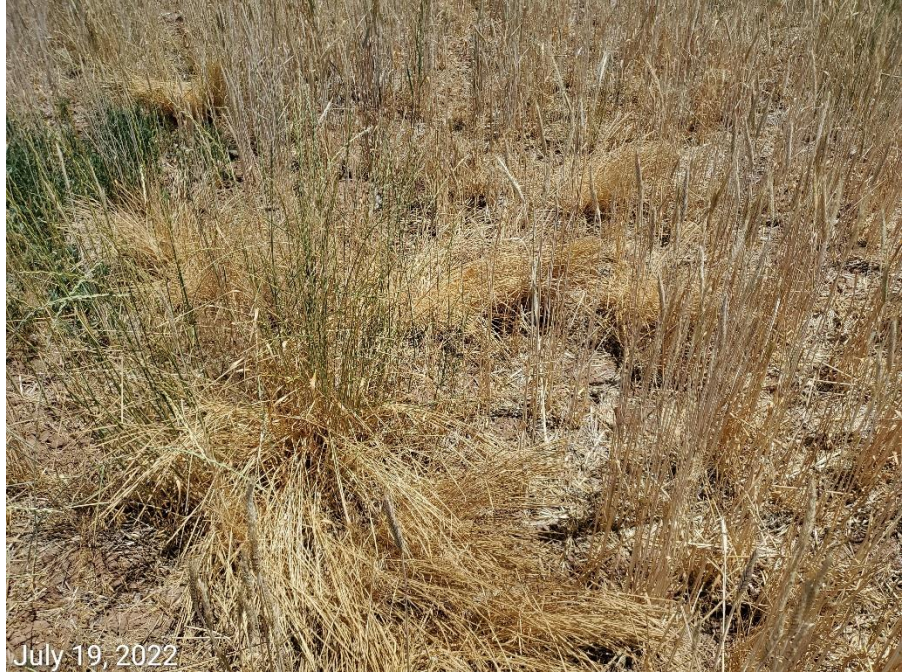
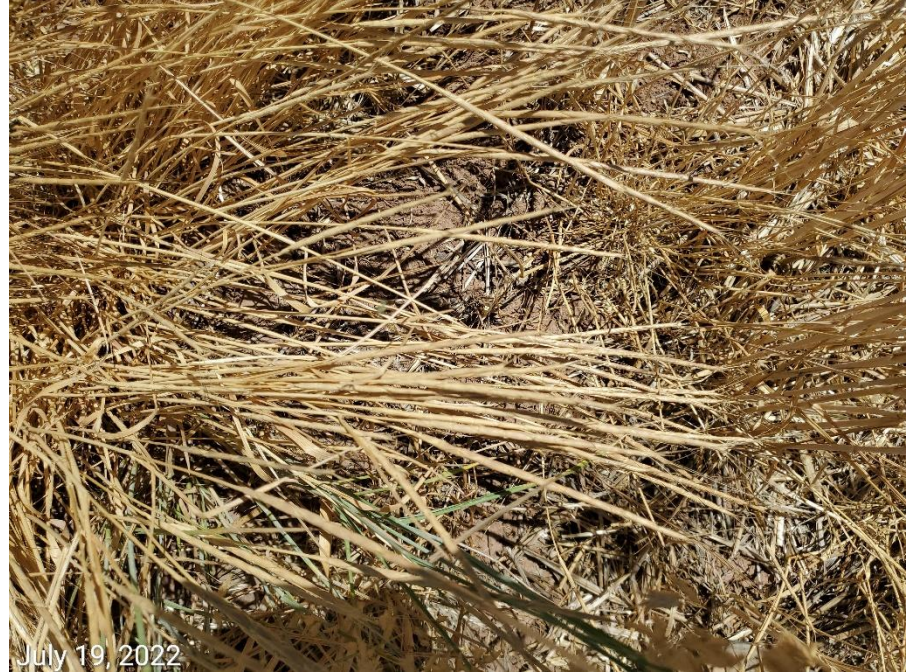
Photo 3: Photos examples showing Jointed Goatgrass establishment on the Location. Ongoing noxious weed monitoring/management has been inadequate. Desirable plant germination was not evident, or poor, on areas of the location with high densities of noxious weeds, and/or annual wheat and rye grasses.

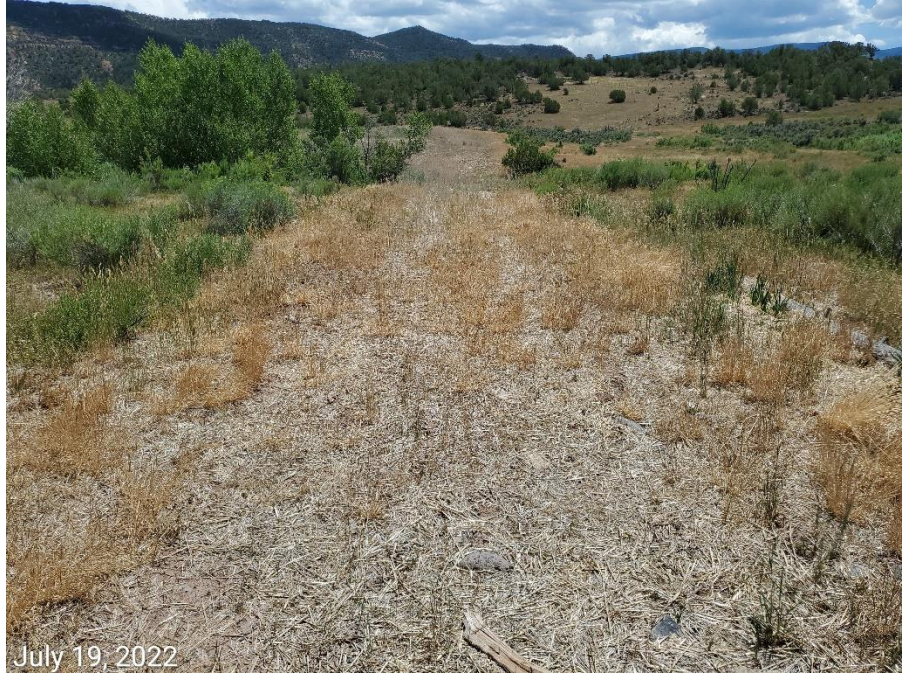
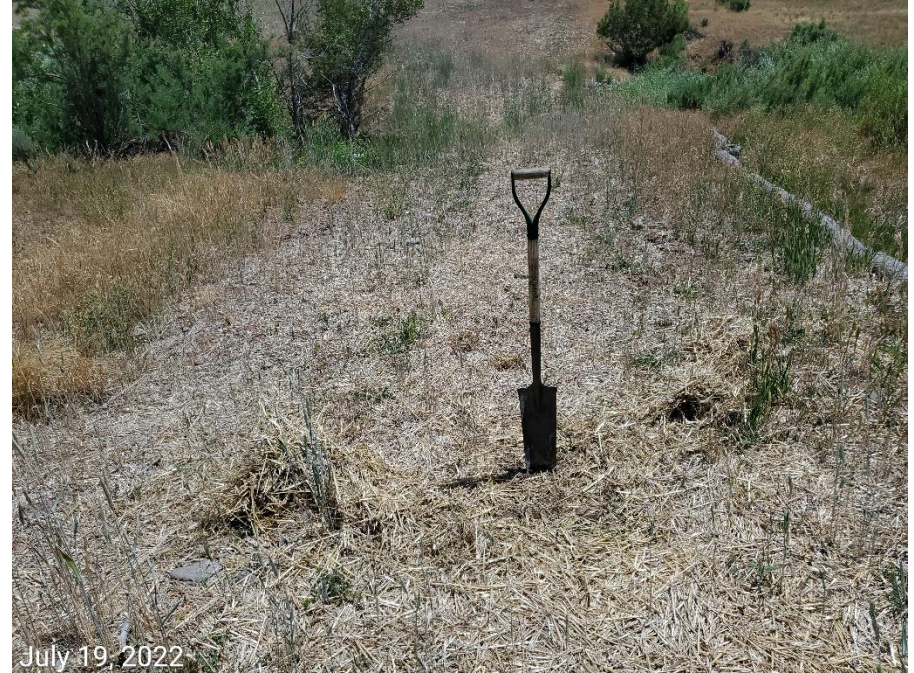
Photo 4: Photos show the access road leading to the Location. Brown vegetation observed in photos is Jointed Goatgrass. Gravel observed remaining at the access road. Photo also shows compaction alleviation of the access road does not appear to have been conducted in accordance with 1004 requirements; compaction issues evident.

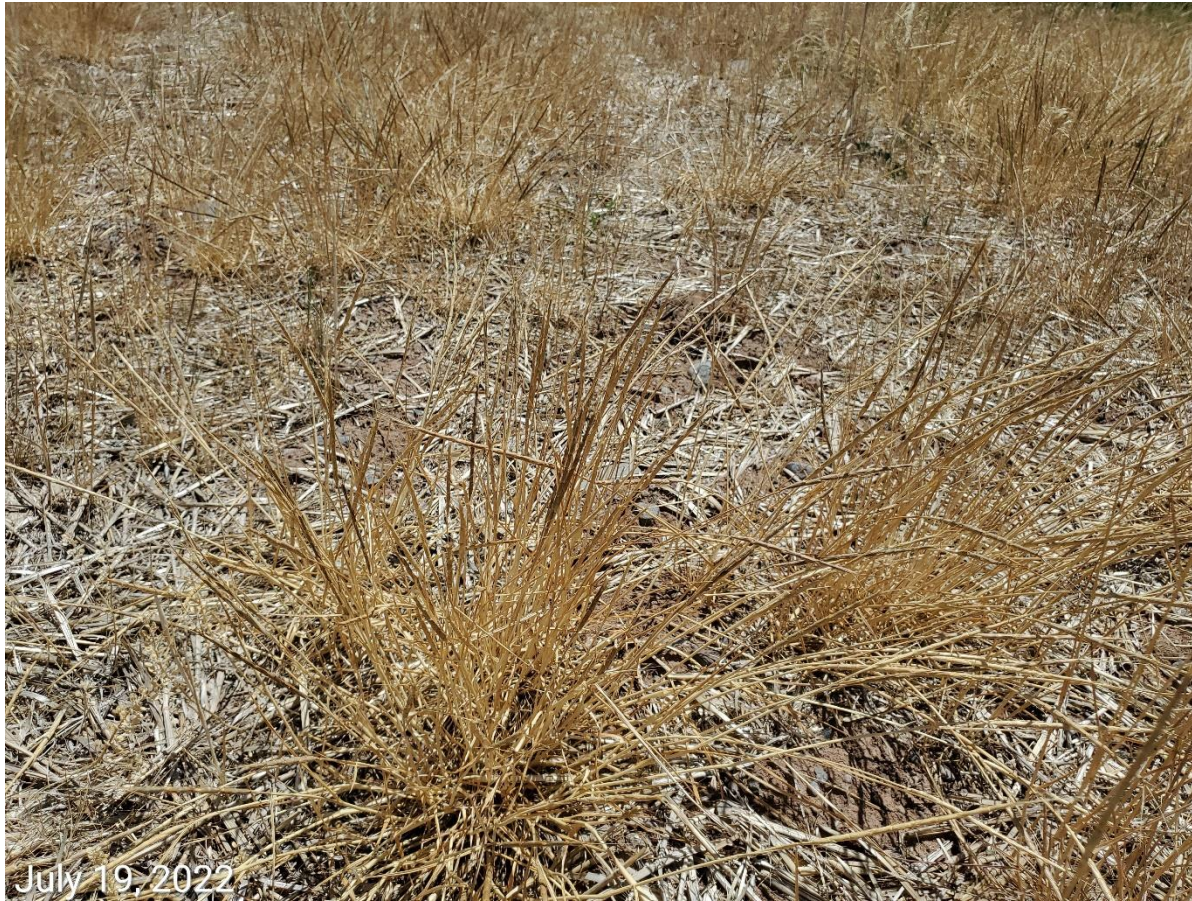
Photo 5: Photo shows Jointed Goatgrass on access road.
