Inspection Photos and Issue Report

Operator: LARAMIE ENERGY LLC # 10433

Location #334552

Mesa County, CO

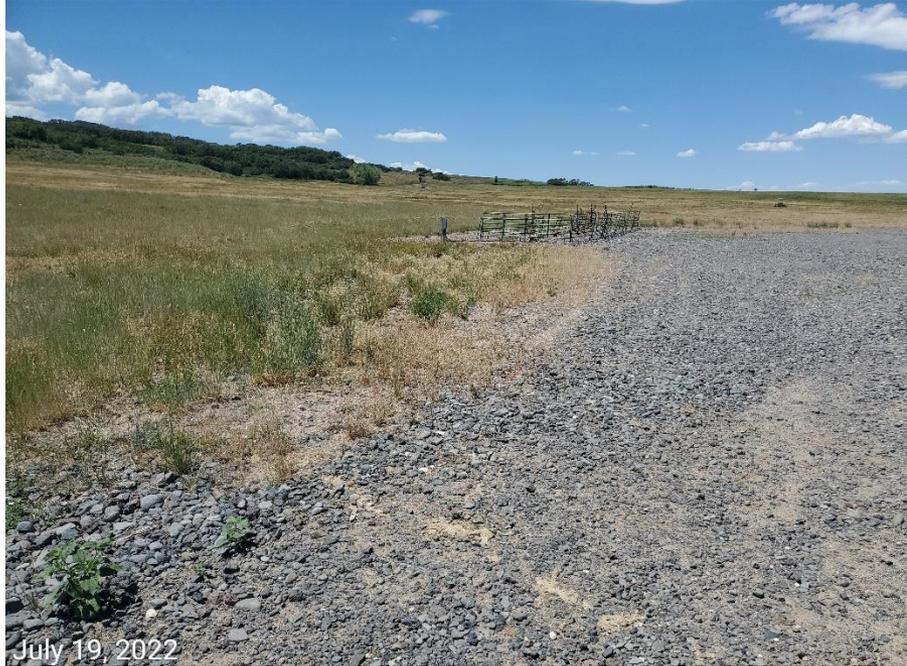
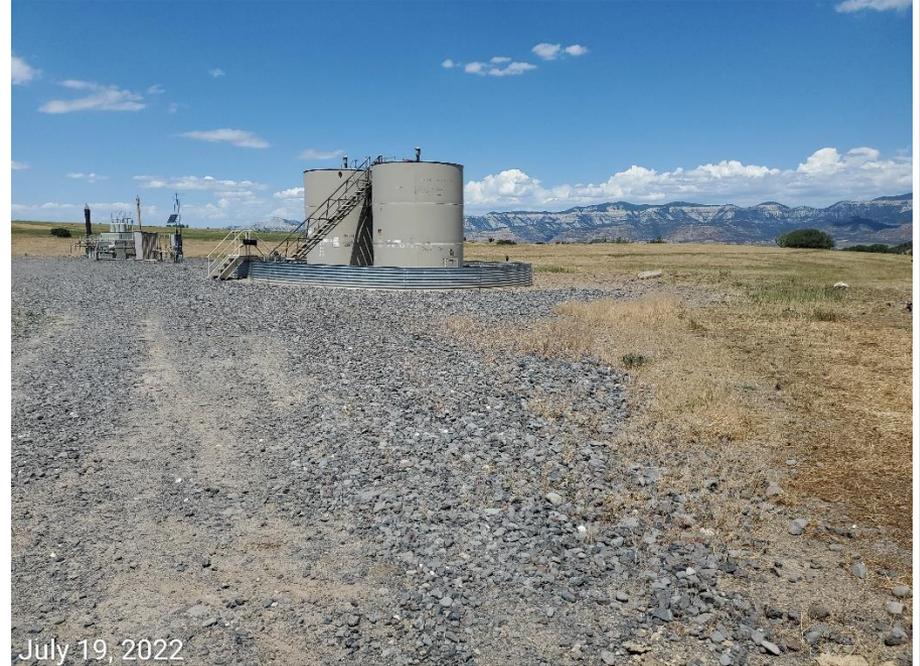
Photo 1: Photos provide an overview of the Location.

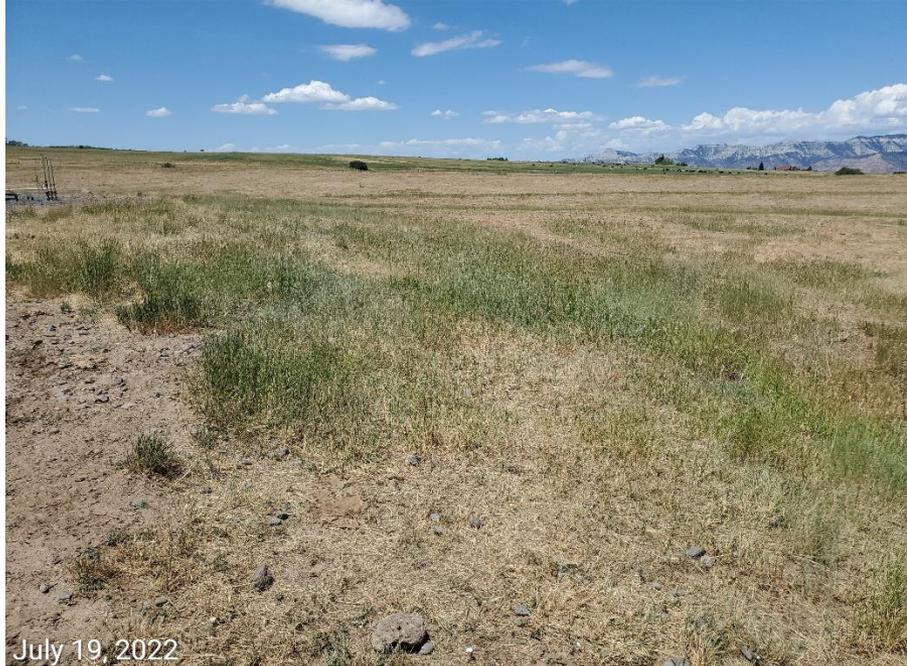
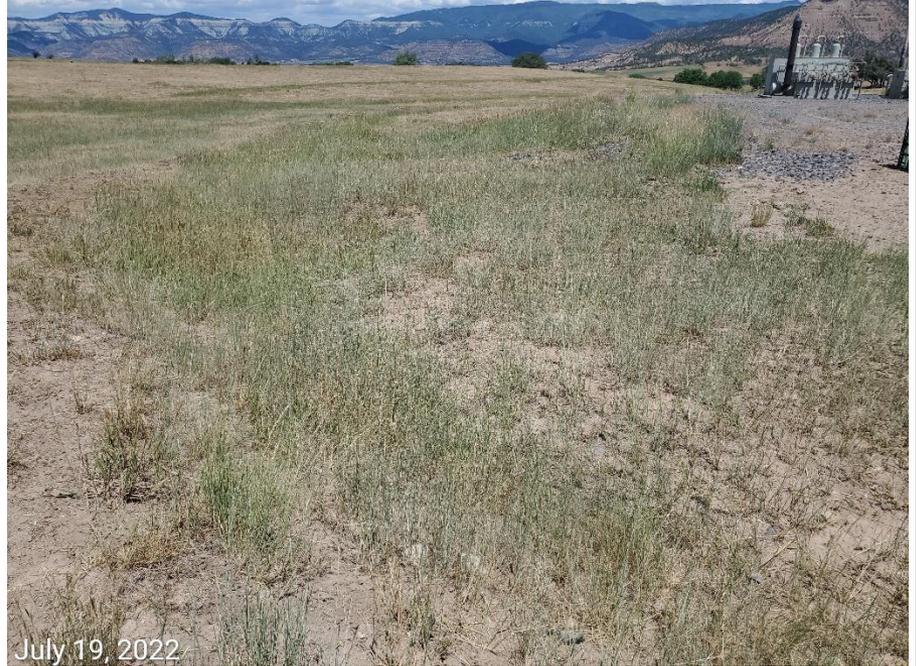
Photo 2: Photos example of other interim areas of the Location; vegetation appears to meet 1003 standards.

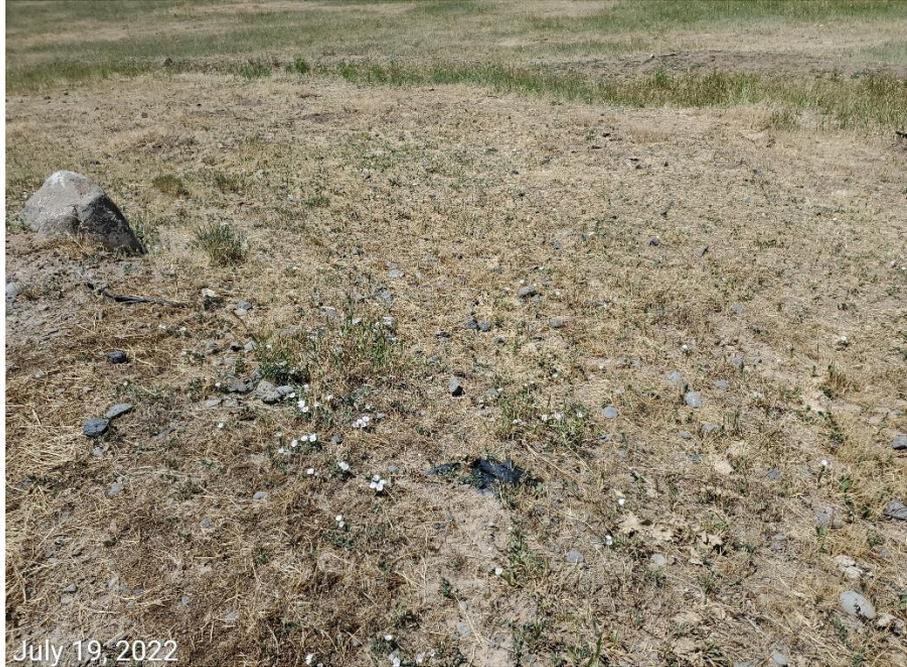
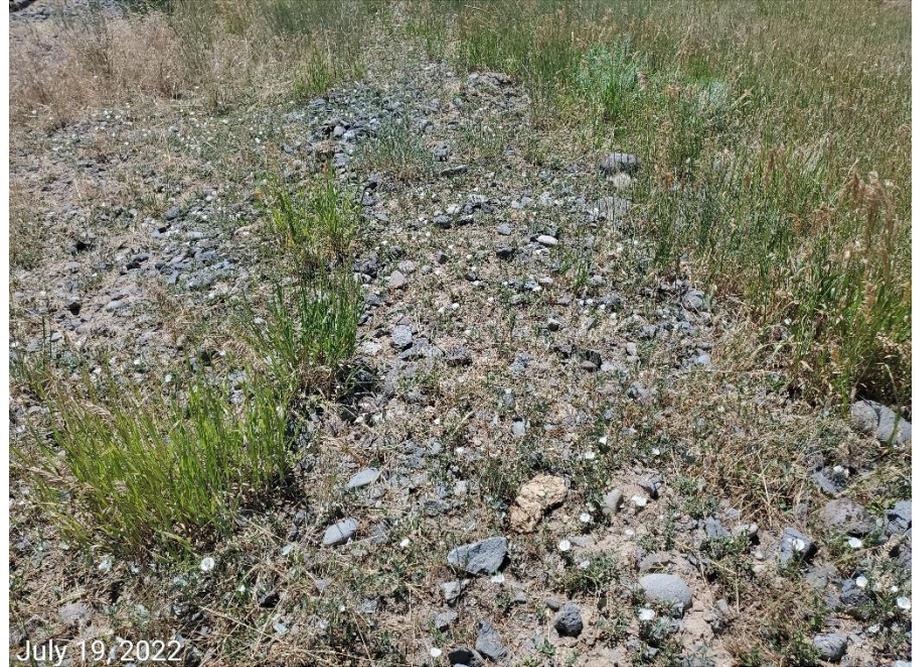
Photo 3: Photos examples showing noxious weeds (bindweed) establishing on the production and interim areas of the Location.

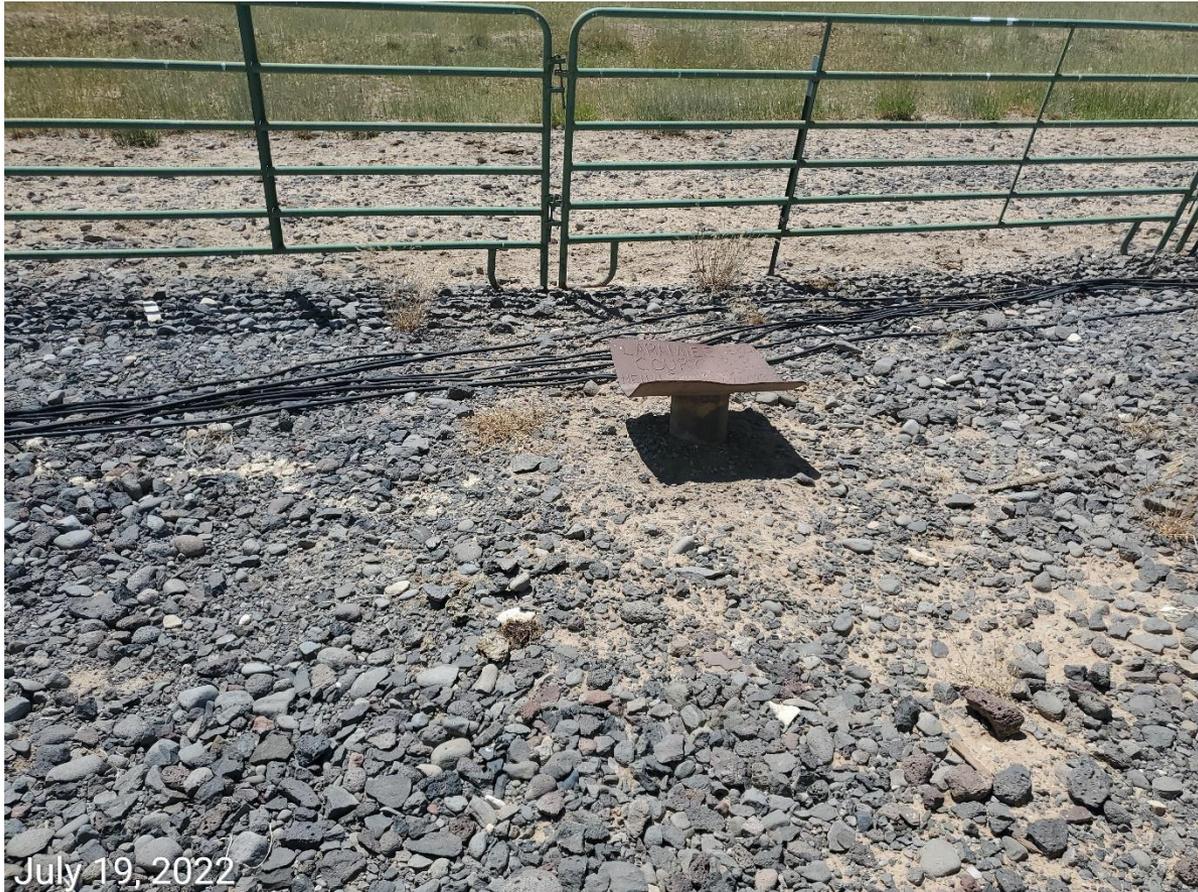
Photo 4: Well marker for the Coury 18-2 well. Marker does not comport with monument requirements, however, marker is located within a string of active wells, does not appear to be interfering with production activities, has been fenced off and not an apparent safety issue.
