Inspection Photos

Operator: Antelope Energy Company LLC - #3250

Location Name: State-66N89W /15NWNE

Inspection Document #: 702800478

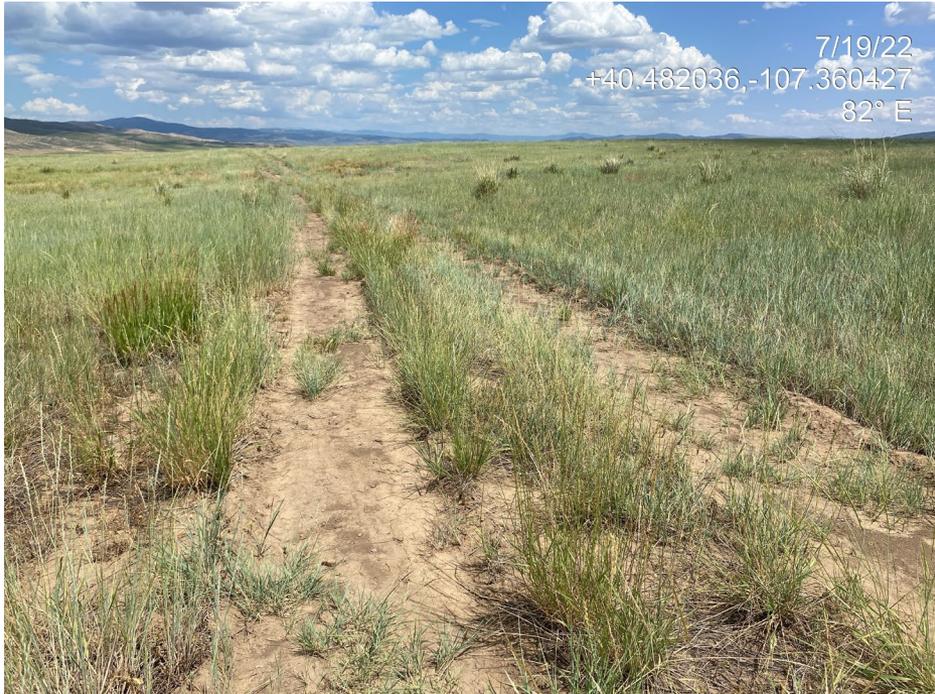
Photo 1. Photo taken from the west of the Location shows the access road. Perennial grass is failing to establish in the tracks.

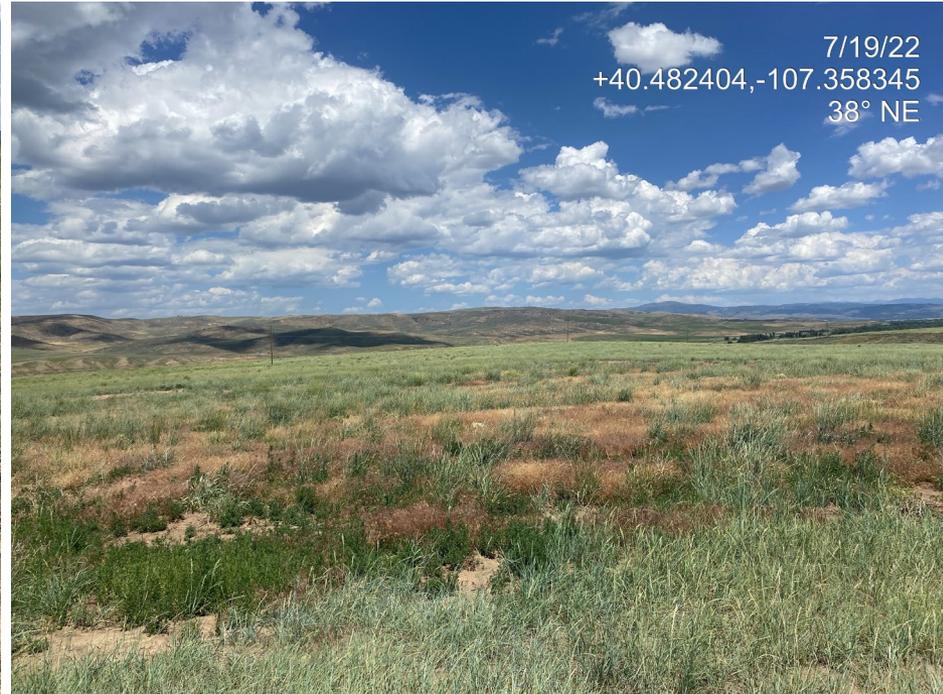
Photo 2. Photo taken from the south shows an overview of the Location.

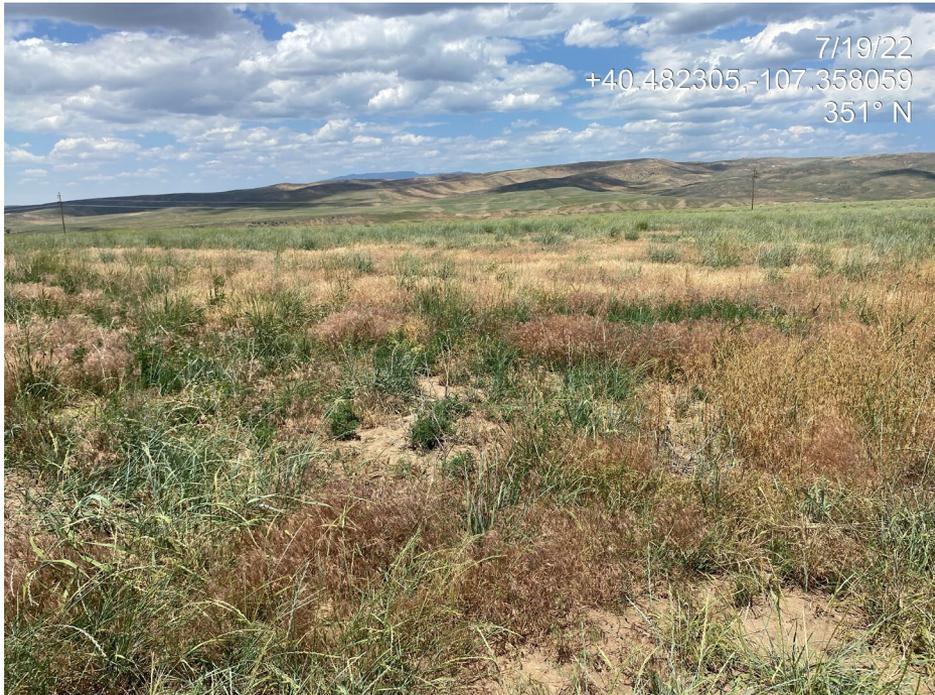
Photo 3. Photo taken from the south shows the vegetation community on Location. Light green vegetation is desirable perennial grasses. Dark green, brown and red vegetation is undesirable plant species and noxious weeds.

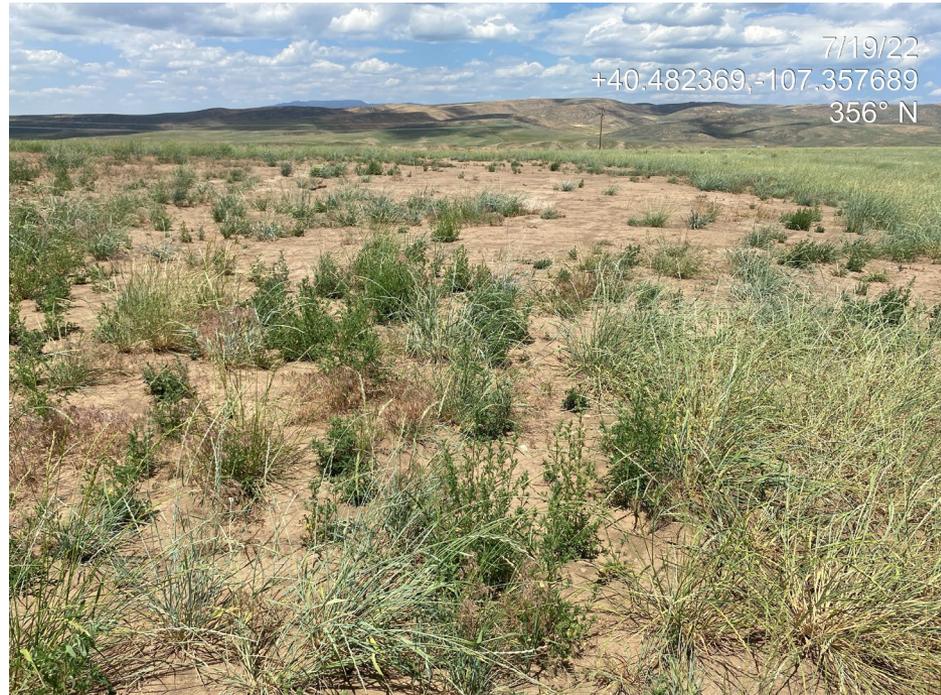
Photo 4. Photo taken from the east shows the vegetation community on Location. Note large patches of bare ground. Vegetation establishment is not uniform.

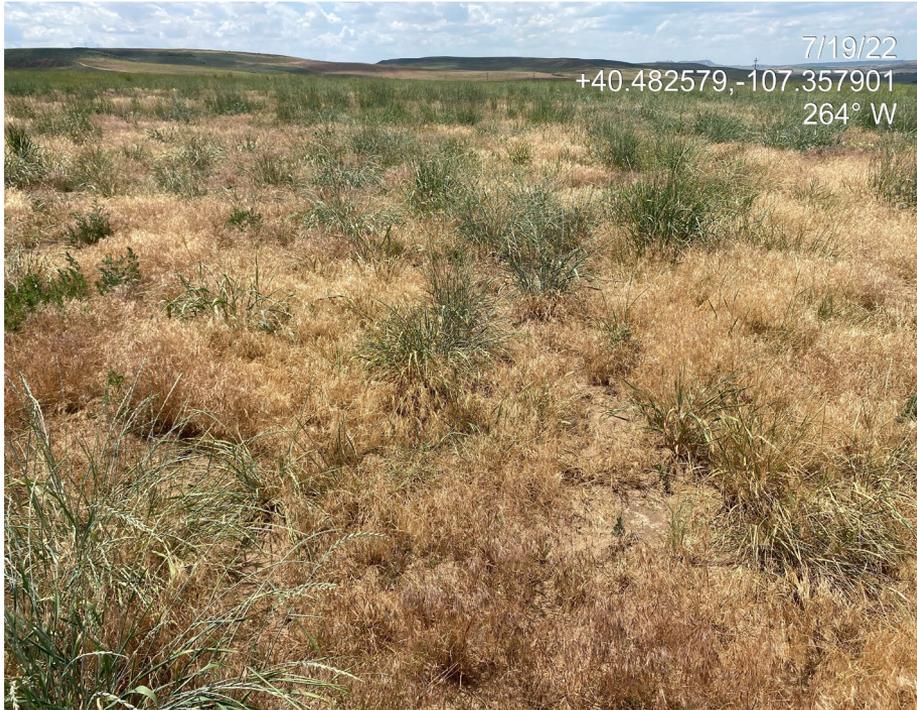
Photo 5. Photo taken from the center of the Location shows areas dominated by cheatgrass (List C Noxious Weed).

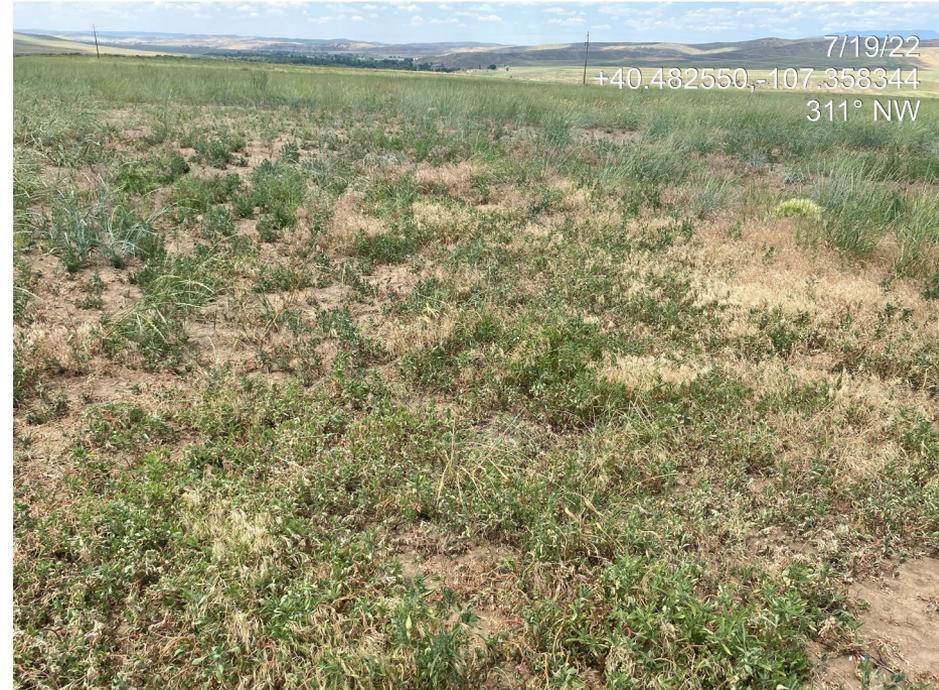
Photo 6. Photo taken from the southwest shows areas dominated by kochia (undesirable plant species) and cheatgrass (List C Noxious Weed).

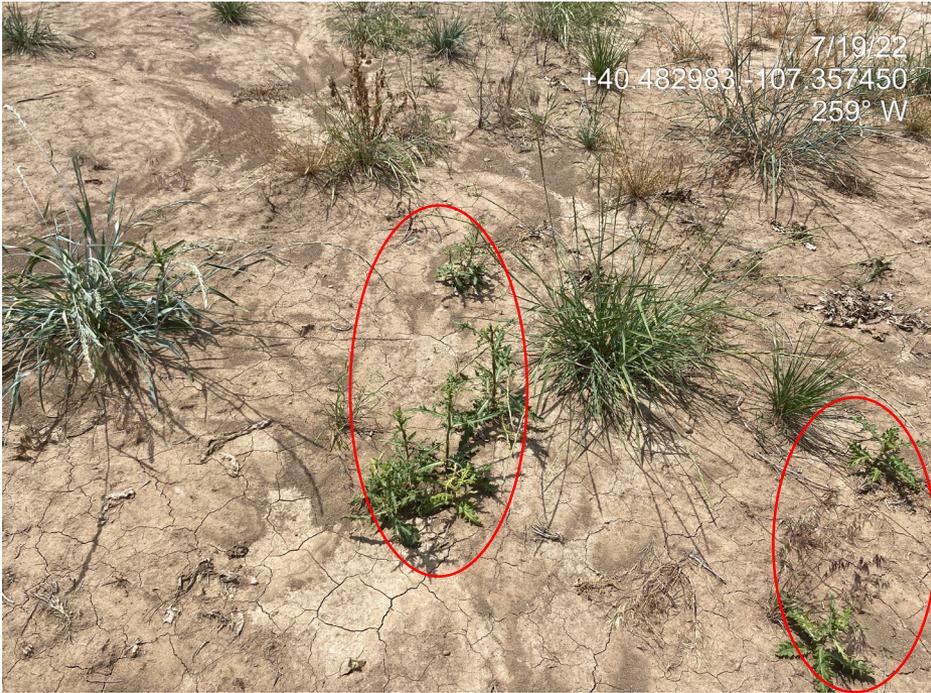
Photo 7. Photo taken from the northeast shows Canada thistle (List B Noxious Weed).

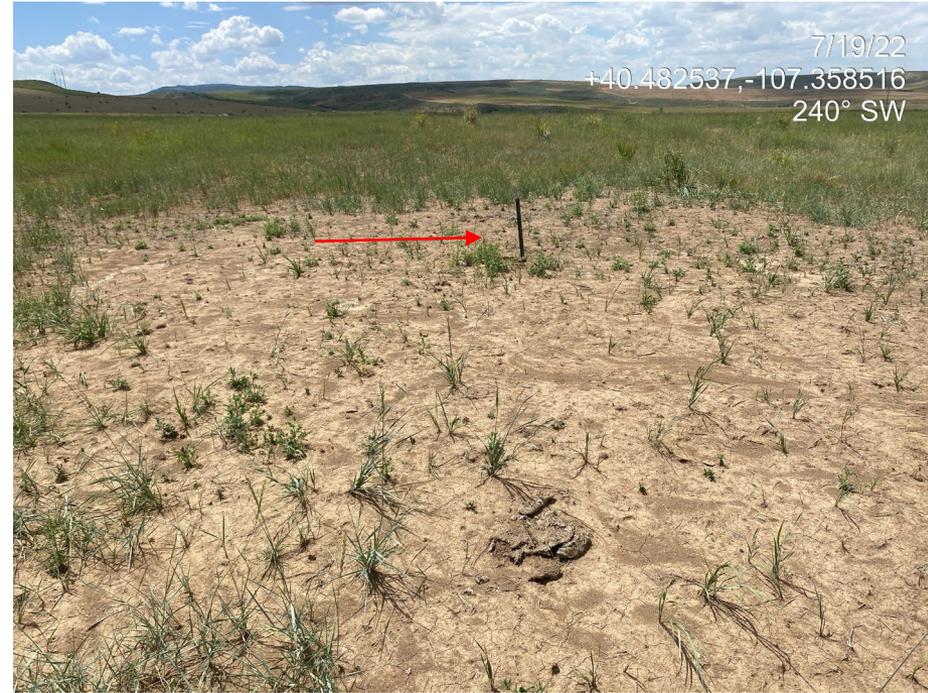
Photo 8. Photo taken from the southwest of the Location shows a t-post remaining on Location (equipment/debris).

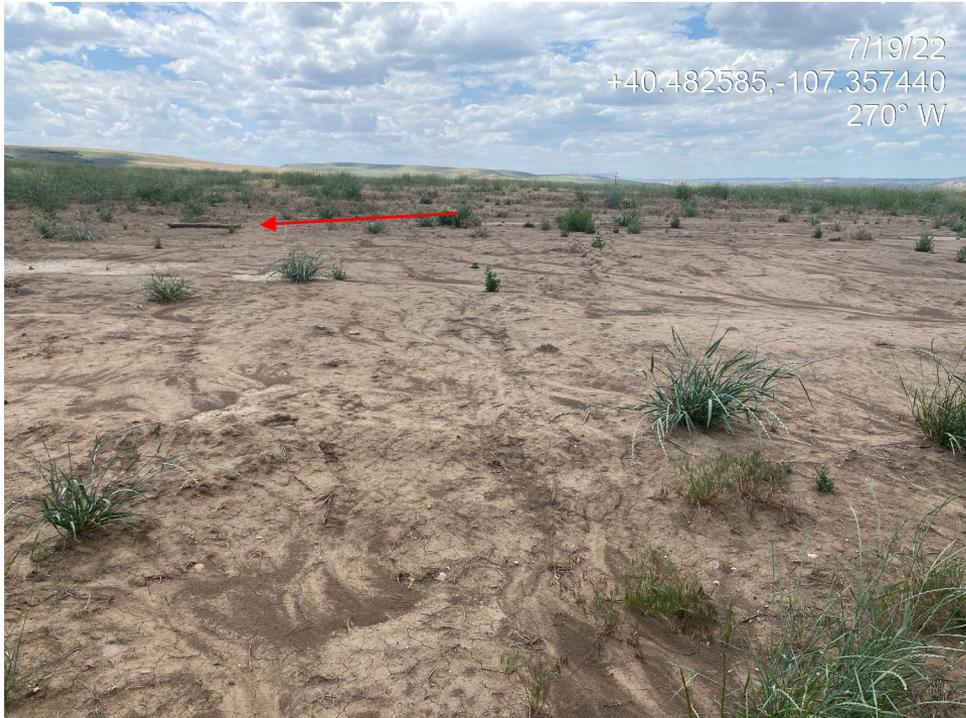
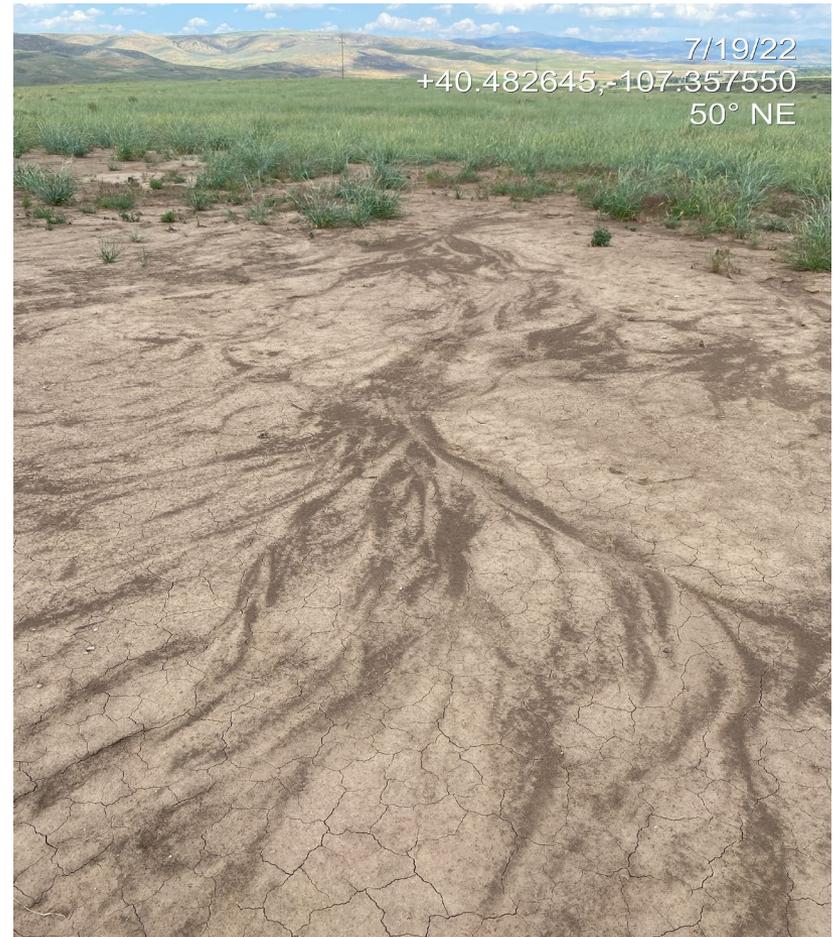
Photo 9. Photo taken from the east of the Location shows where perennial grasses have failed to establish. Bare and exposed soil dominates. Water flow patterns are evident, indicating soil erosion. Note also the wooden post left on Location (equipment/debris)

Photo 10. Refer to Photo 9 comment.

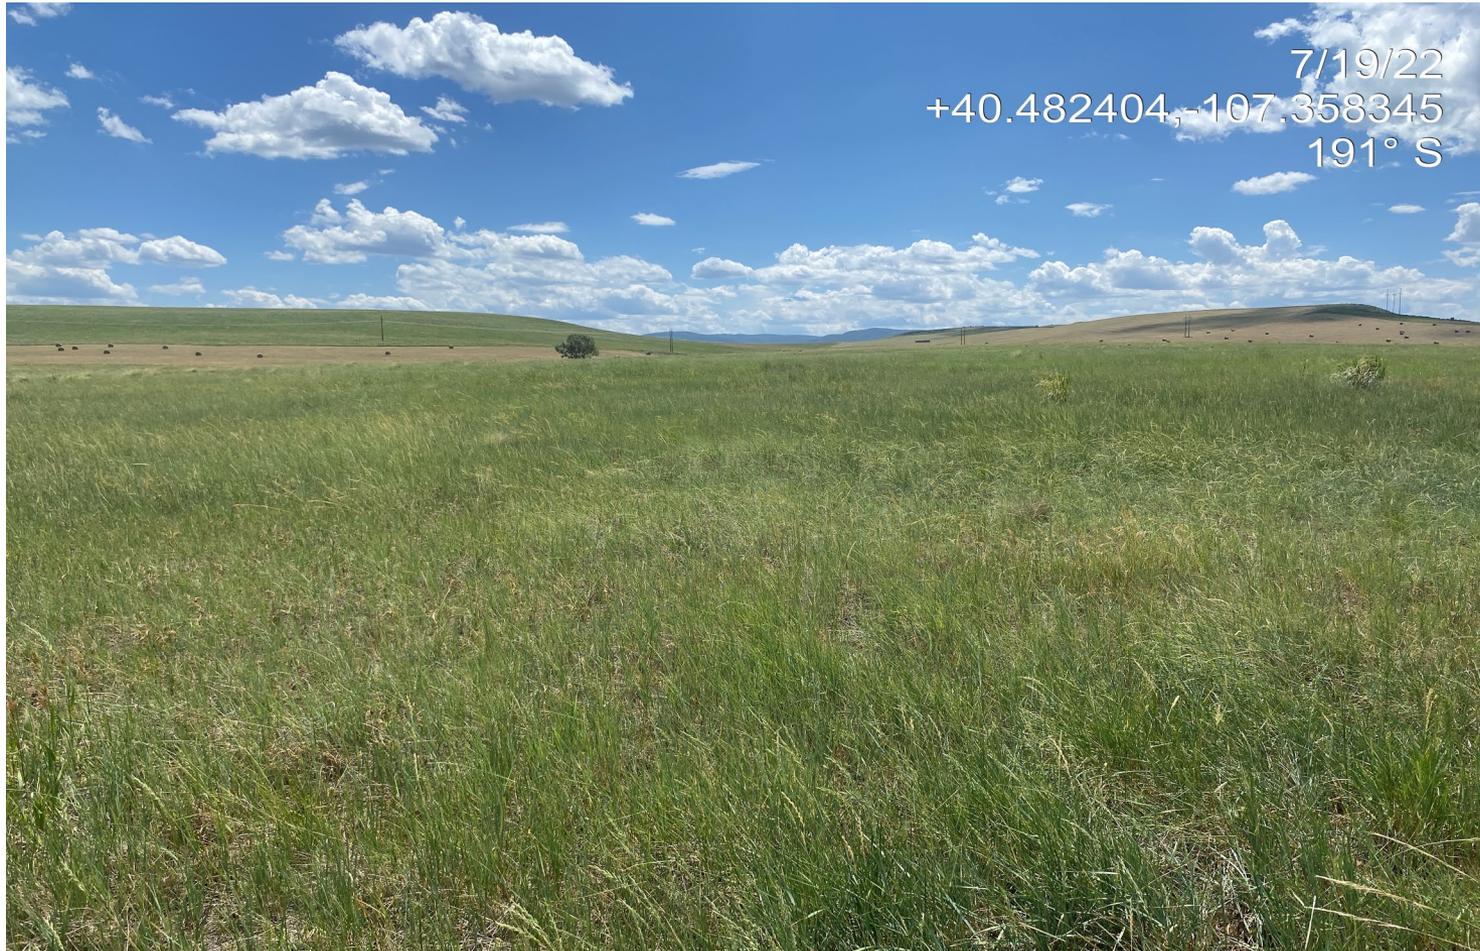
Photo 11. Photo taken from to the south of the Location shows reference area vegetation.
