# Construction and Stormwater Inspection

Operator: EXTRACTION OIL & GAS INC- #10459

Location ID: 460669

Inspection Document #: 697504069

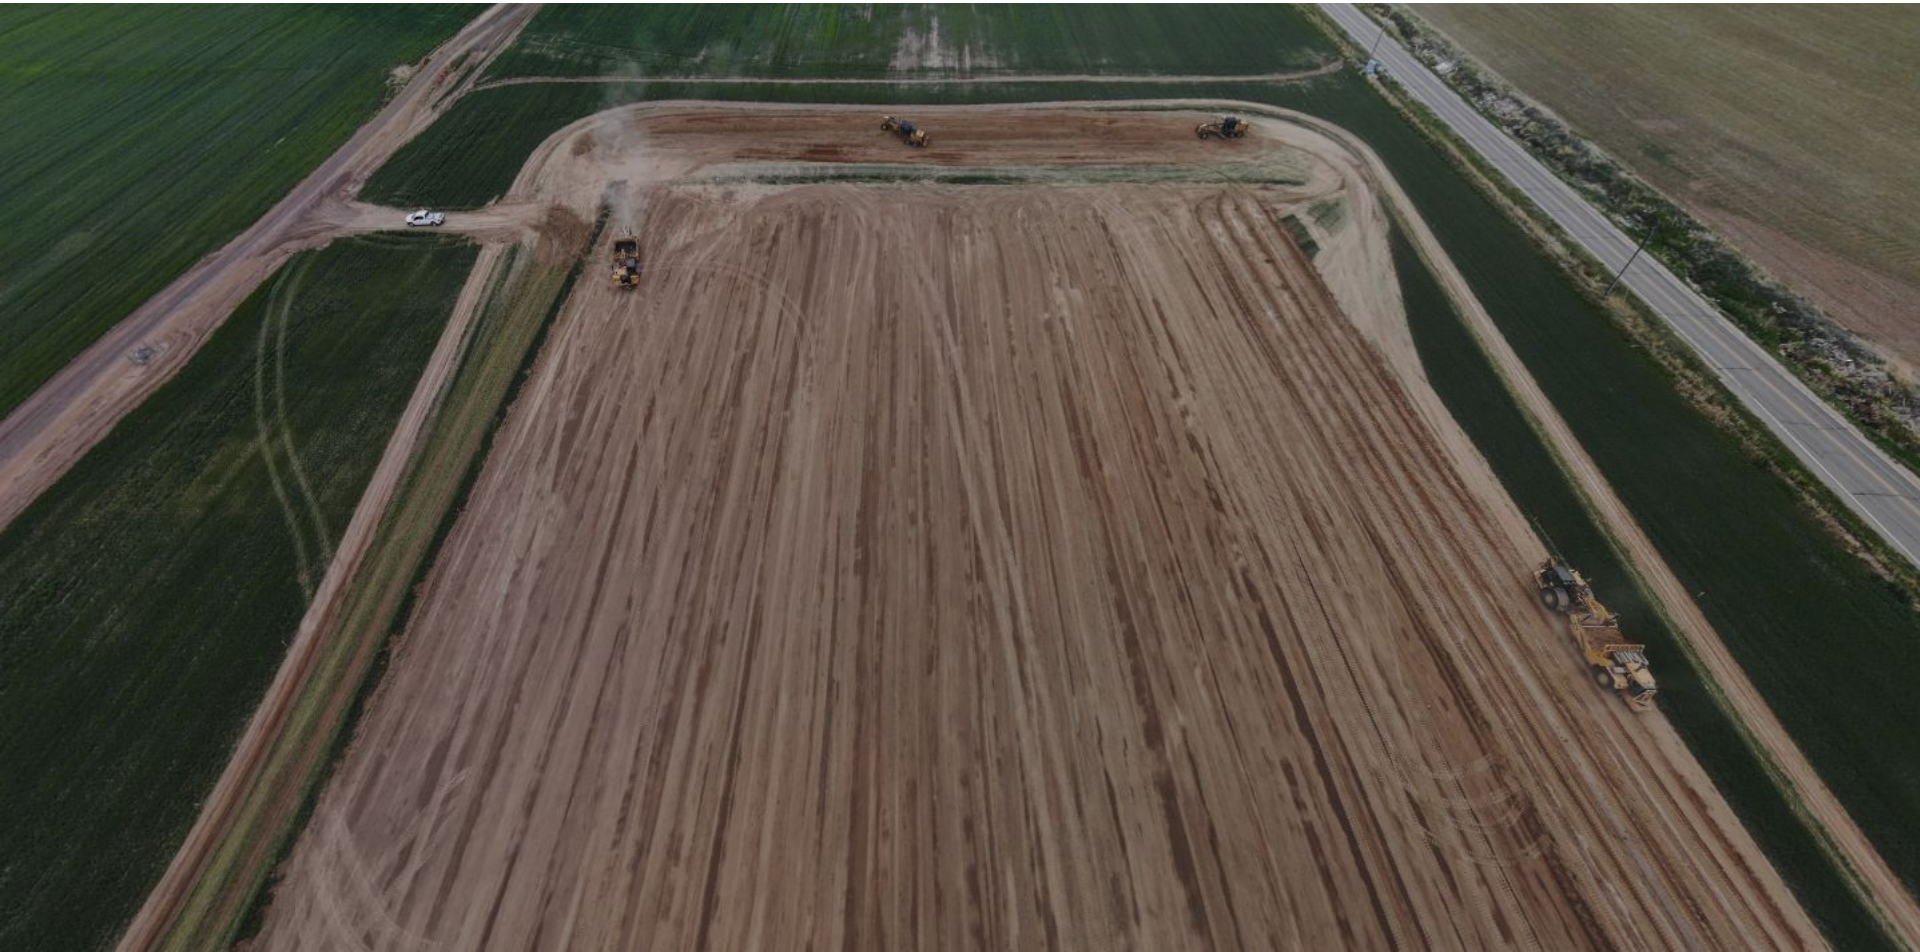
**Photo 1.** Drone imagery from 6/9/2022 illustrates the central-southern location during active construction operations. Topsoil has been stockpiled along the southern perimeter of location. Photo also illustrates the perimeter ditch and berm BMP.

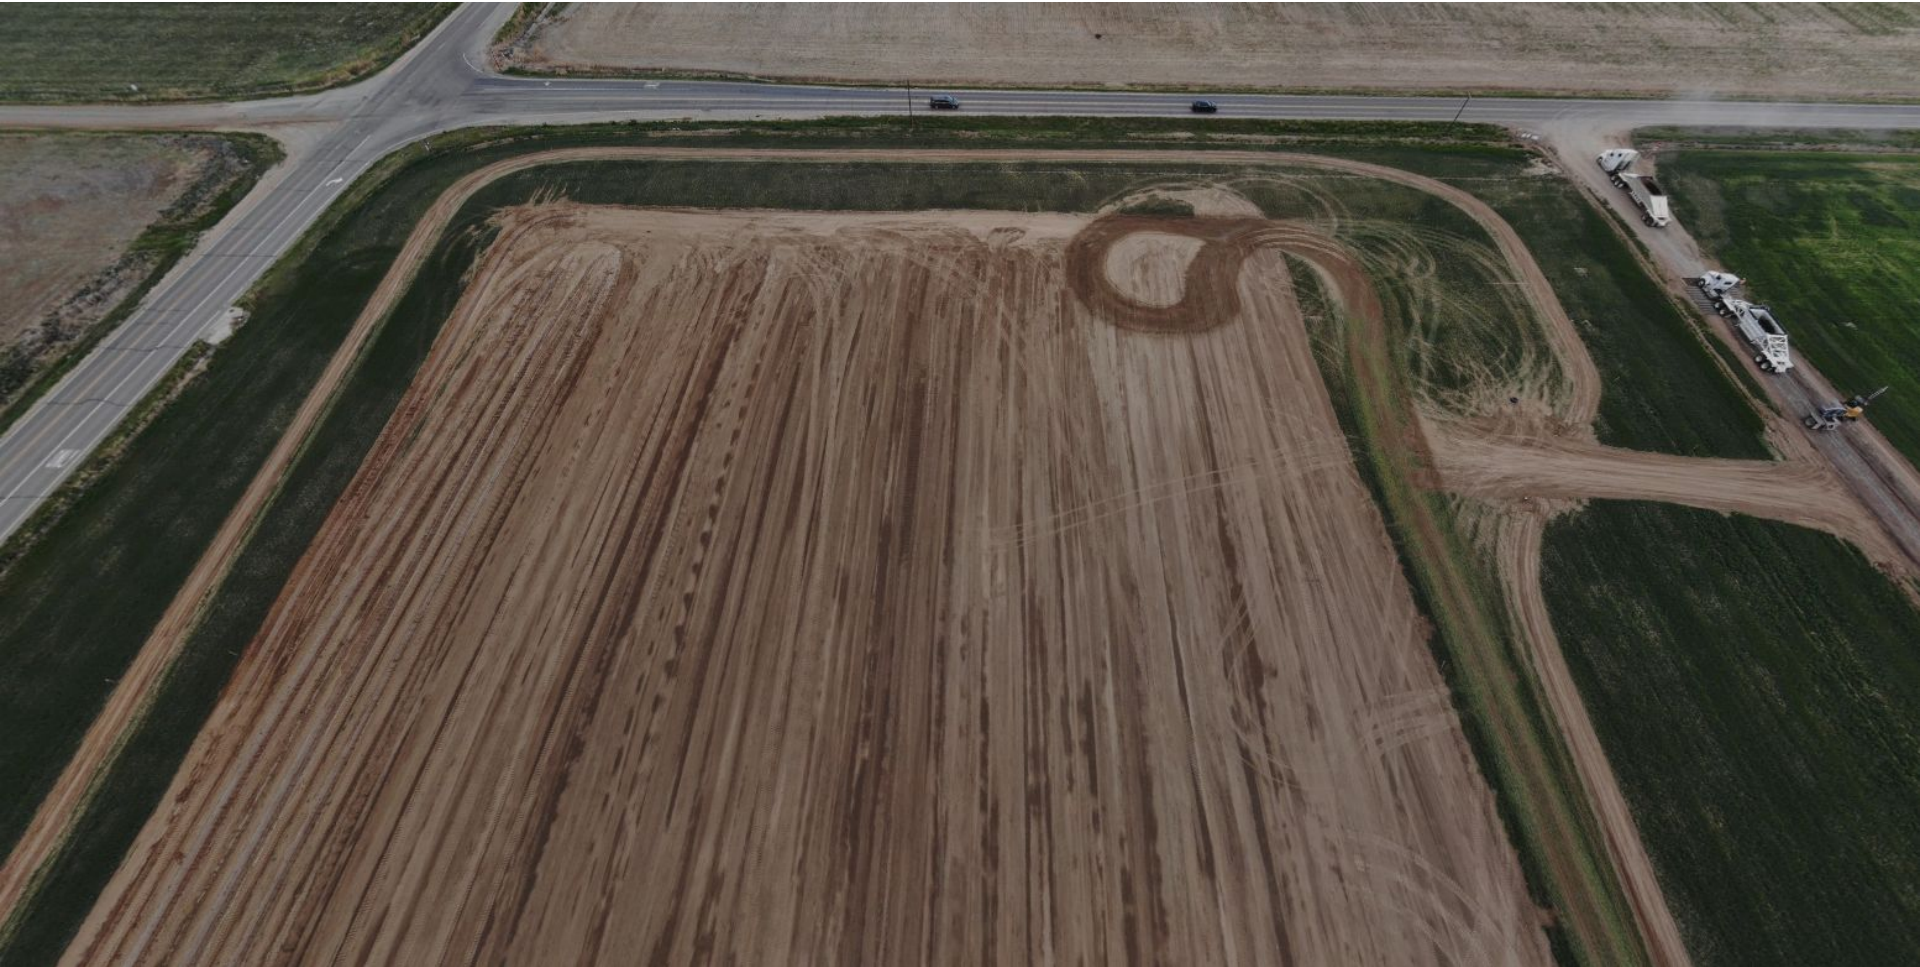
**Photo 2.** Drone imagery from 6/9/2022 illustrates the central-northern location during active construction operations.

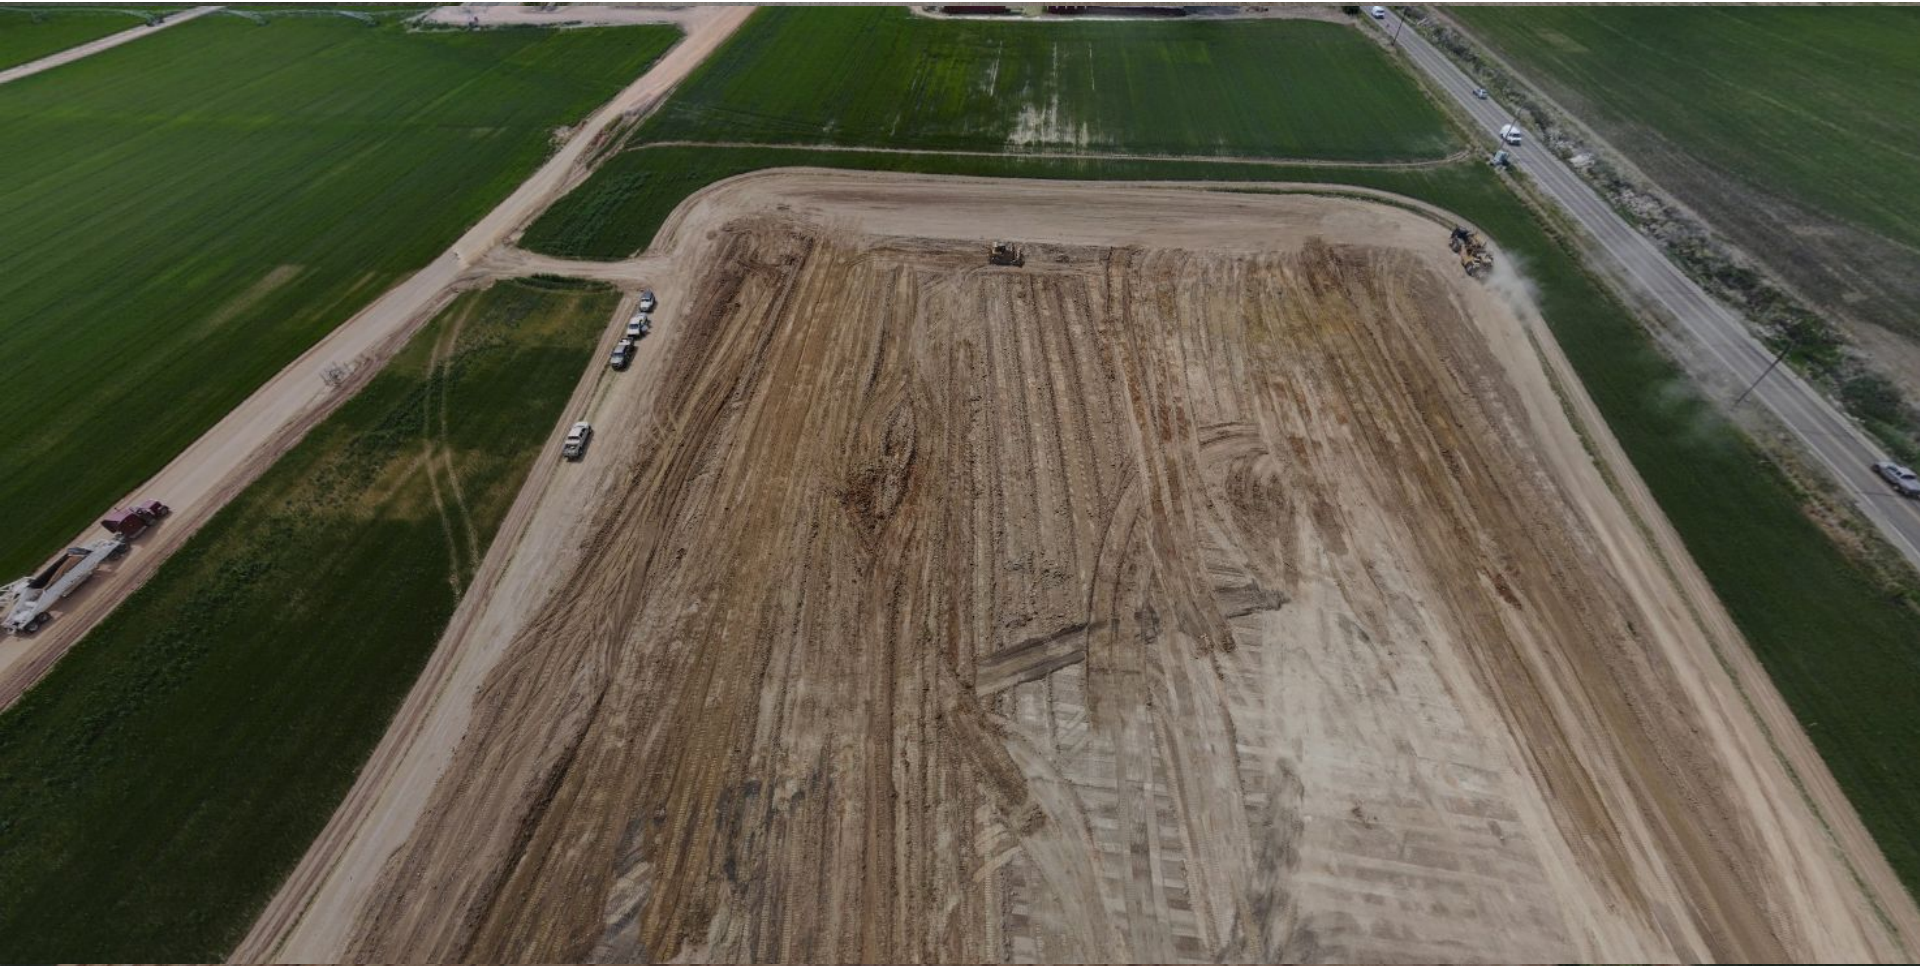
**Photo 3.** Drone imagery from 6/17/2022 illustrates the central-southern location during active construction operations.

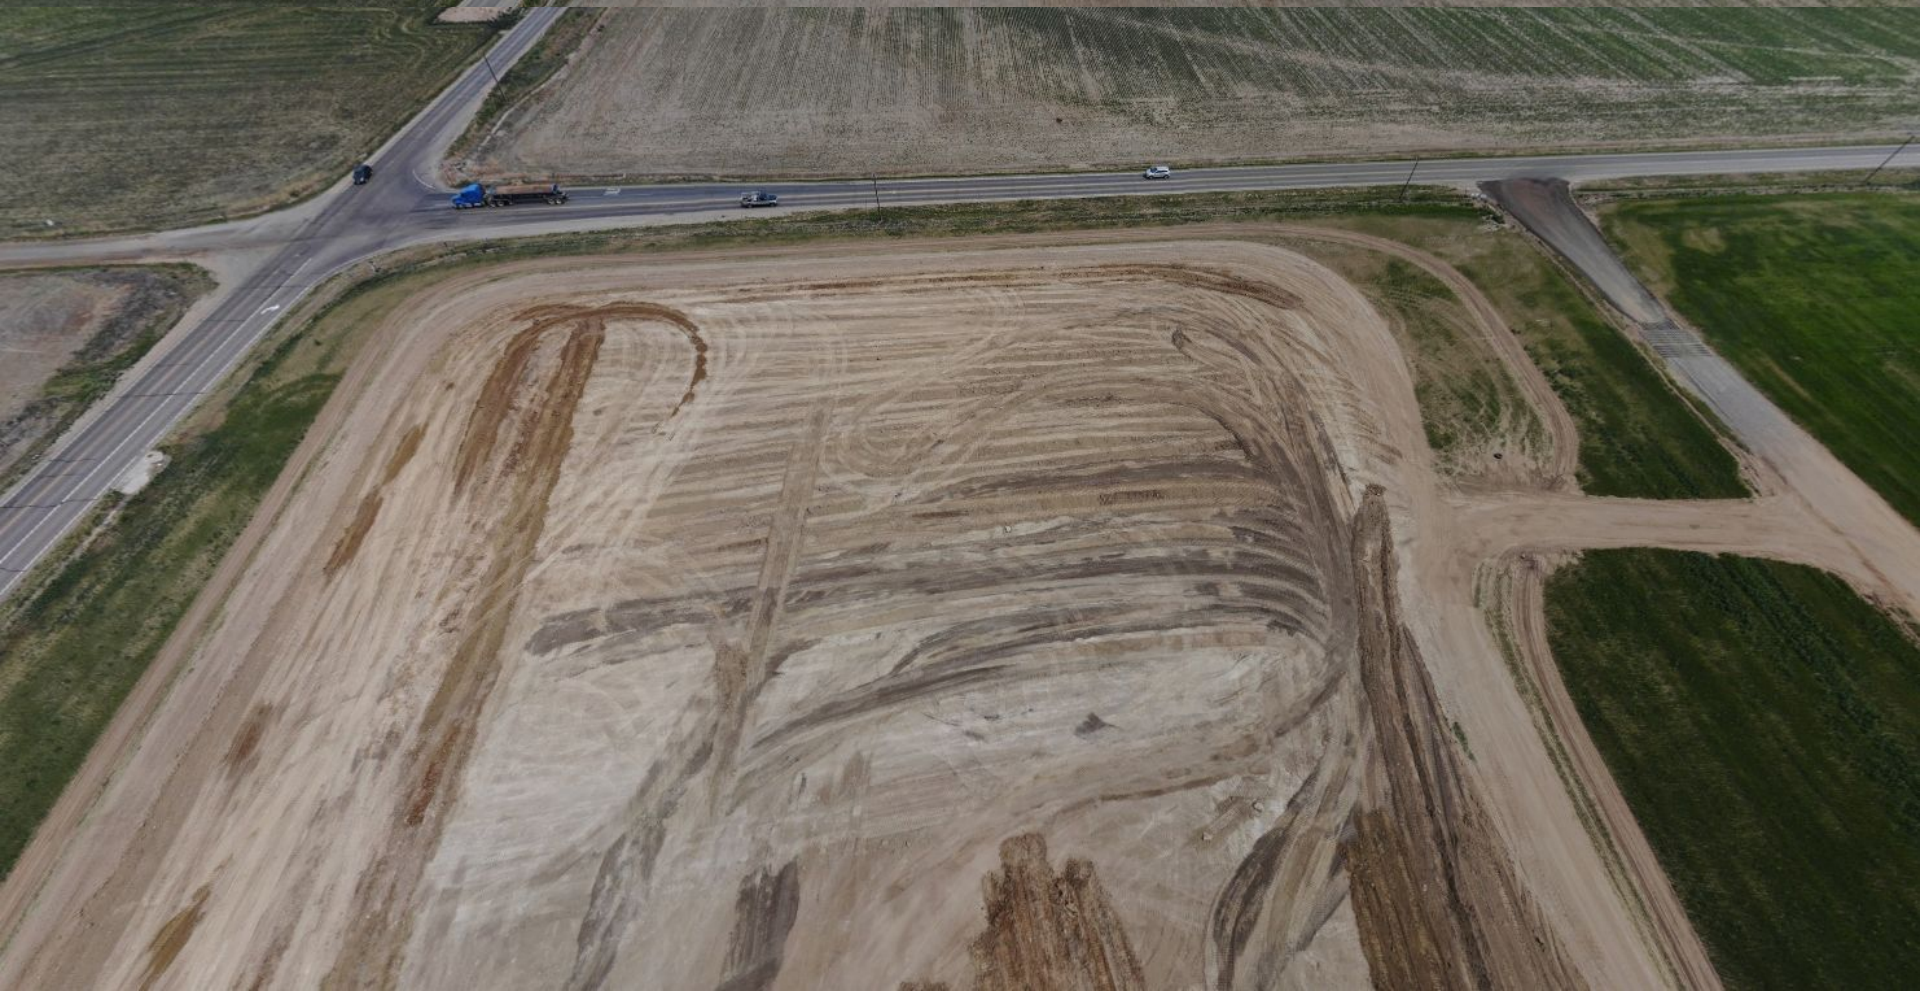
**Photo 4.** Drone imagery from 6/17/2022 illustrates the central-northern location during active construction operations.

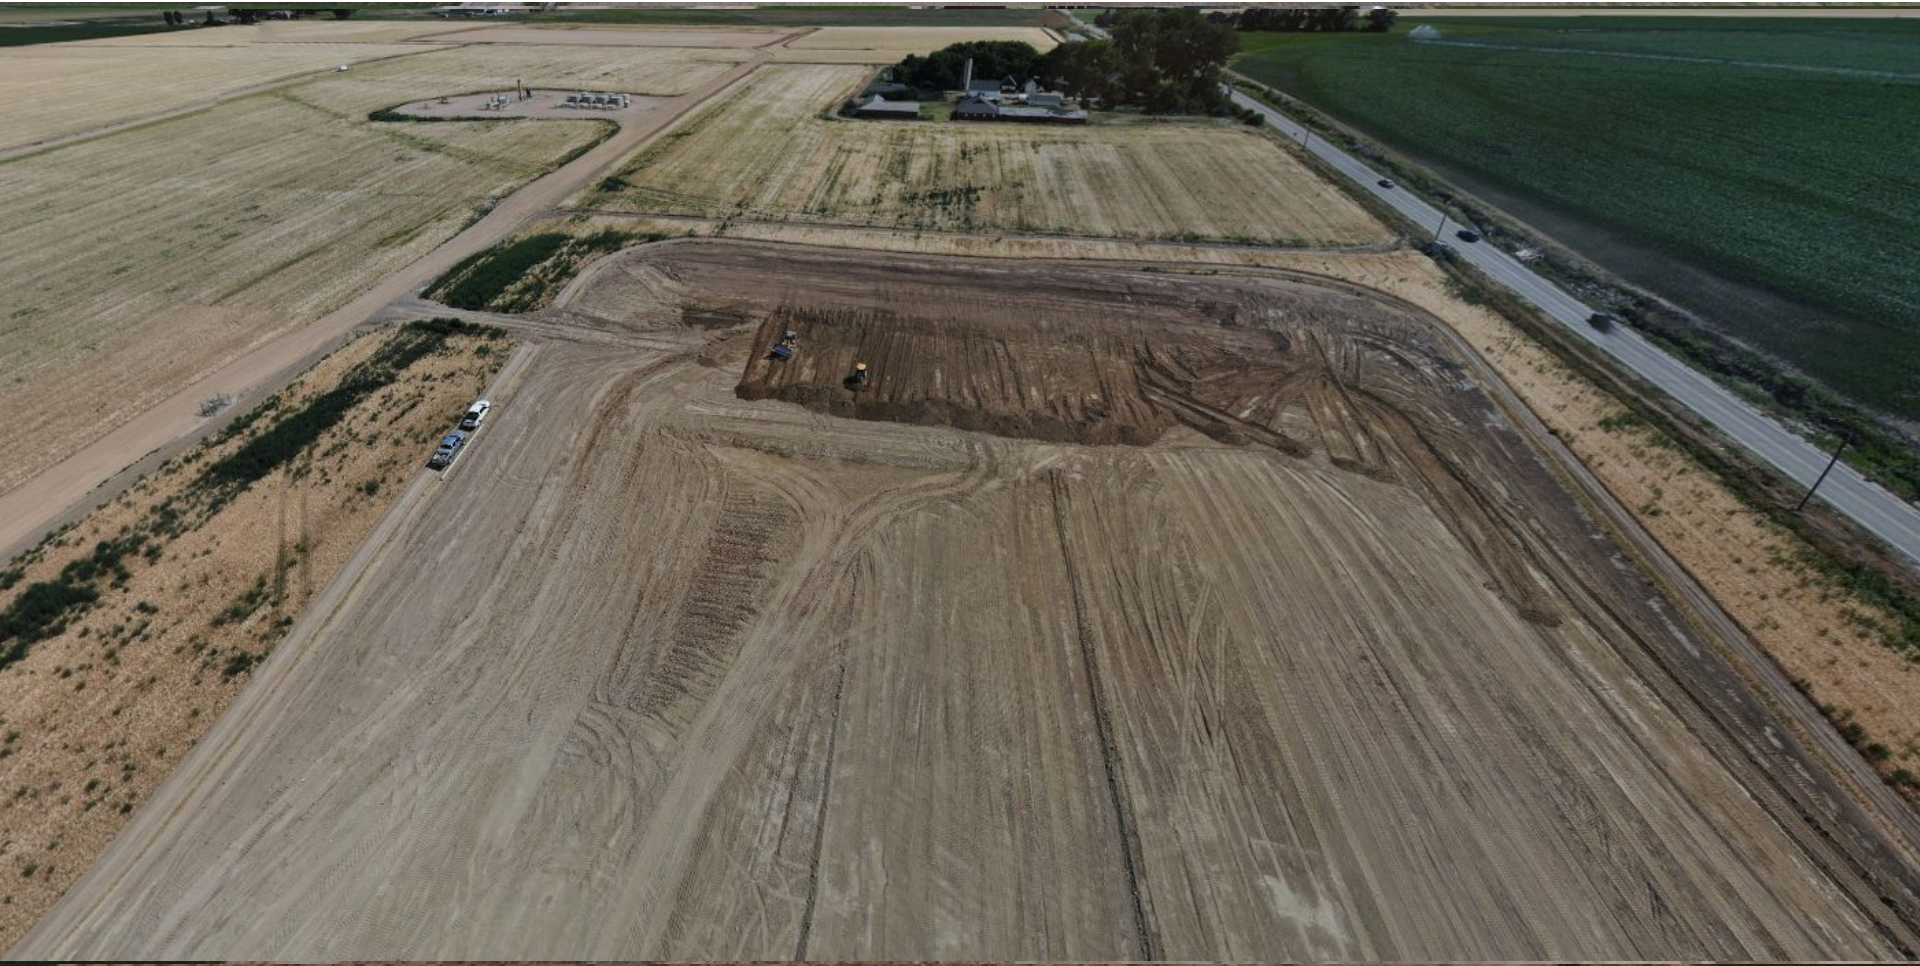
**Photo 5.** Drone imagery from 7/13/2022 illustrates the central-southern location during active construction operations.

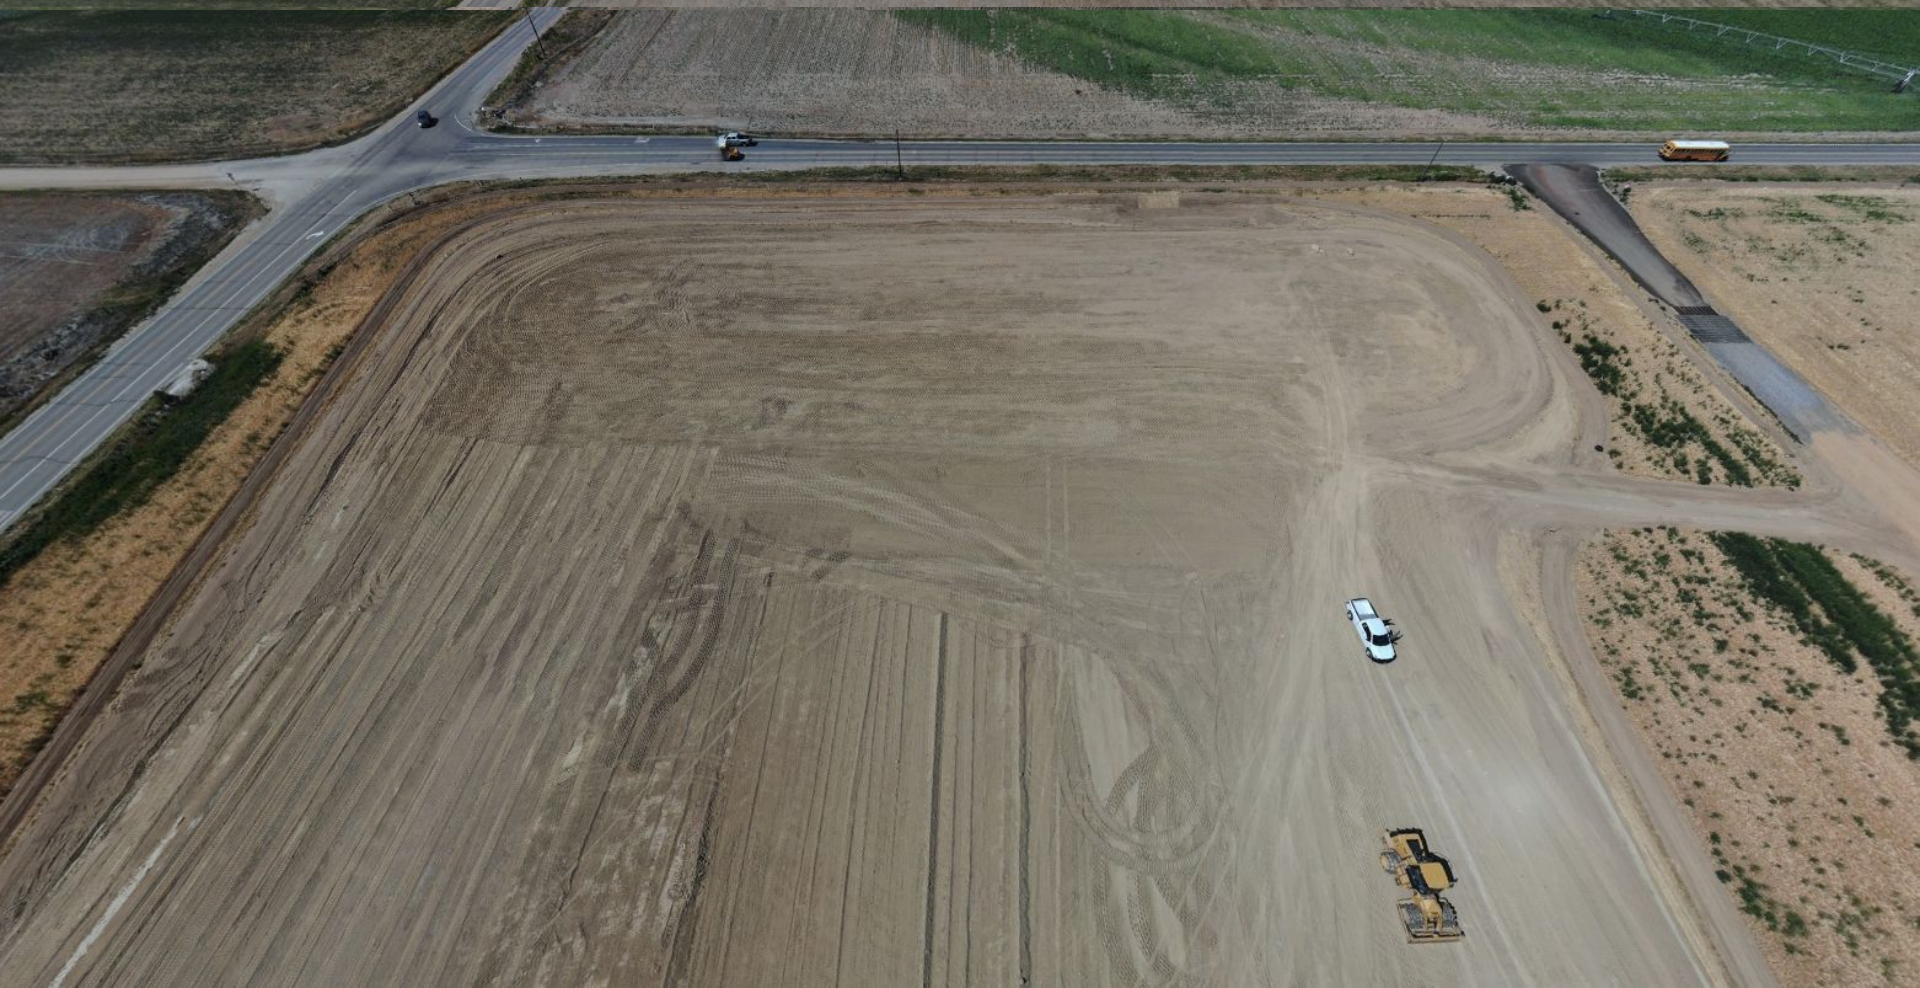
**Photo 6.** Drone imagery from 7/13/2022 illustrates the central-northern location during active construction operations.

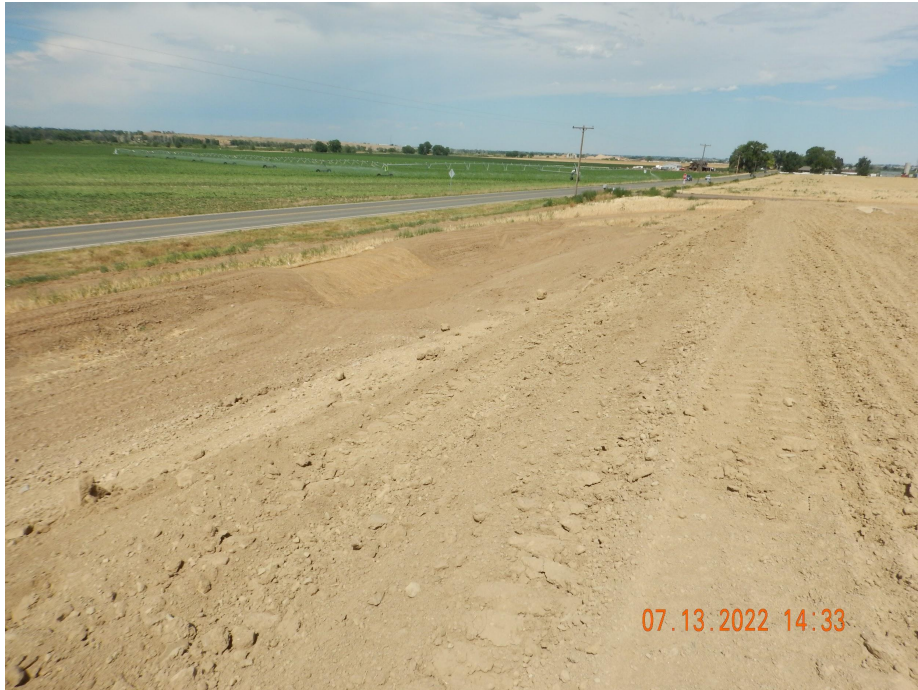
**Photo 7.** Photo taken from the northeastern location, facing Northeast. Photo illustrates a sediment trap BMP with a temporarily stabilized outlet.

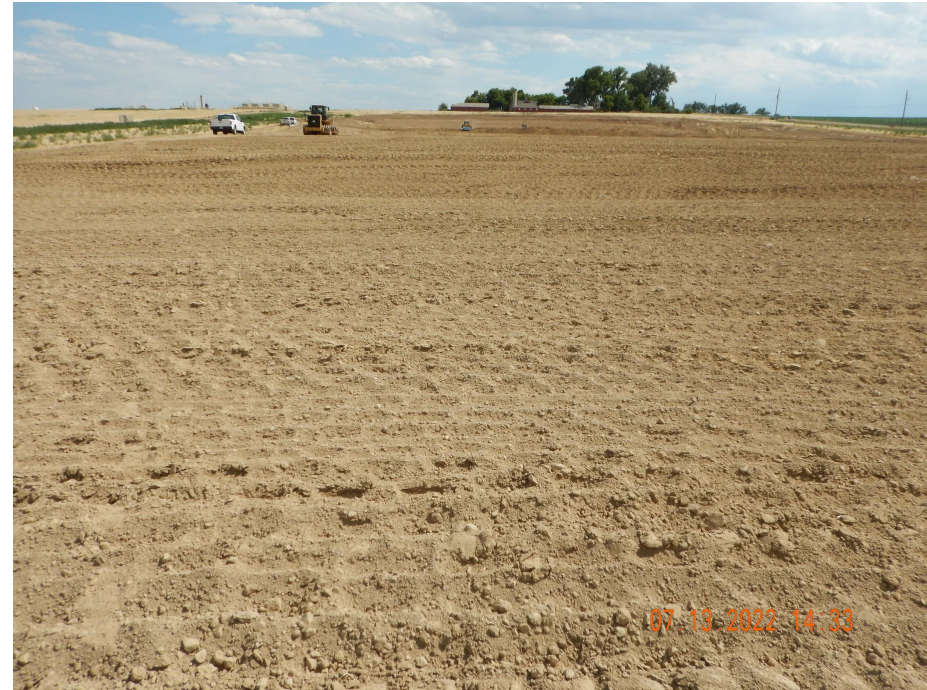
**Photo 8.** Photo taken from the northern location, facing South. Photo illustrates there appears to be a retention area being constructed for the final stormwater BMPs.
