Interim Reclamation Inspection

Operator: KERR MCGEE OIL & GAS ONSHORE LP #47120

Location ID: 323207

Location Name: CHAMPLIN 86 AMOCO I #1

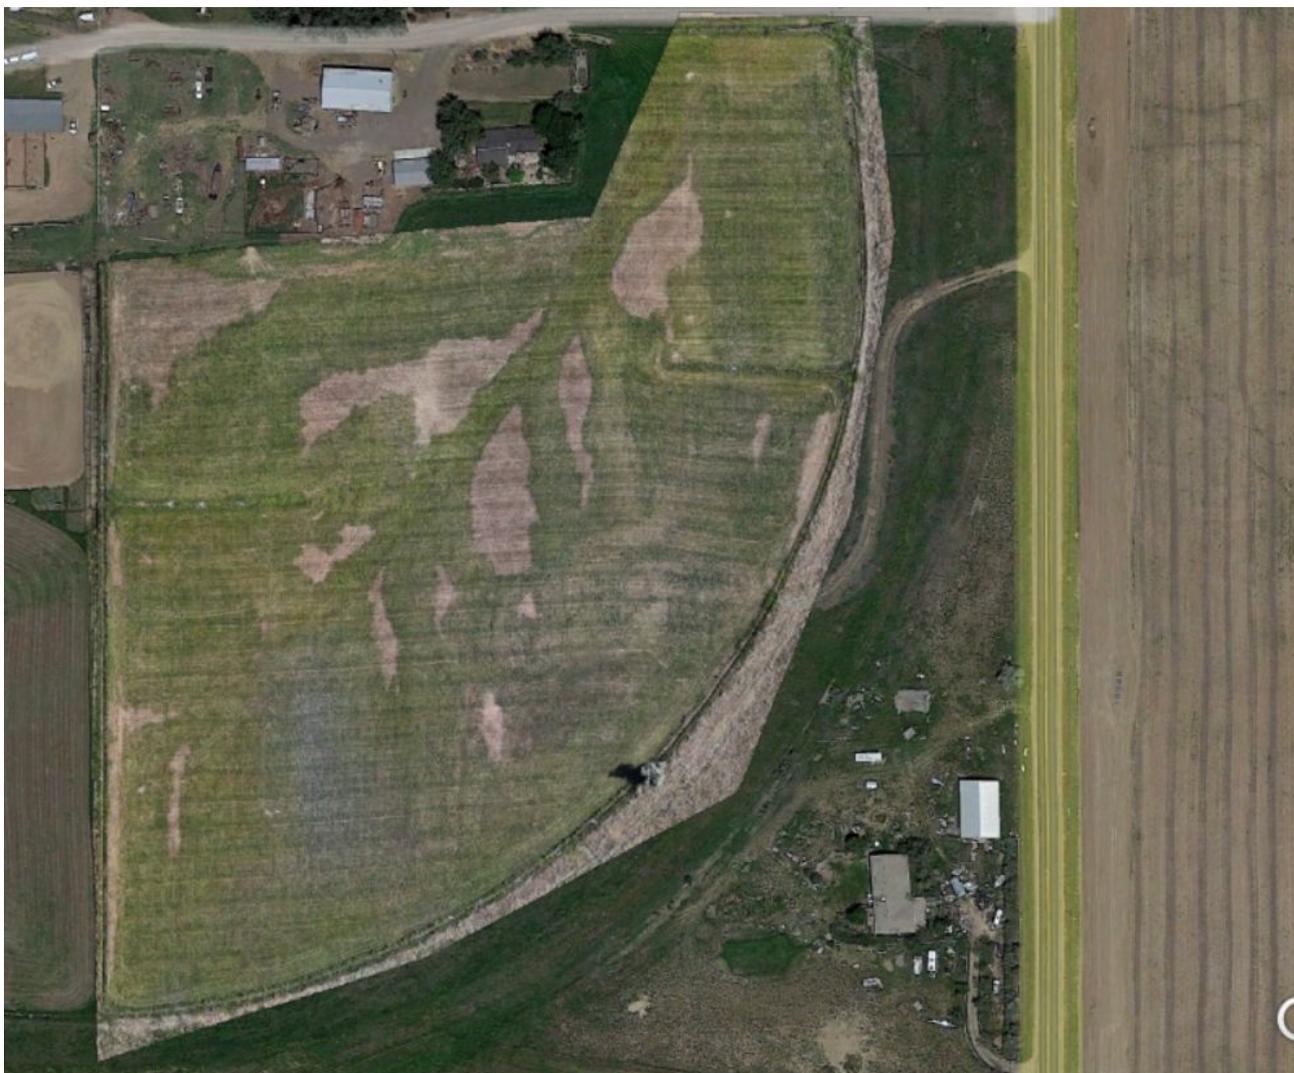
Photo 2. COGCC Drone aerial imagery from July 16, 2022 overlaid onto Google Earth. This imagery is illustrating the current vegetation, which will be referenced again in Photo #4.

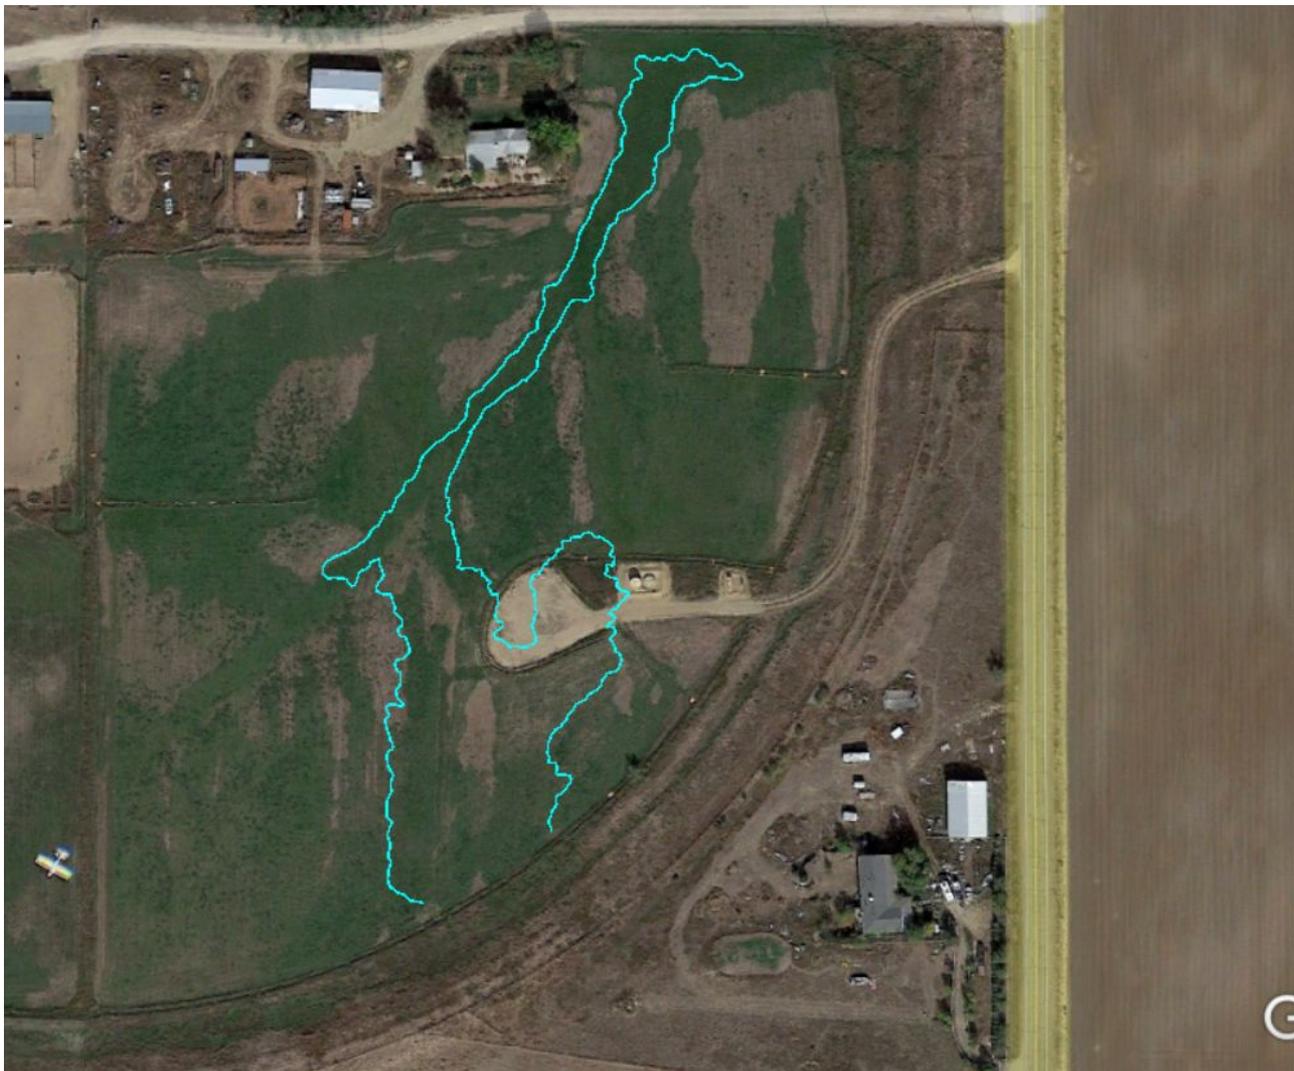
Photo 3. Google Earth aerial imagery from 10/9/2015 with data (blue line) that was collected on July 16, 2022. The blue polygon illustrates where flood irrigation was occurring and it appears the western location is too high and impacted vegetation off location.

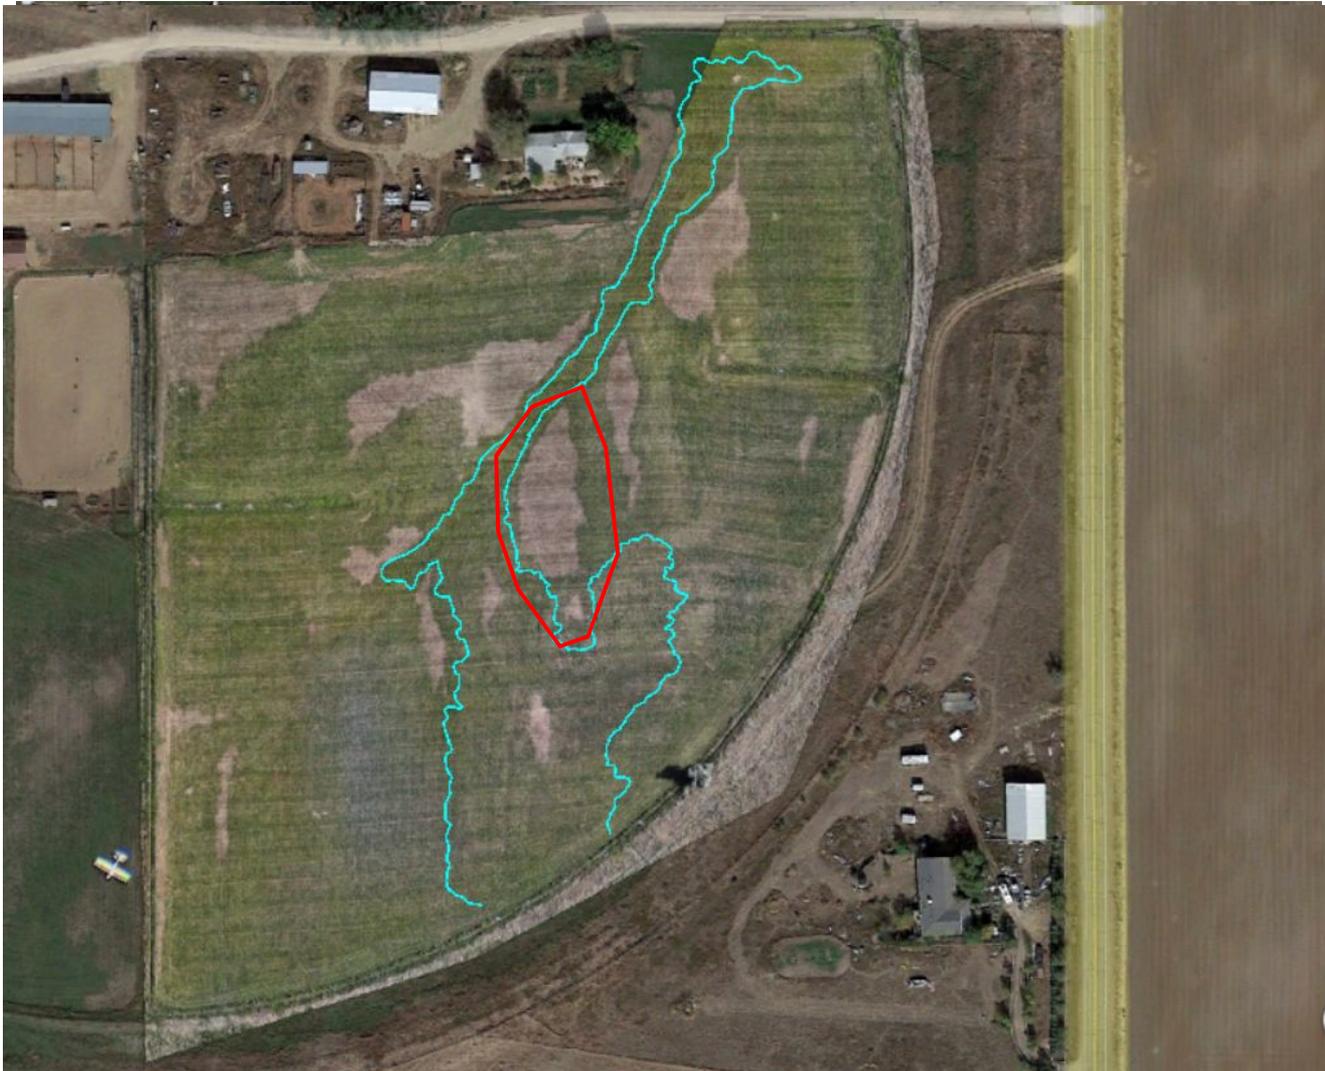
Photo 4. COGCC Drone aerial imagery from July 16, 2022 overlaid with the blue polygon. This image is illustrating that area of vegetation that appears to be impacted due to the location not being properly contoured.

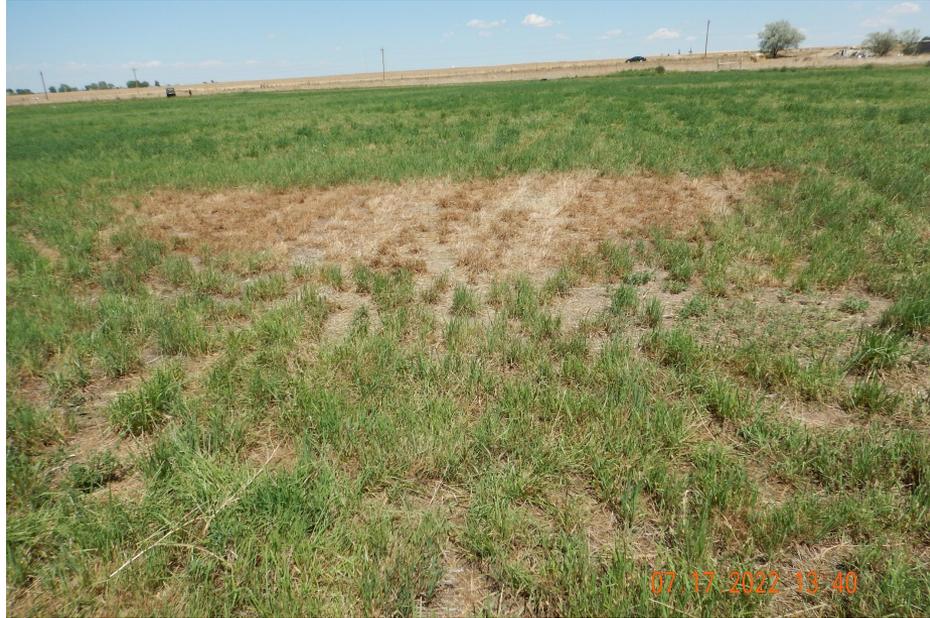
Photo 5. Photo taken from the western location, facing East. Photo illustrates an area that appears to be higher in elevation that appears to be impacted vegetation off location.

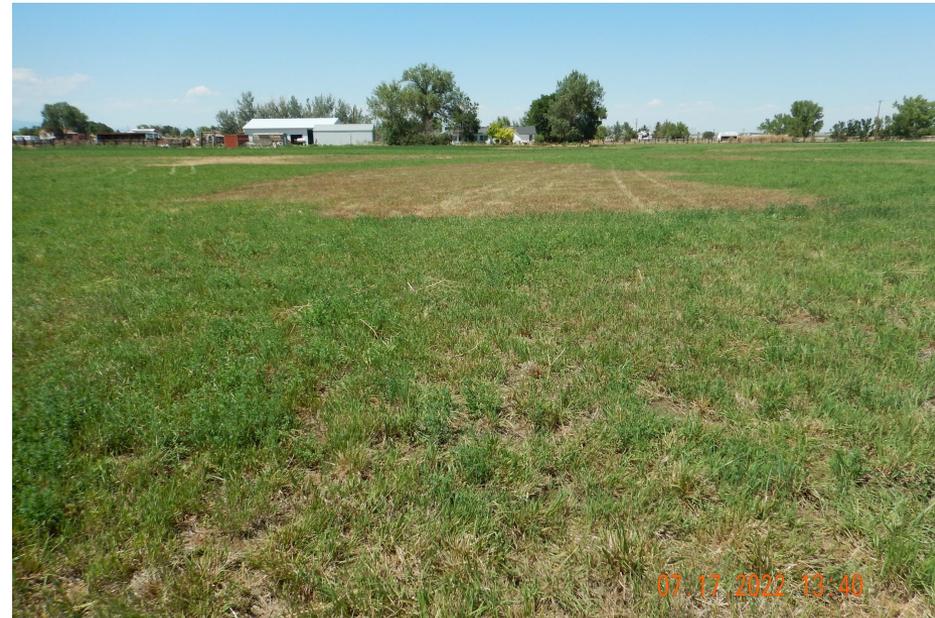
Photo 6. Photo taken from the previous photo location, facing Northwest. Photo illustrates the approximate ¼ acre area that appears to be impacted due to a contouring issue along the western location.
