Inspection Photos and Issue Report

Operator: CAERUS PICEANCE LLC # 10456

Location #458475

Rio Blanco County, CO

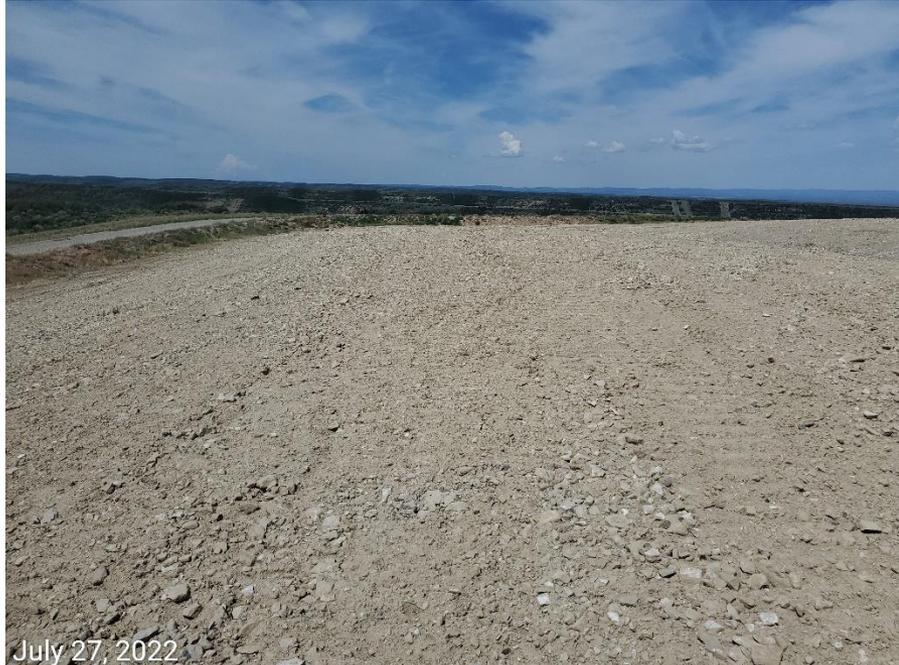
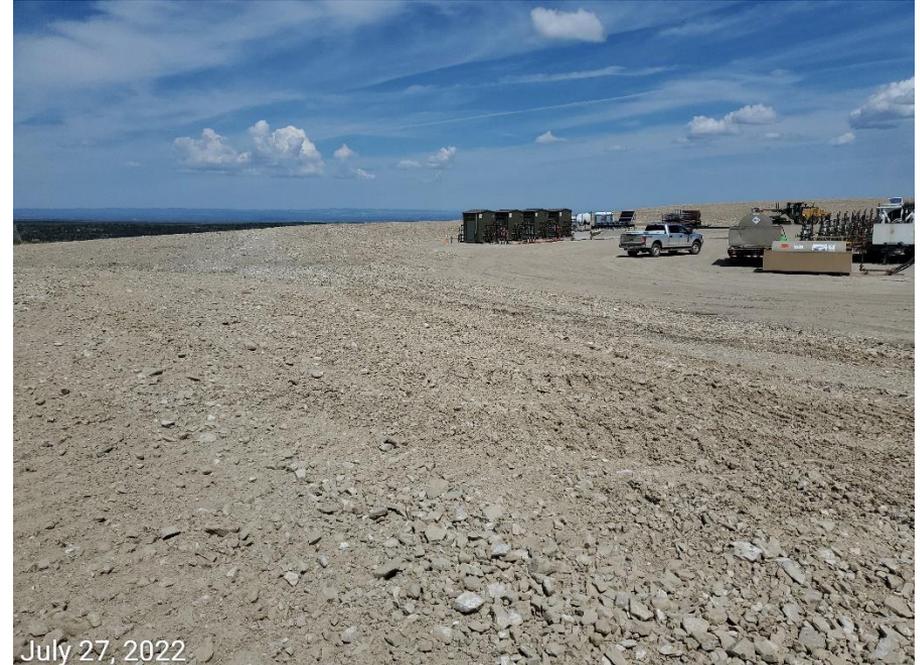
Photo 1: Photos 1-2 taken from the north end of the Location. Photos provide an overview of the Location, from west, northwest, northeast to east. Though interim reclamation has commenced, work in accordance with 1003 Rules have not been completed- topsoil has not been replaced and revegetation activities have not been conducted. Interim reclamation was required by 5/3/2021.

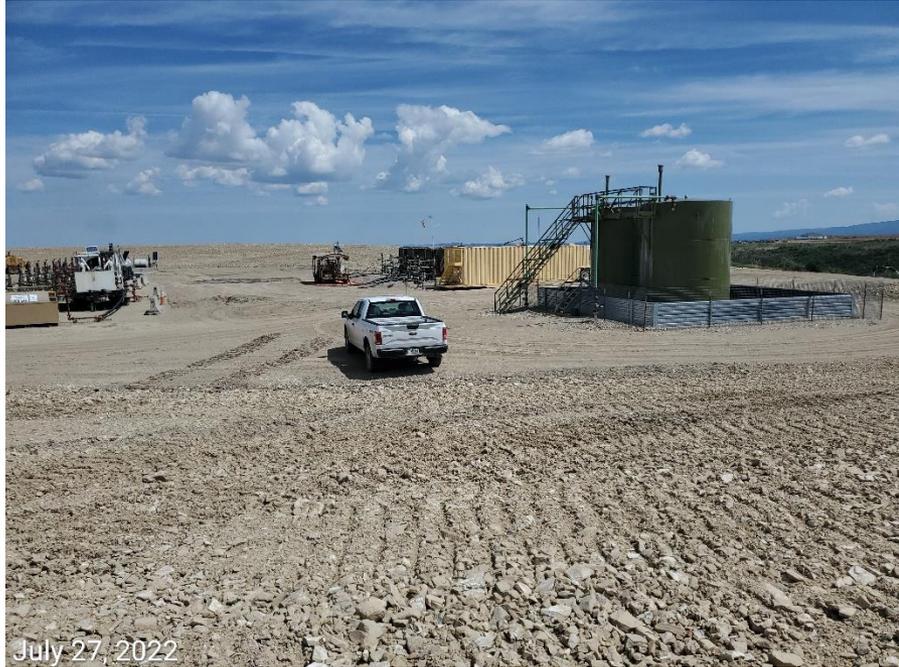
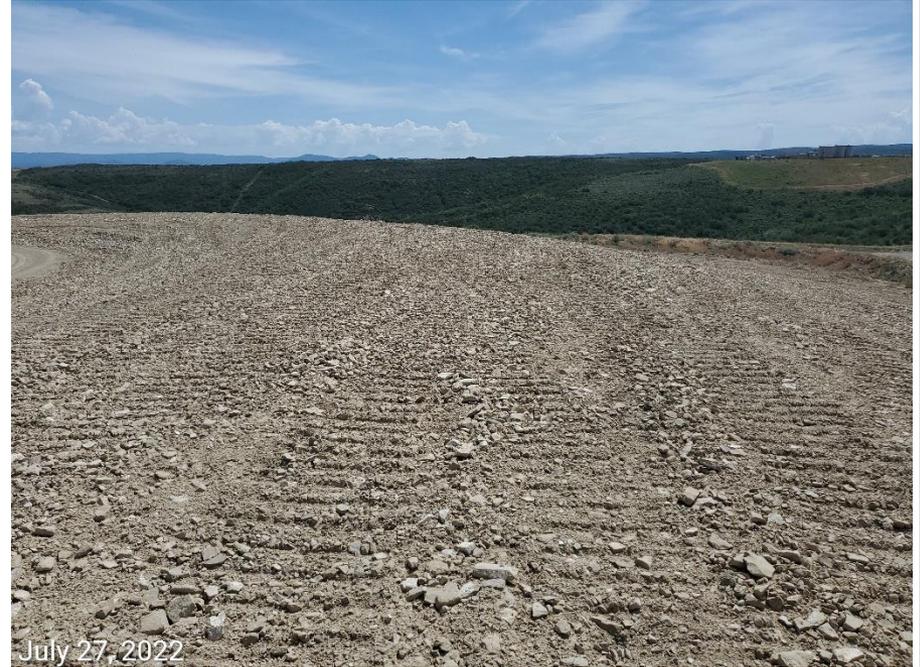
Photo 2: See comments under photo 1.

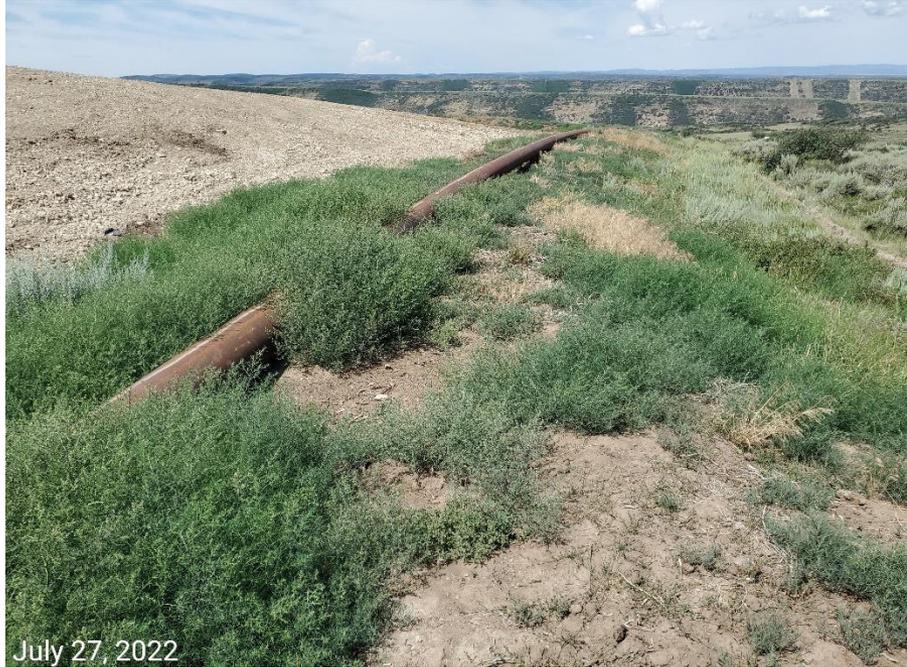
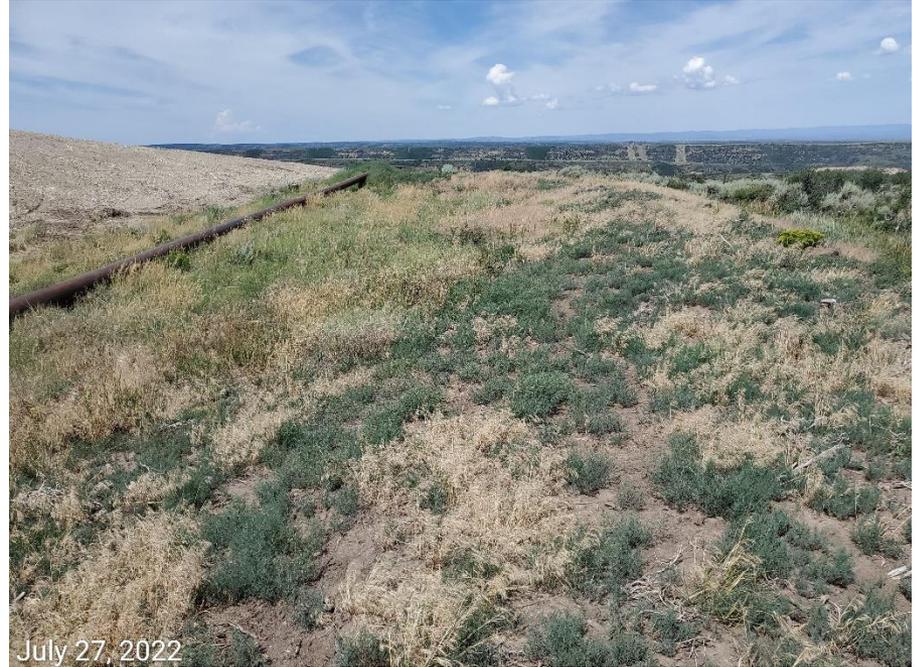
Photo 3: Photo taken from the topsoil stockpiles along the perimeter of the Location. Photos show 1) BMPs to protect topsoil stockpile per 1002.c remains inadequate, and 2) topsoil has not been replaced during interim reclamation. Vegetation predominantly undesirable plant species including Russian Thistle, cheatgrass. Noxious weeds including Houndstongue and musk thistle also observed along areas of the topsoil stockpile.

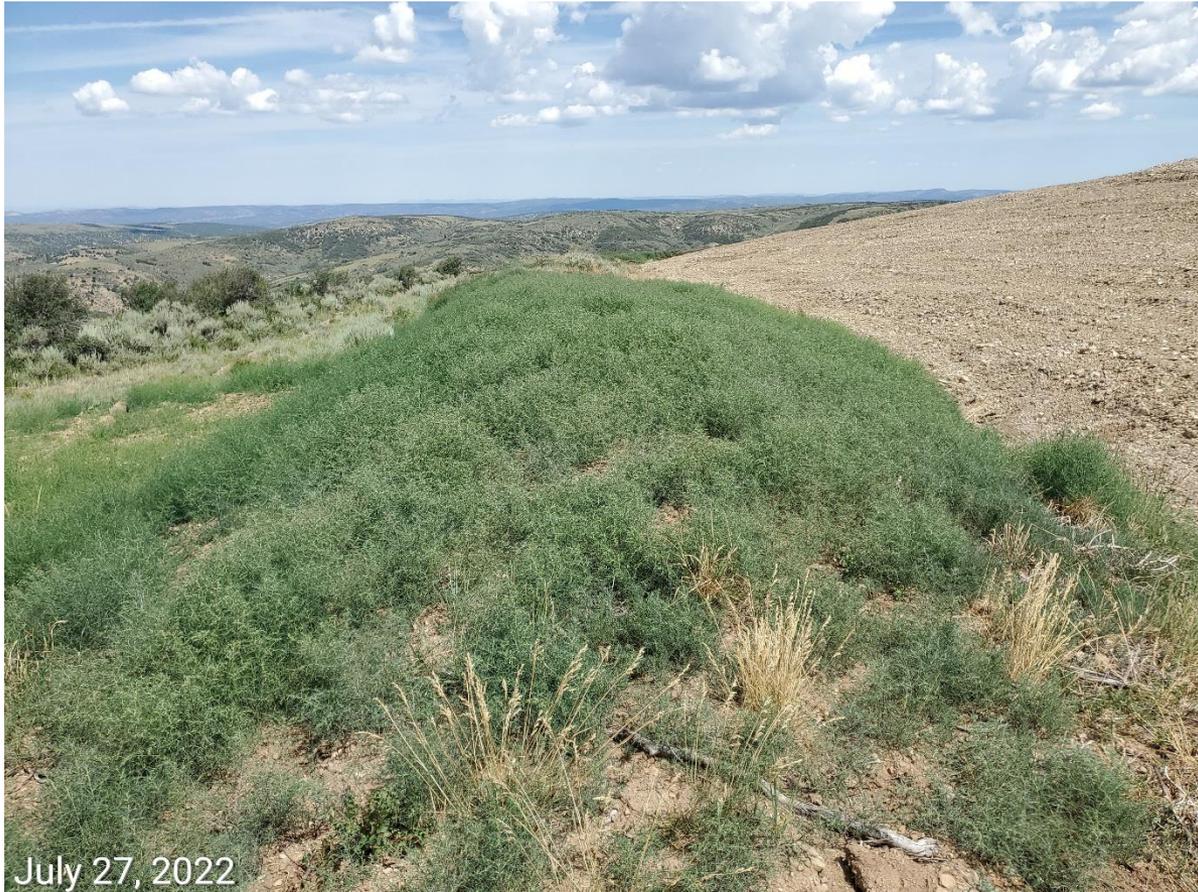
Photo 4: Photo taken from the topsoil stockpiles along the perimeter of the Location. Photos show 1) BMPs to protect topsoil stockpile per 1002.c remains inadequate, and 2) topsoil has not been replaced during interim reclamation. Vegetation predominantly undesirable plant species including Russian Thistle, cheatgrass. Noxious weeds including Houndstongue and musk thistle also observed along areas of the topsoil stockpile.

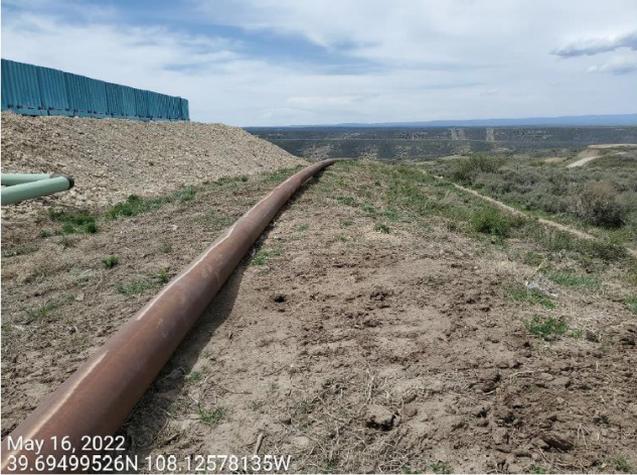
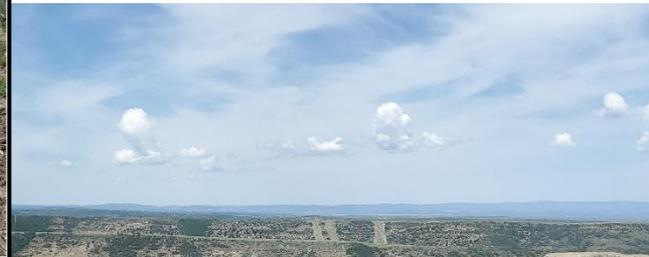
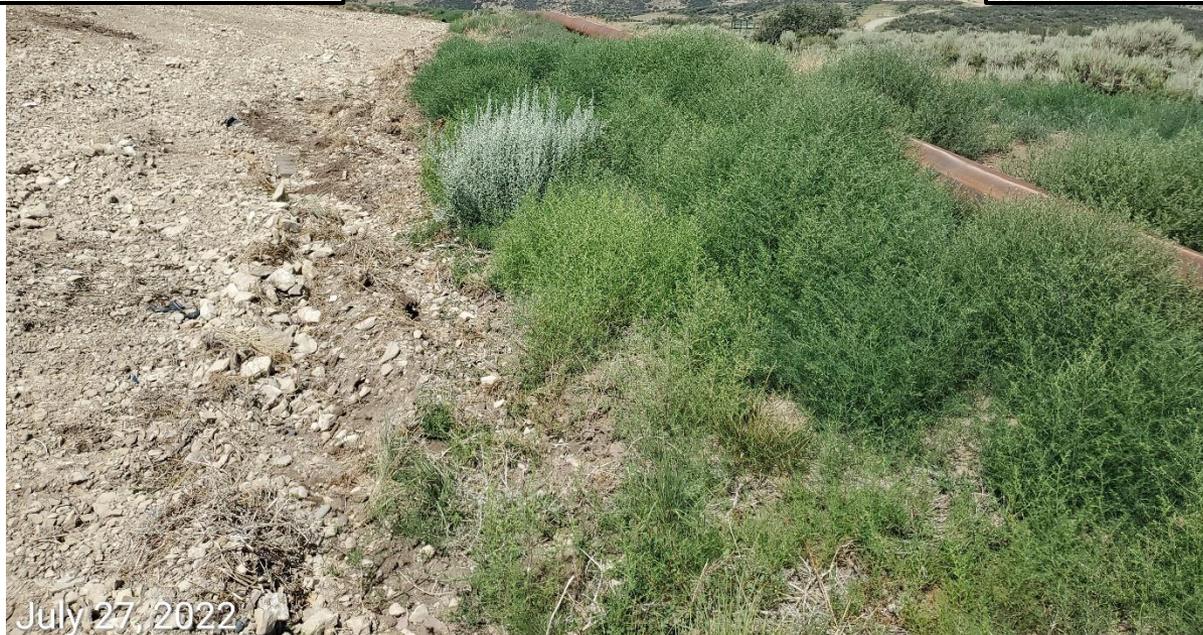
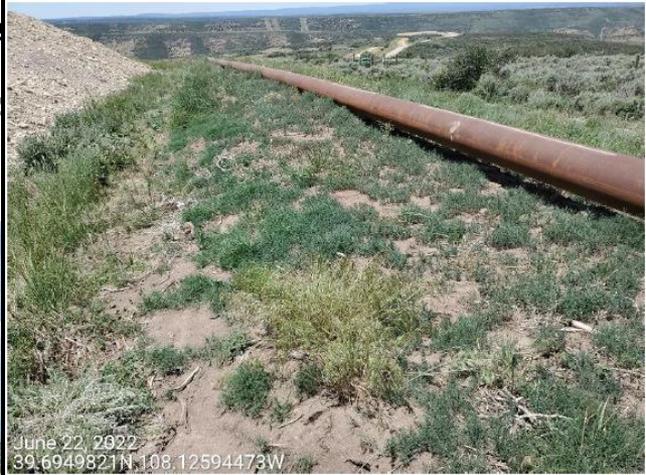
Photo 5: Photo (middle) taken from the topsoil stockpile on the north end of the Location. Photos in the top left (5/16/2022) and right (6/22/2022) taken from along the same section/location of the stockpile. Photos show 1) BMPs to protect topsoil stockpile per 1002.c remains inadequate, and 2) topsoil has not been replaced during interim reclamation. Vegetation in photos predominantly Russian thistle.
