Inspection Photos

Location ID: 313256

Location Name: Brown-66N92W /8NENW

Inspection Document #: 702800492

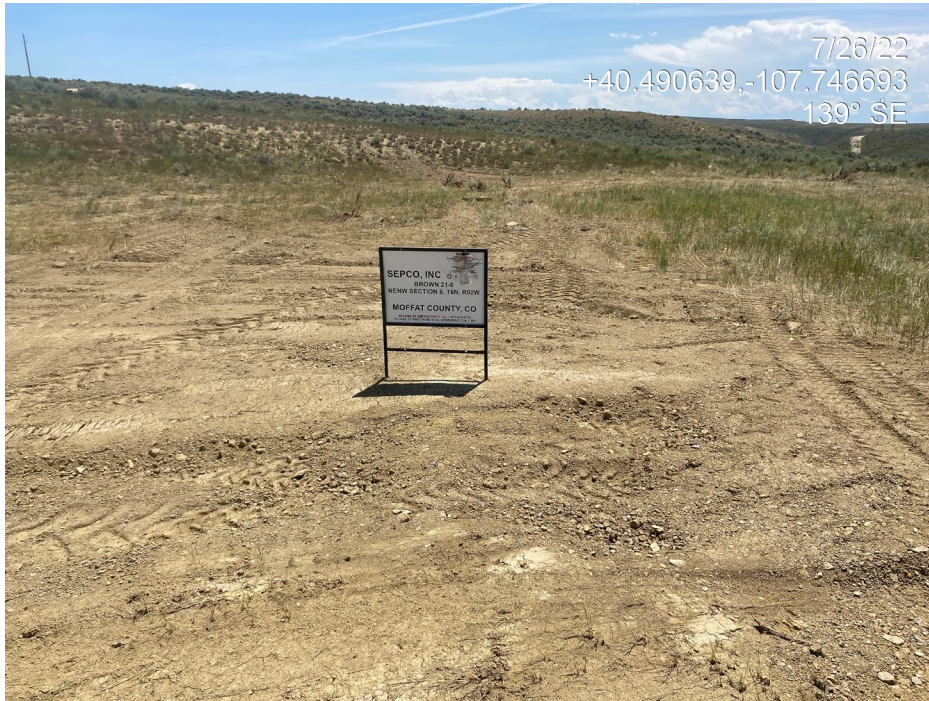
Photo 1. Photo taken from the center of the Location shows the Location sign.

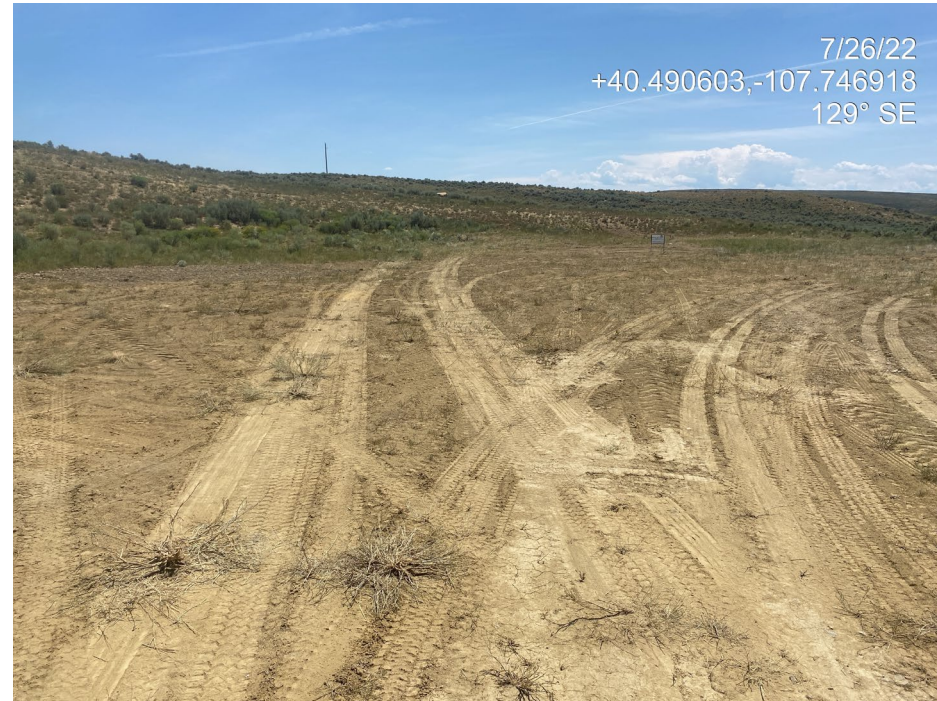
Photo 2. Photo taken from the north, at the Location entrance shows an overview of the Location.

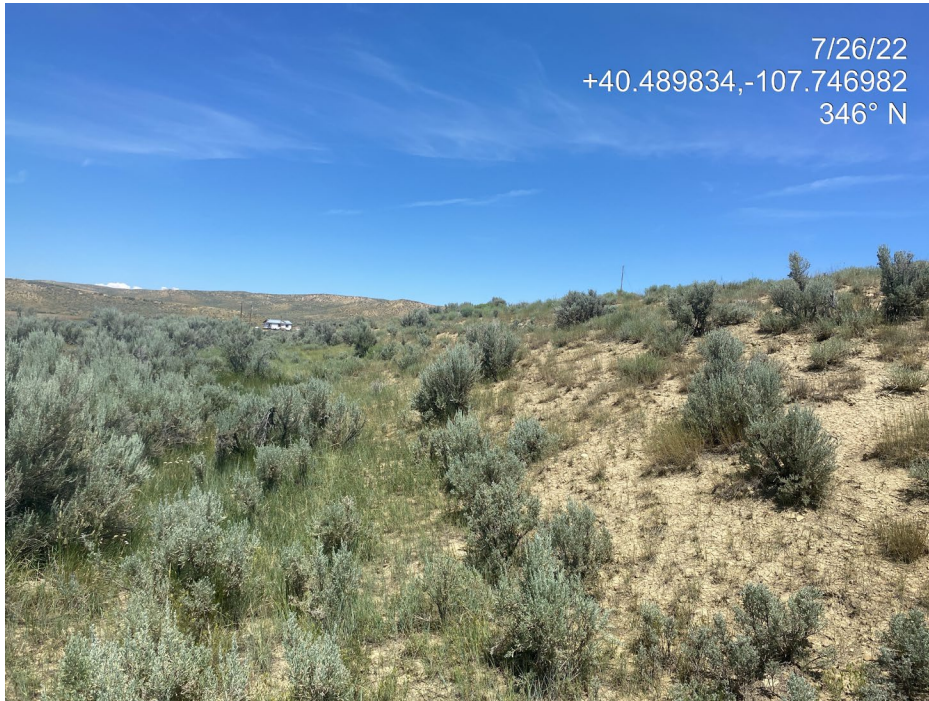
Photo 3. Photo taken from the west of the Location shows the fill slope of the Location. The Location must be recontoured/regraded.

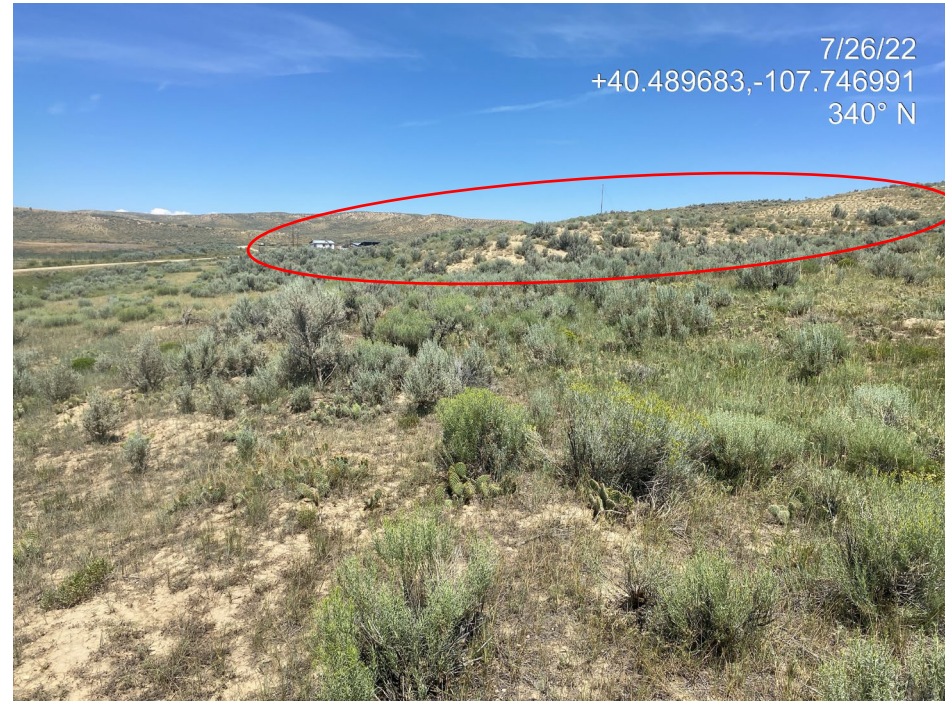
Photo 4. Photo taken from the southwest of the Location shows the transition from the undisturbed area (foreground) to the Location. Photo shows cut and fill slopes within the red circle. The Location must be recontoured/regraded.

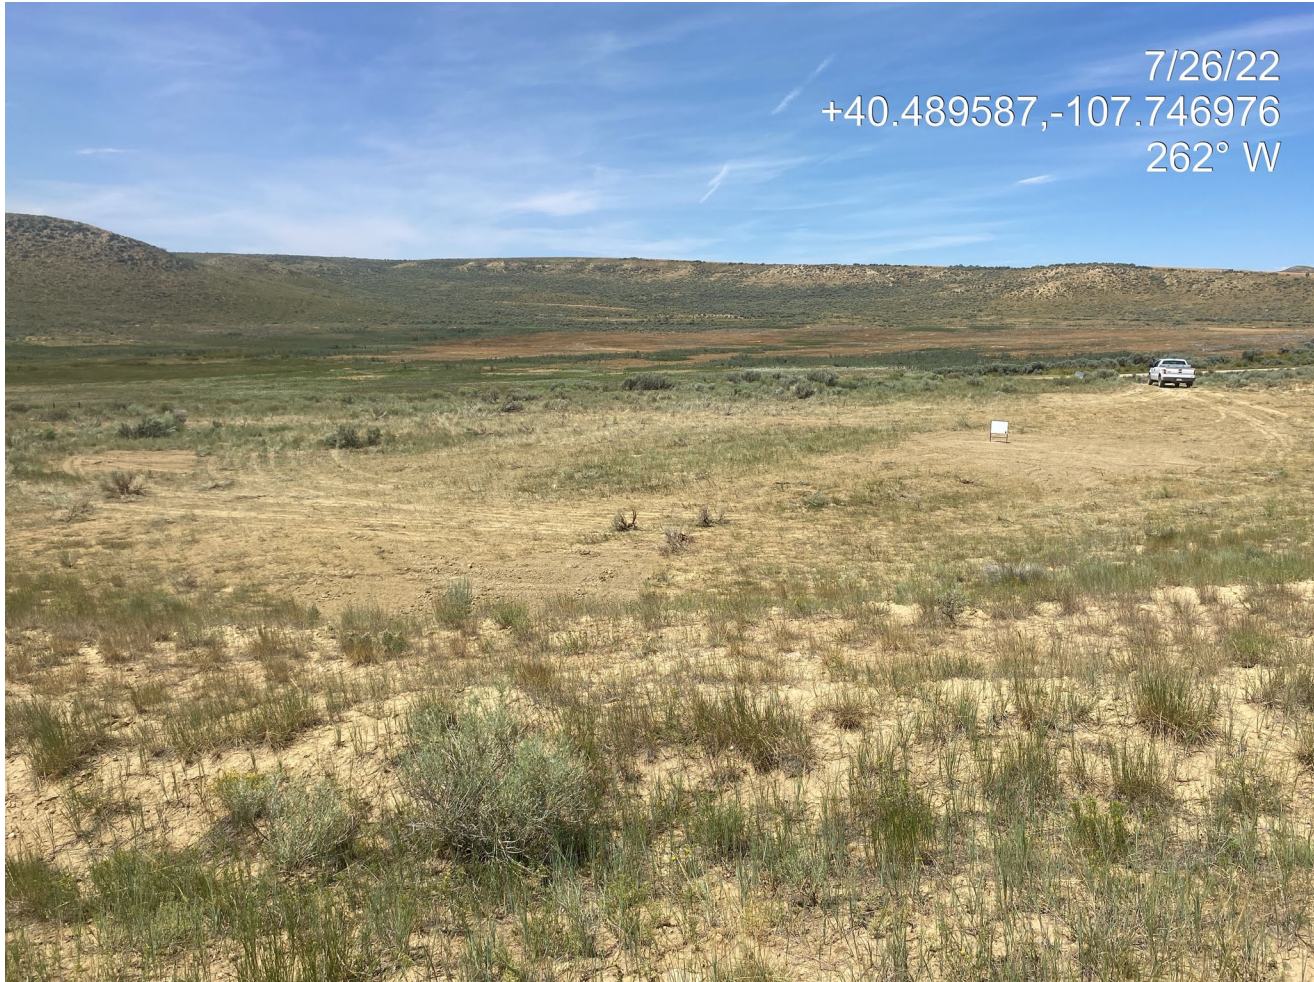
Photo 5. Photo taken from the east of the Location shows the cut slope (foreground) has been seeded with crested wheatgrass, a non-native species which is not found in adjacent reference areas.

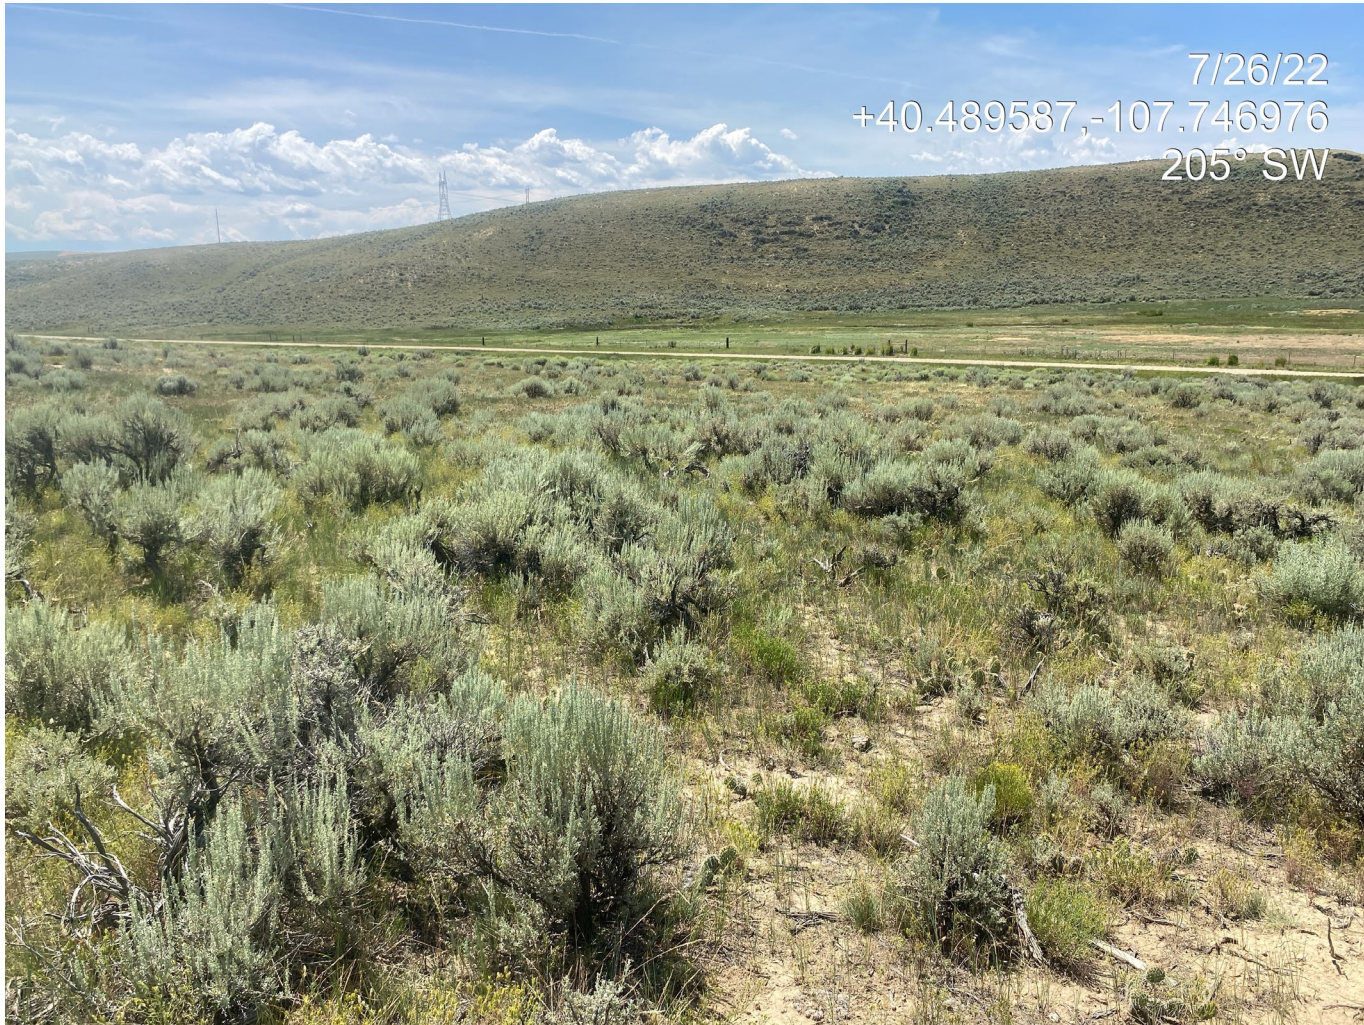
Photo 6. Photo taken from the south of the Location shows the reference area vegetation community is native rangeland.
