Inspection Photos and Issue Report

Operator: CAERUS PICEANCE LLC # 10456

Location #467272

Rio Blanco County, CO

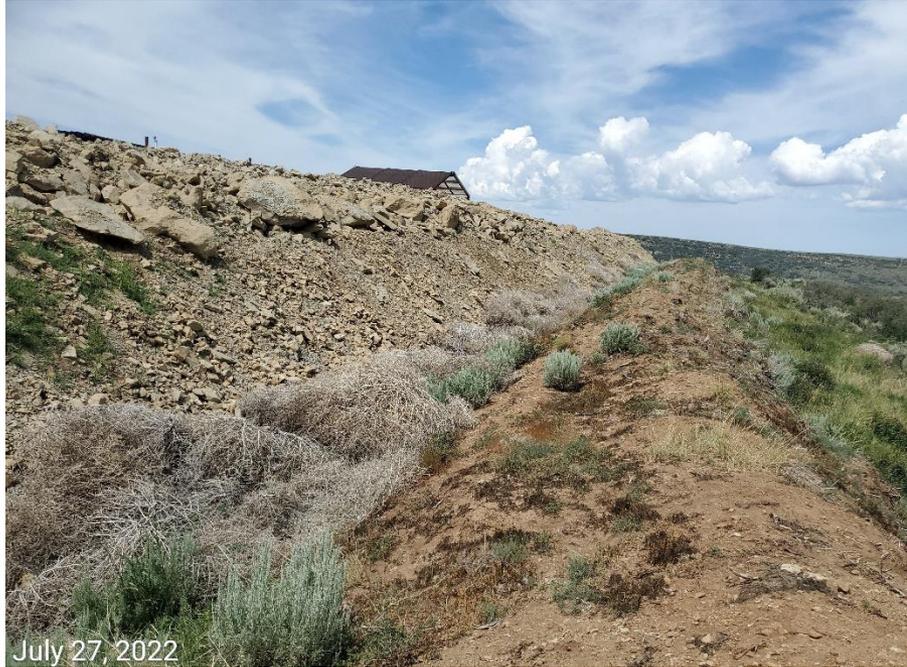
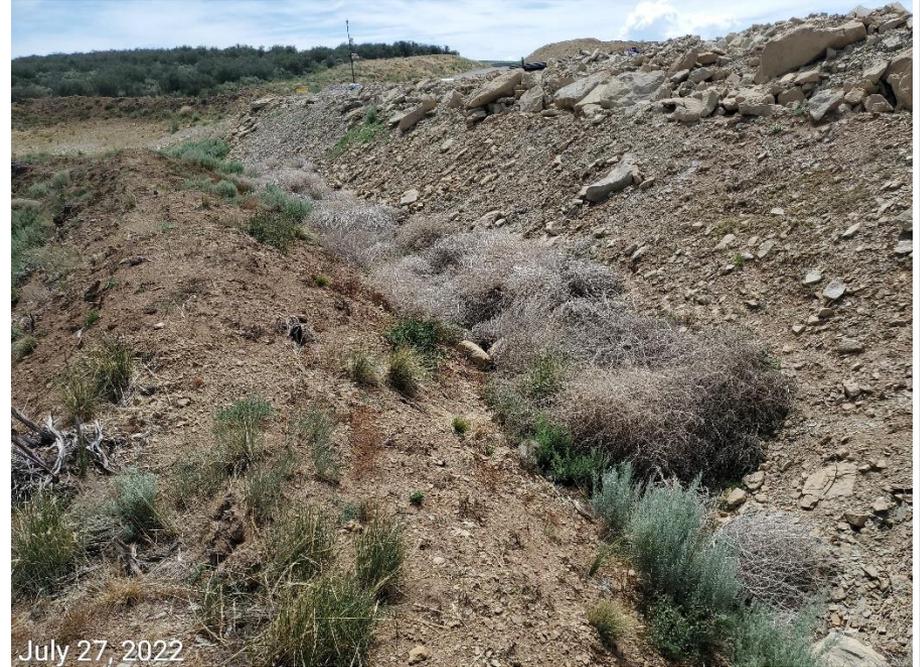
Photo 1: Photos taken from the north end of the Location. Photos examples showing weed debris remaining on the Location. Photos also examples showing topsoil berm along the perimeter or the Location remains in use at the base of the fill slopes/subsoils of the Location as a stormwater control to manage runoff. BMPs to minimize erosion, degradation, and to ensure segregation of soils remain missing or insufficient to protect stockpiled soils.

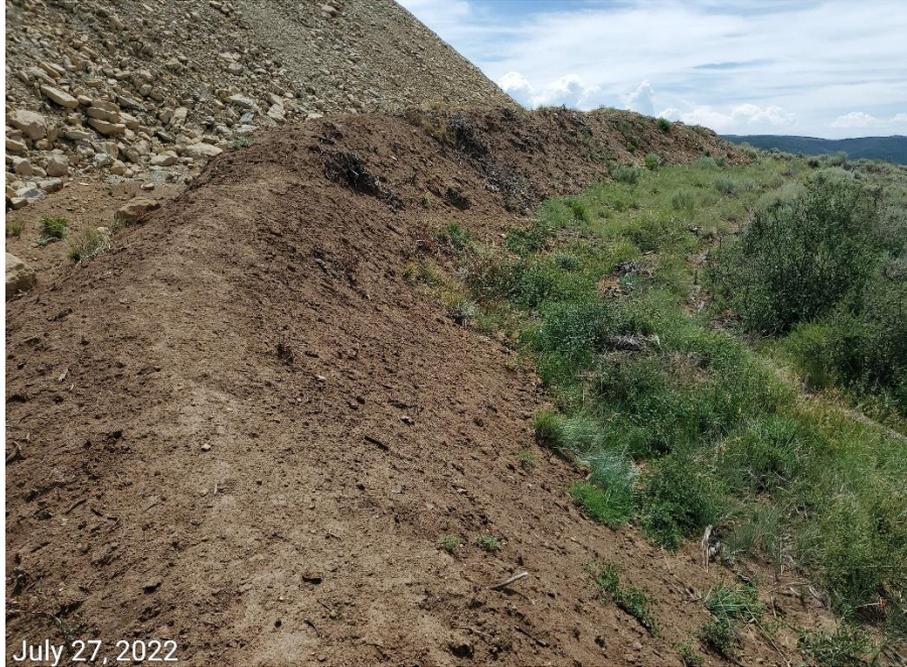
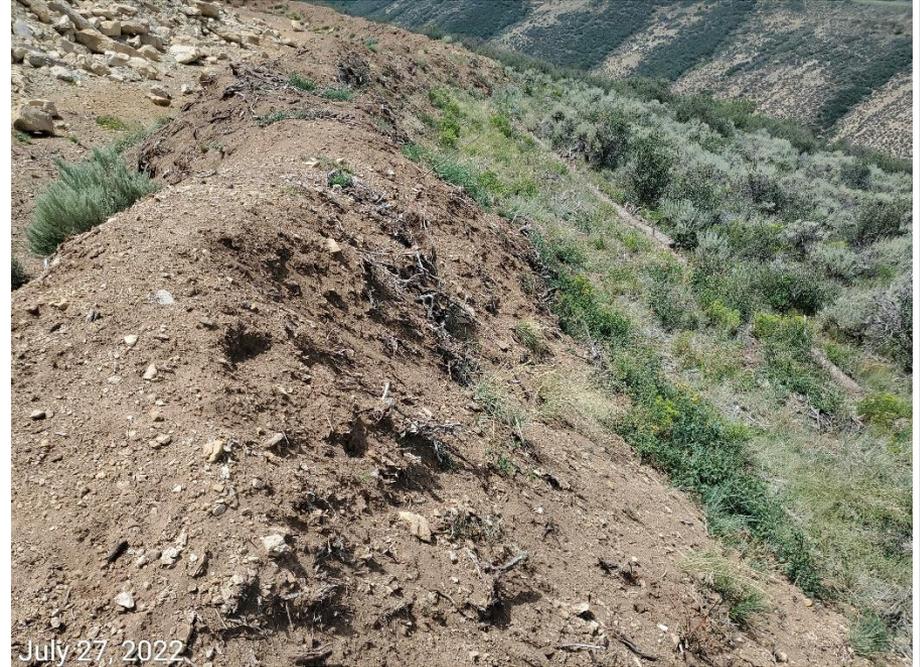
Photo 2: Photos examples showing topsoil stockpiles remain bare and at risk to wind and water erosion; BMPs to minimize erosion, degradation, and to ensure segregation of soils remain missing or insufficient to protect stockpiled soils. Topsoil stockpile along perimeter of the Location also remains in use at the base of the fill slopes/subsoils of the Location as a berm and sediment trap/pond to manage stormwater runoff. Topsoil is not an appropriate material to construct stormwater control measures, and places the topsoil at risk of degradation, contamination, loss/displacement due to stormwater discharge; use of topsoil as a stormwater control does not comport with Rule 1002.b and 1002.c.

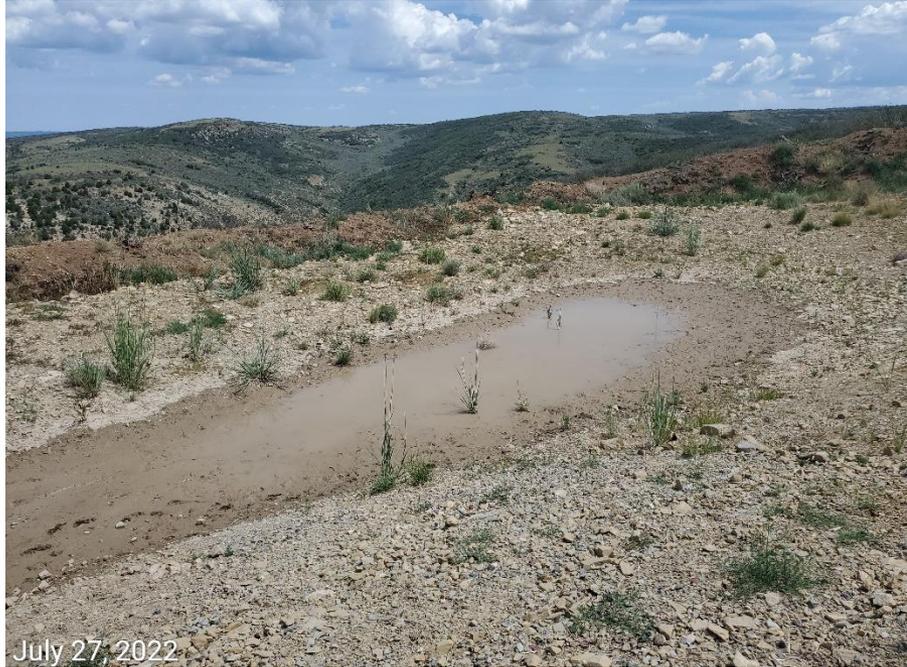
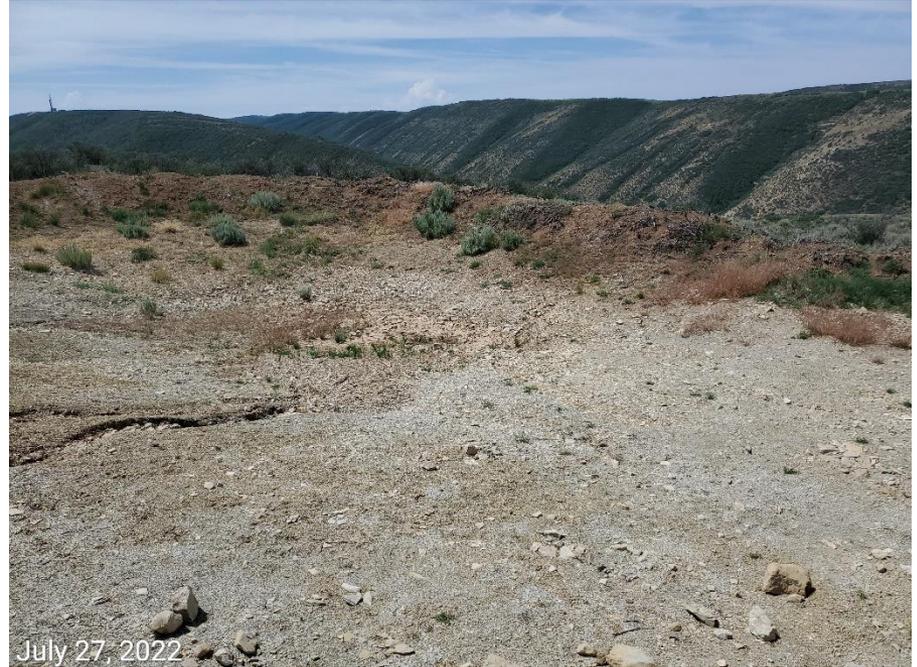
Photo 3: Photo taken from the sediment traps/ponds on the north and south end of the Location. Photos show topsoil stockpile along perimeter of the Location also remains in use at the base of the fill slopes/subsoils of the Location as a berm and sediment trap/pond to manage stormwater runoff. See comments under photo 2.

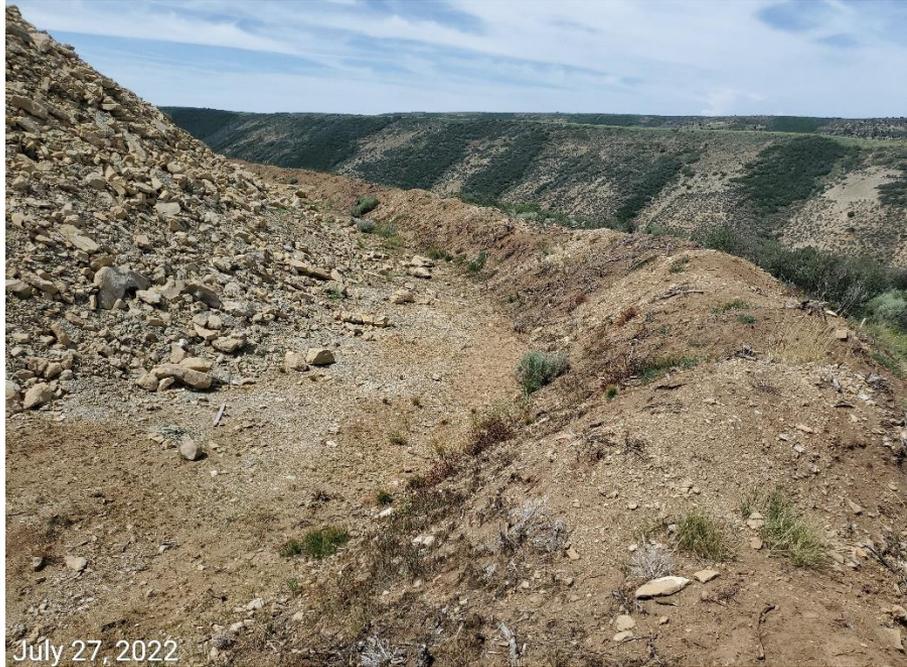
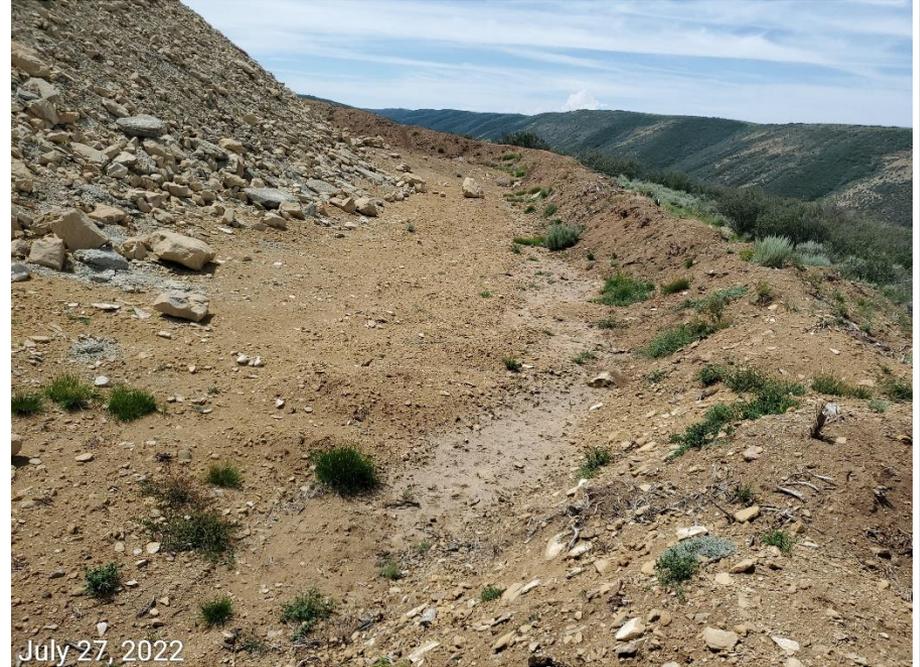
Photo 4: Photos taken from the sediment traps/pond on the west end of the Location. Photos show topsoil stockpile along perimeter of the Location also remains in use at the base of the fill slopes/subsoils of the Location as a berm and sediment trap/pond to manage stormwater runoff. See comments under photo 2.

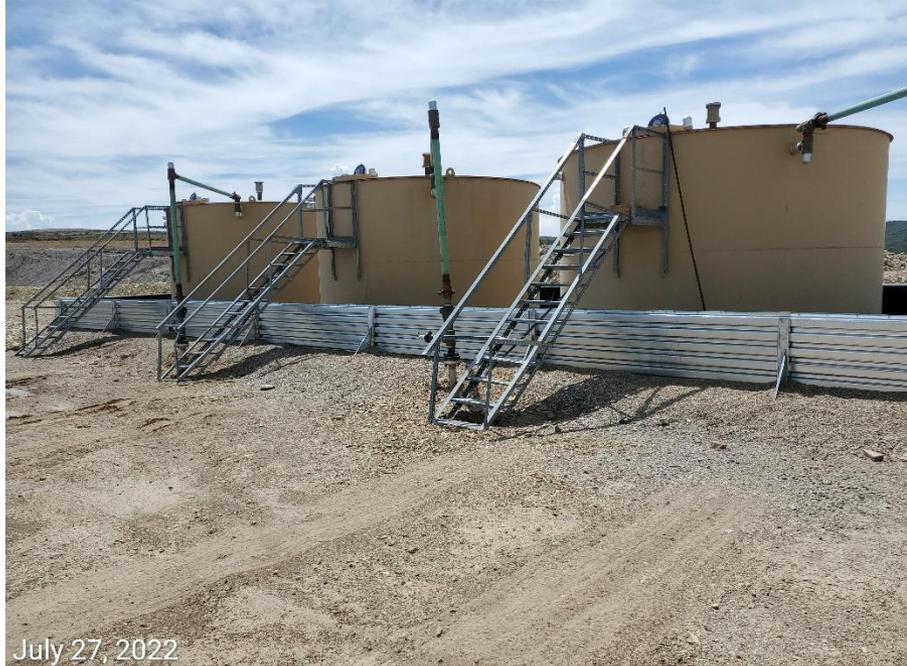
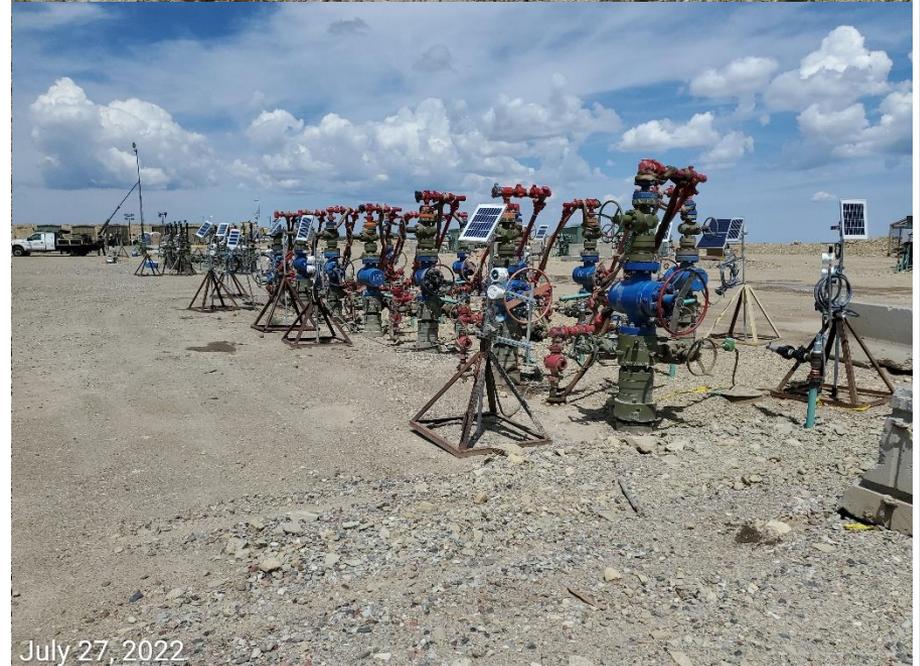
Photo 5: Photos show tank battery facility, and wells on Location; signage/labelling remains missing from the facility, tanks and wells.
