Inspection Photos and Issue Report

Operator: CAERUS PICEANCE LLC # 10456

Location #479214

Garfield County, CO

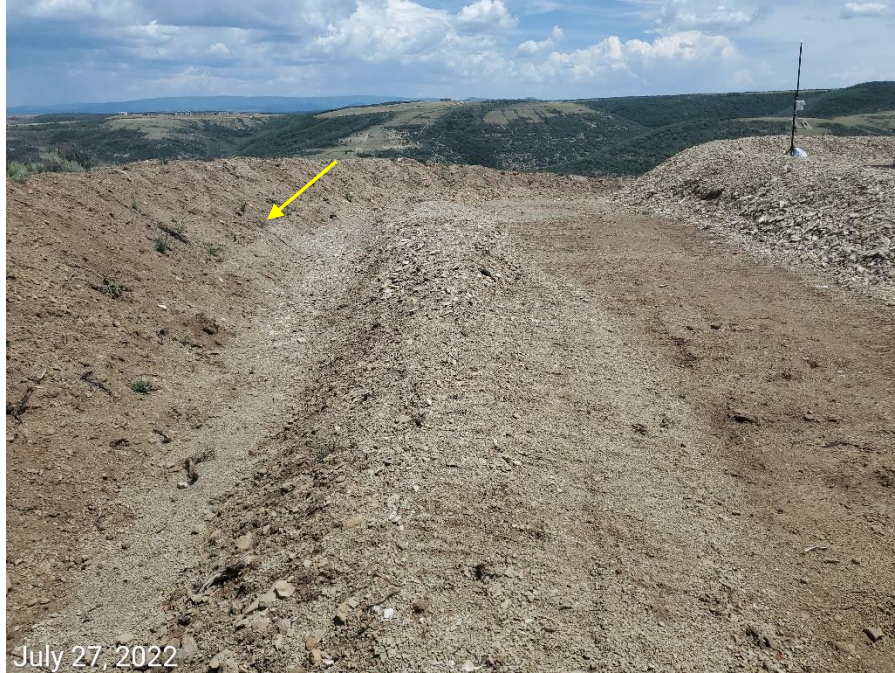
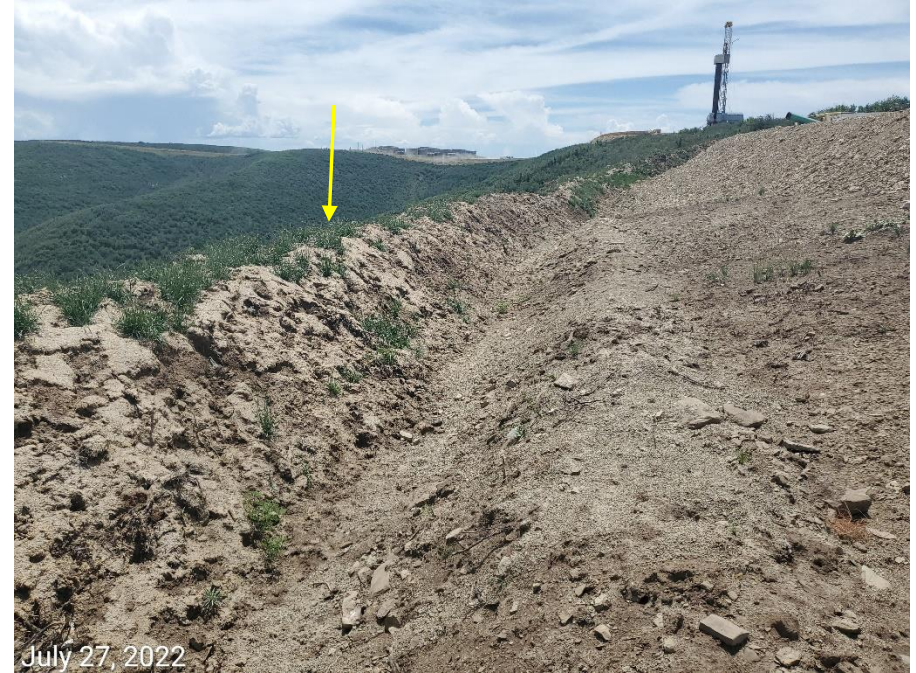
Photo 1: Photo taken from the perimeter stormwater ditch. Photo example showing topsoil (yellow arrow) in use as part of stormwater controls (ditch/berm) to manage runoff on the Location.

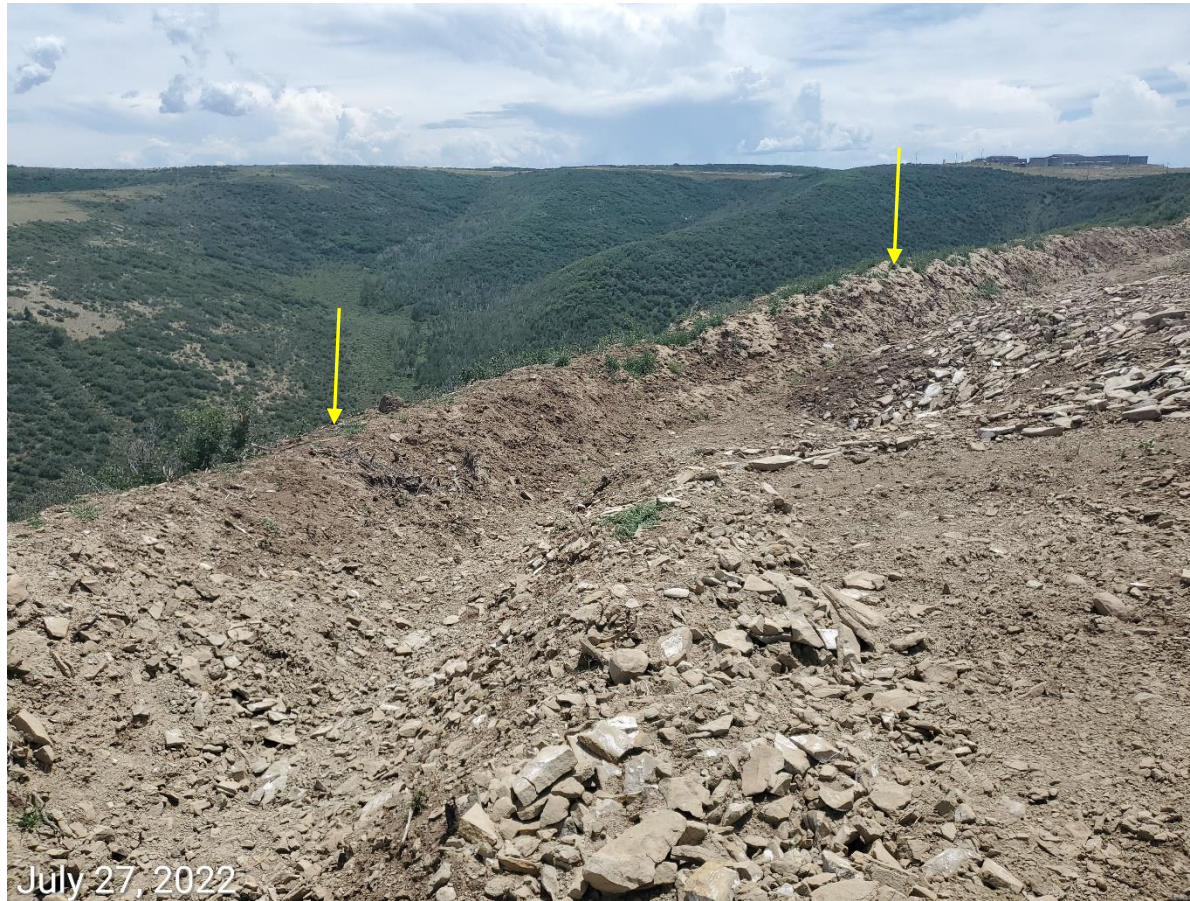
Photo 2: Photos examples showing topsoil remains in use as part of the Locations perimeter stormwater controls, specifically.

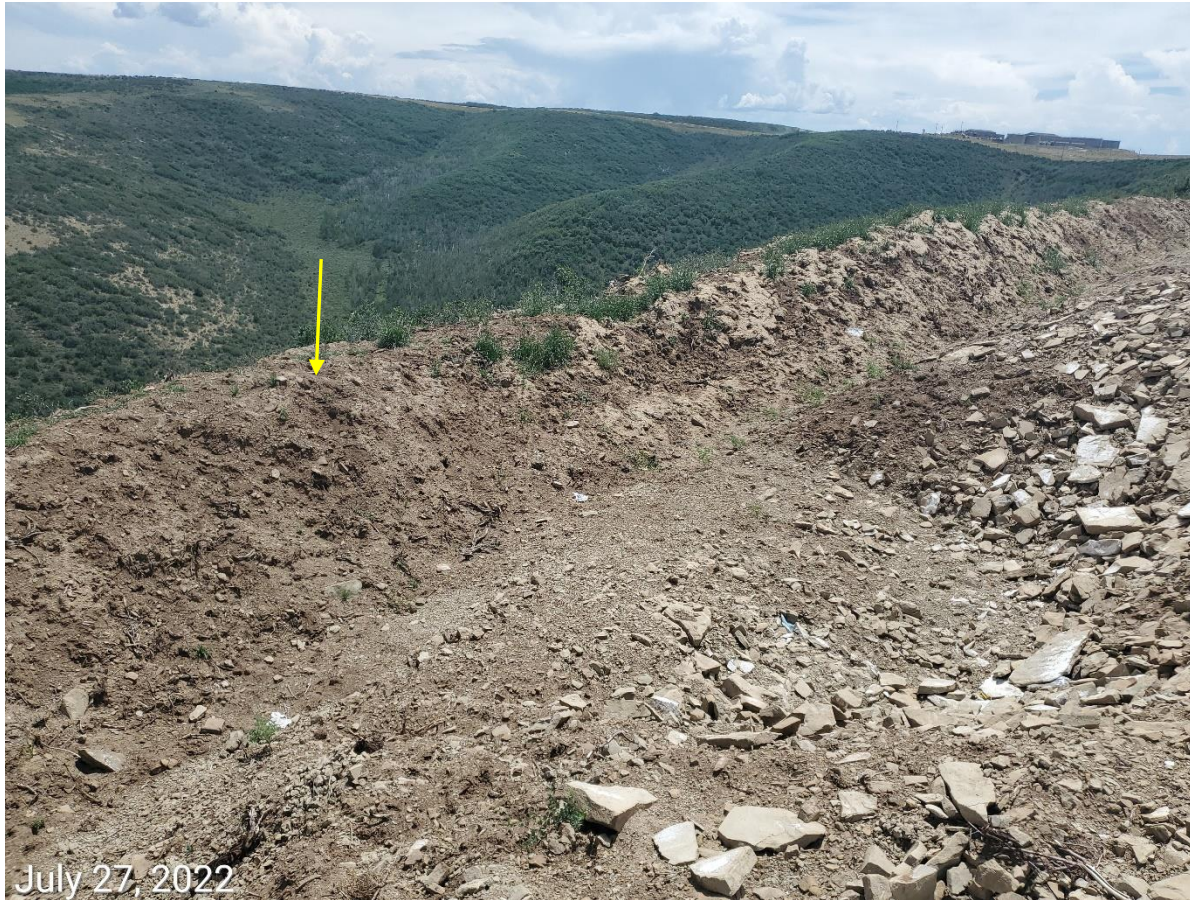
Photo 3: Photos examples showing topsoil remains in use as part of the Locations perimeter stormwater controls, specifically, the sediment trap on the east end of the Location. Photo also shows control has not been constructed with an engineered outlet to allow for proper stormwater discharge.
