Inspection Photos

API: 071-08769

Operator: WAPITI OPERATING LLC

Inspection Date: 8/1/2022

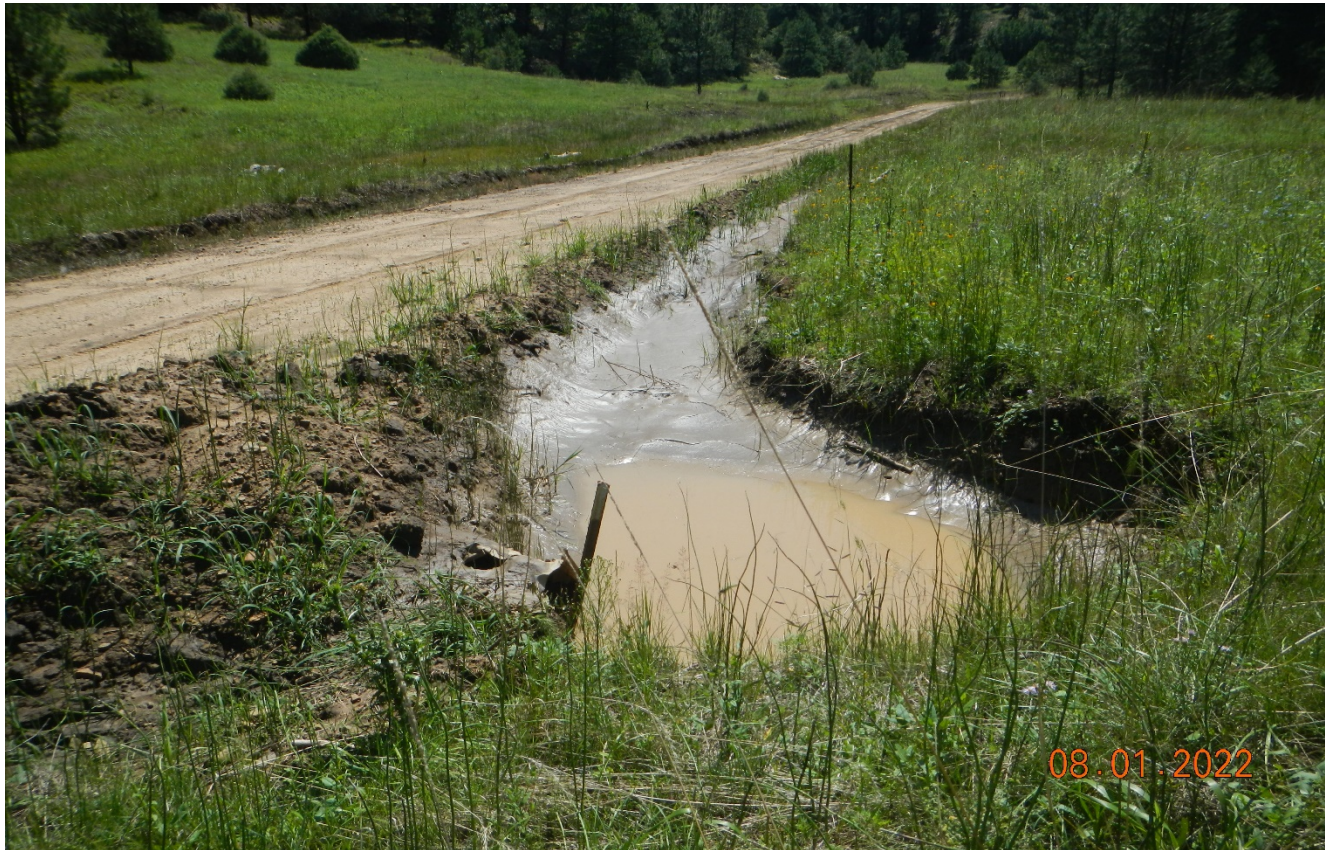
Photo 1. This culvert inlet was cleaned out however, the culvert is full of sediment. Previous corrective action was not completed. Lat/Long:37.00581,-104.83861.

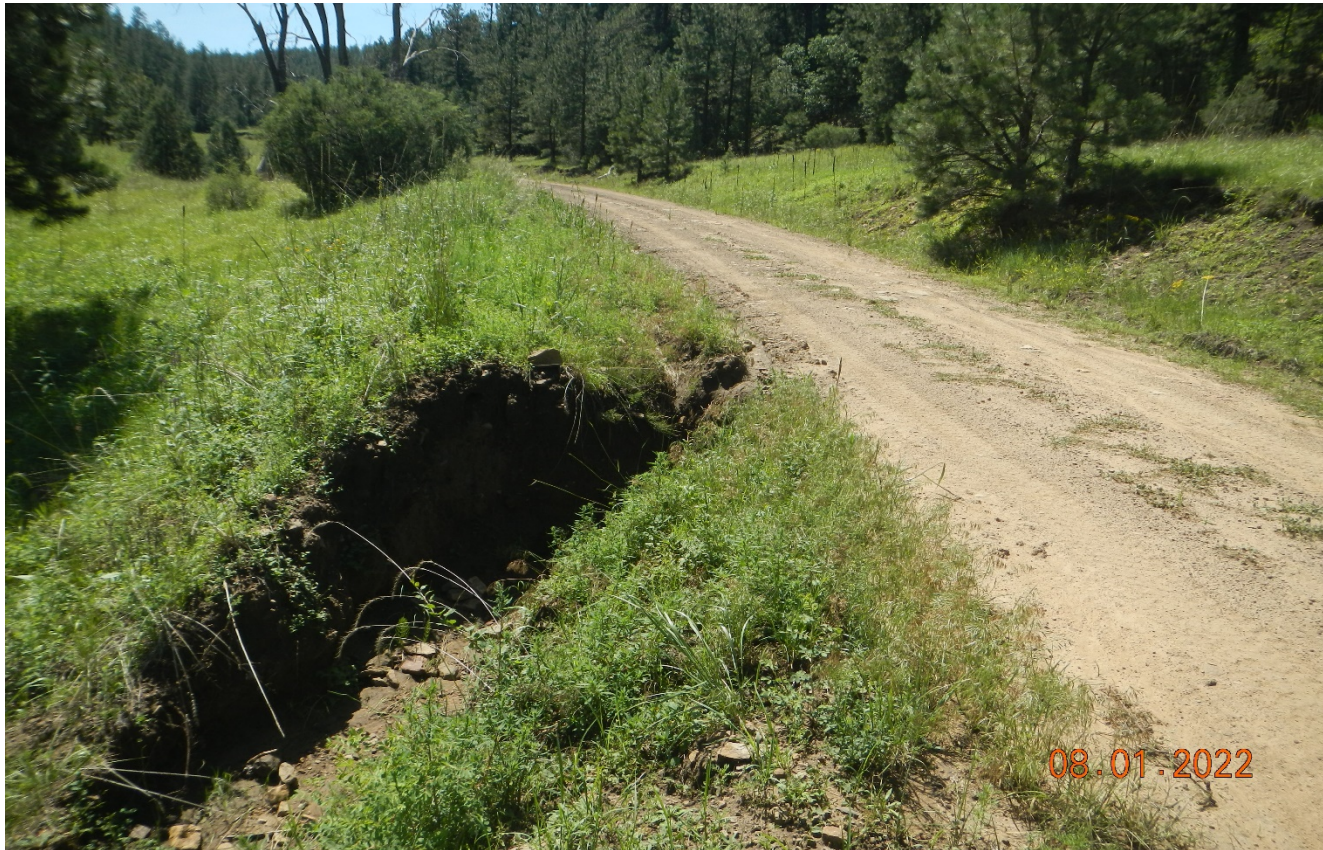
Photo 2. There is an erosion gully along the road that needs to be repaired and stabilized. Previous corrective action was not completed.

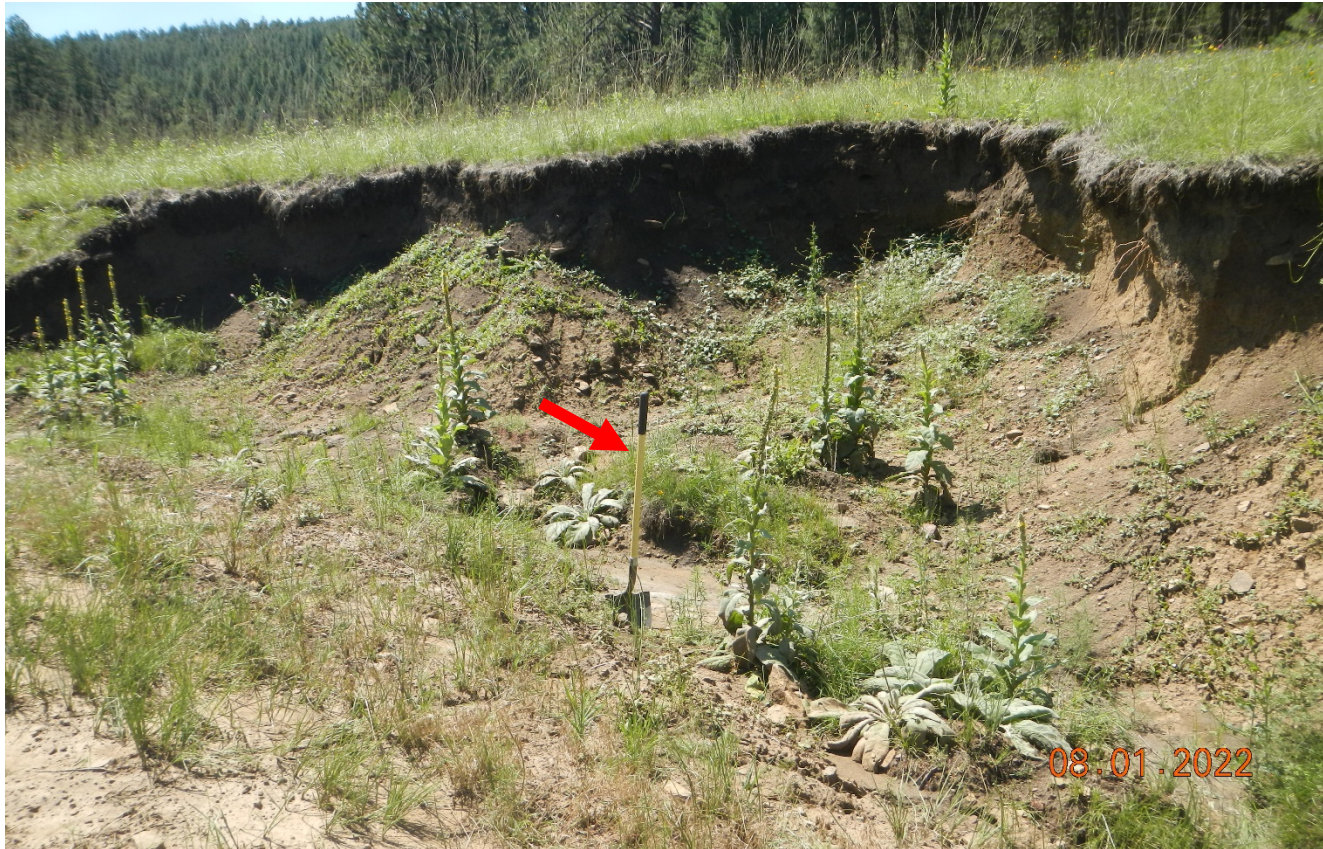
Photo 3. The side of the road is eroded and not stabilized. Erosion head cutting is continuing to occur further back. This area needs to be repaired and stabilized. Previous corrective action not completed. Red arrow points to 4.5 ft. shovel. Lat/Long:36.99952,-104.83425. There are also noxious shown in the photo.

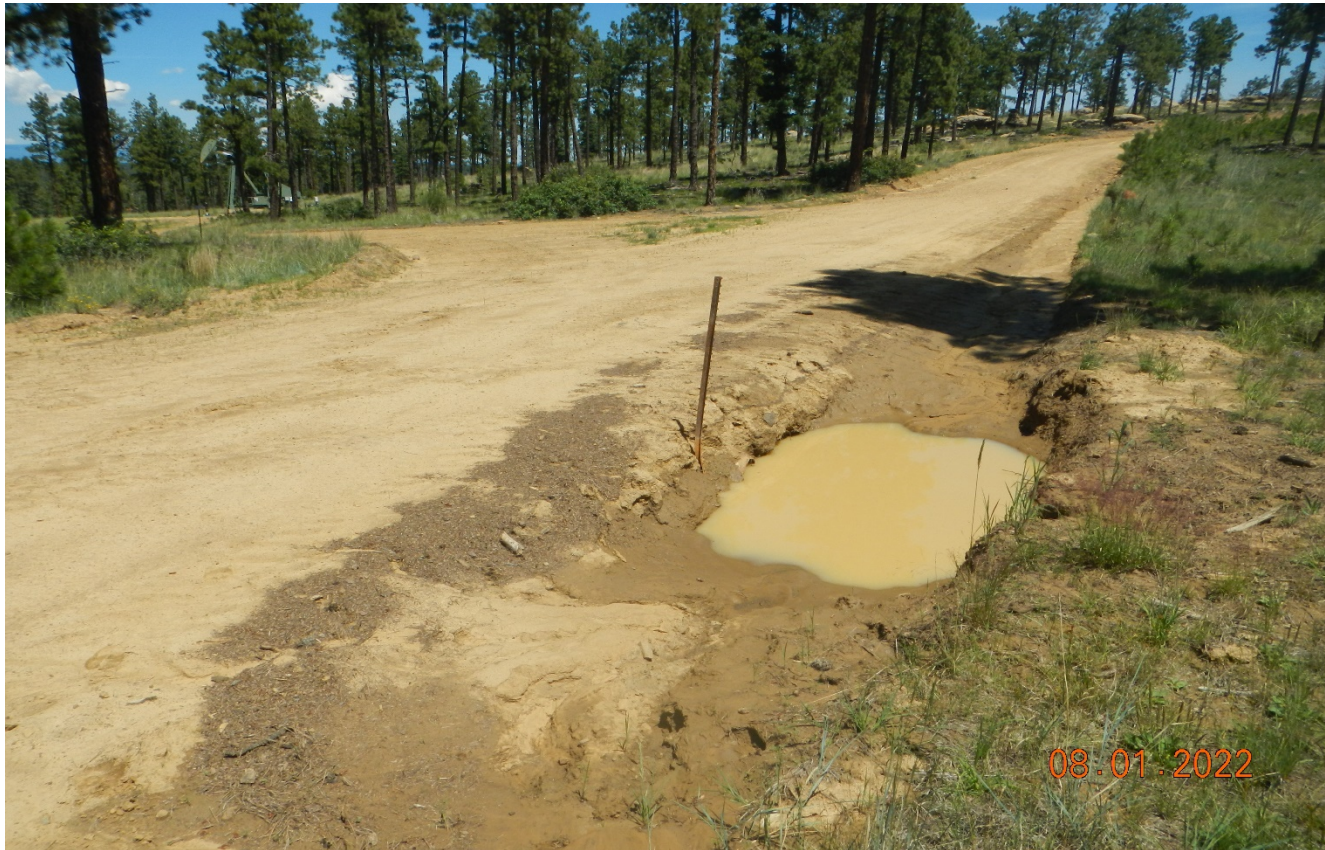
Photo 5. This culvert inlet was cleaned out however, the culvert is full of sediment which needs to be cleaned out. Lat/Long:36.99405,-104.84710.

Previous corrective action not completed.

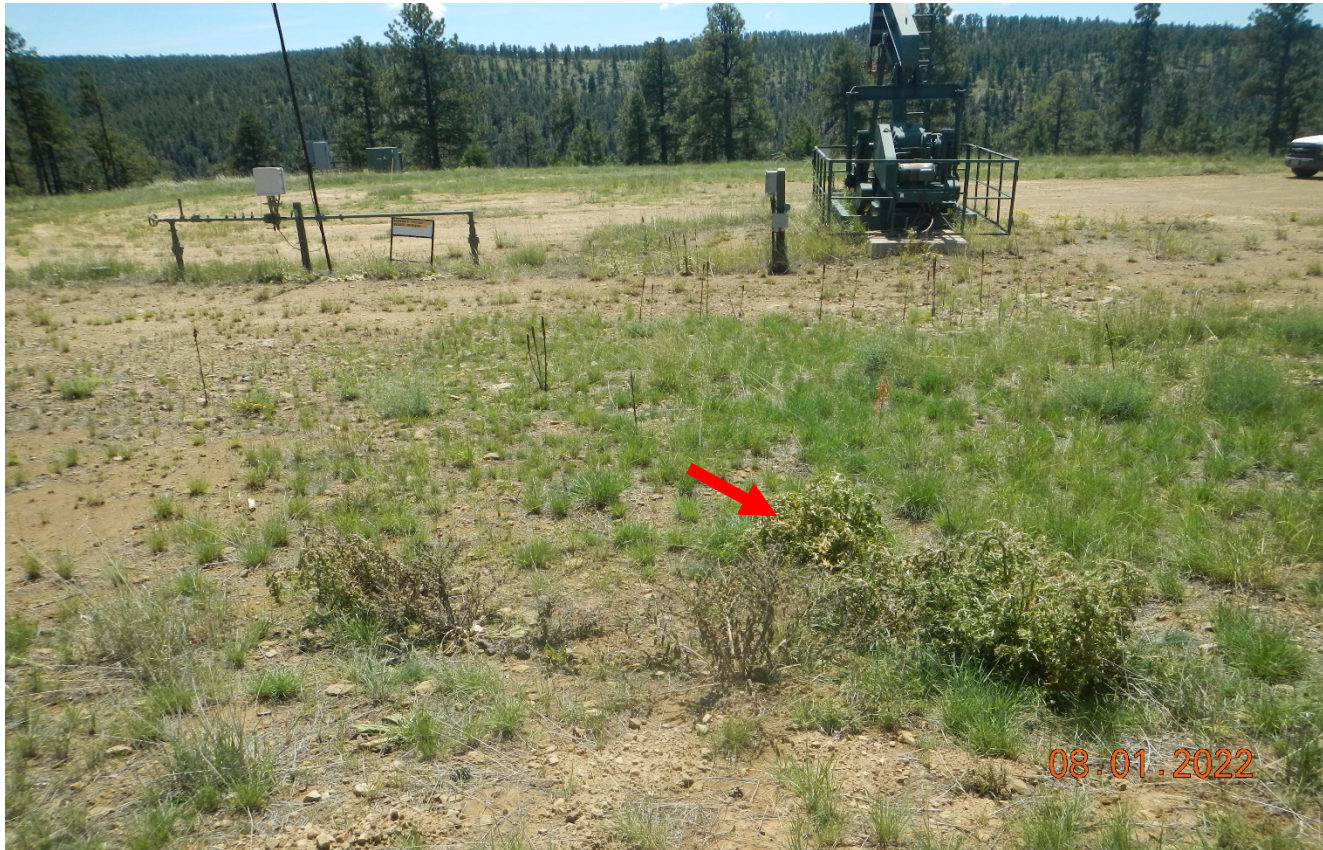
Photo 7. There are noxious weeds Hounds tongue which has not been controlled. The noxious weeds have already produced seed so the weeds will now need to be bagged and removed. Previous corrective action not completed.
