Final Reclamation Inspection

Operator: Texaco Exploration and Production INC-
#86900

Location ID: 393535

Location Name: PETERSON, MAX #12

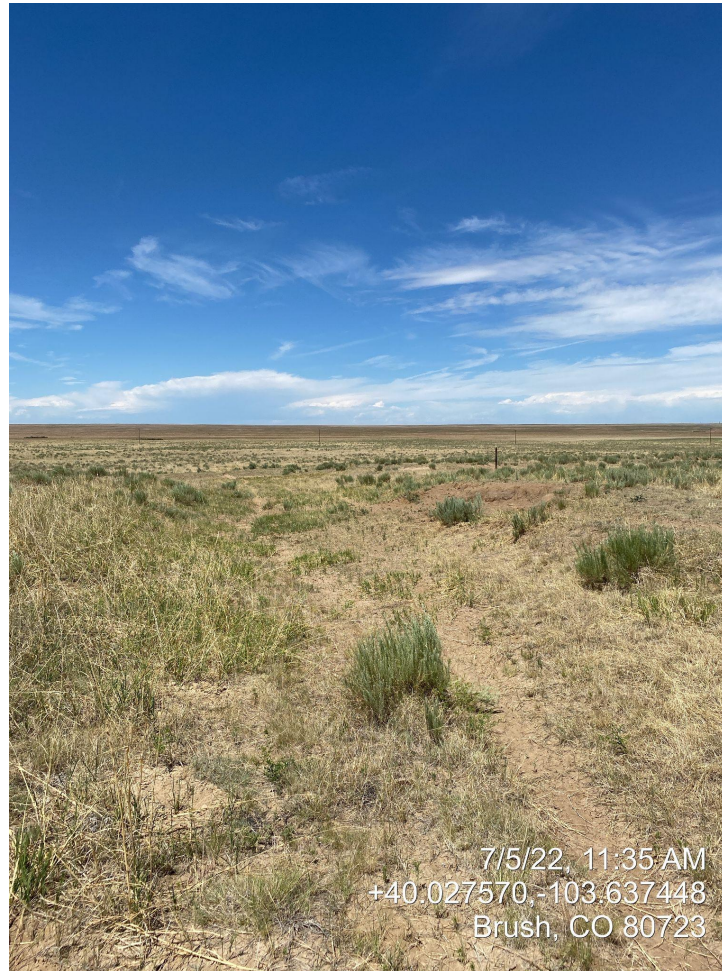
Photo 1. Access road photo taken east of location, looking west. Photo illustrates access road has not been recontoured or reshaped.

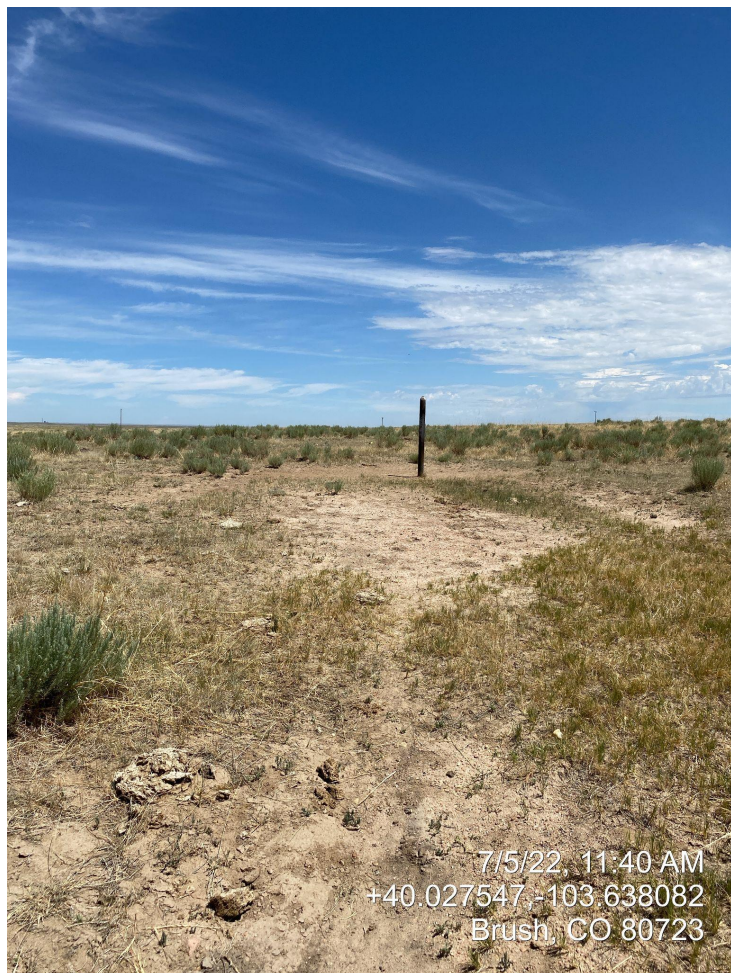
Photo 2. Location photo taken from southern portion, facing north. Photo illustrates large areas of non-uniform vegetation cover resulting in bare soil.

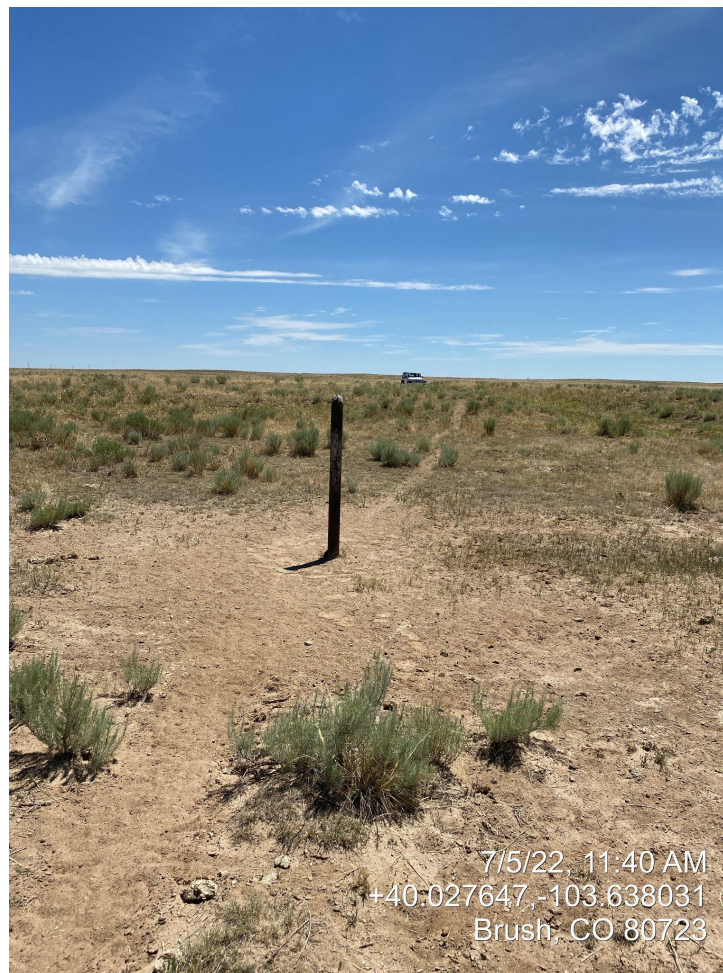
Photo 3. Location photo taken from western portion, facing east. See comments in Photo 2.

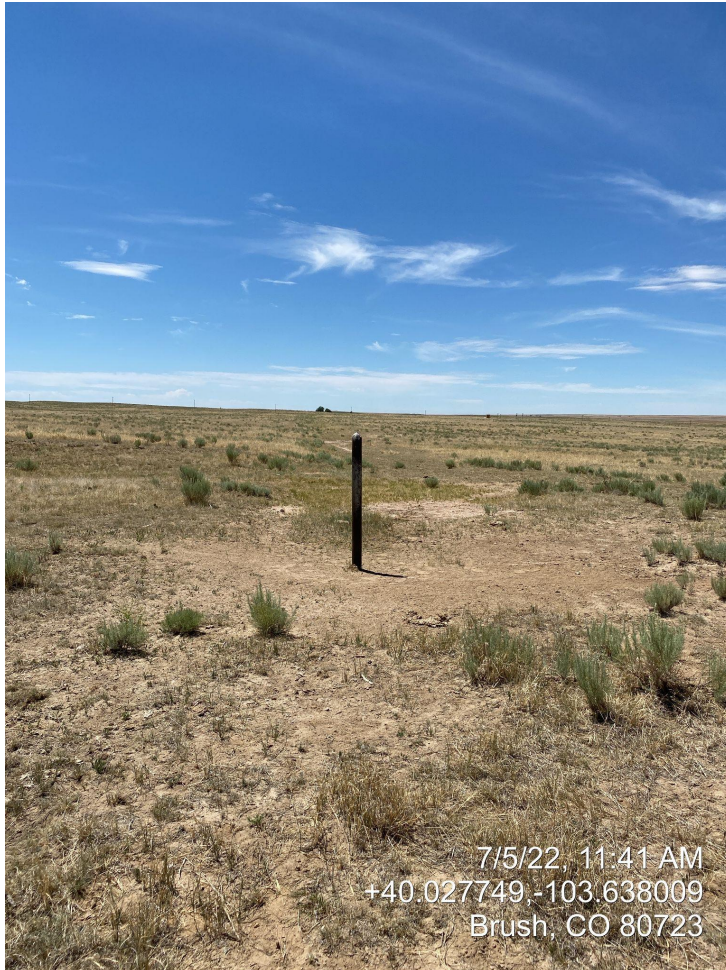
Photo 4. Location photo taken from northern portion, facing south. See comments in Photo 2.

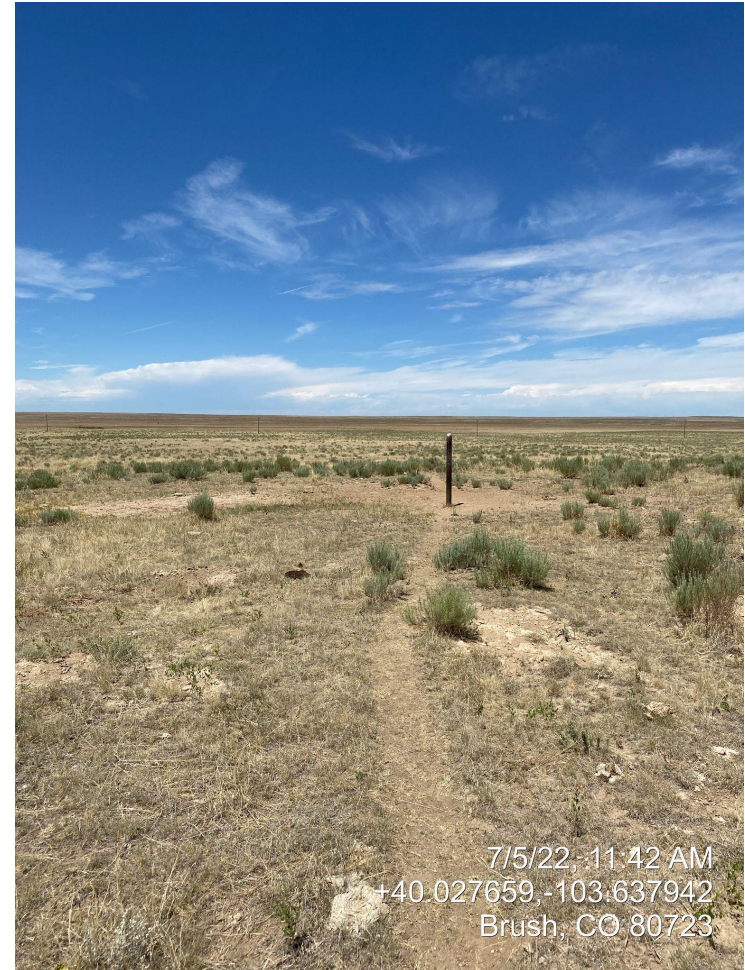
Photo 5. Location photo taken from eastern portion, facing west. See comments in Photo 2.

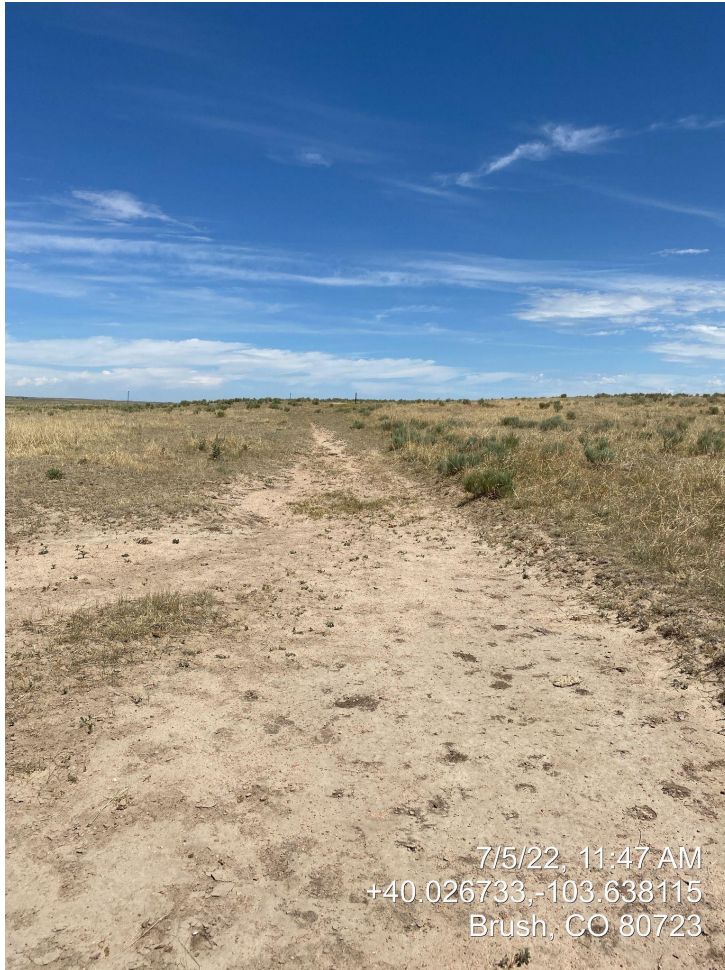
Photo 6. Southern access road photo taken south of location, facing north. Large areas of non-uniform vegetation cover resulting in bare soil. Access road has not been reclaimed.

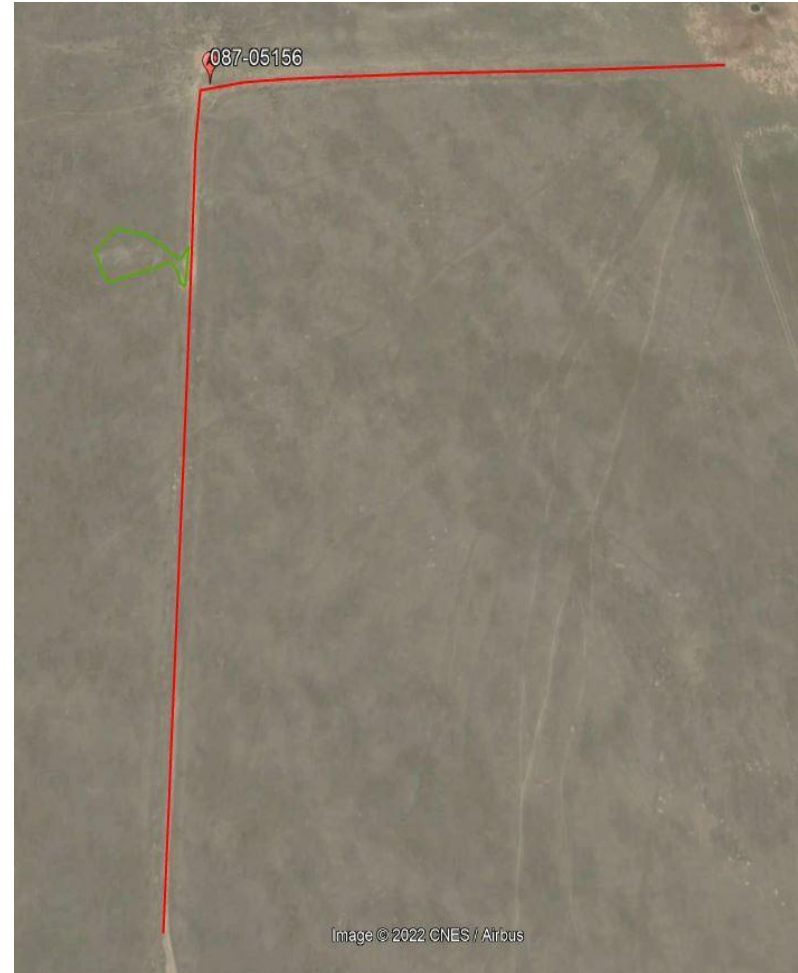
Photo 7. Access roads for location (red line) that have not been reclaimed, and offsite disturbance (green polygon) not reclaimed.

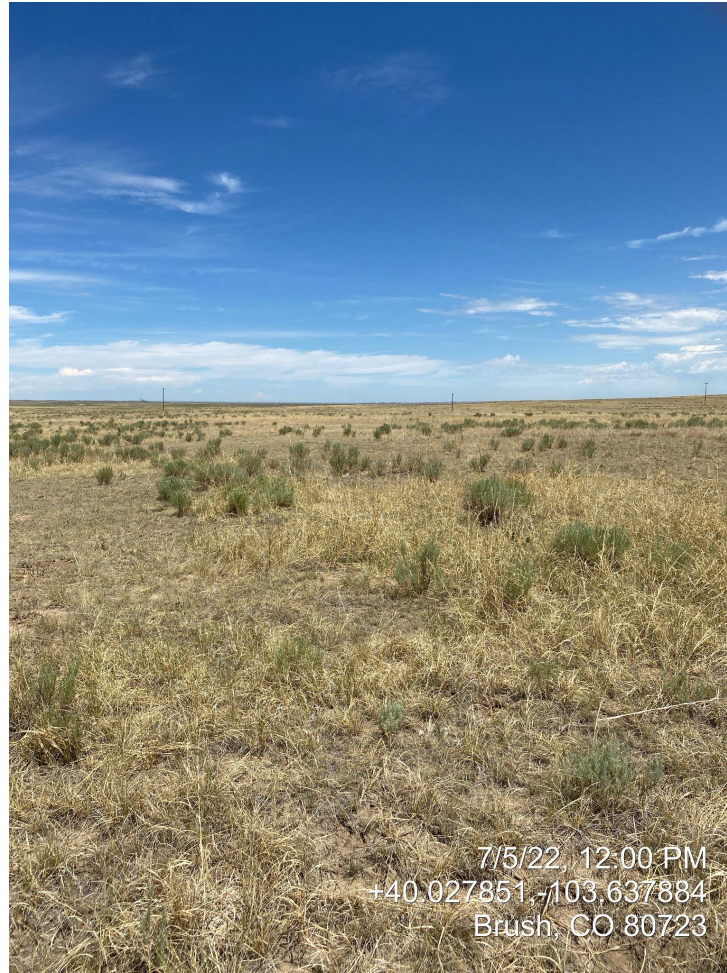
Photo 8. Reference area photo taken east of location, facing north. Reference area illustrates uniform plant cover of native species (e.g. sand drop seed, buffalo grass, sand sage).
