Final Reclamation Inspection

Operator: CRESTONE PEAK RESOURCES OPERATING
LLC-10633

Location ID: 321534

Inspection Photos
Location Name: Bury Crandell #22-23
Location ID: 321534

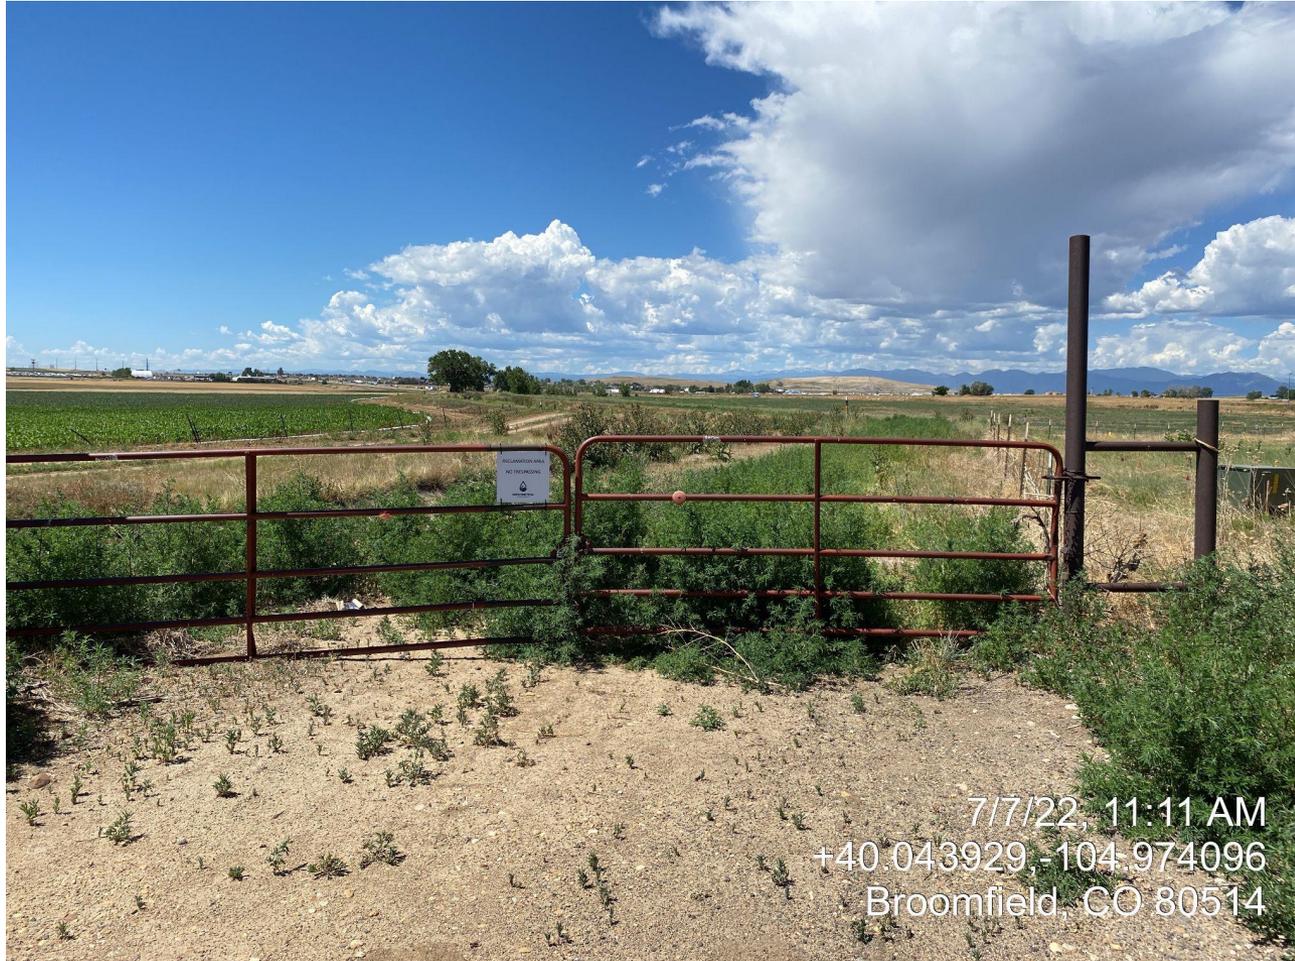
Photo 1. Access road entrance, facing southwest. Photo illustrates presence of weedy vegetation (kochia).

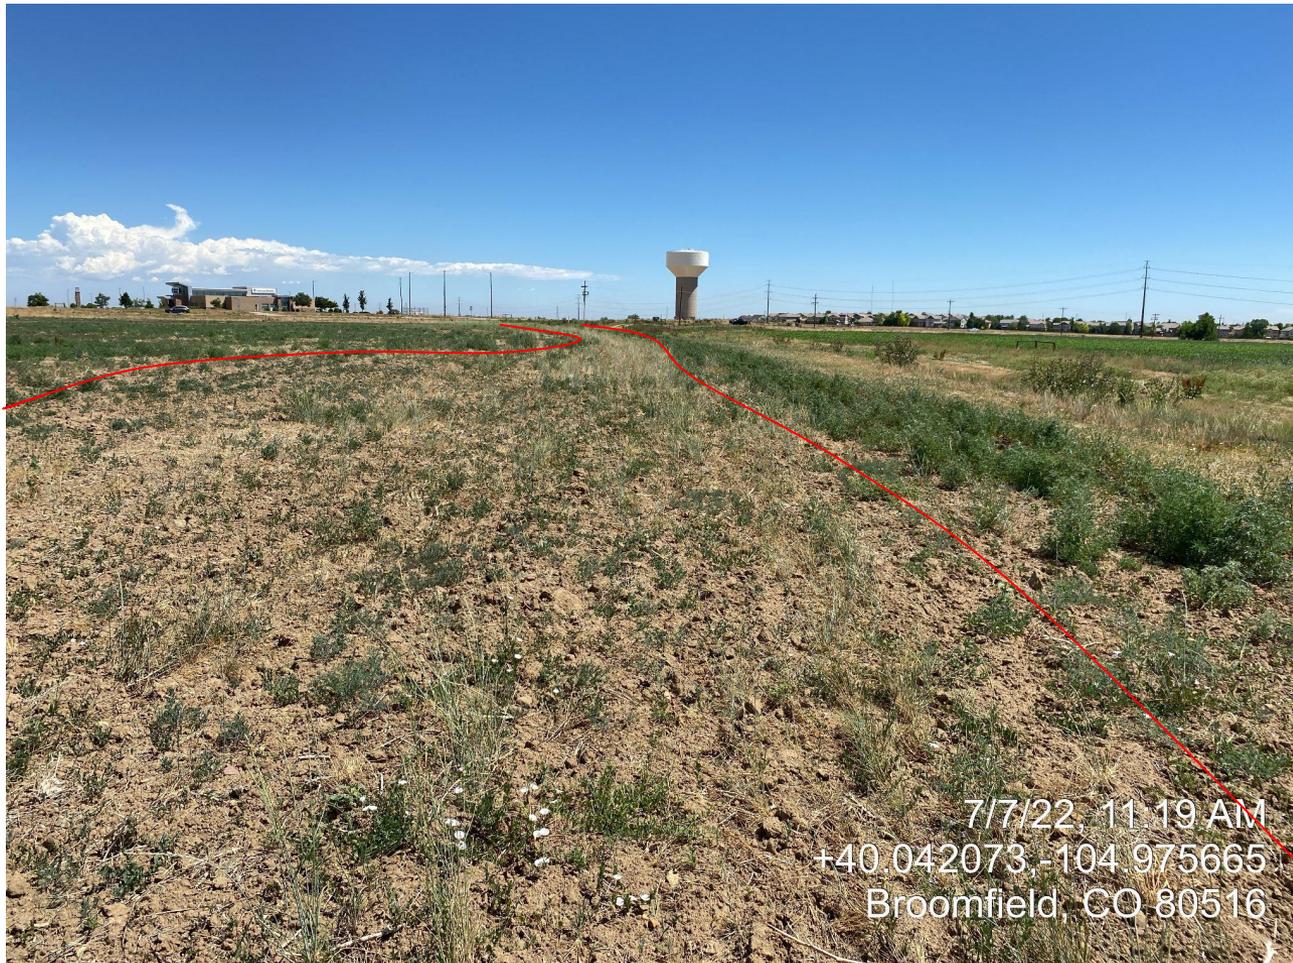
7/7/22, 11:19 AM
+40.042073, -104.975665
Broomfield, CO 80516

Photo 2. Reclaimed area outlined in red, facing north. Photo illustrates reclaimed area with weedy vegetation (kochia) and List B and C noxious weeds (musk thistle, field bindweed). Area to the right of outline managed by ditch company.

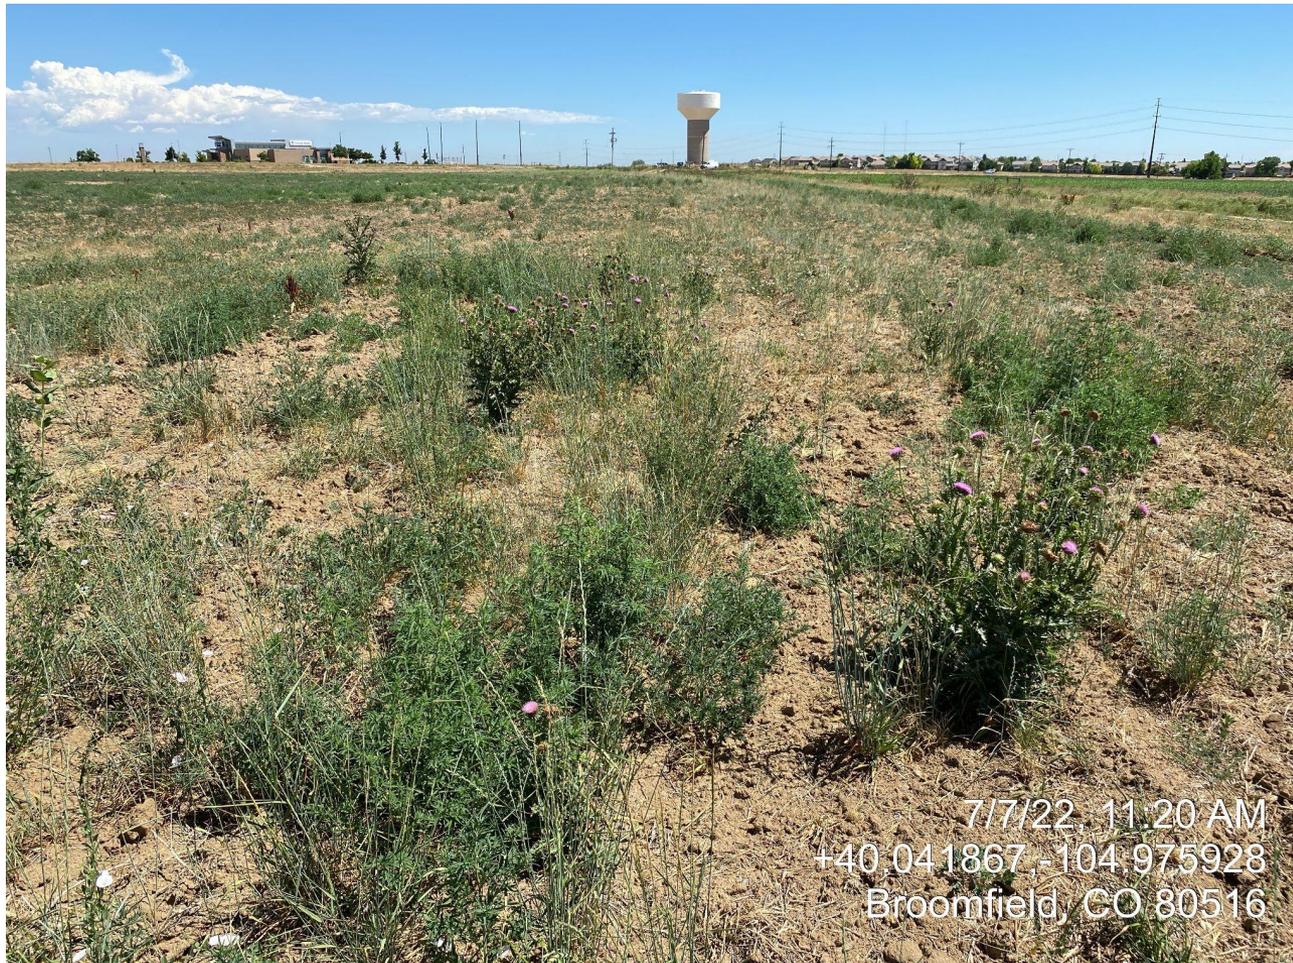
Photo 3. Reclaimed area photo taken in center of location, facing north. List B and C noxious weeds present (musk thistle, field bindweed) and other annual weedy vegetation.

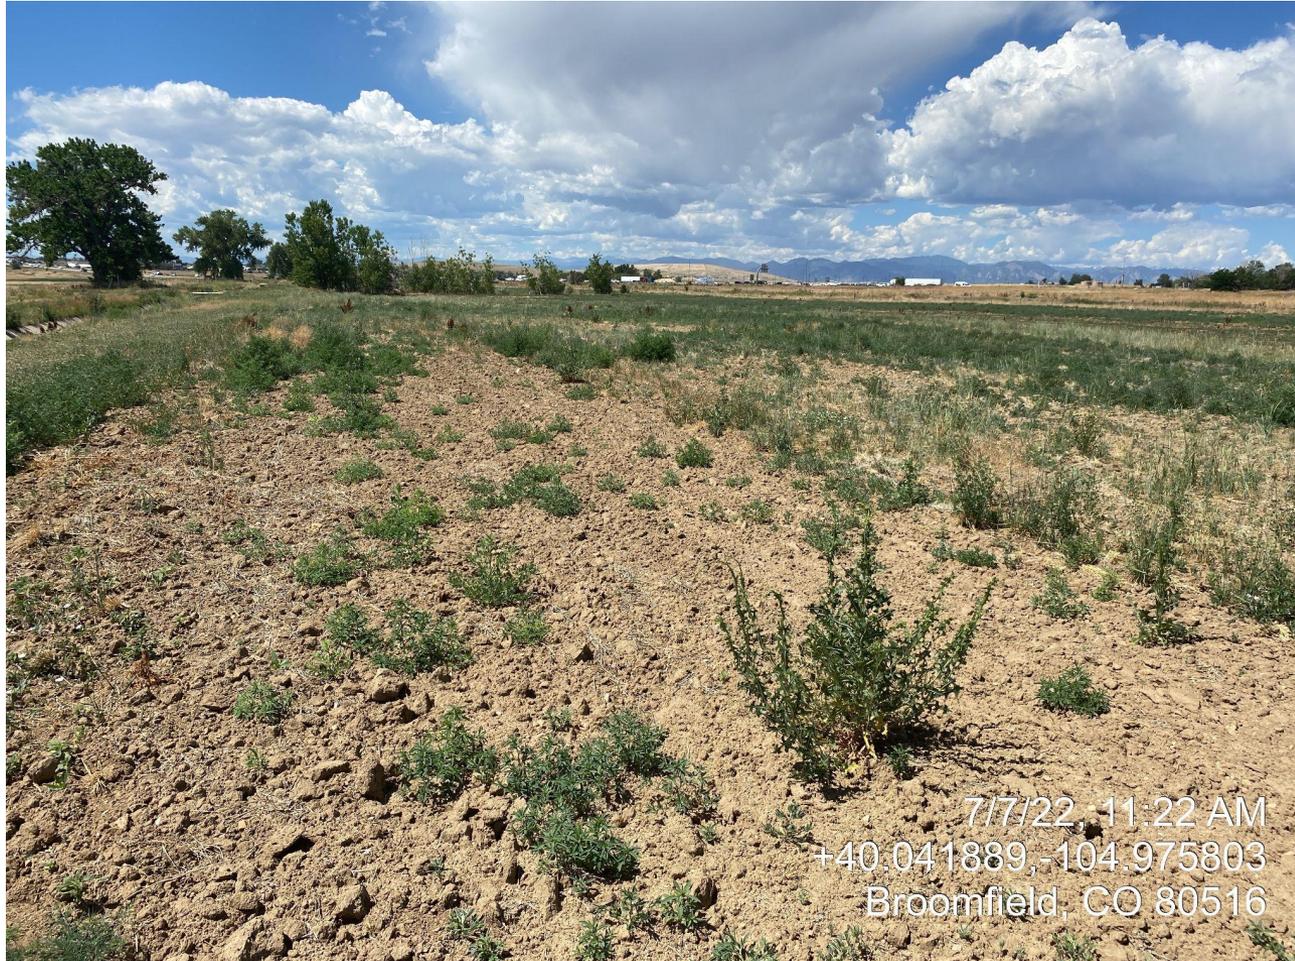
Photo 4. Reclaimed area photo taken from center of location, facing south. Weedy vegetation observed.

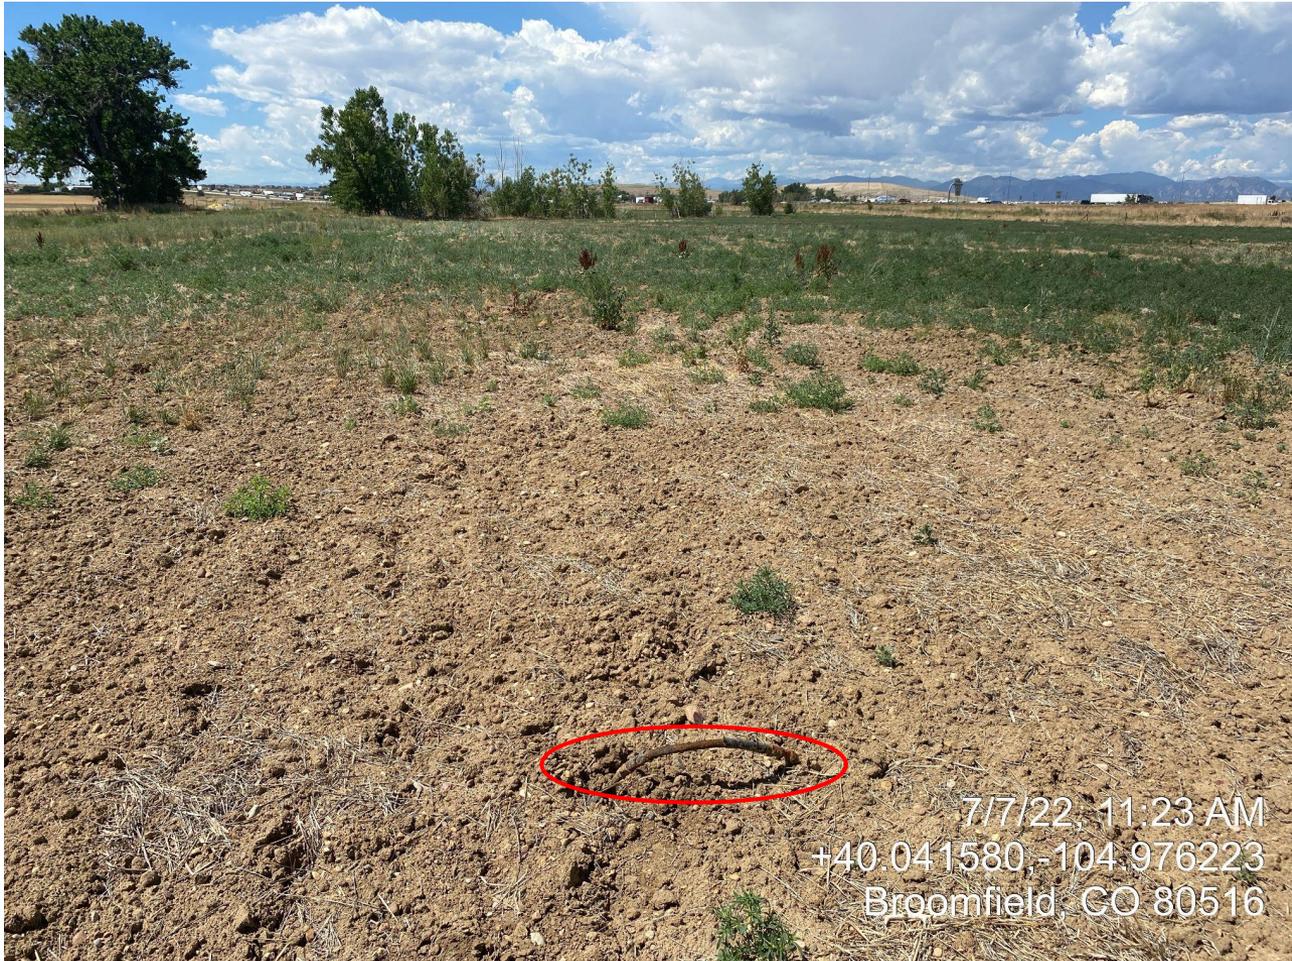
Photo 5. Reclaimed area photo taken from center of location, facing south. Non-uniform vegetation cover resulting in bare soil and debris (highlighted in red) observed.
