Inspection Photos

API: 071-07040

Operator: EVERGREEN NATURAL RESOURCES

Inspection Date: 8/3/2022

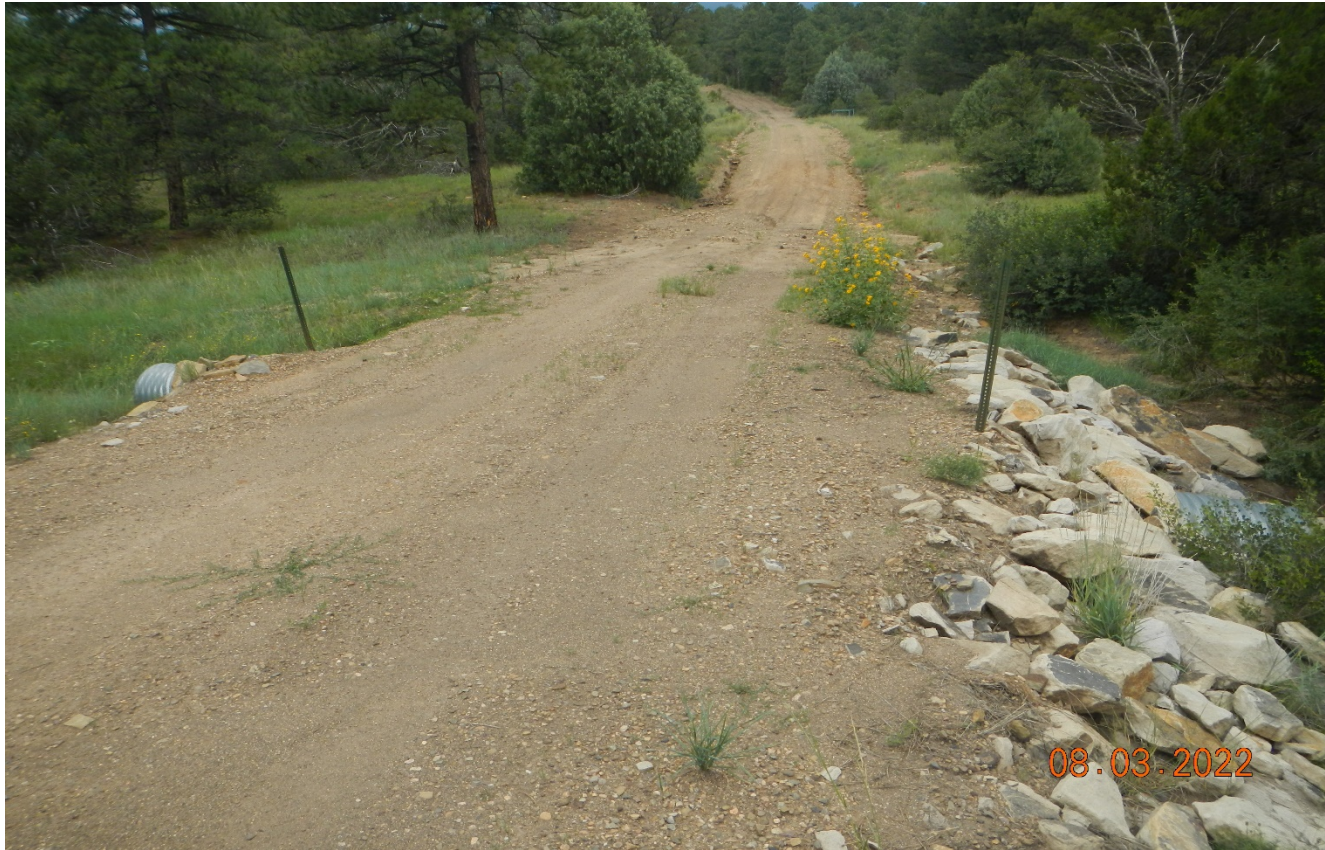
Photo 1. Facing west at the drainage crossing. This area has been repaired.

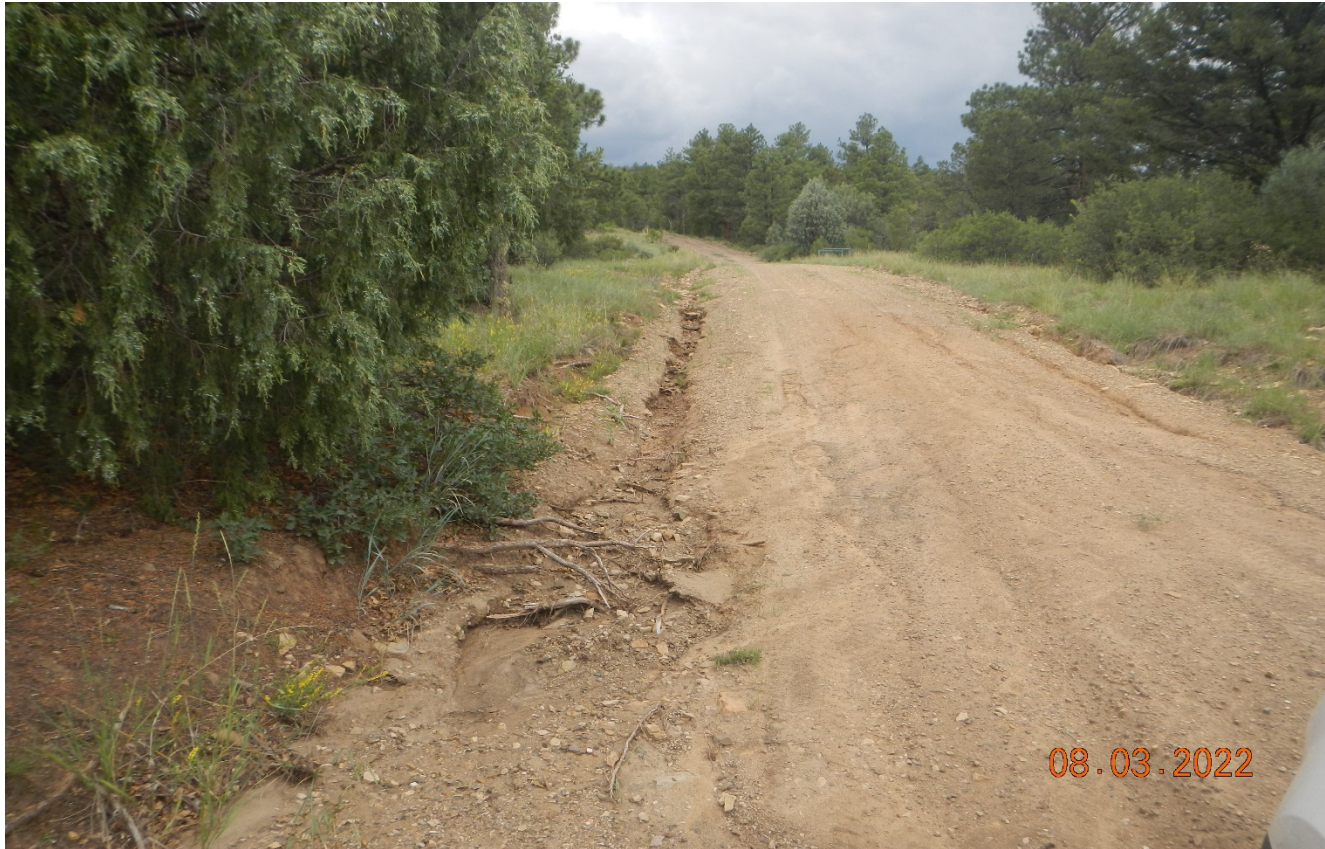
Photo 2. Further along the road there is erosion channeling occurring on the roadside. BMP's need to be installed to prevent erosion.

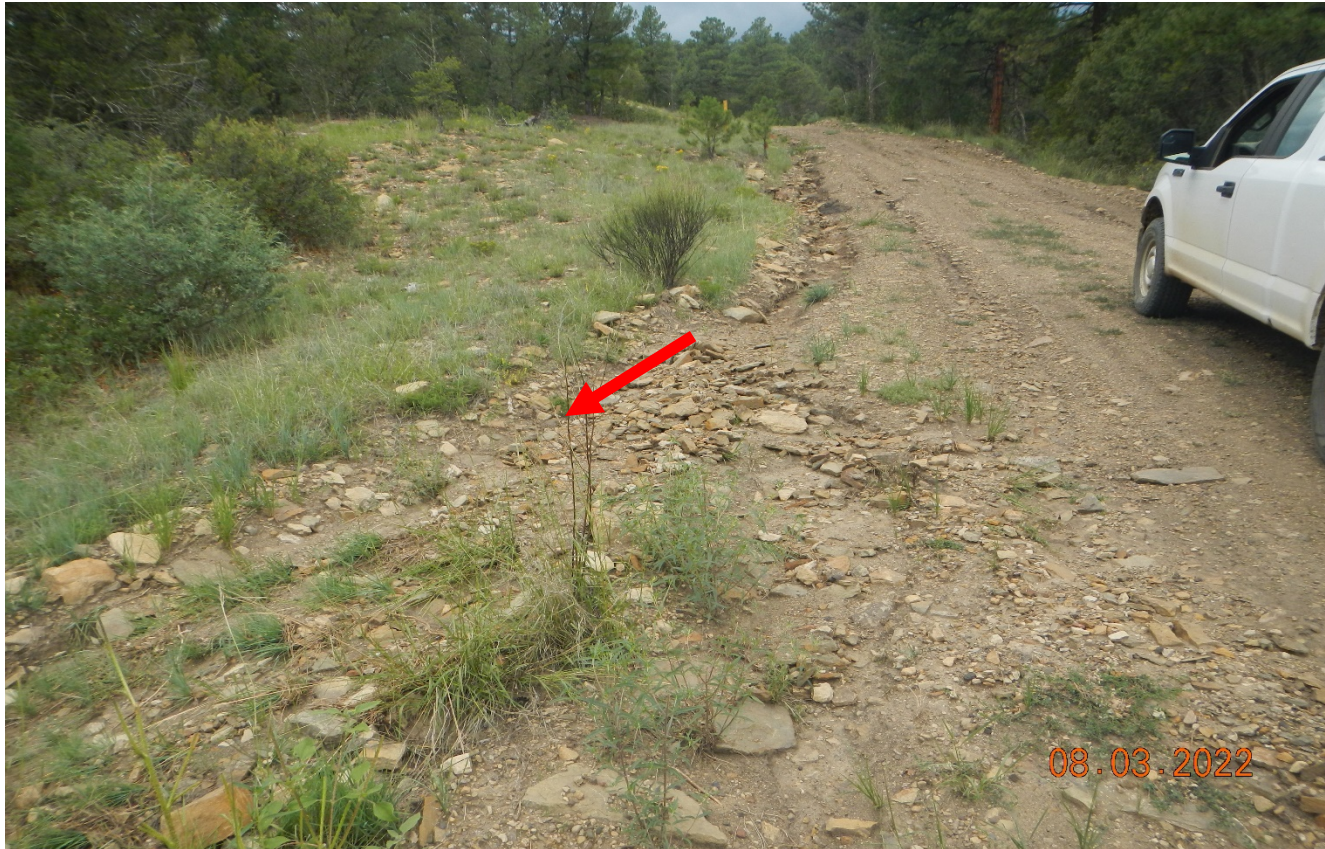
Photo 3. Stormwater should be directed off the road instead it appears to be going down the road causing erosion shown in previous photo.
