Inspection Photos

API: 071-08113

Operator: EVERGREEN NATURAL RESOURCES

Inspection Date: 8/3/2022

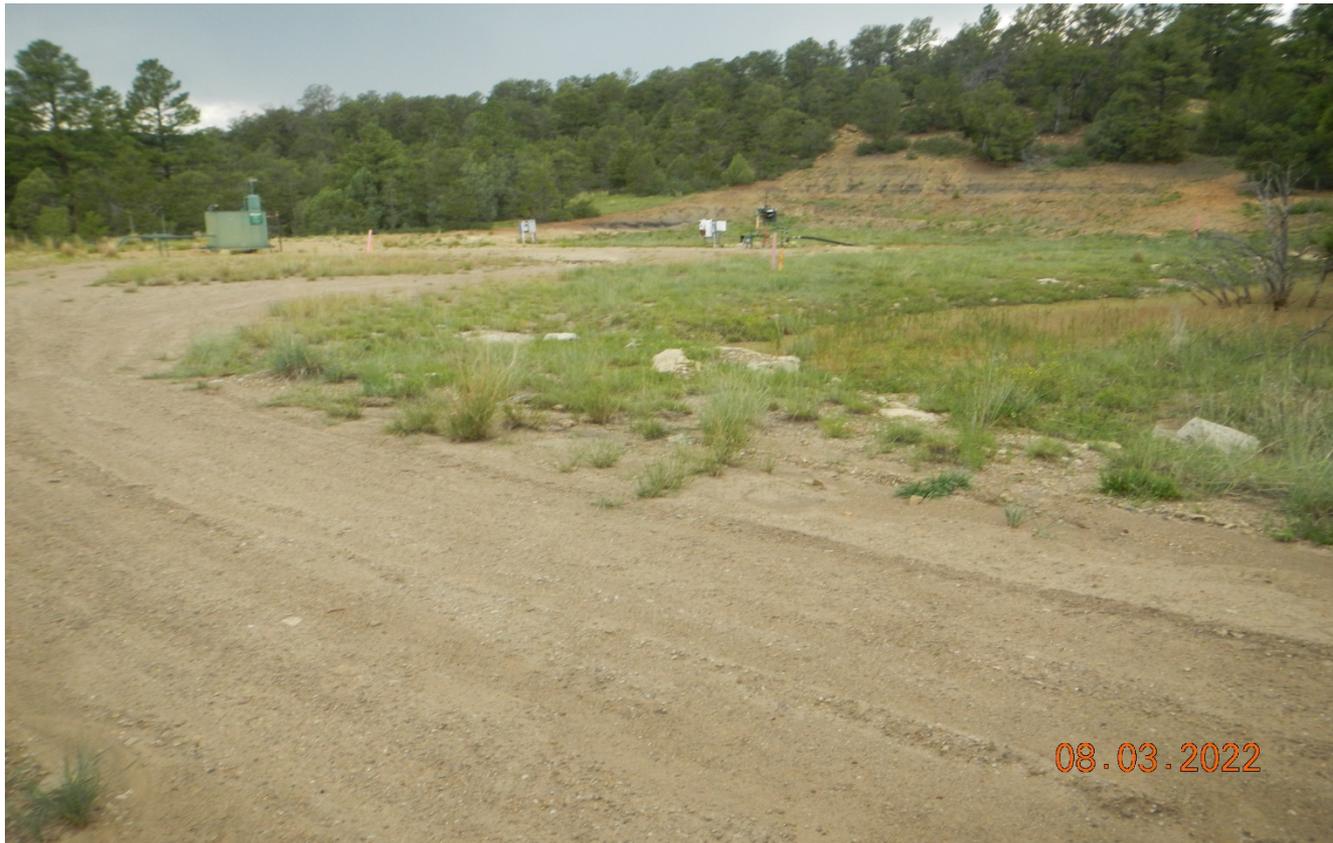
Photo 1. Facing southwest toward the well site.

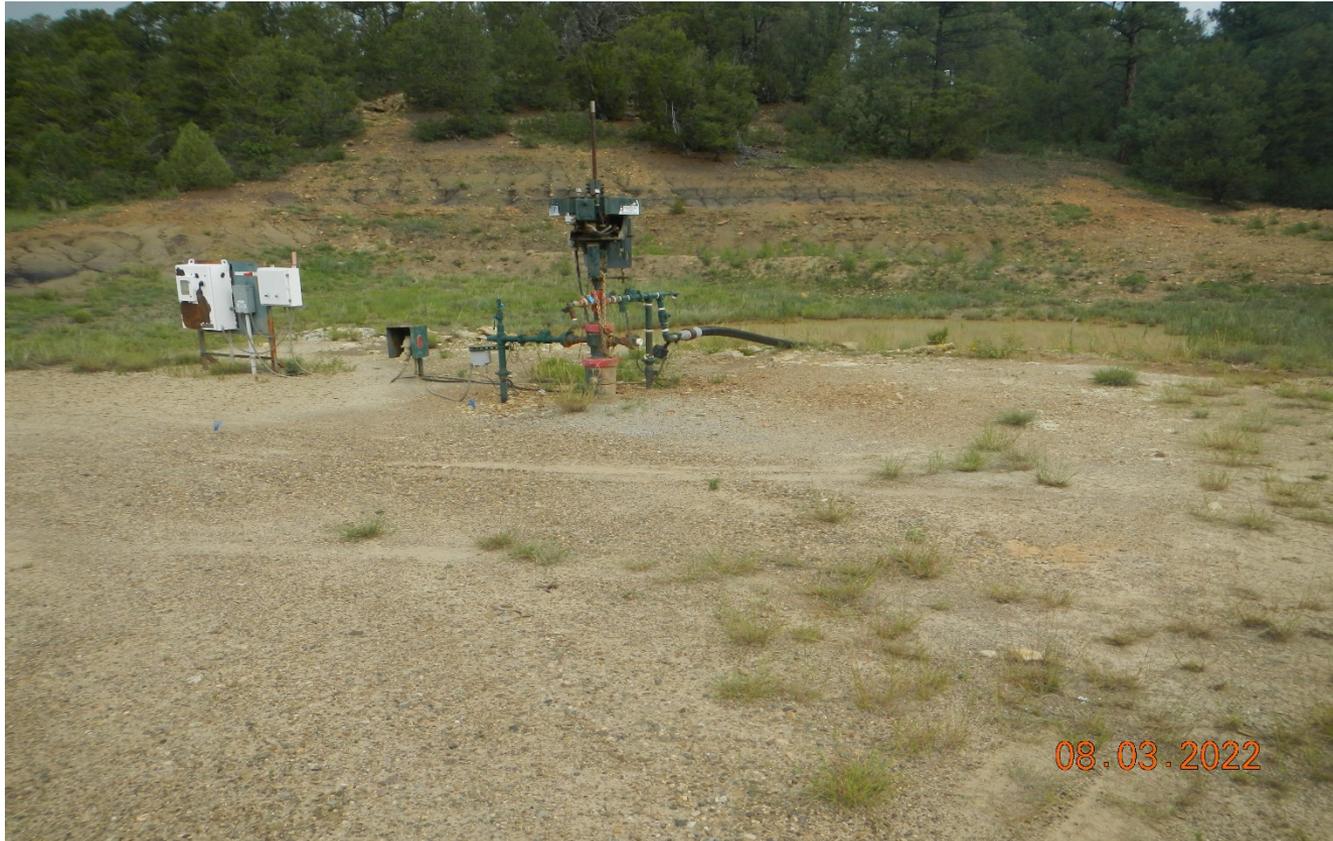
Photo 2. Facing west toward the well and pit.

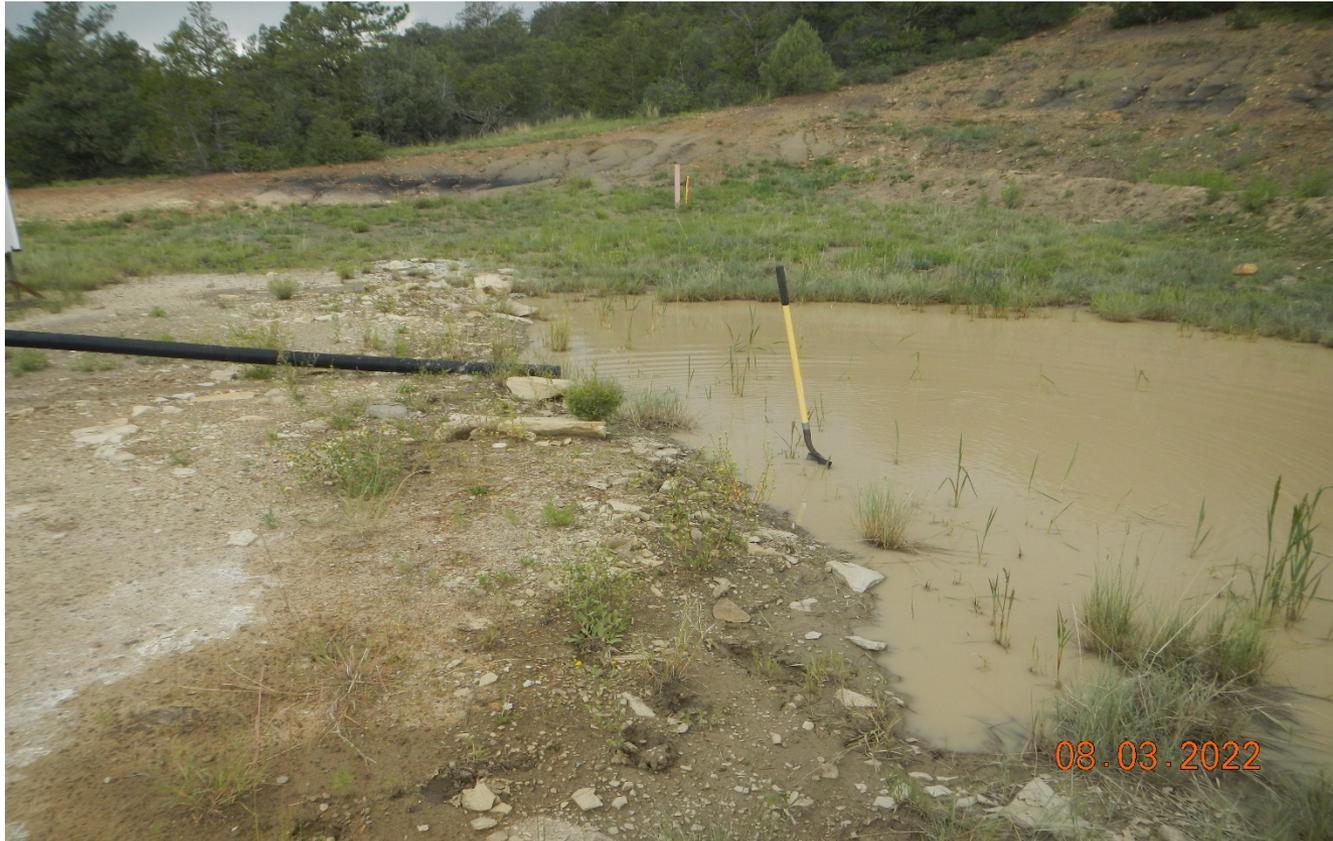
Photo 3. Facing toward the pit. The pit is shallow; less than 2 ft. deep and needs to be constructed to allow 2 ft. freeboard. Previous corrective action was not completed. Water level is above the freeboard.

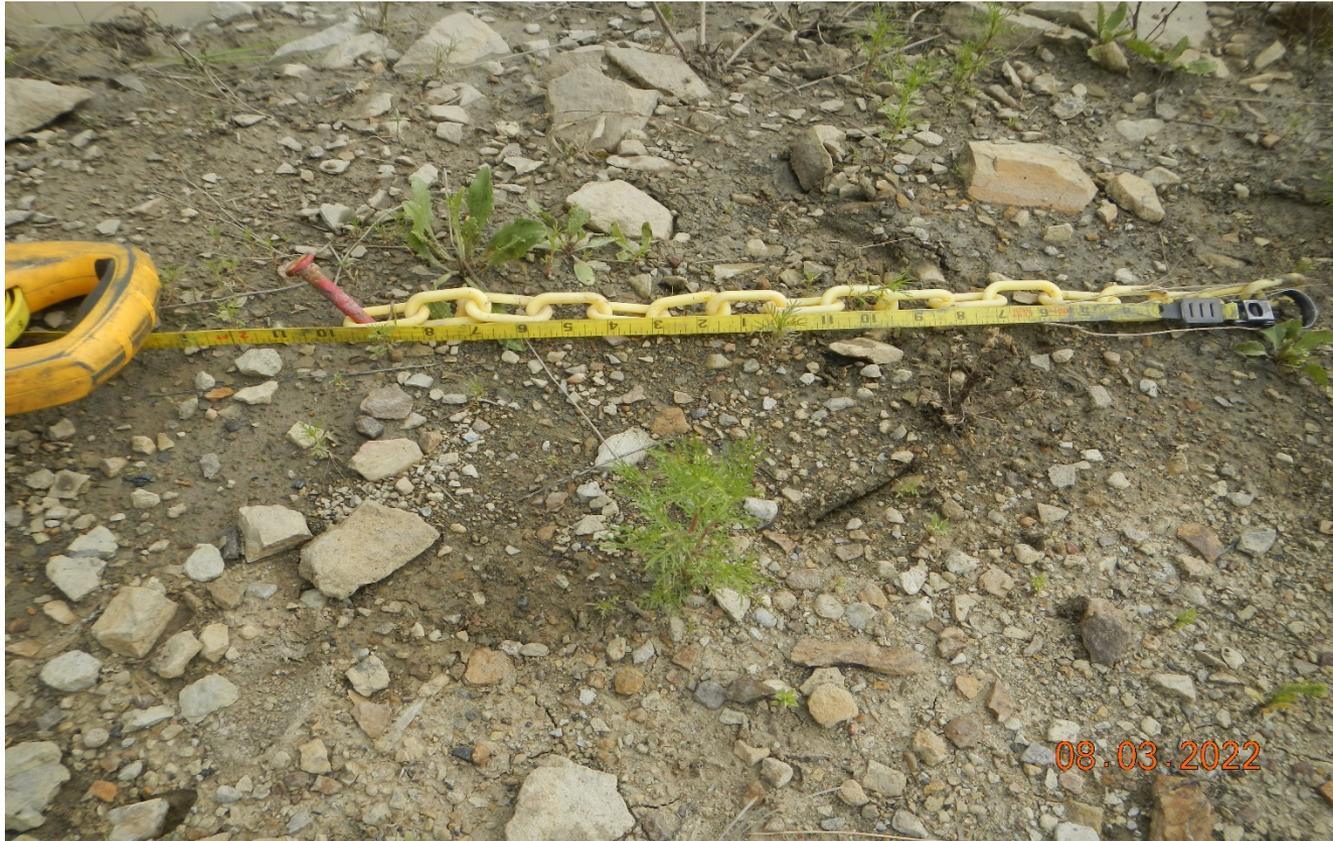
Photo 4. The freeboard marker is not is not 2ft. In length and does not show the vertical depth where it is installed. (Lays on the slope of the ground)
