Inspection Photos

API: 071-09287

Operator: EVERGREEN NATURAL RESOURCES

Inspection Date: 8/3/2022

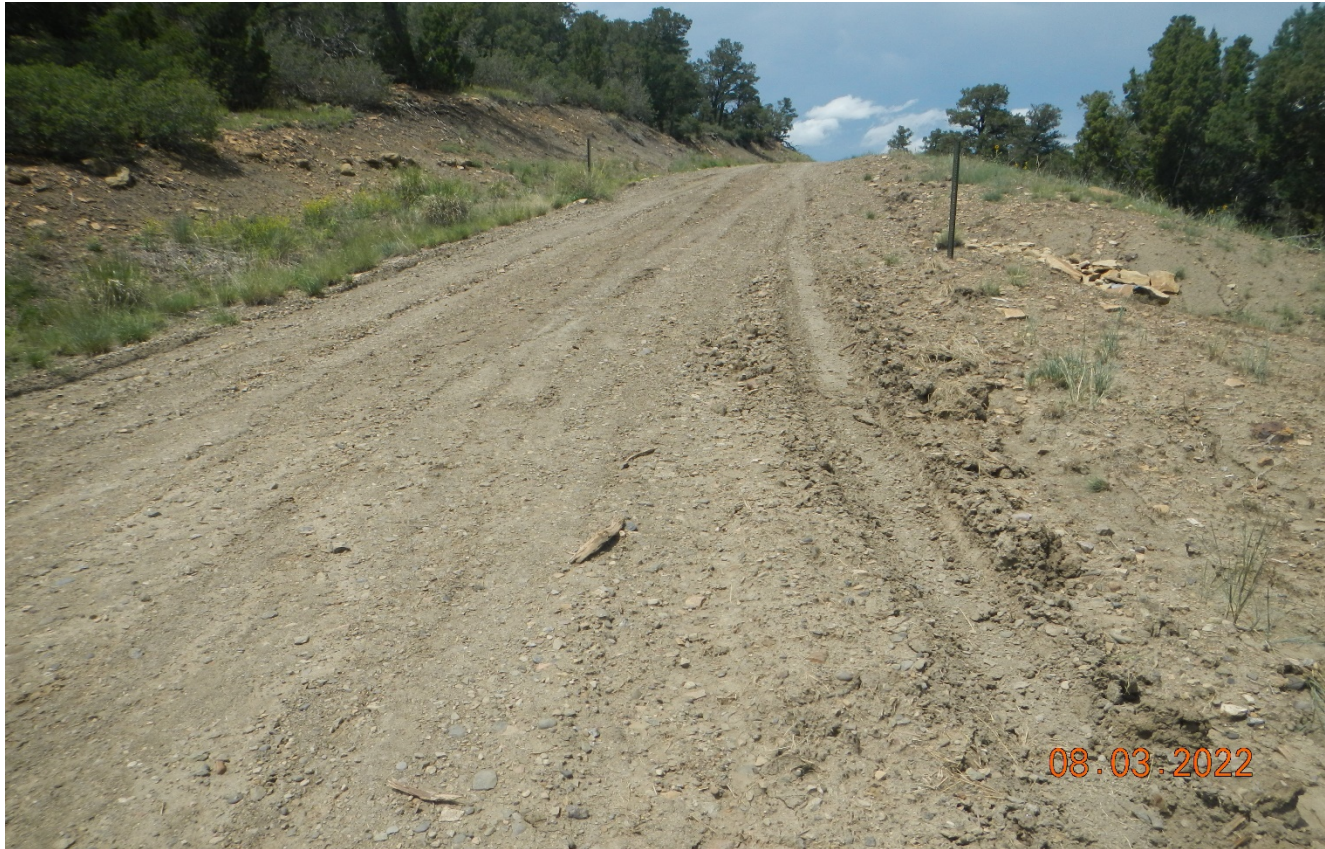
Photo 1. Facing northwest the beginning of the access road. The road has not been recontoured and reclaimed. It does not appear the road is stabilized.

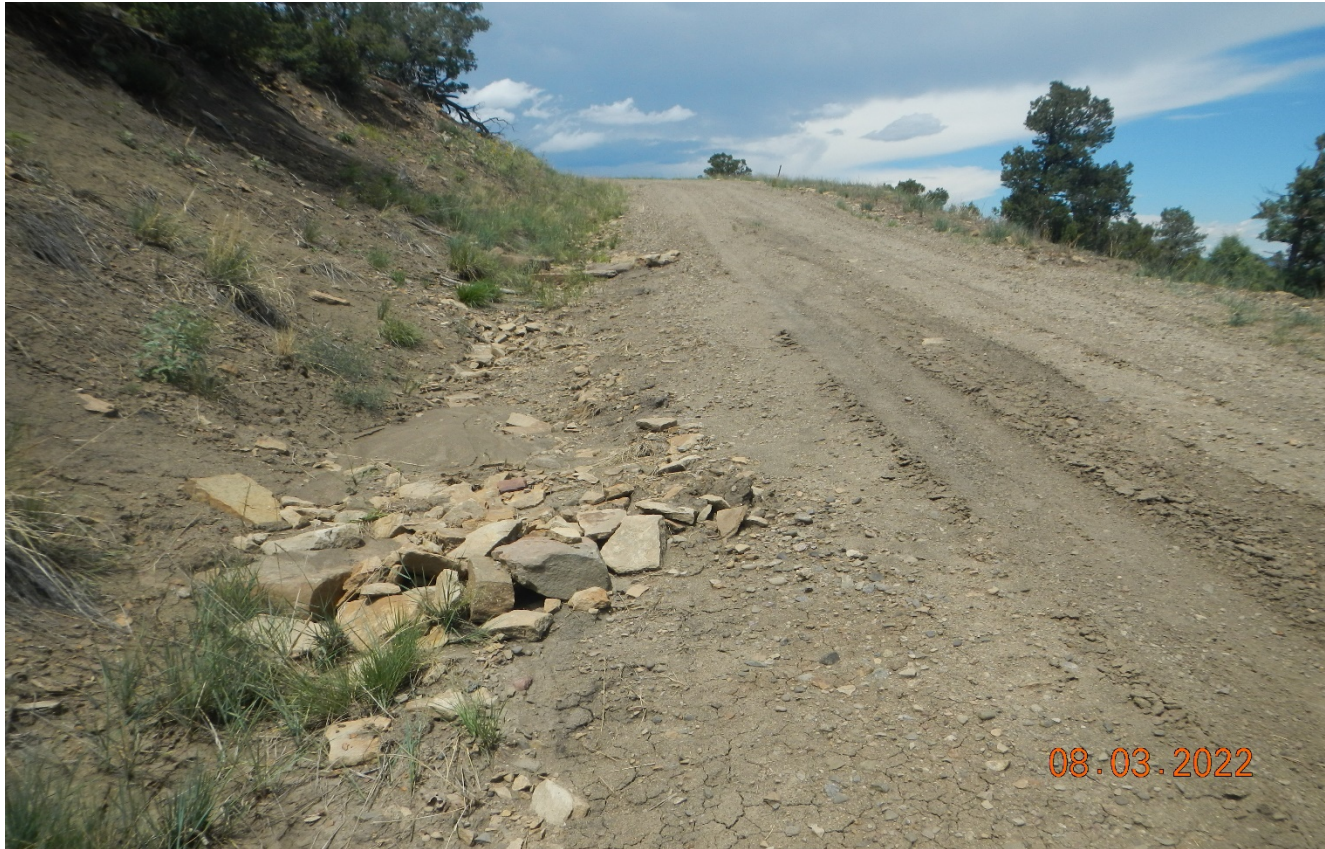
Photo 2. Facing northwest along the access road. There have been rock check dams installed however they are filled in with sediment and not properly installed.

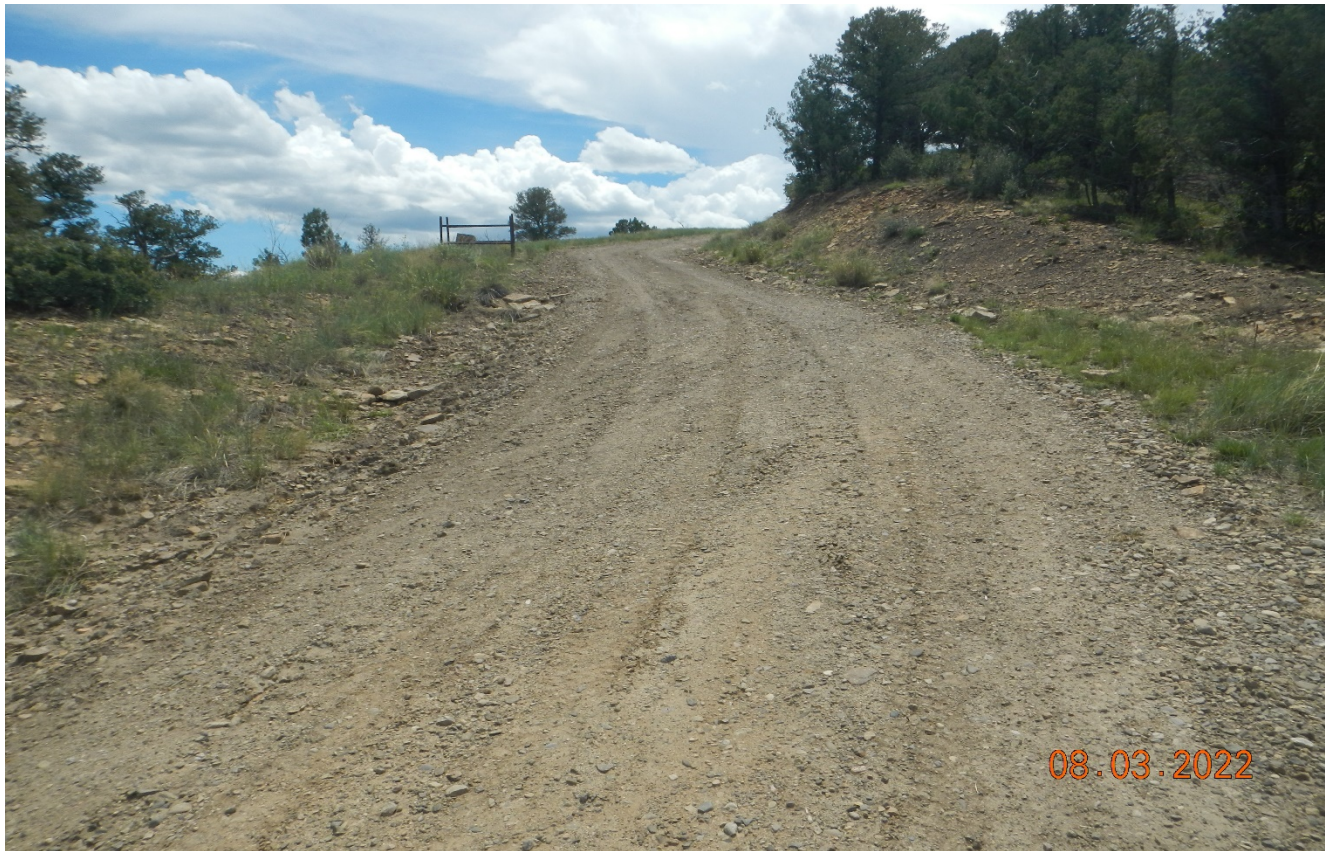
Photo 3. Facing south along the access road. The road has not been recontoured and reclaimed.

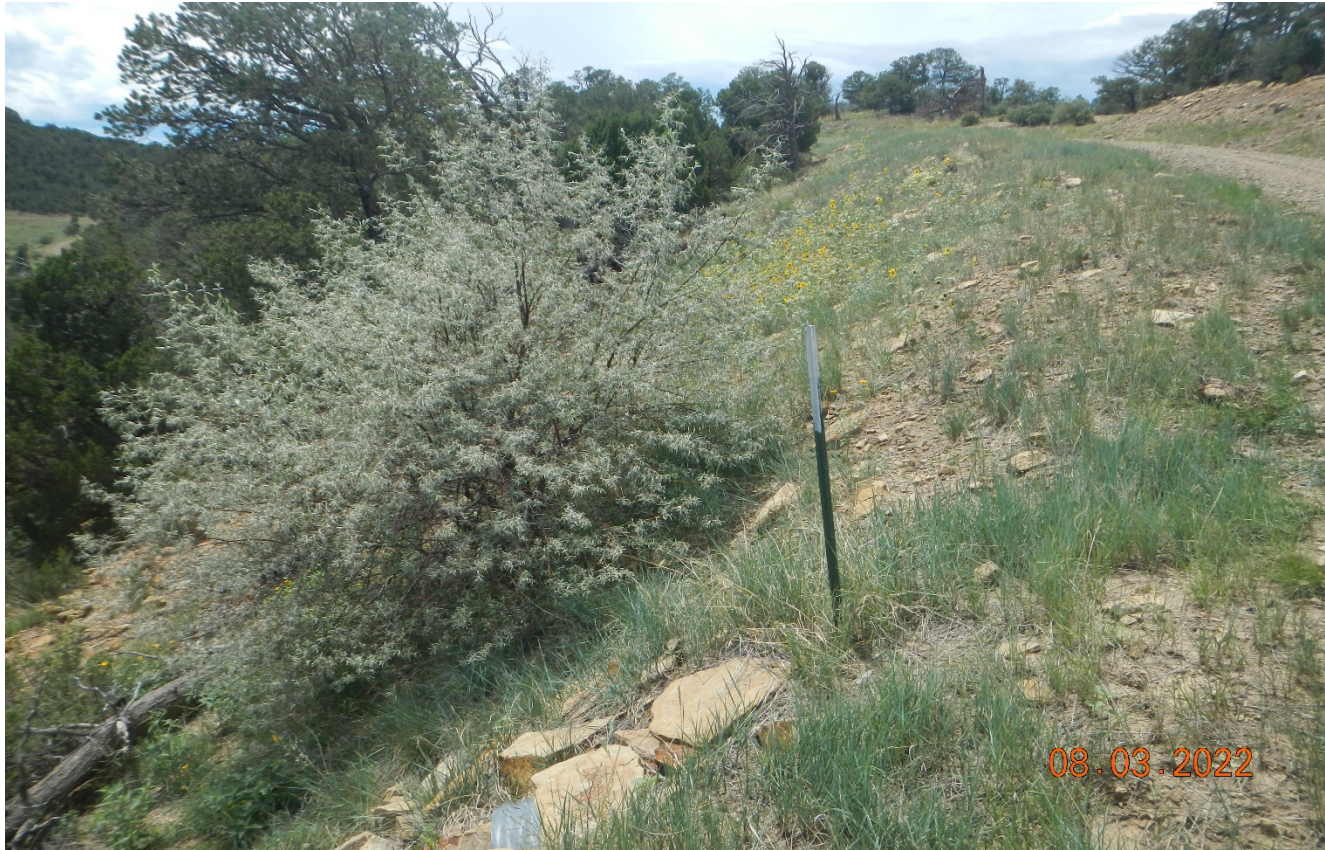
Photo 4. There is a Russian olive tree growing on the side of the road. This is a list B noxious weed and need to be removed and controlled.

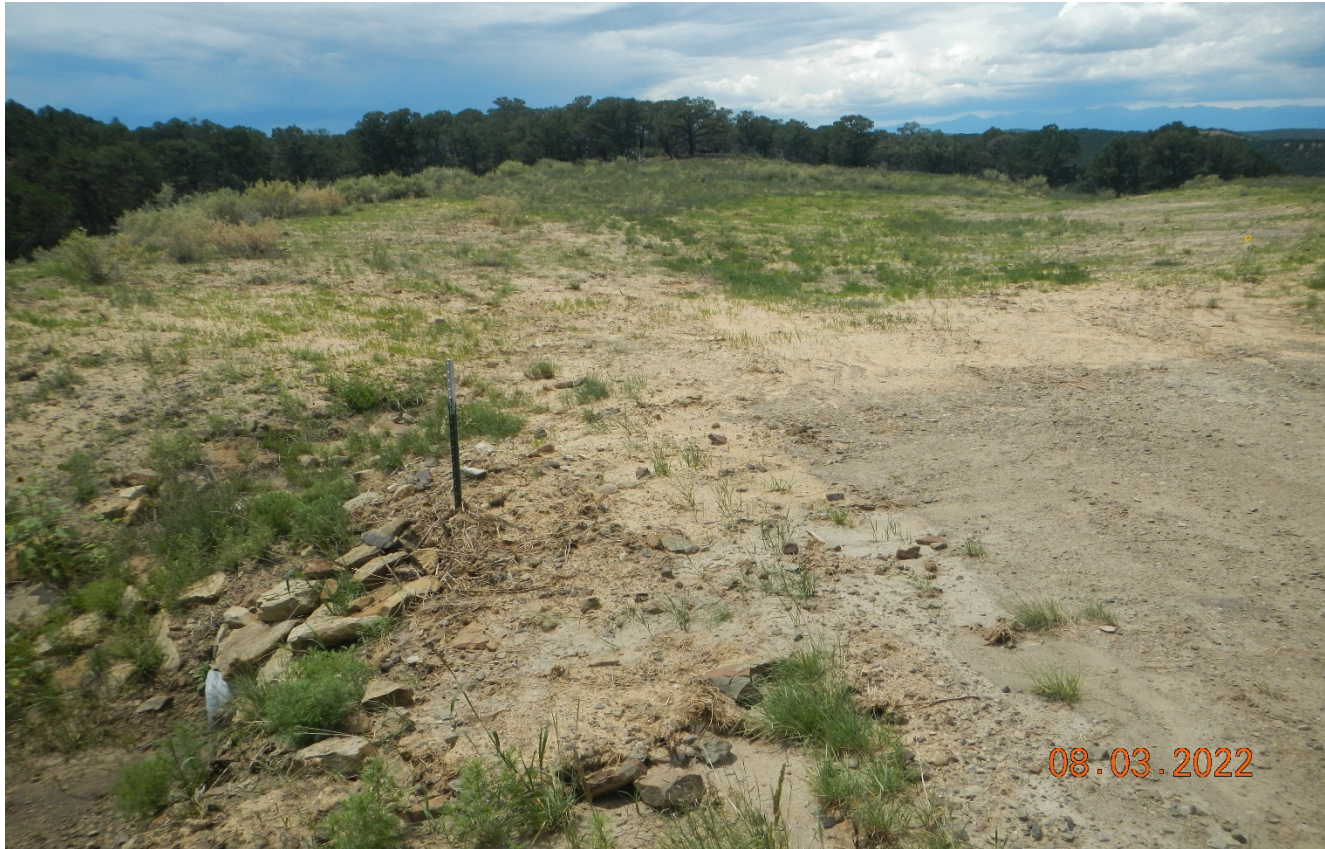
Photo 5. Facing west toward the location. The location has not been recontoured. The location was reseeded and hydromulched.

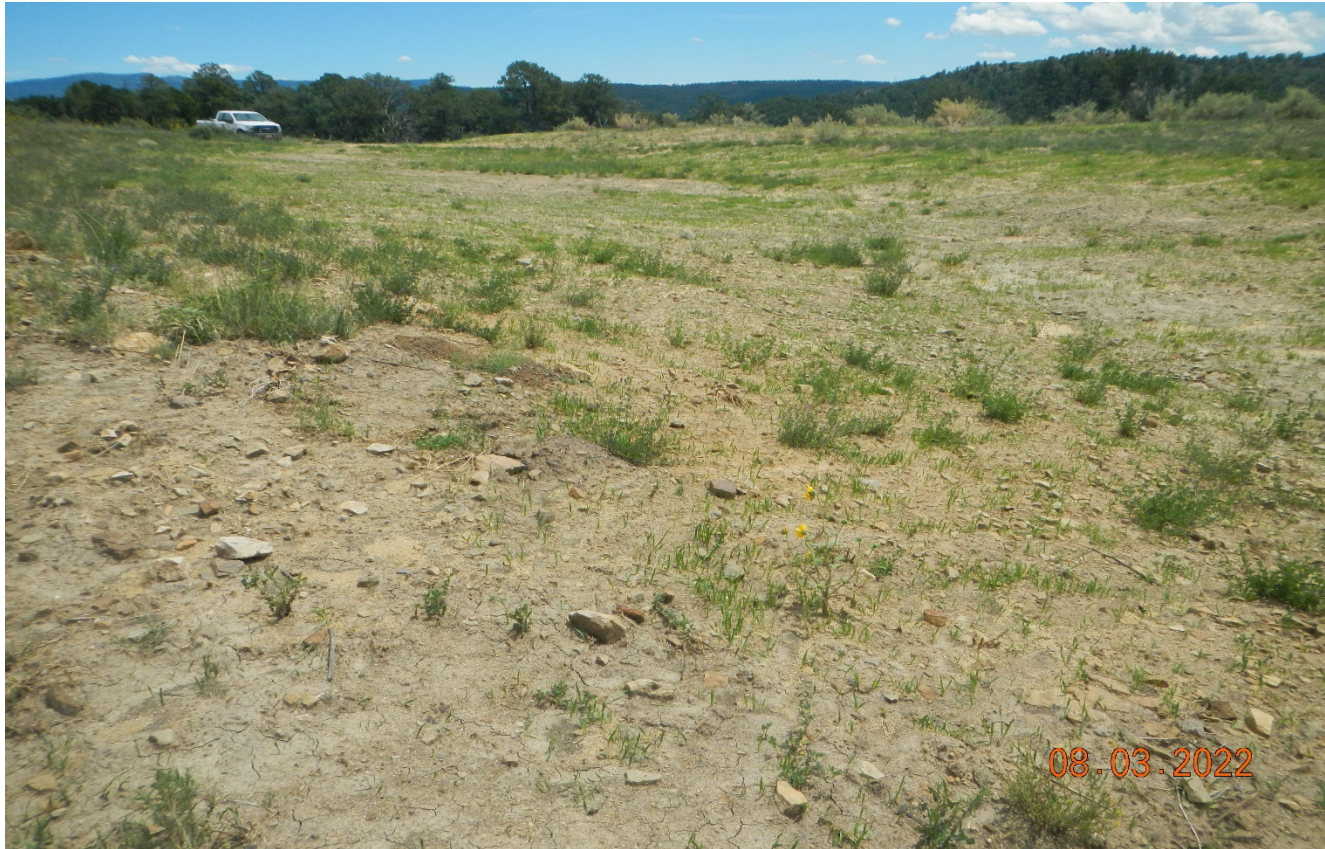
Photo 6. Facing southeast at the location. The location was reseeded and hydromulched.

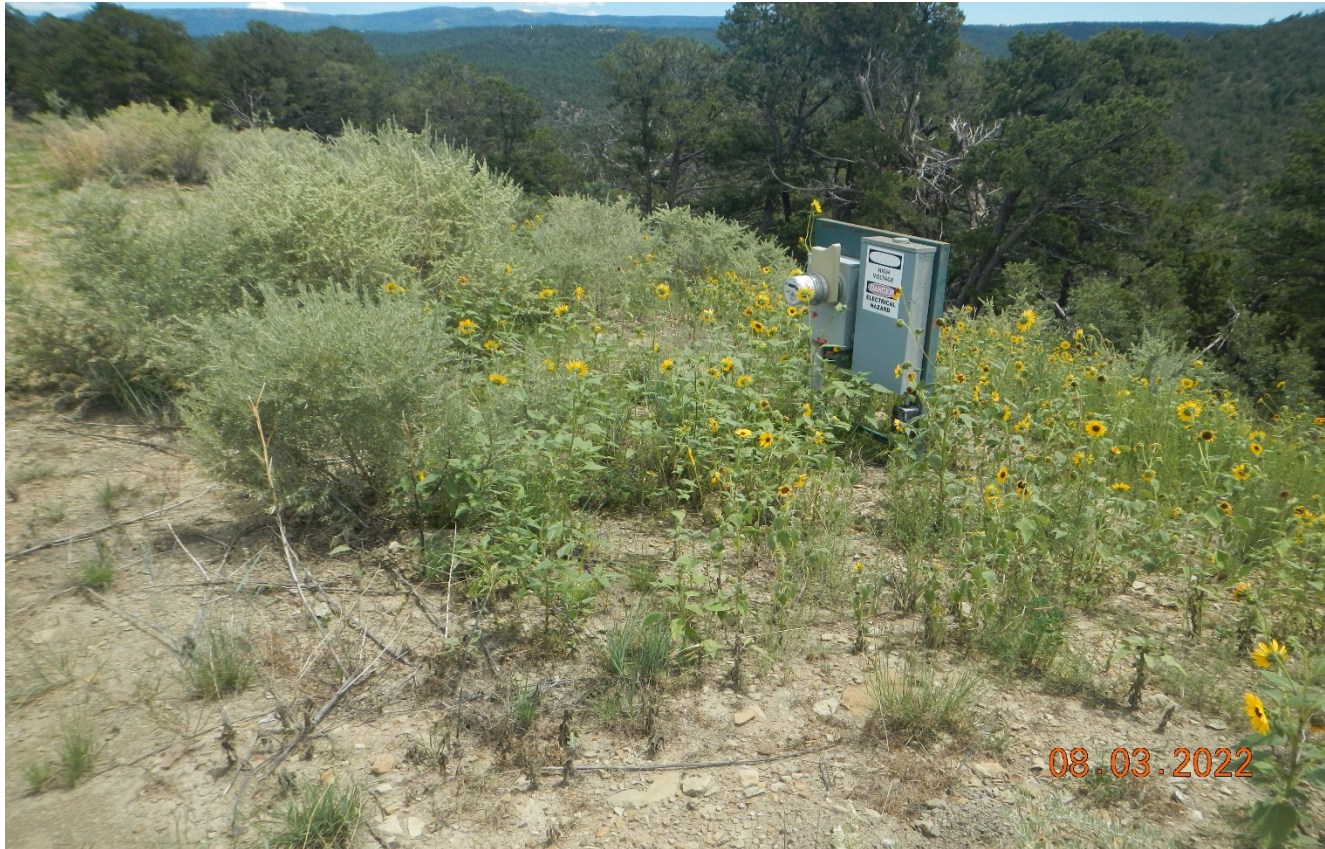
Photo 8. The electric utility remains at the southwest side of the location.

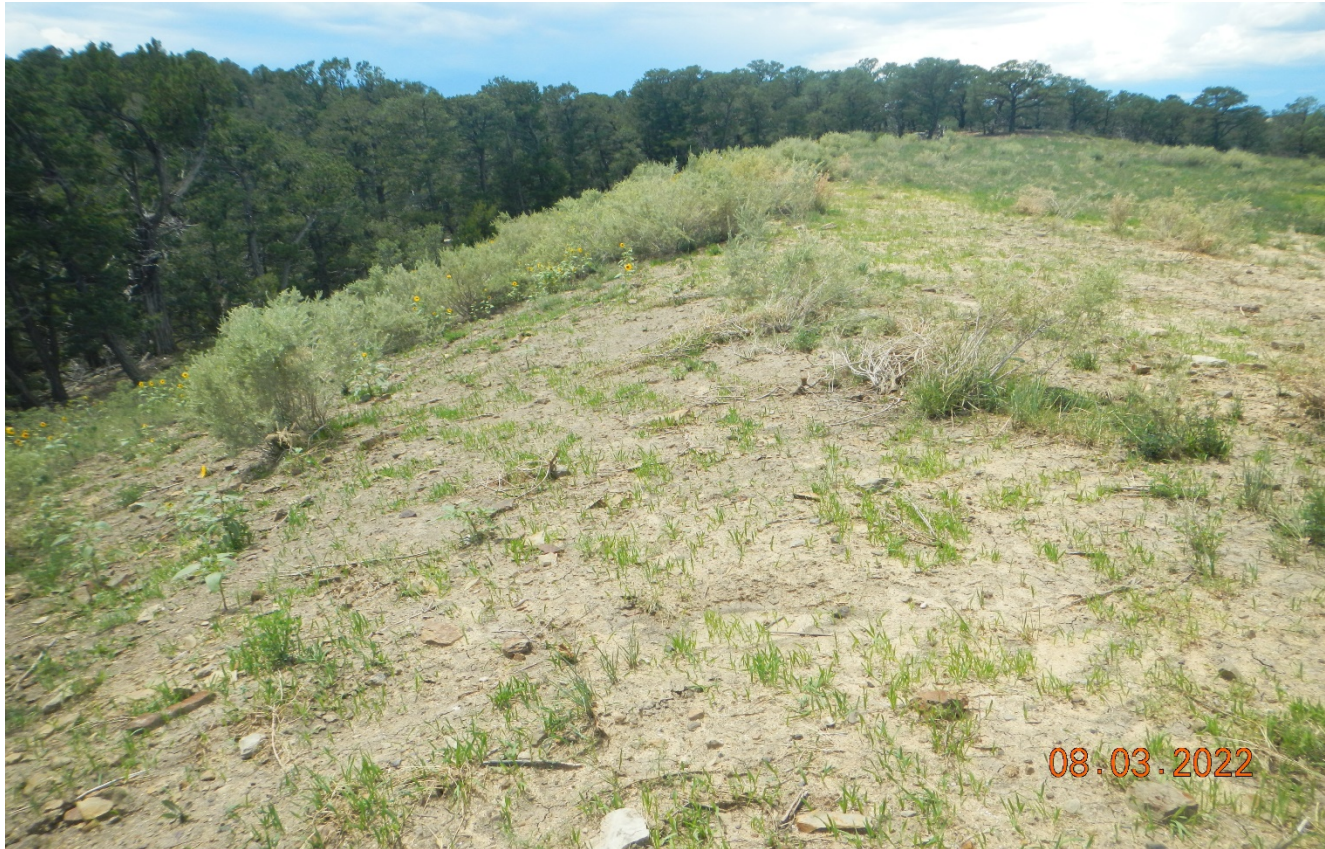
Photo 9. Facing west at the south fill slope side of the location.
