Inspection Photos

API: 071-09246

Operator: EVERGREEN NATURAL RESOURCES

Inspection Date: 8/3/2022

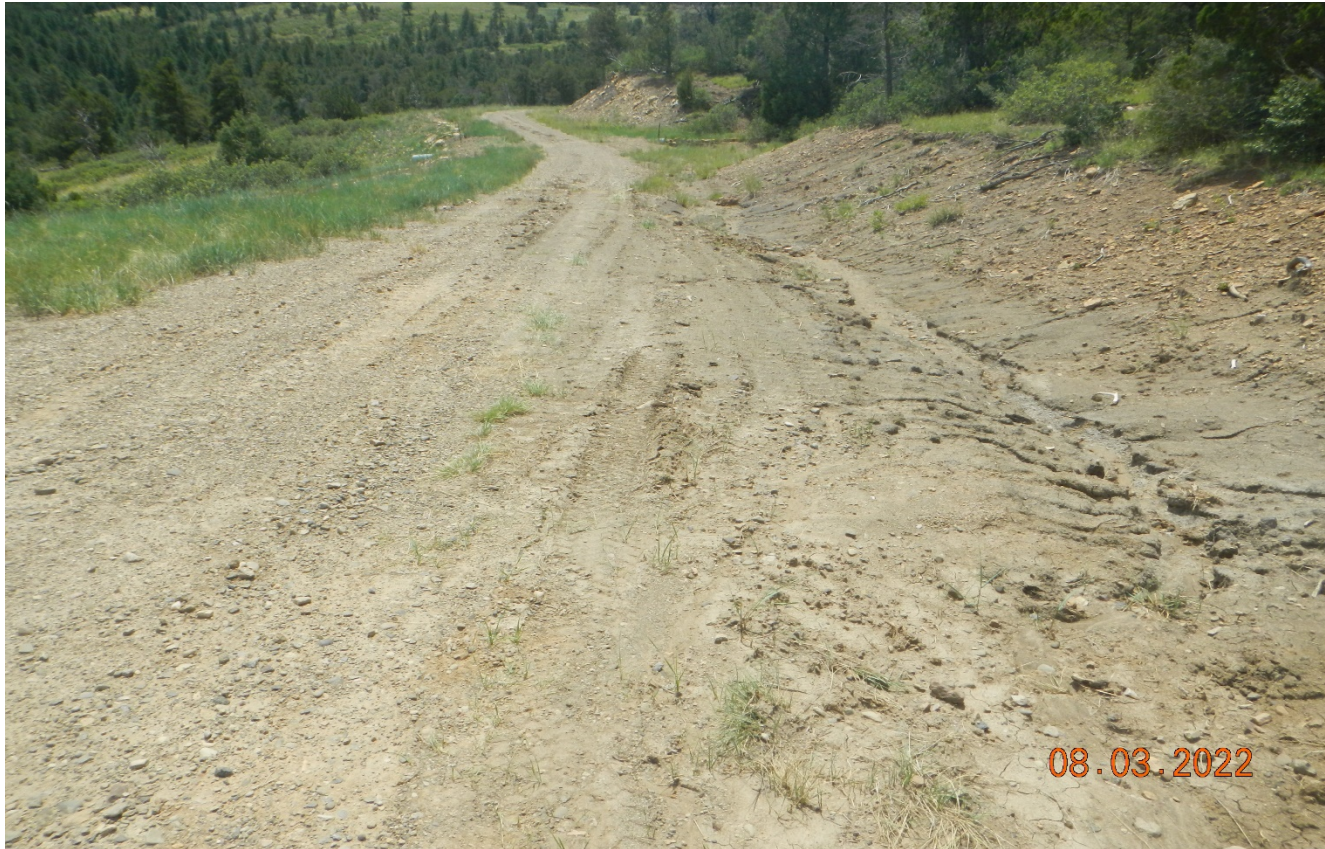
Photo 1. Facing southwest the beginning of the access road. The road has not been recontoured and reclaimed. The roadside is not stabilized and there is signs or erosion.

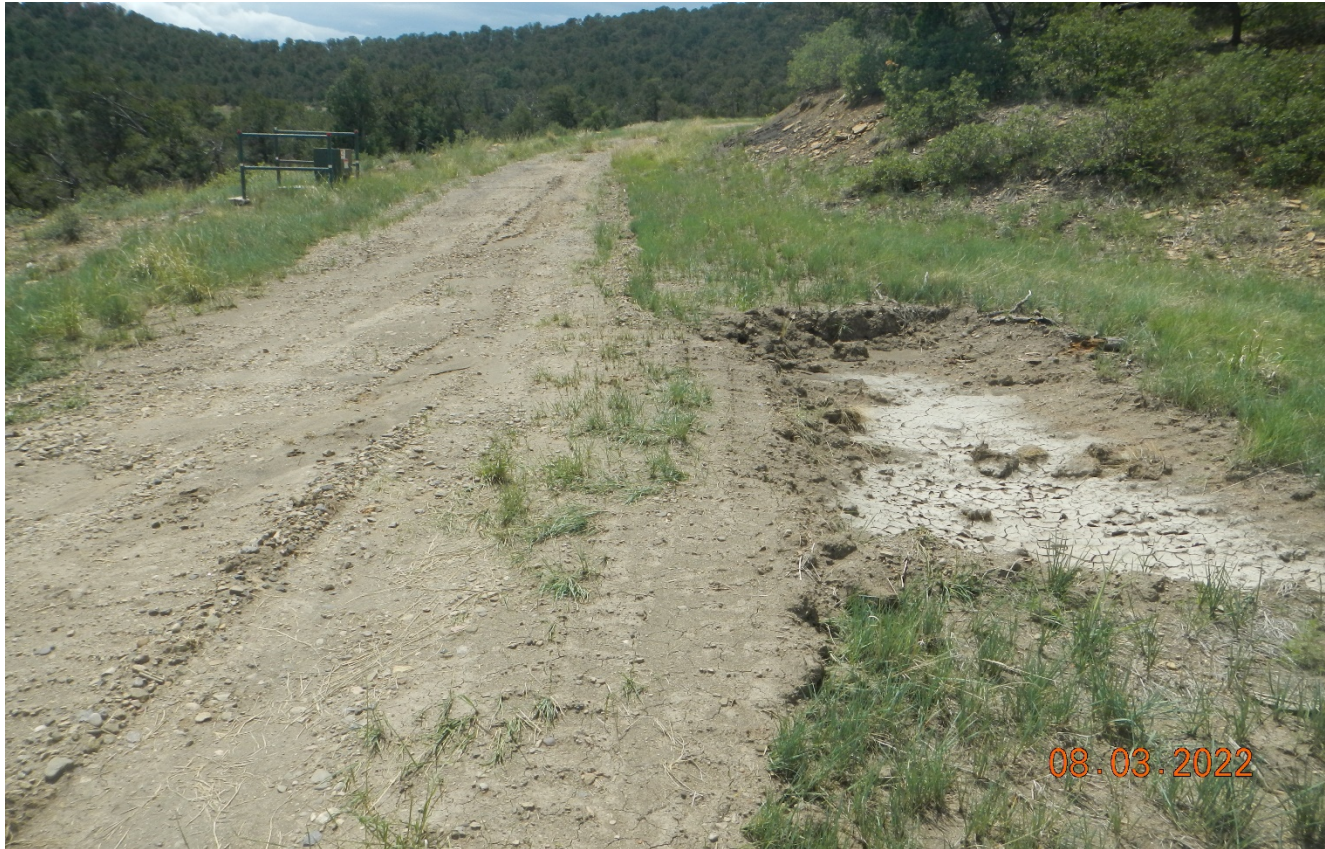
Photo 2. Facing southwest along the access road. There was recent work performed along the road. This area was partially excavated. Areas of disturbance need to be reclaimed.

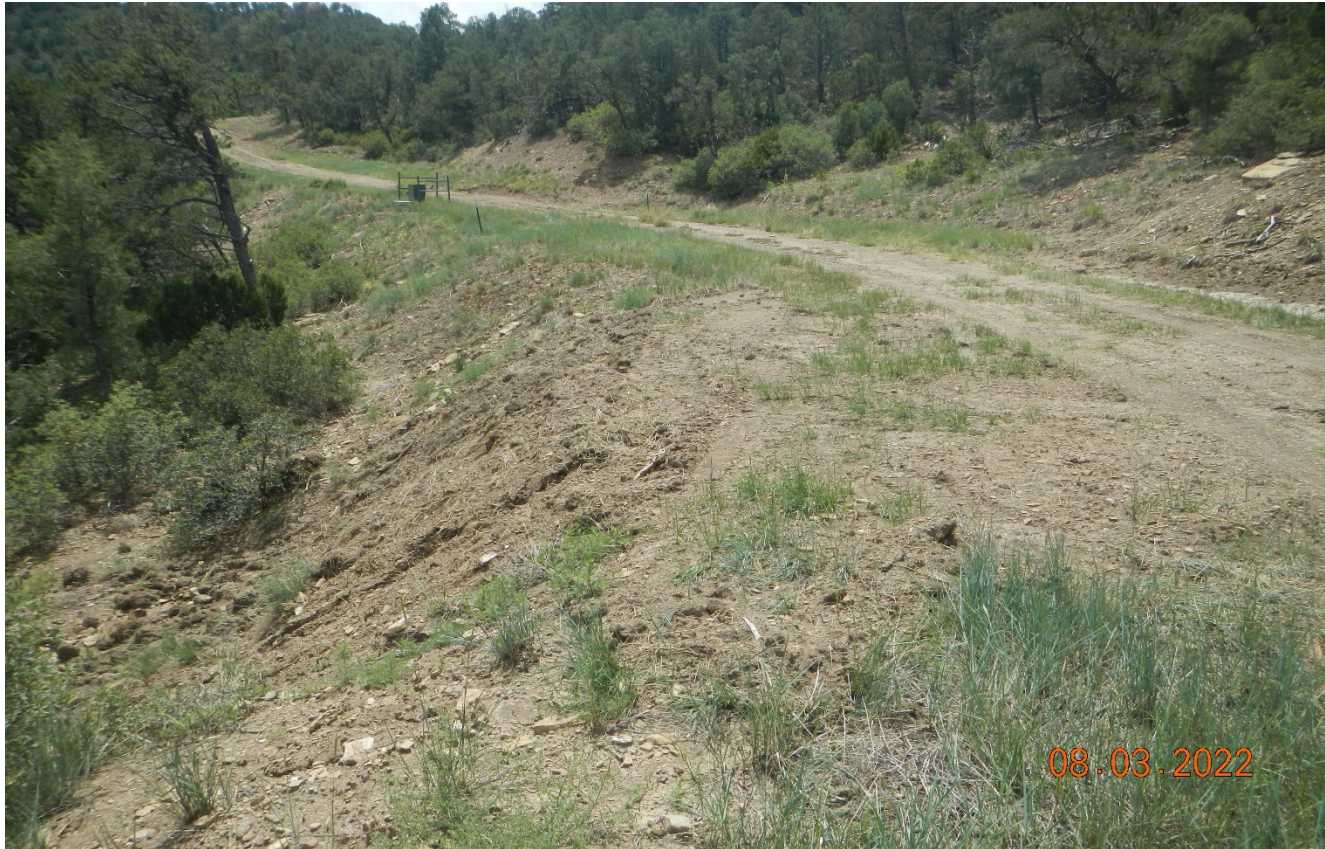
Photo 3. Facing southwest along the access road. Excavated material was placed on the fill slope of the road. Areas of disturbance need to be reclaimed.

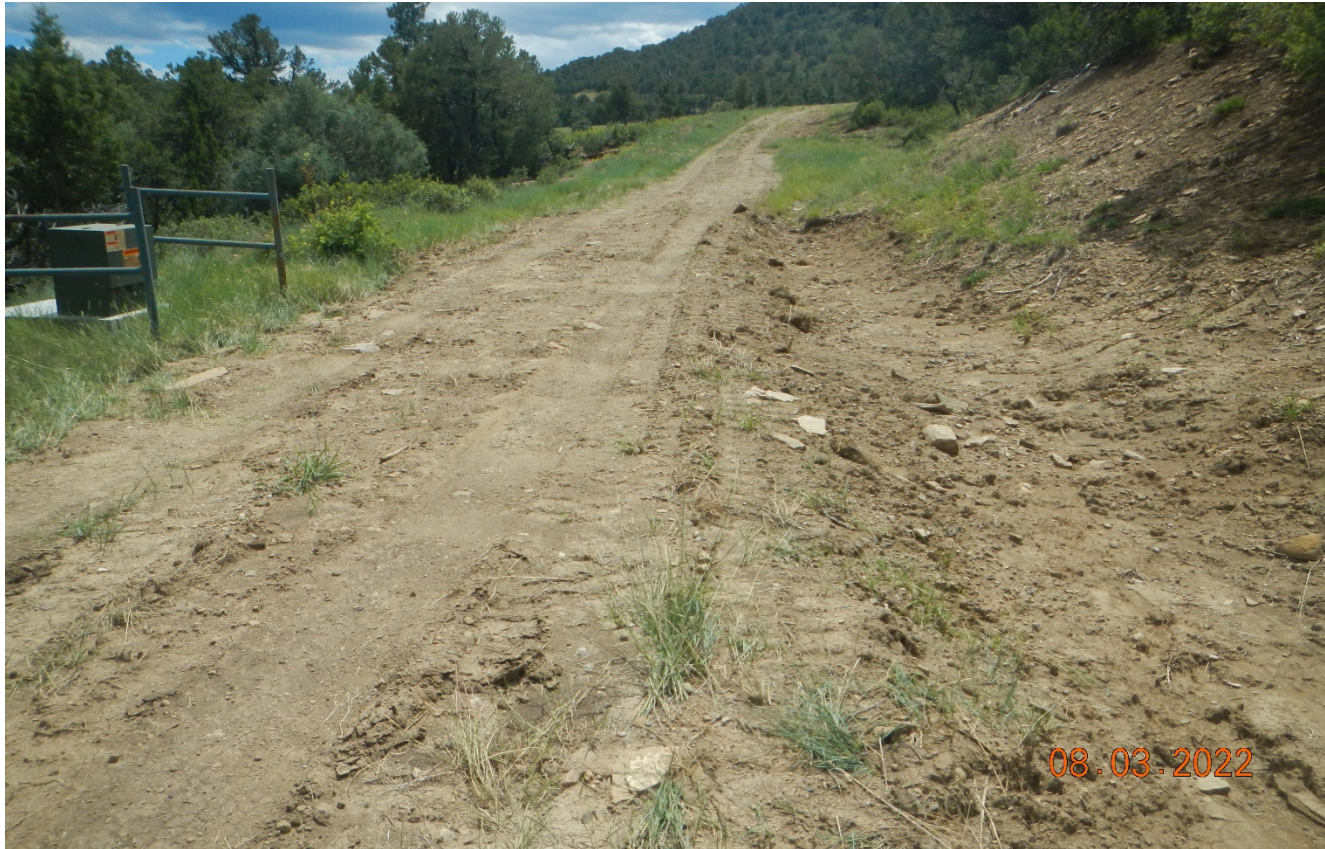
Photo 4. Facing southwest along the access road. There was recent work performed along the road. This area was partially excavated and material was placed on the road. Areas of disturbance need to be reclaimed.

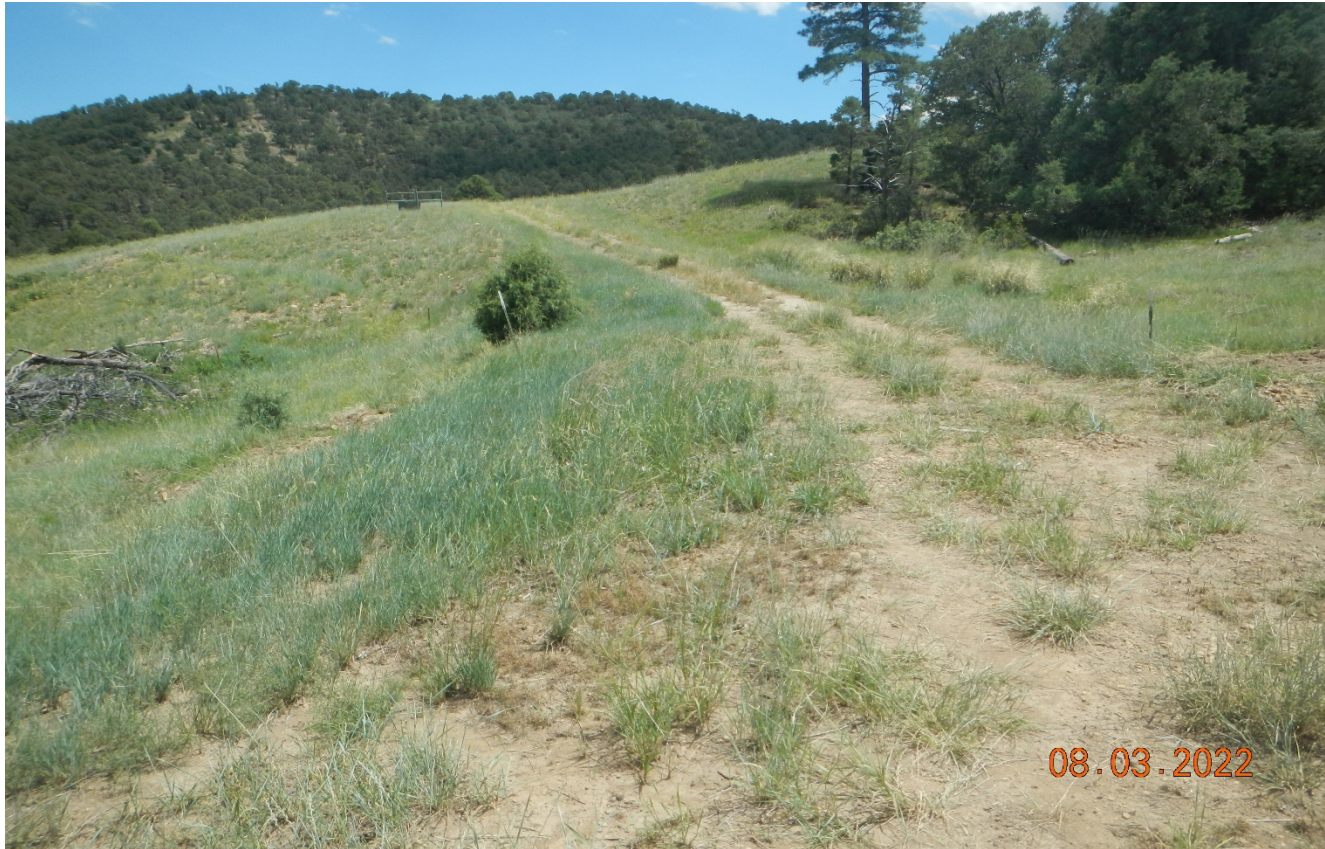
Photo 6. Facing southeast toward the access road and location.

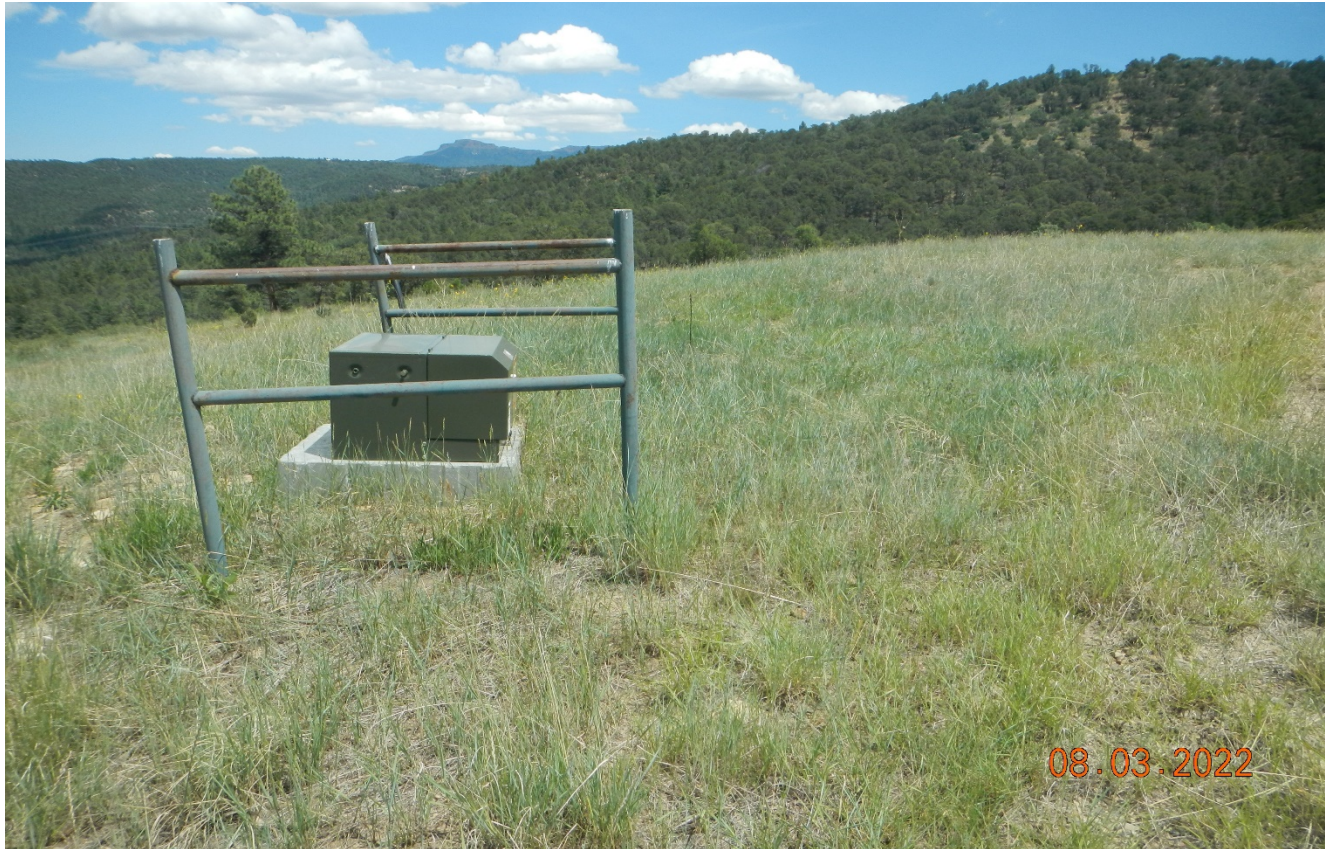
Photo 6. The electric utility remains at the location.

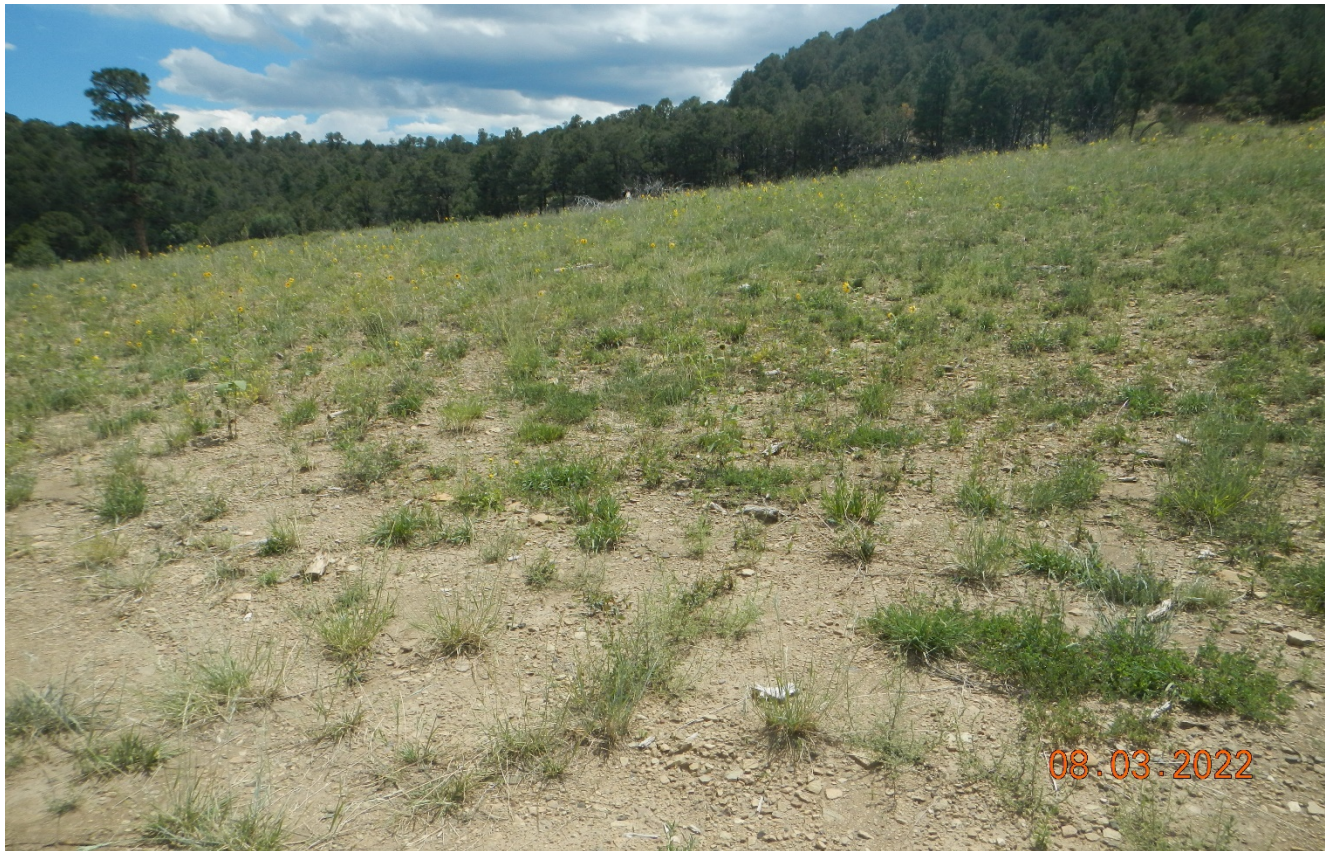
Photo 7. Facing southeast at the location.

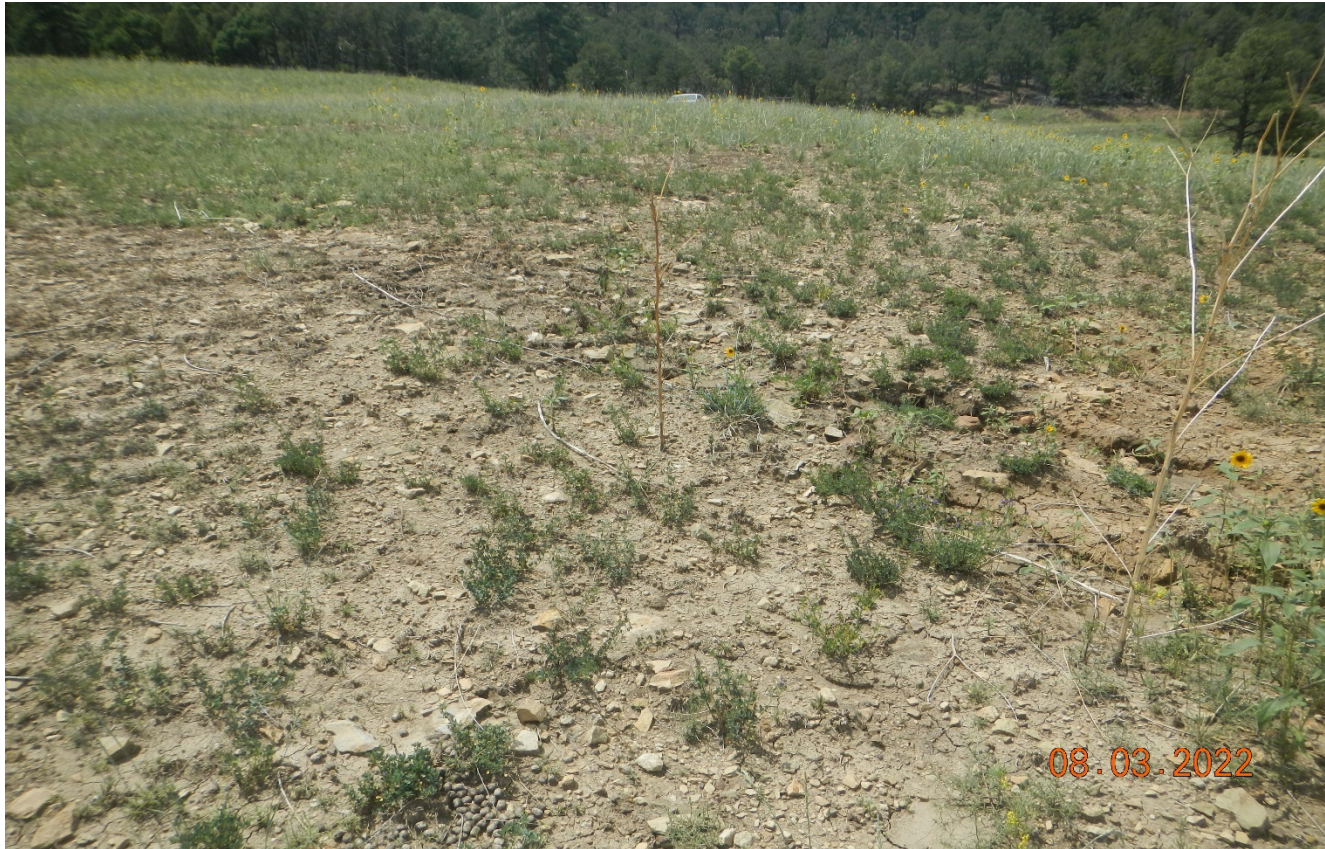
Photo 8. Facing west at the location. There are areas of the location that have not established vegetation.

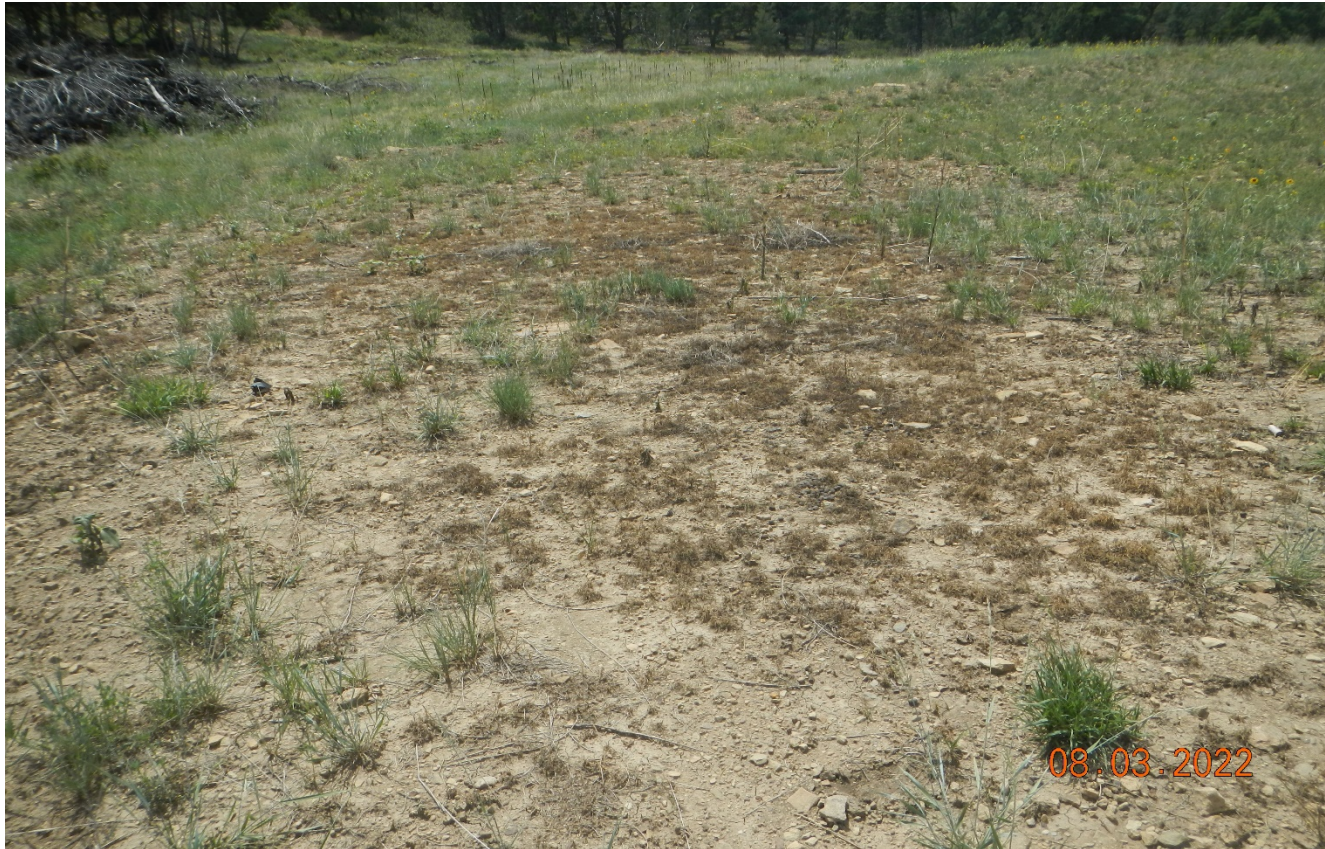
Photo 10. East side of the location facing southwest. There are areas of the location that have not established vegetation.

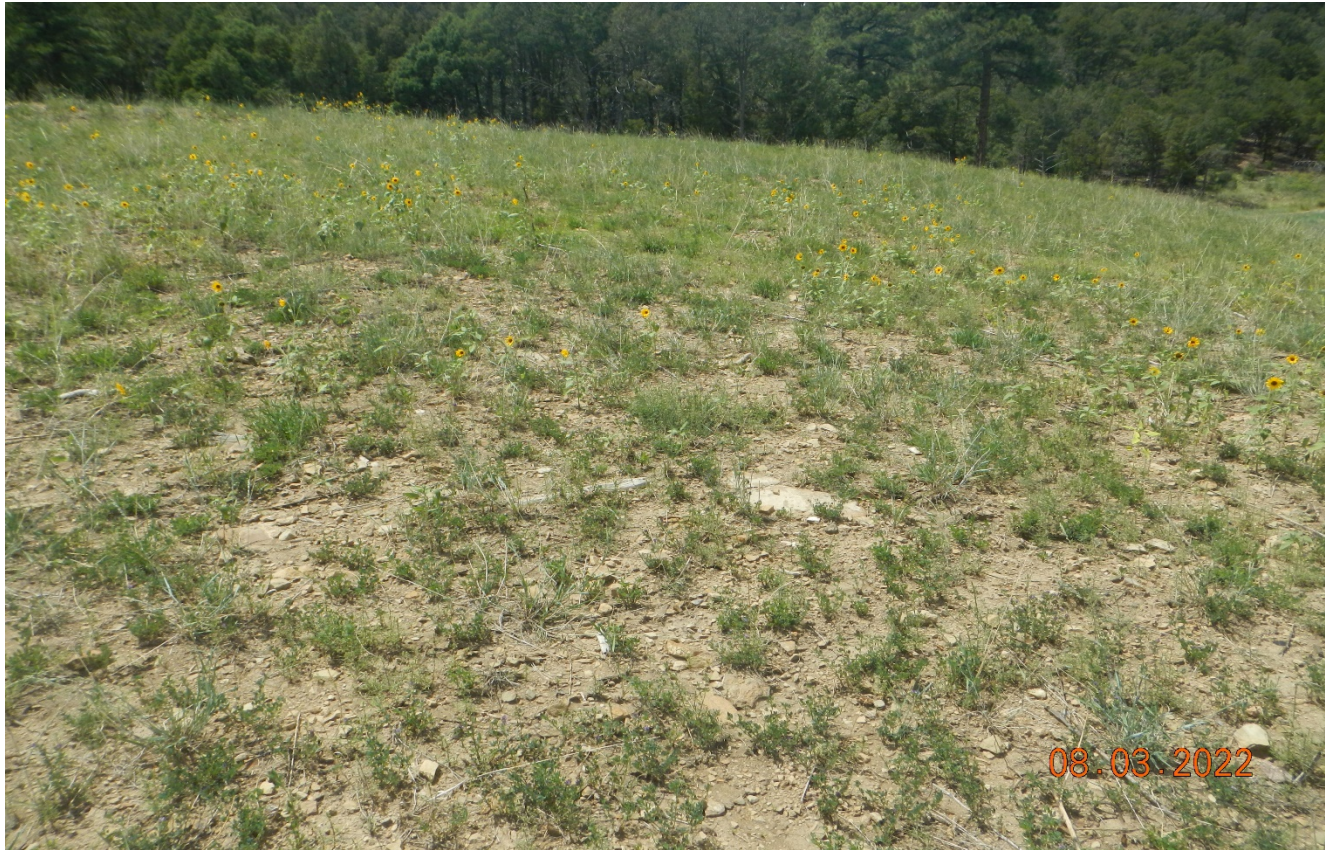
Photo 11. Facing west at the south side of the location. Vegetation is progressing in this area of the location.
