Inspection Photos

Operator: TEP Rocky Mountain LLC - #96850

Location Name: South Leverich 18-13 Pad

Inspection Document #: 702800557

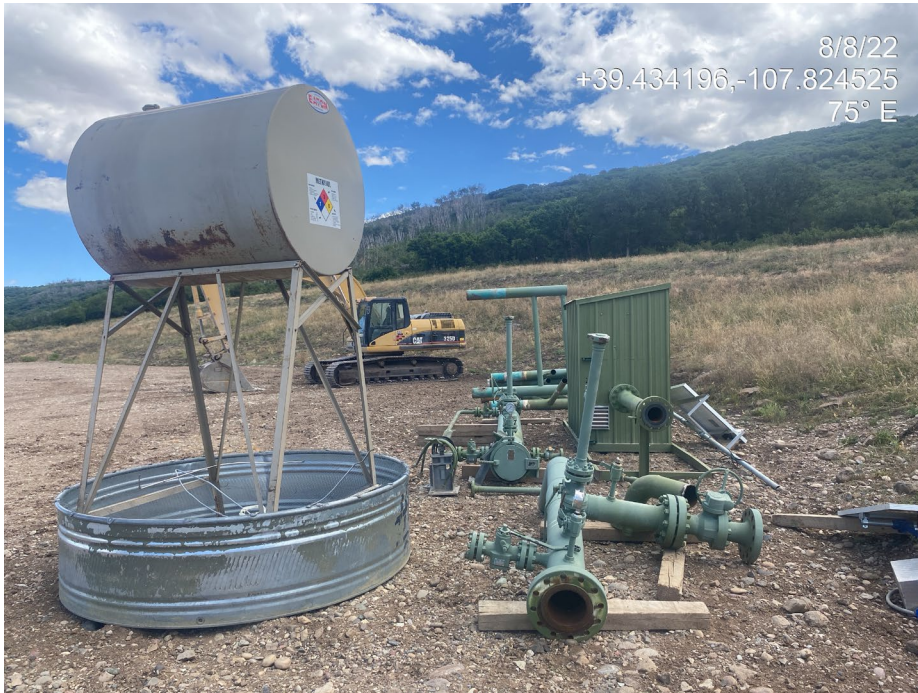
Photo 2. Photo taken from the south of the Location shows storage of unused equipment. Form 4, request to store equipment is “In Process”.

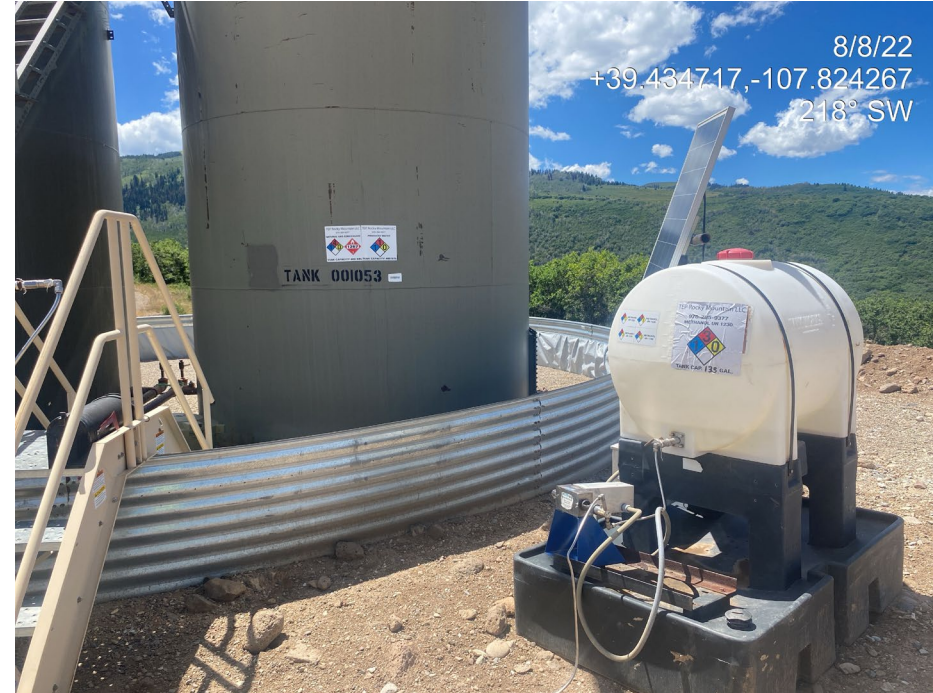
Photo 3. Photo shows methanol tank has been labeled, addressing a previous corrective action.

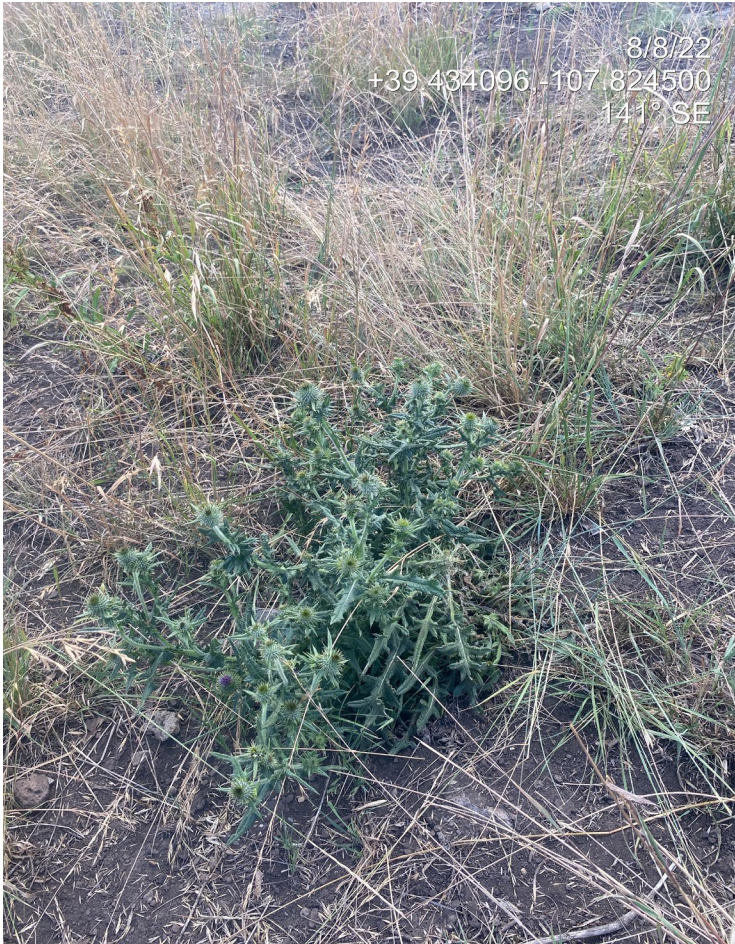
Photo 4. Photo taken from the south of the Location shows an example of bull thistle, (CO List B Noxious Weed) found throughout the Location.

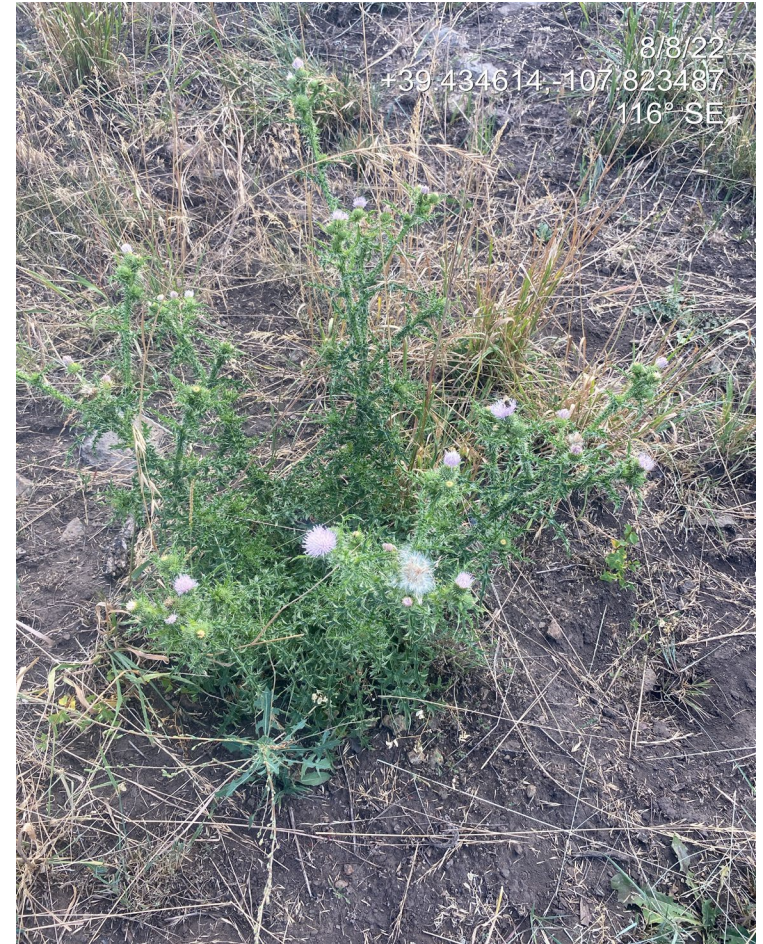
Photo 5. Photo taken from the east of the Location shows an example of plumeless thistle, (CO List B Noxious Weed) found throughout the Location.

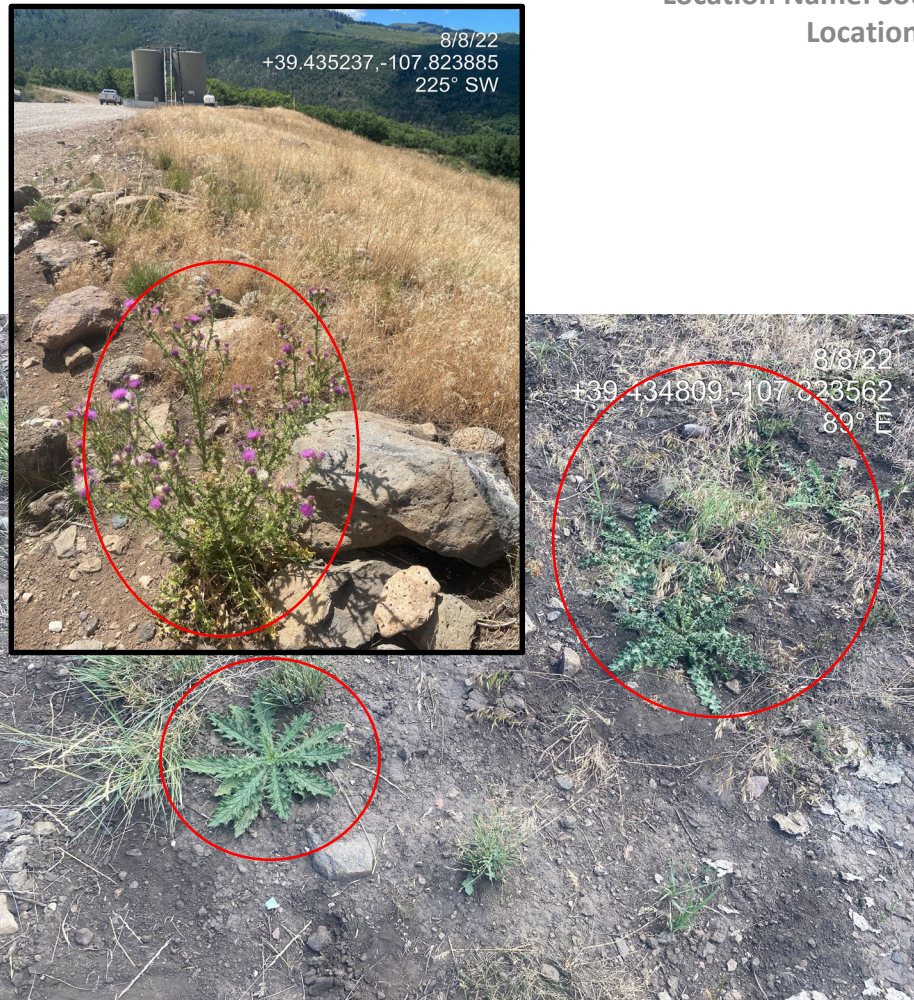
Photo 6. Photo taken from the east of the Location shows plumeless and bull thistle rosettes. Inset taken to the north shows plumeless thistle.

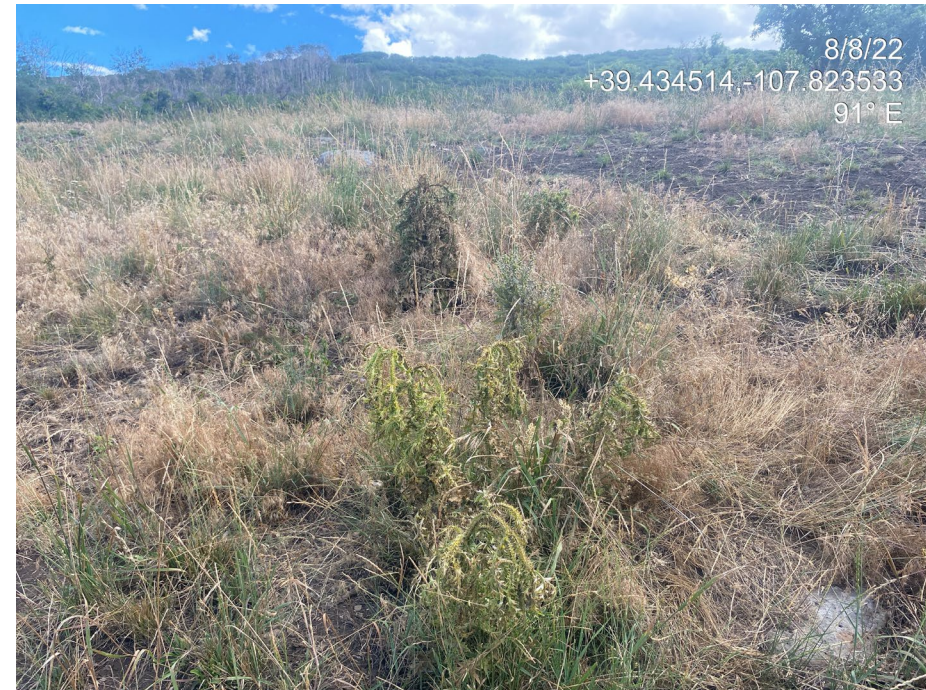
Photo 7. Photo taken from the east of the Location shows multiple noxious thistles which appear to have been recently treated. Many noxious weeds remain untreated. See Photos 4, 5, 6.
