Inspection Photos and Issue Report

Operator: LARAMIE ENERGY LLC - 10433

Location #312436

Mesa County, CO

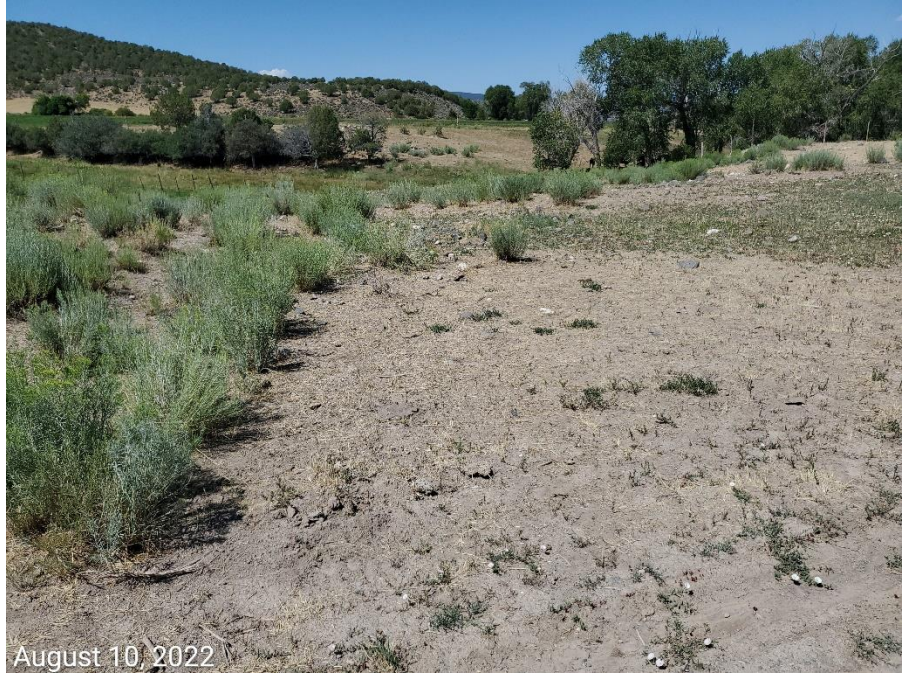
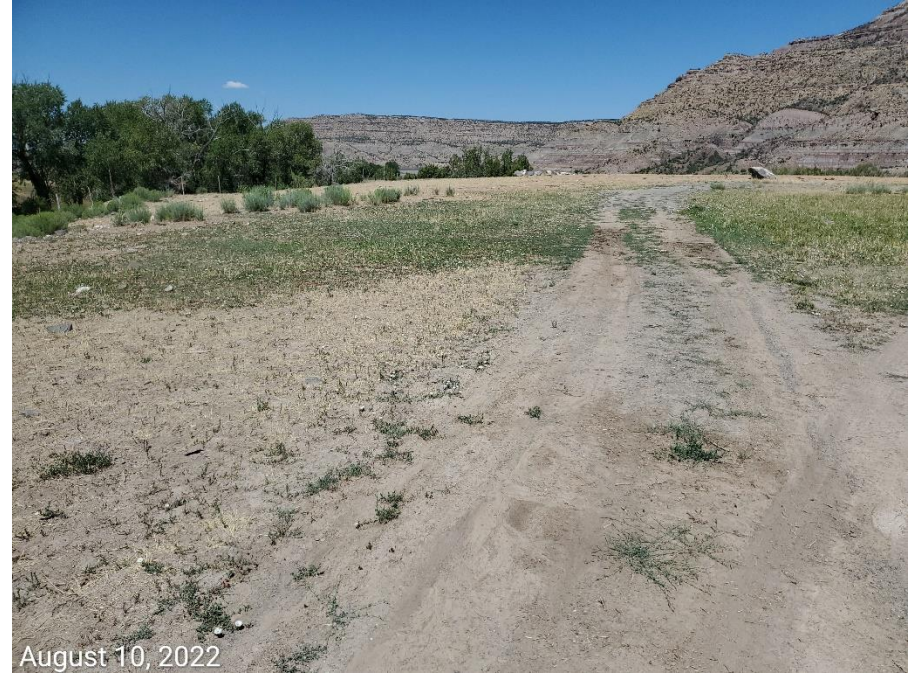
Photo 1: Photo 1-2 taken from the south end of the Location, and provide an overview of the Location from west, northwest, northeast to east. Photos show that Location that have not been reclaimed in accordance with 1004 Rules; Location has not been decompacted, recontoured/regraded and revegetated.

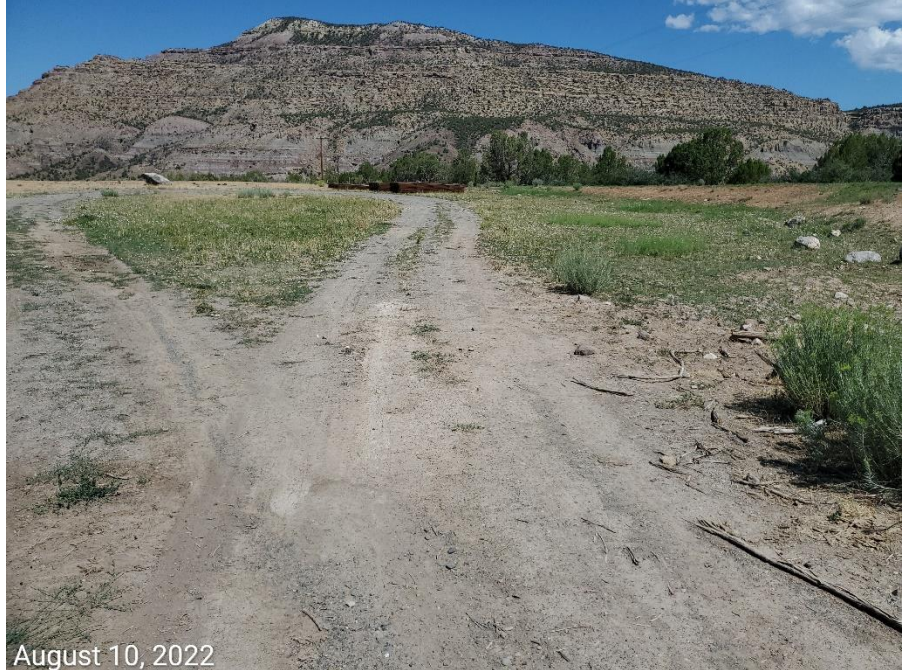
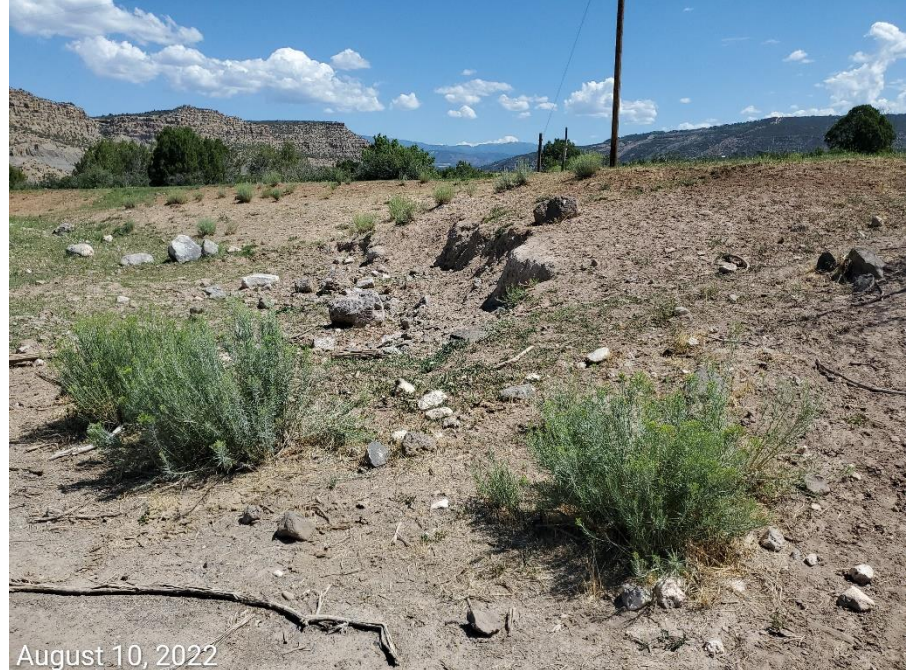
Photo 2: See comments under photo 1.

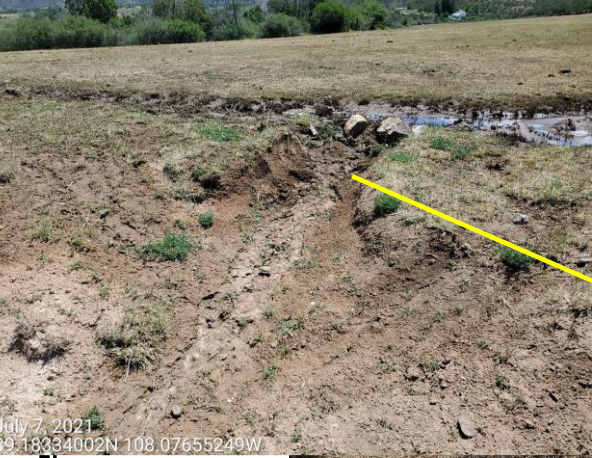
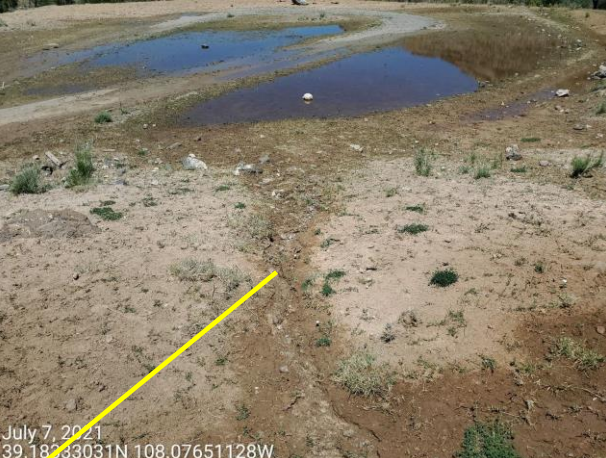
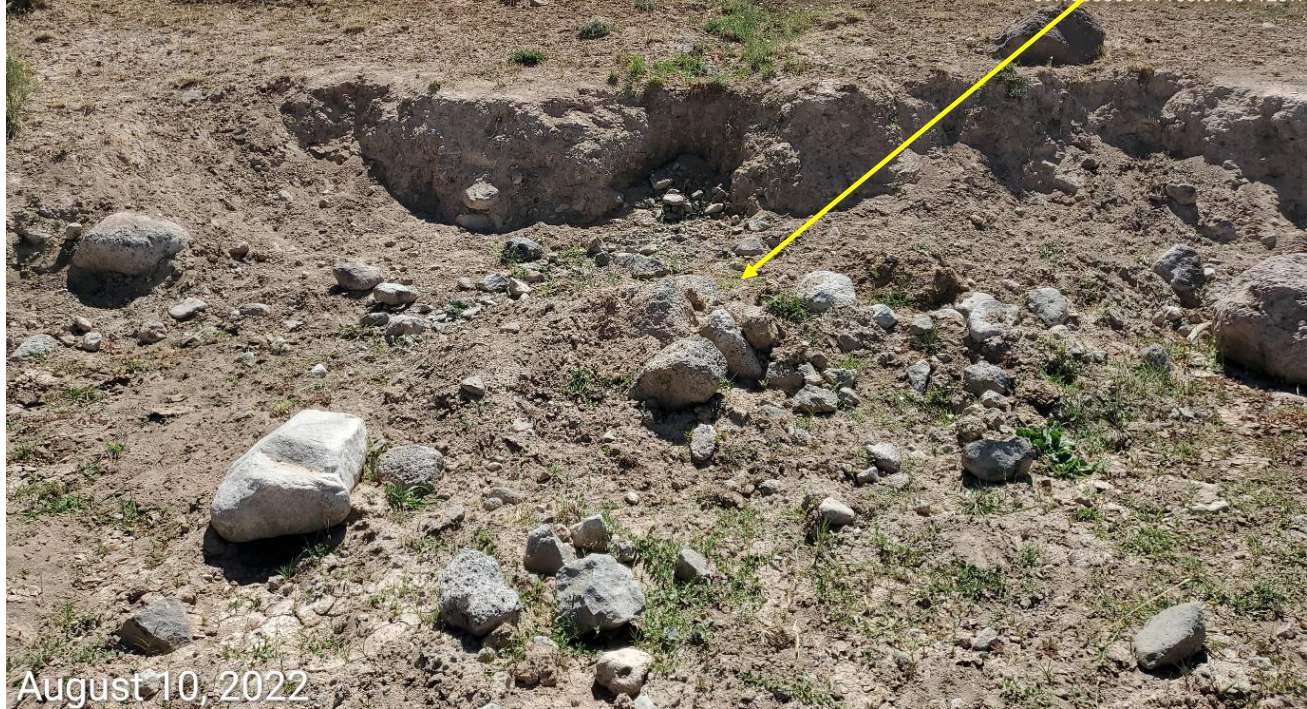
Photo 3: Photo taken from the cut slopes. Photos in the top left/right of the corner taken from the 7/7/2021 inspection. Photo center shows cut slopes have continued to erode. Stormwater BMPs remain missing/insufficient.

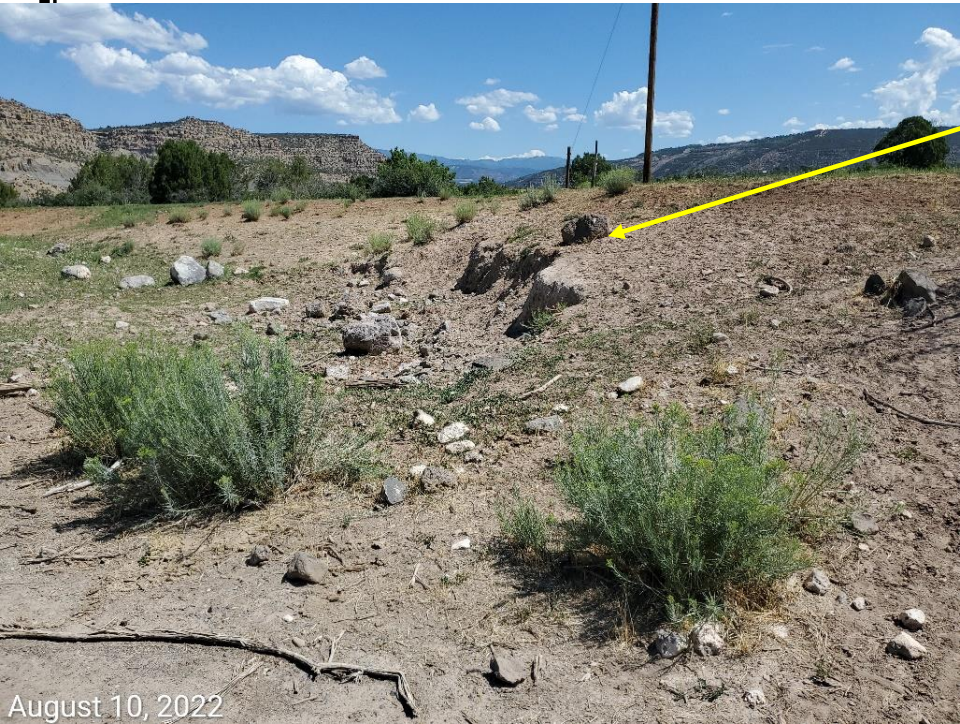
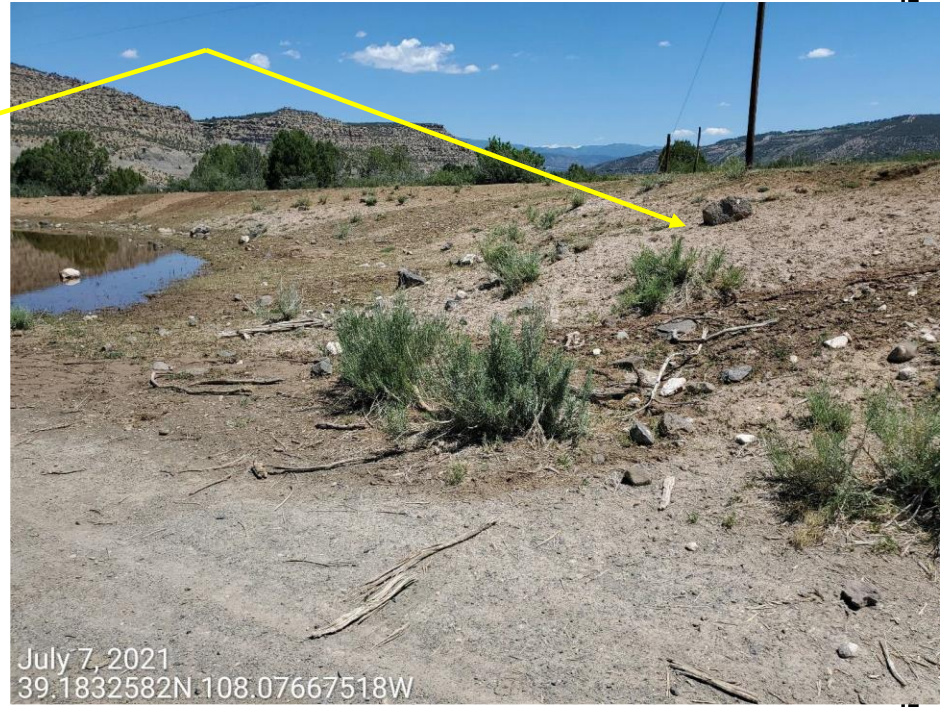
Photo 4: Continued from photo 3. Photo right from the 7/7/2021 inspection. Photos a comparison showing the degradation of the cut slope.

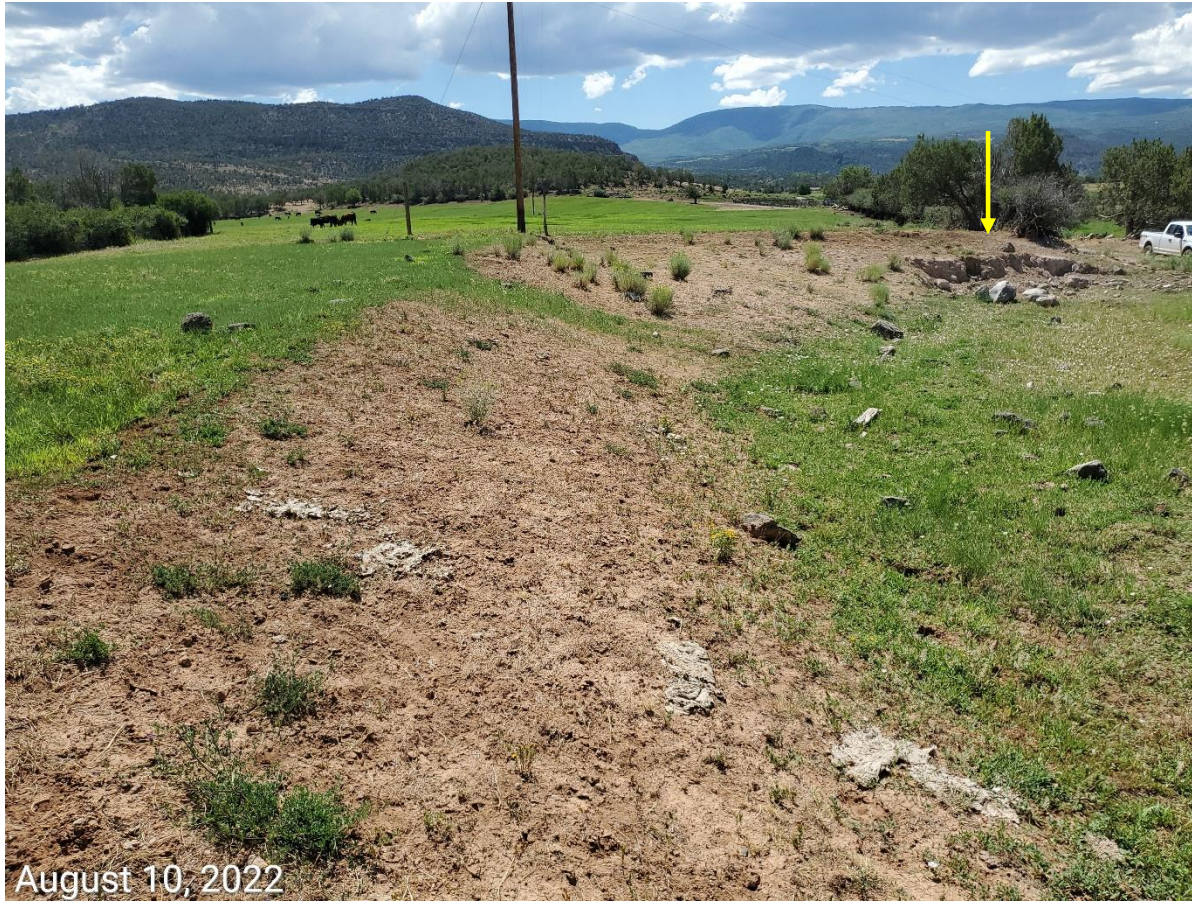
Photo 5: Photo shows cut slopes remaining on the Locaiton. Photo also show areas observed in photo 3 where erosion degradation has persisted.

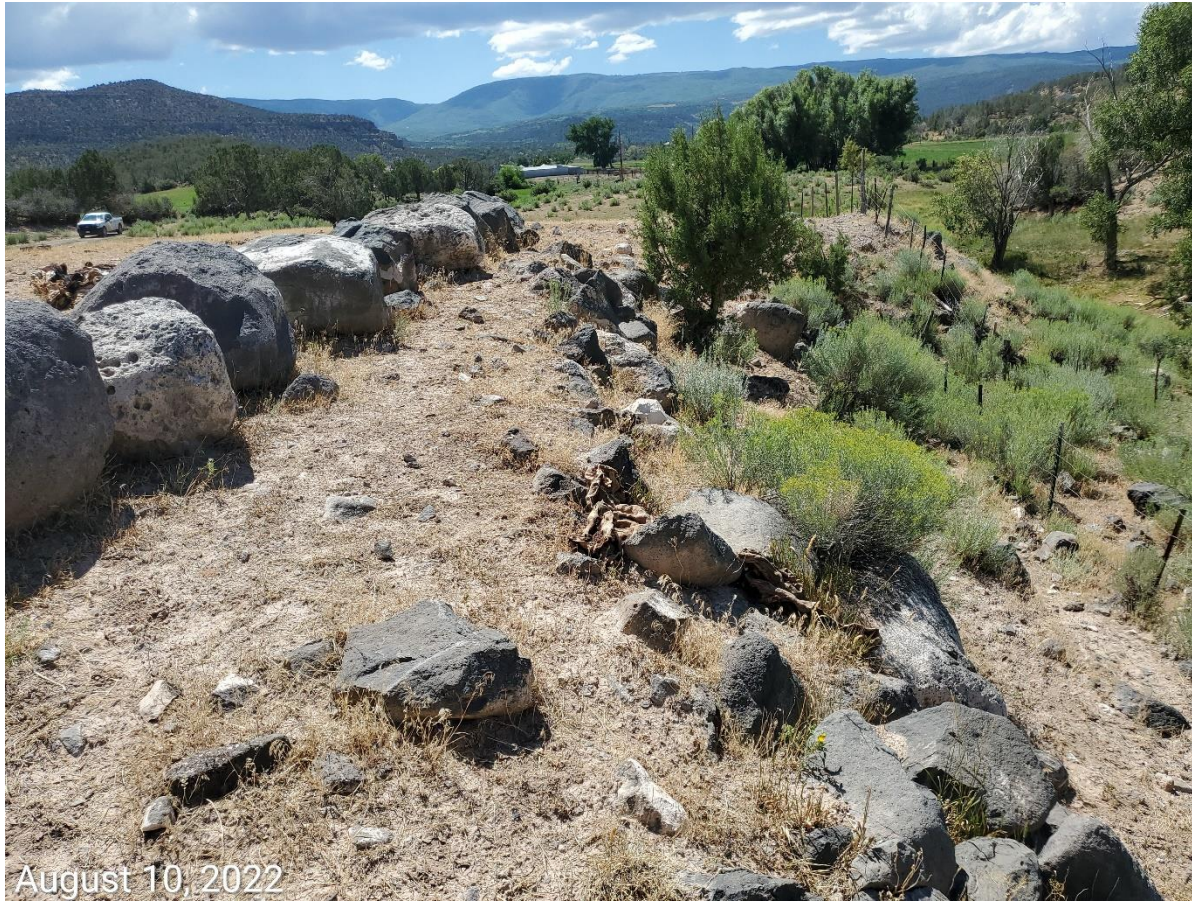
Photo 6: Photo shows fill slopes remaining on the Location.

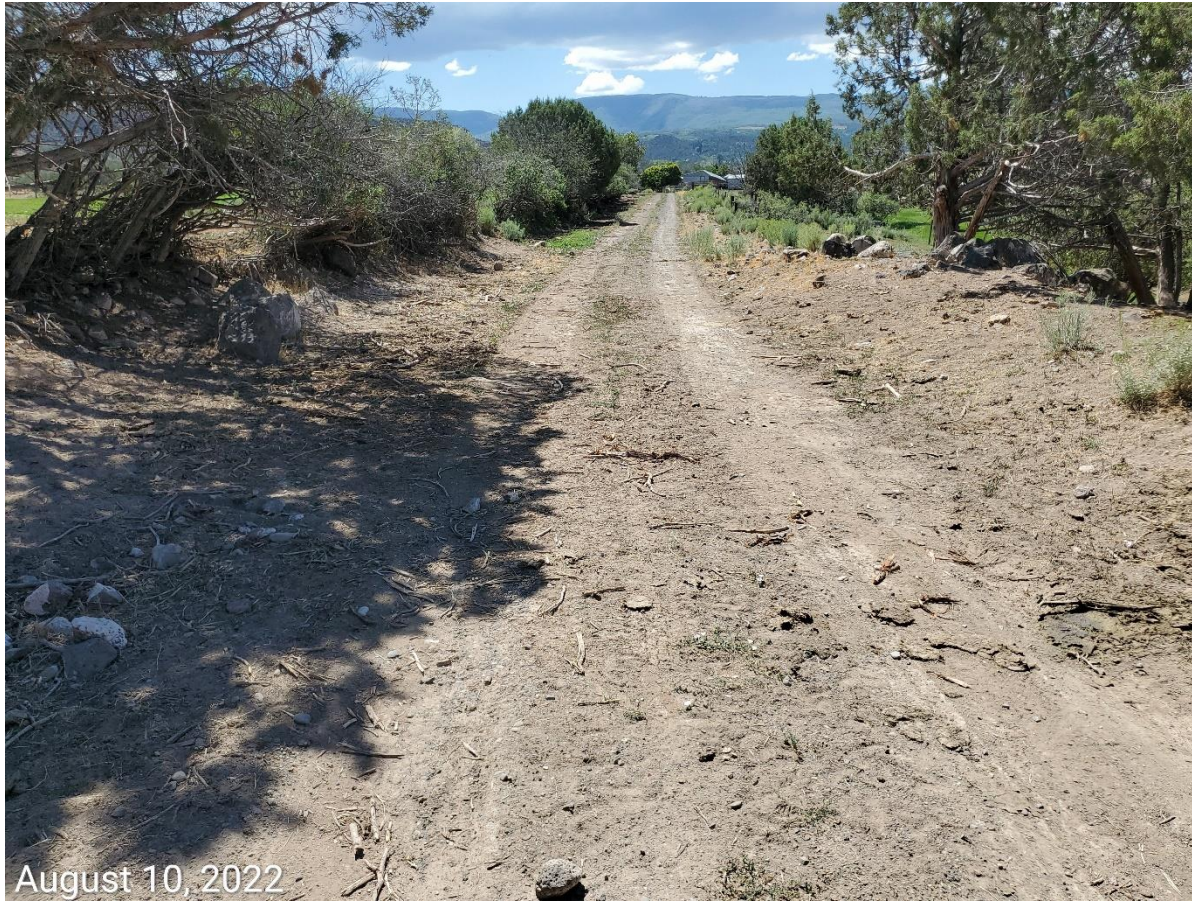
Photo 7: Photo shows access road remaining.

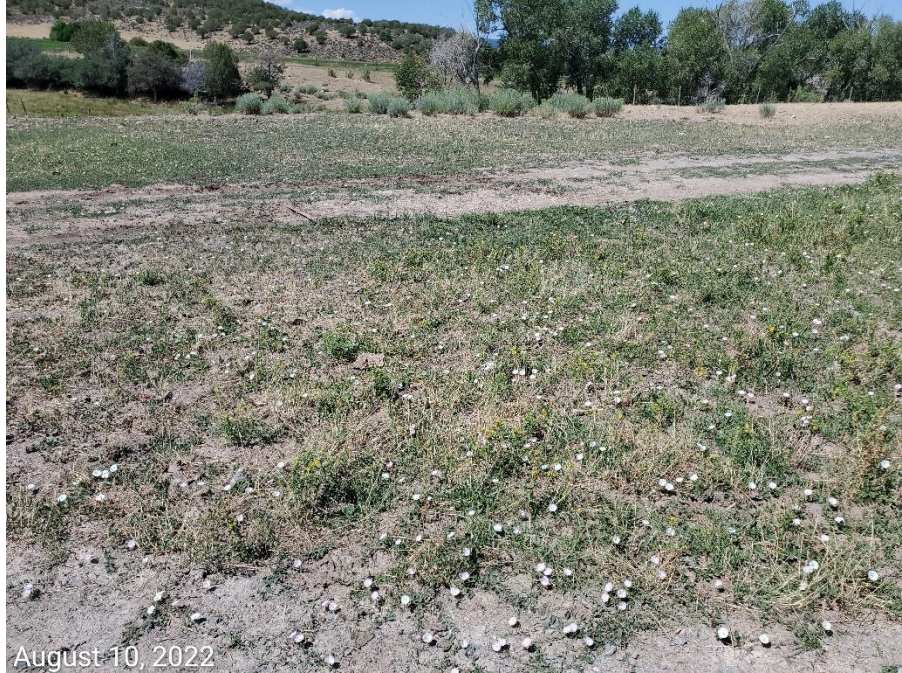
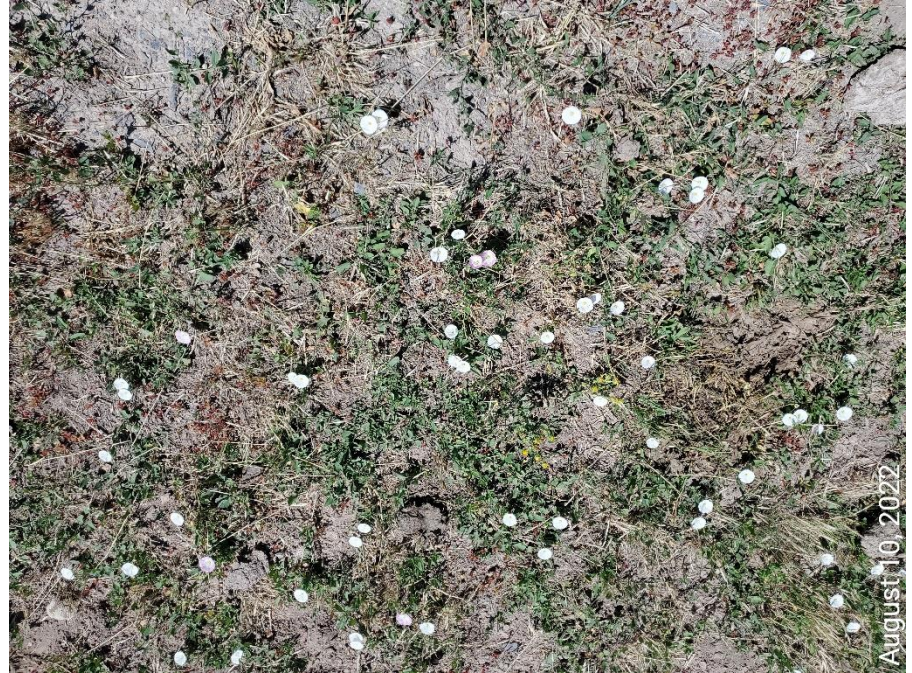
Photo 8: Photos examples showing Undesirable and Noxious Plant species (Field Bindweed, white flowers) have continued to establish and spread throughout the Location.
