Final Reclamation Inspection

Operator: H & R WELL SERVICES, INC - #36980

Location ID: 389360

Inspection Photos
Location Name: STATE WARREN #1
Location ID: 389360

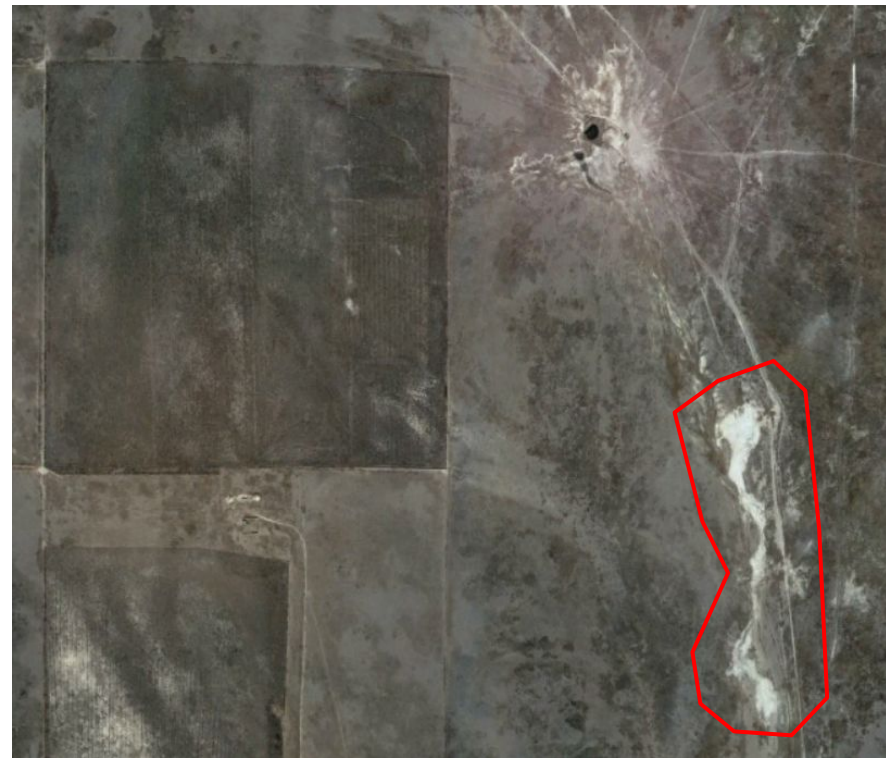
Photo 2. Google Earth aerial imagery from 10/15/2015.

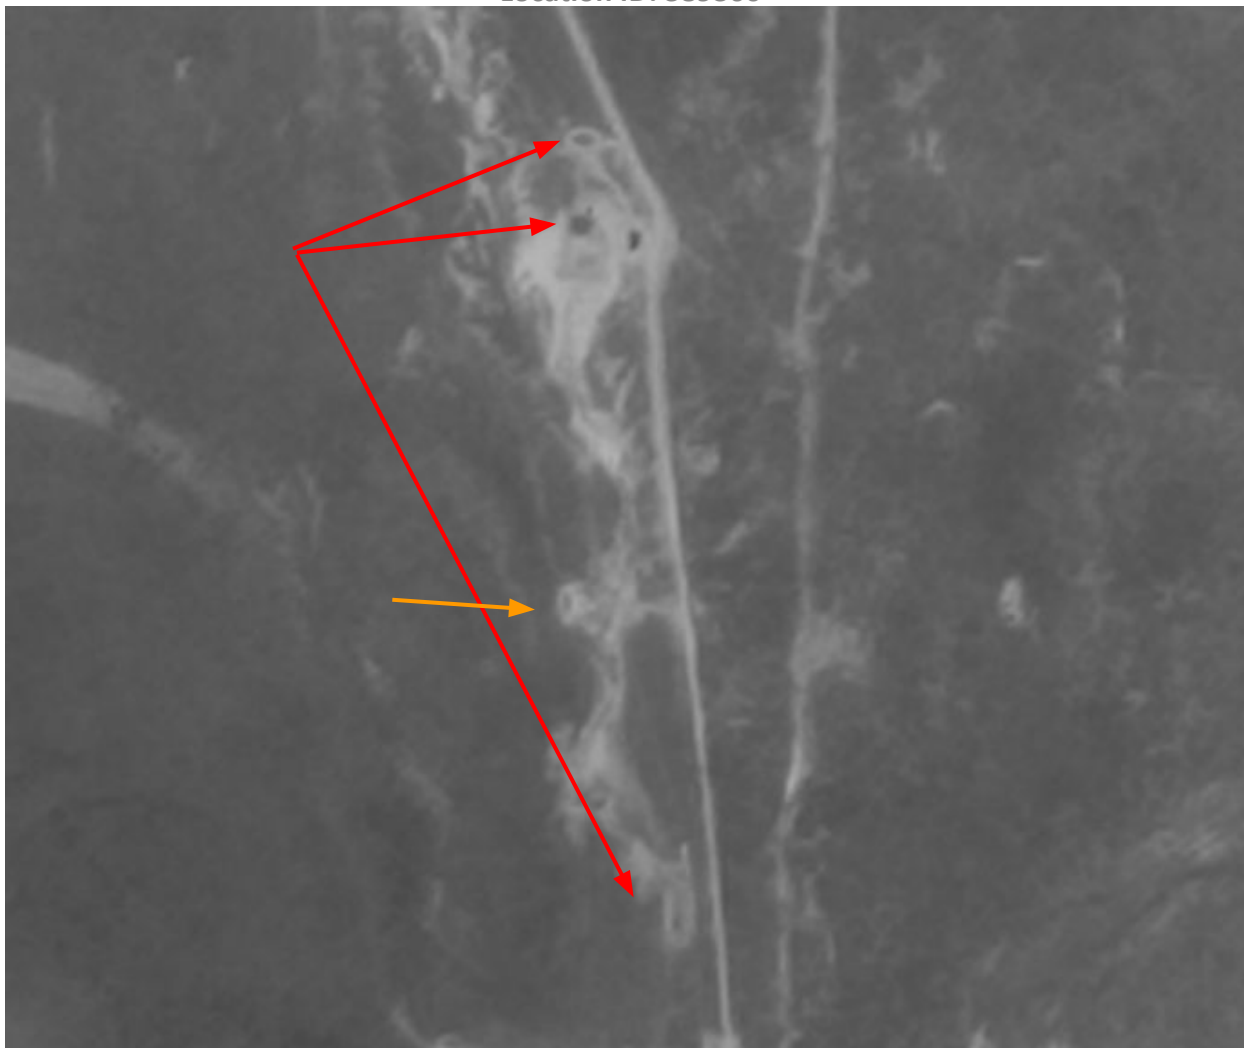
Photo 4. USGS imagery from 1993 illustrates the well, associated pit and produced water spill (red arrows). This imagery illustrates how the produced water spill has migrated further south.

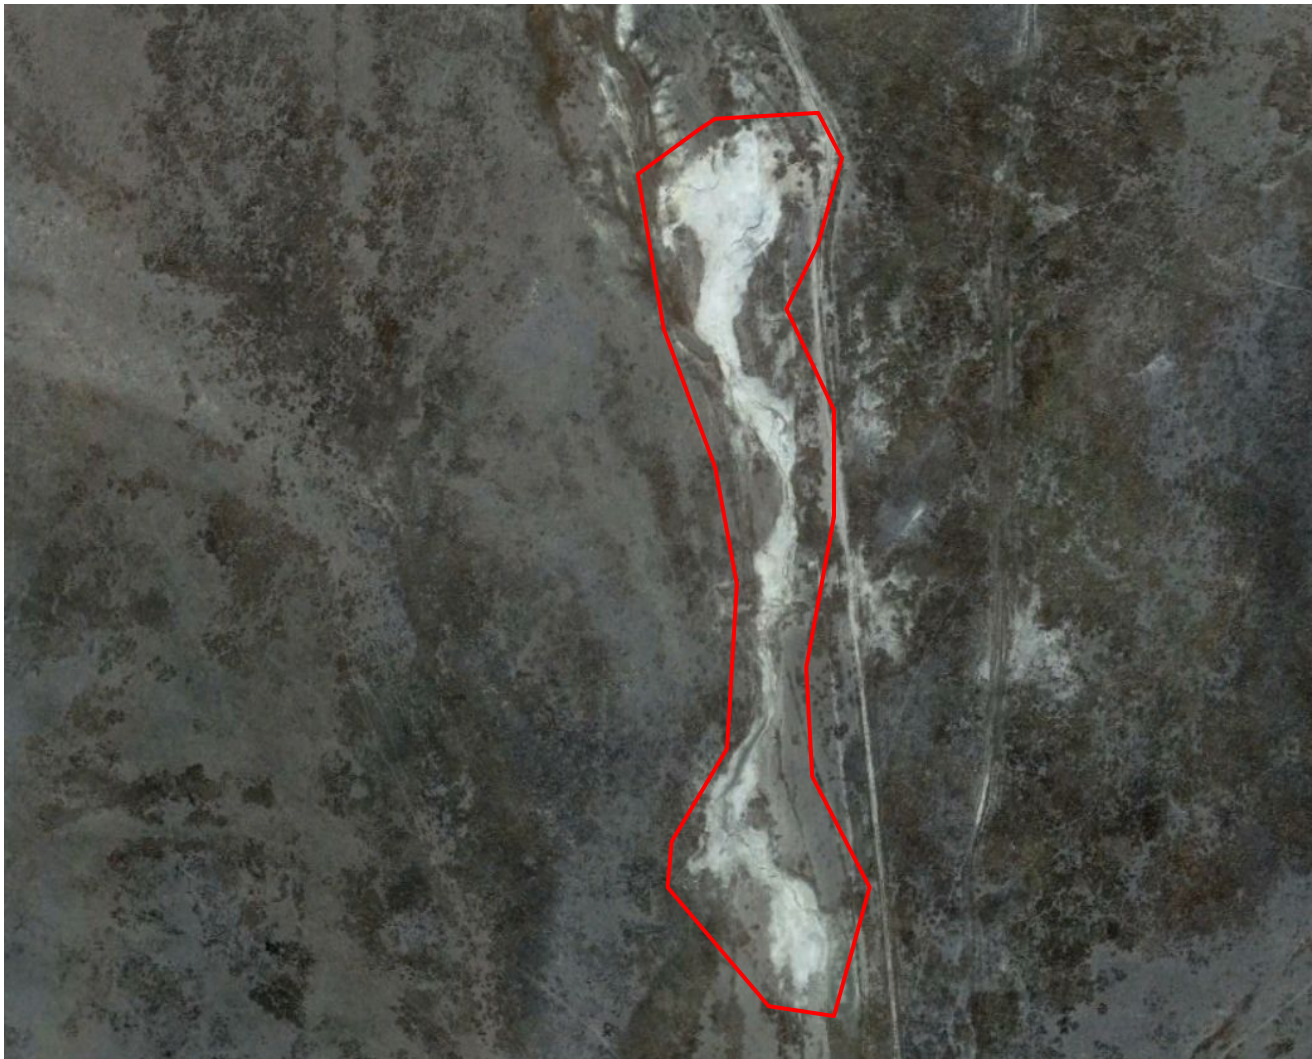
Photo 5. Google Earth aerial imagery from 10/15/2015 illustrates the visual extent of the produced water spill (red) which is further than previously illustrated in the 2016 inspection.

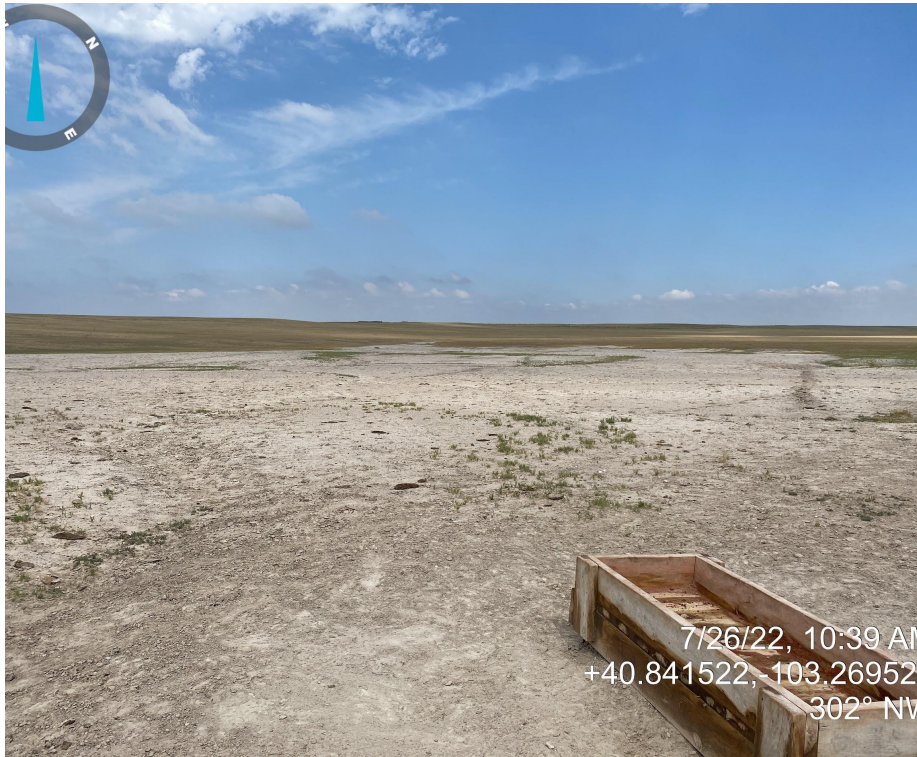
Photo 6. Photo taken from the southern spill area, facing Northwest. Photo illustrates an area that appears to be impacted by a produced water spill related this well.

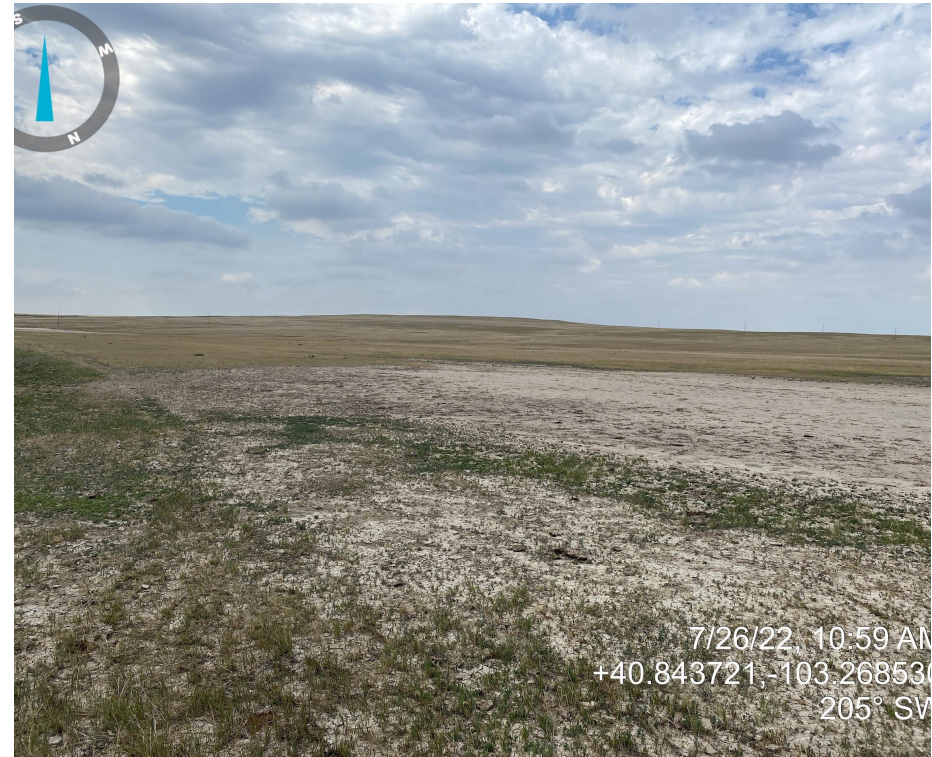
Photo 7. Photo taken from the southern spill area, facing Southwest. See comments under Photo 6.
