# Inspection Photos

API: 061-06590

Operator: OXY USA INC

Inspection Date: 8/11/2022

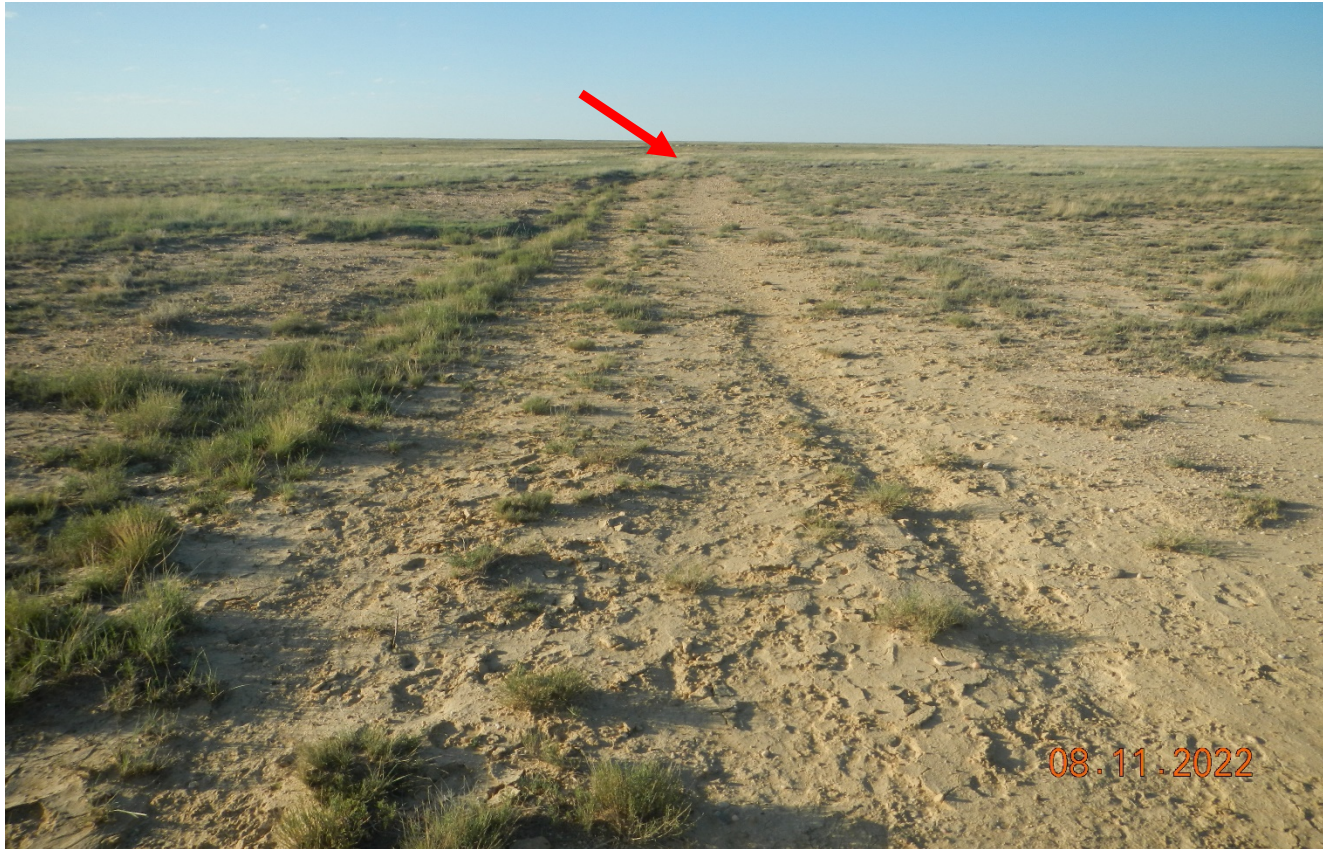
**Photo 1.** Facing southeast along the former access road. Vegetation has not re-established in this area and there is erosion. Location is shown at red arrow.

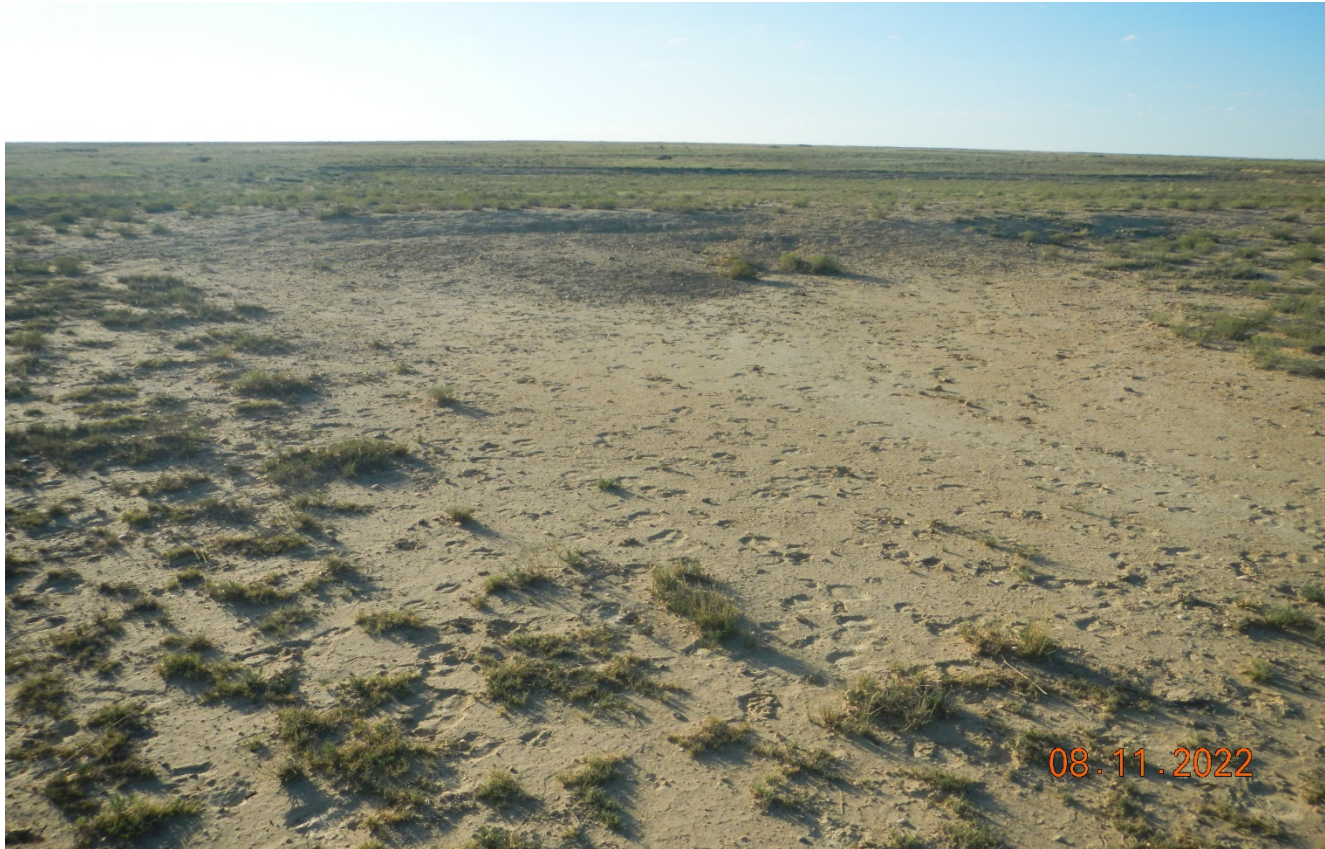
**Photo 2.** Facing southeast at the location. The fill slope has not been recontoured. There is no vegetation growth along this area.

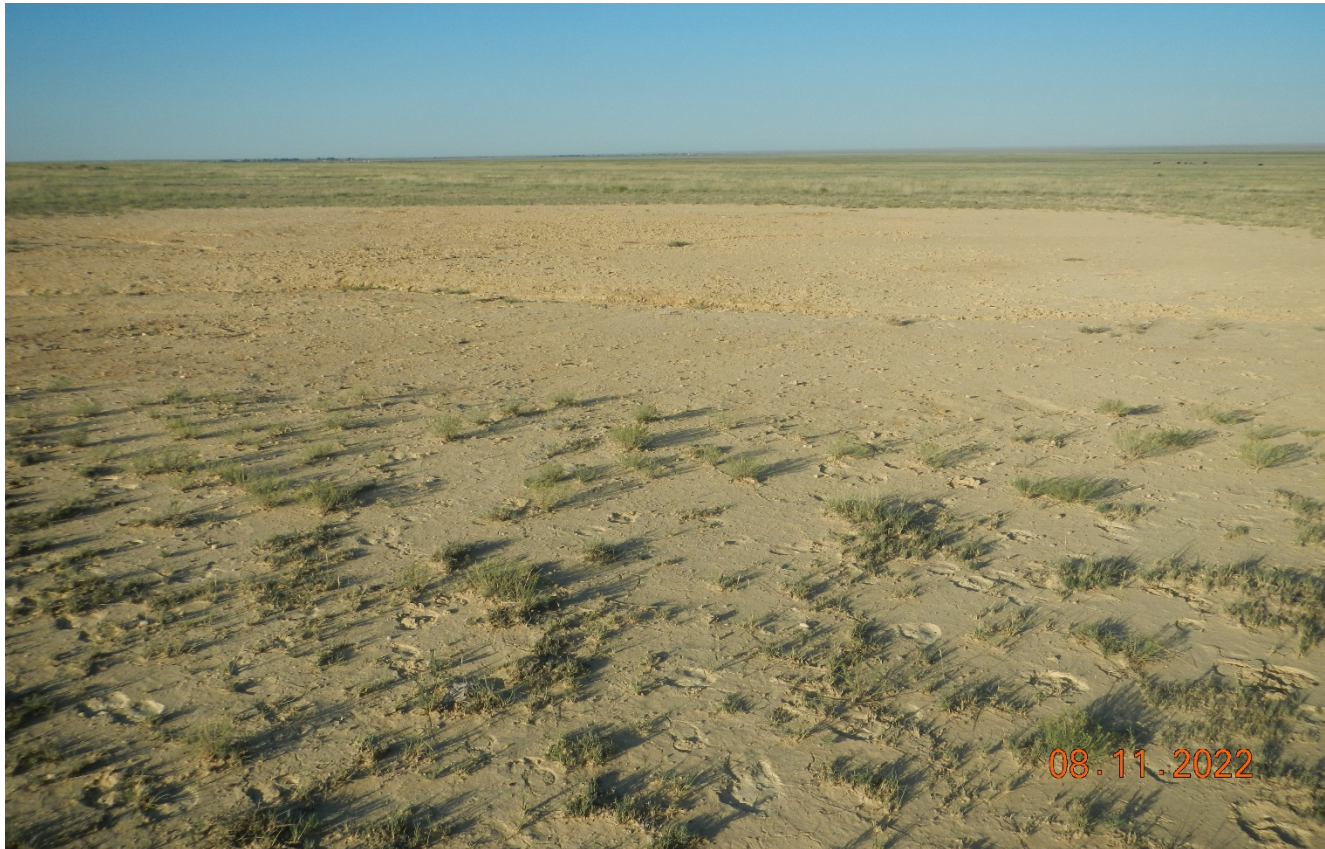
**Photo 3.** Facing southwest at the location. There is no vegetation observed in this bare area approximately 120'x120'. There may be soil issues preventing vegetation establishment.

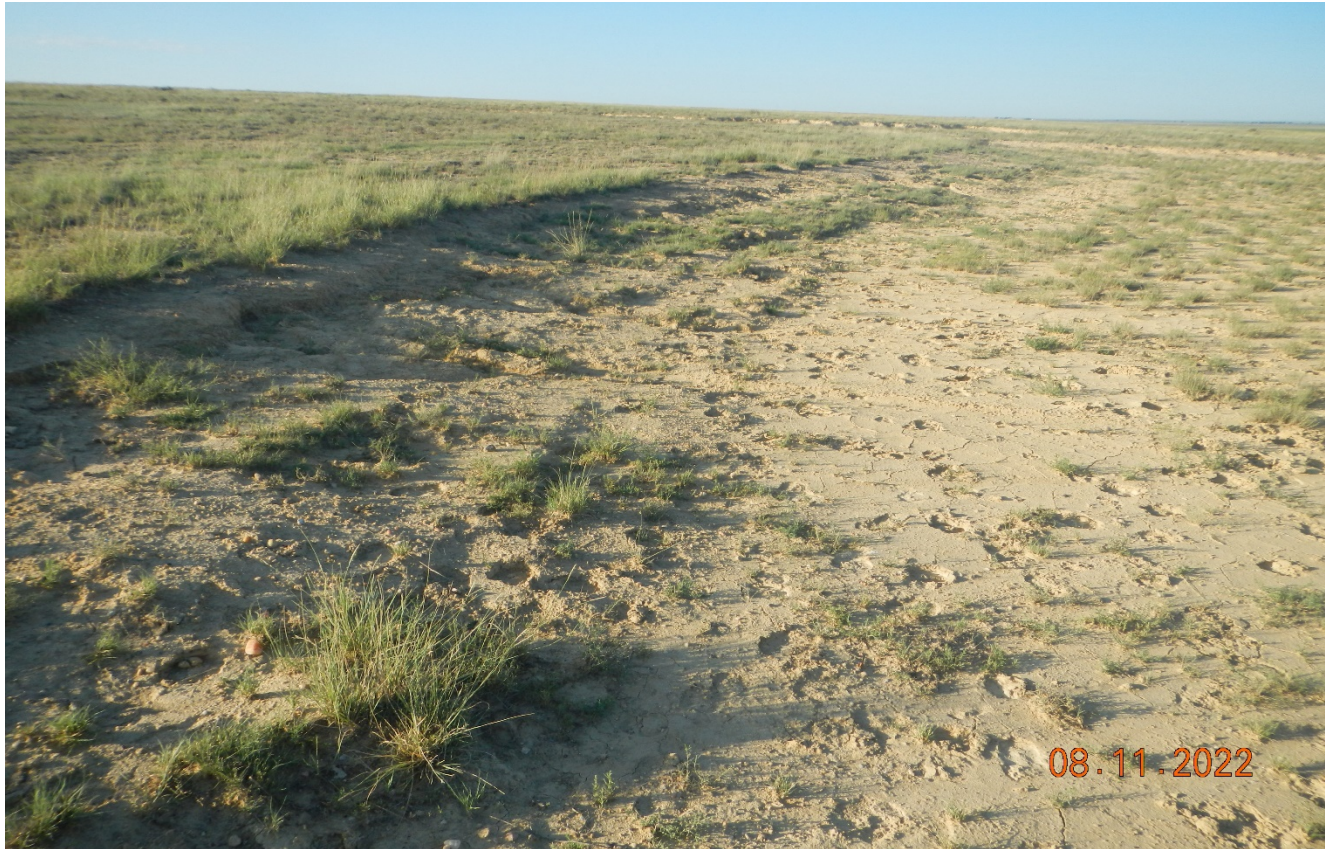
**Photo 4.** Facing southwest along the cut slope which is not recontoured. There are signs of erosion and soils are not stabilized.

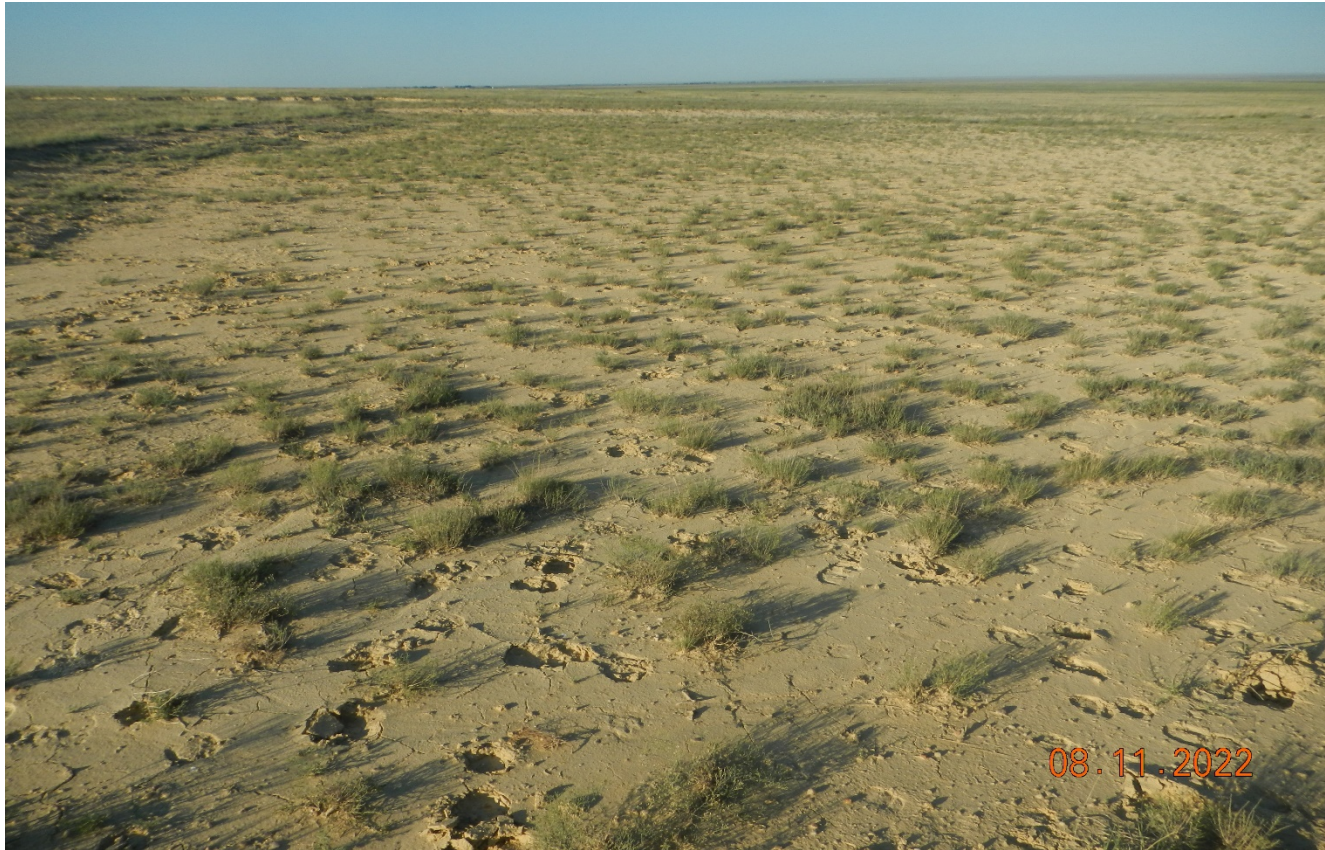
**Photo 5.** Facing southwest at the at the eastern corner of the location.

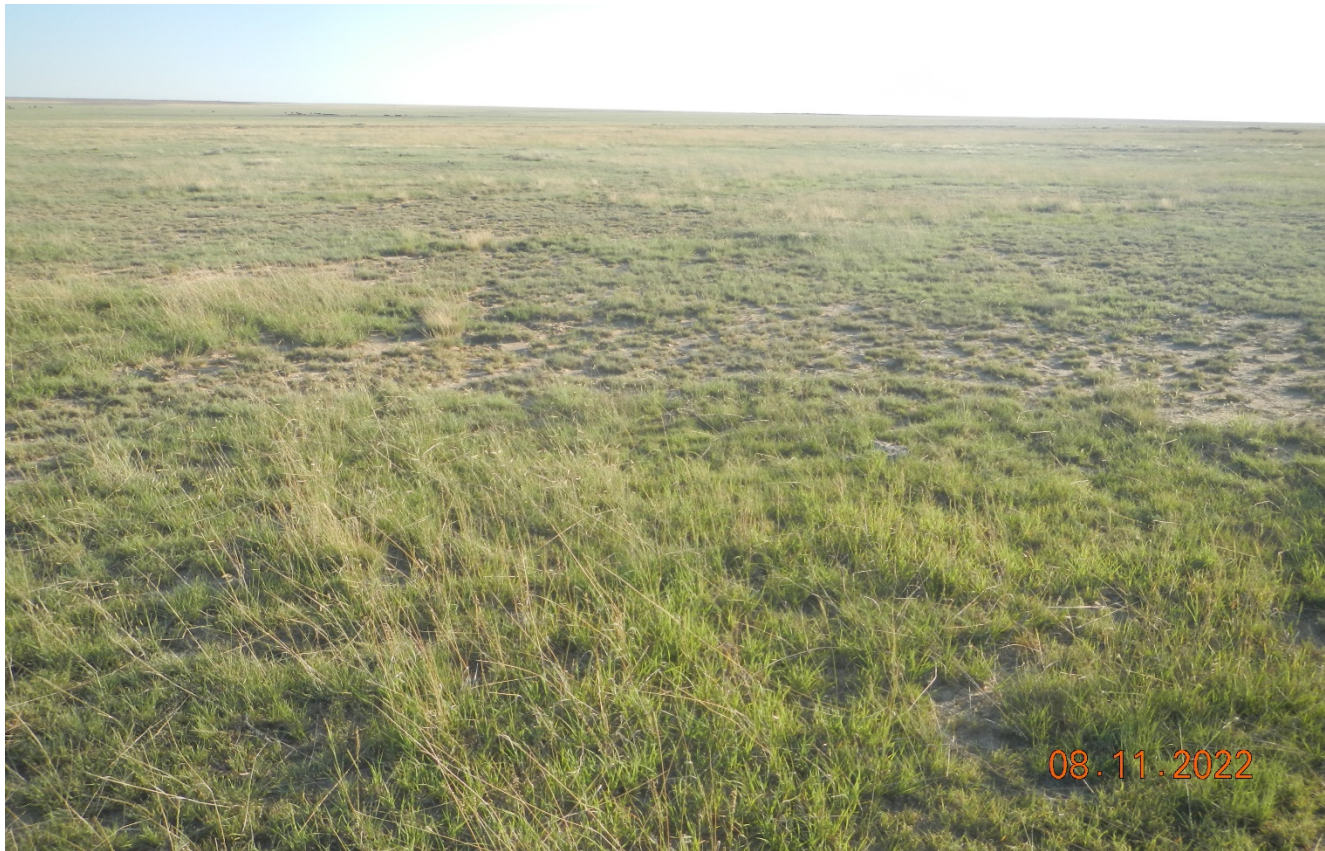
**Photo 6.** Facing east toward the surrounding undisturbed rangeland consisting of Blue grama, Sand dropseed among other native species.

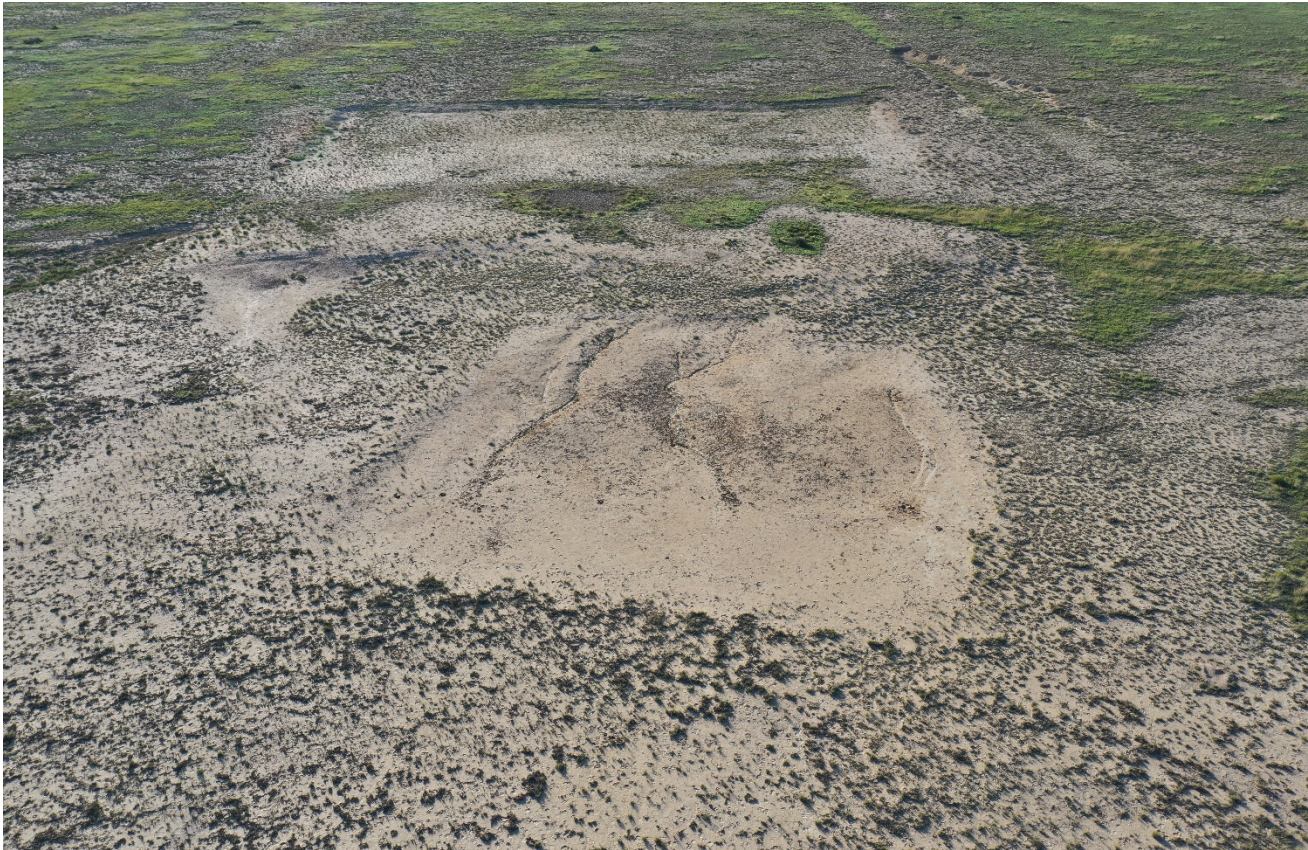
**Photo 7.** Drone aerial photo facing southeast toward the location.

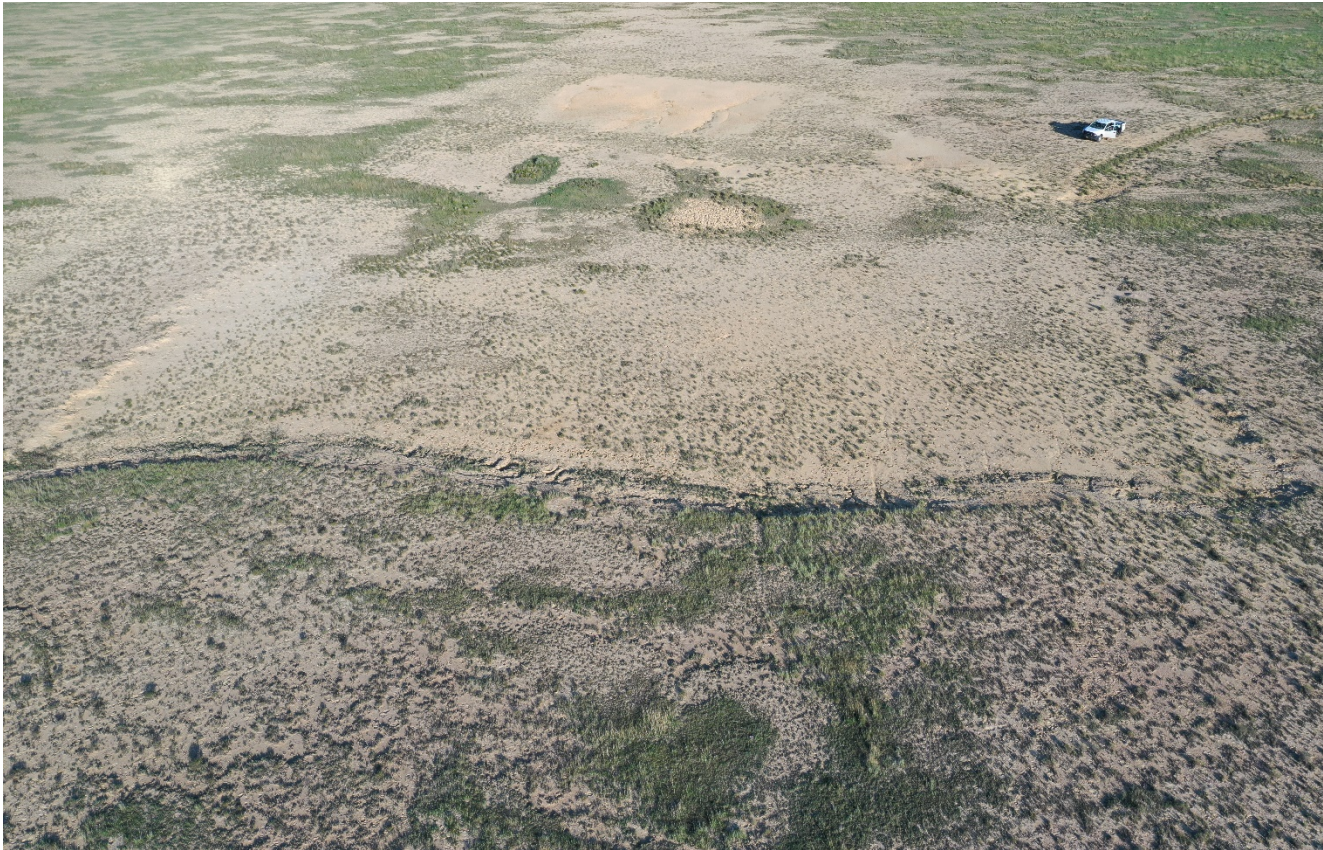
**Photo 8.** Drone aerial photo facing northwest toward the location.
