Inspection Photos and Issue Report

8/17/2022

Operator: CAERUS PICEANCE LLC #10456

Location #479214

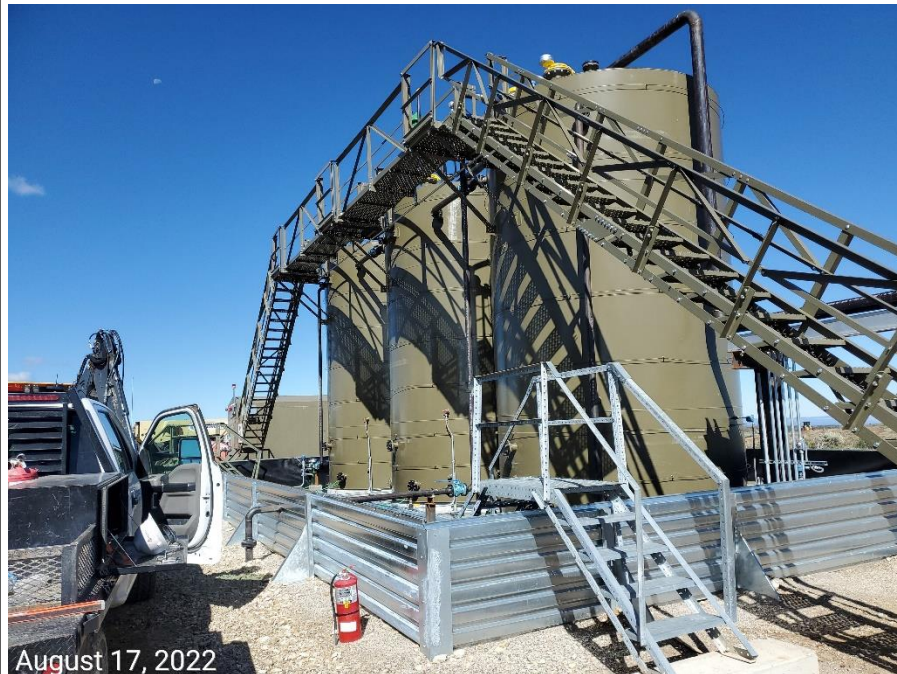
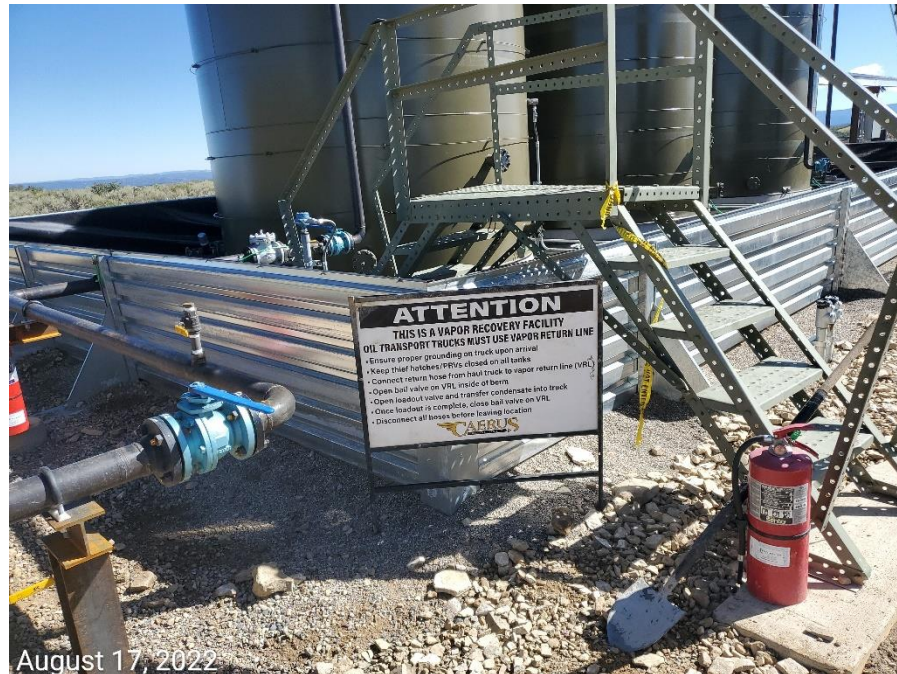
Photo 1: Tanks/Battery on the north end of the Location; tanks missing required labeling.

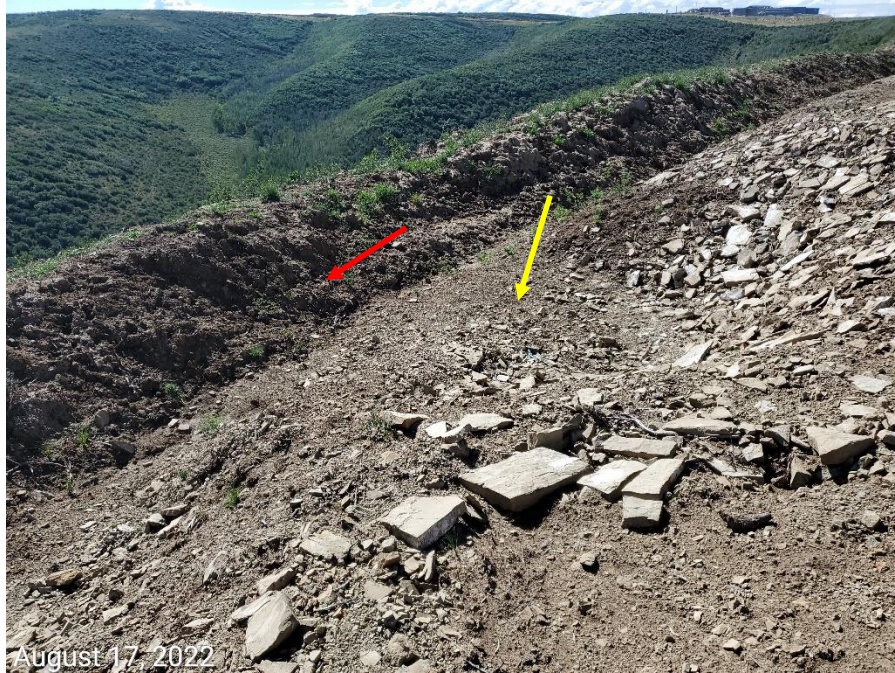
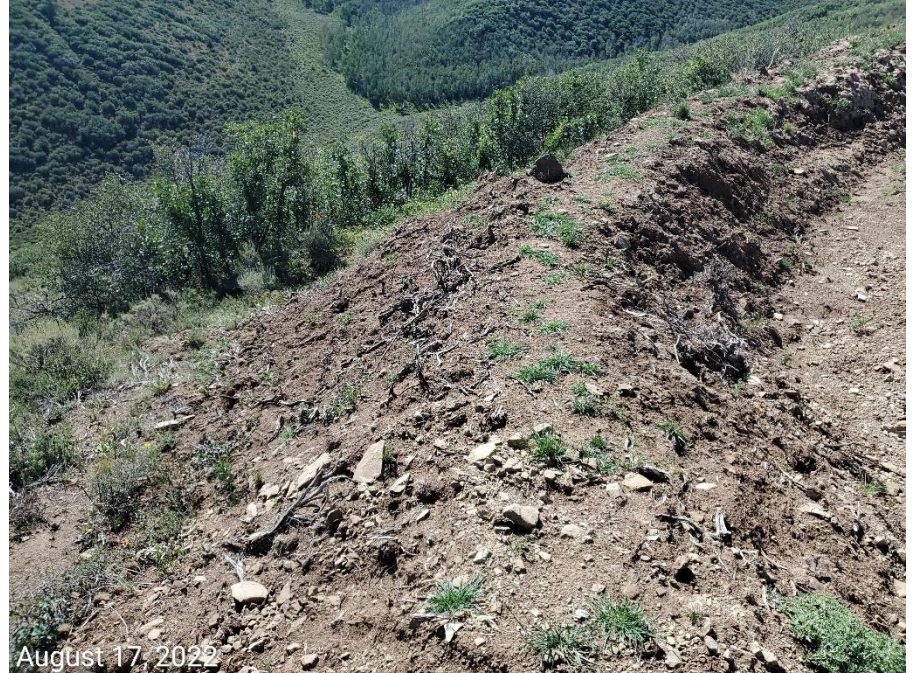
Photo 2: Photos taken from the perimeter topsoil stockpile on the east end of the Location. Photos examples showing topsoil remains (red arrow) in use as part of the Location perimeter stormwater ditch/berm and sediment trap (yellow arrow). Photos also examples showing BMPs to protect and stabilize the topsoil stockpiles remains missing or insufficient; hydromulch previously implemented has not been maintained in proper functioning condition.

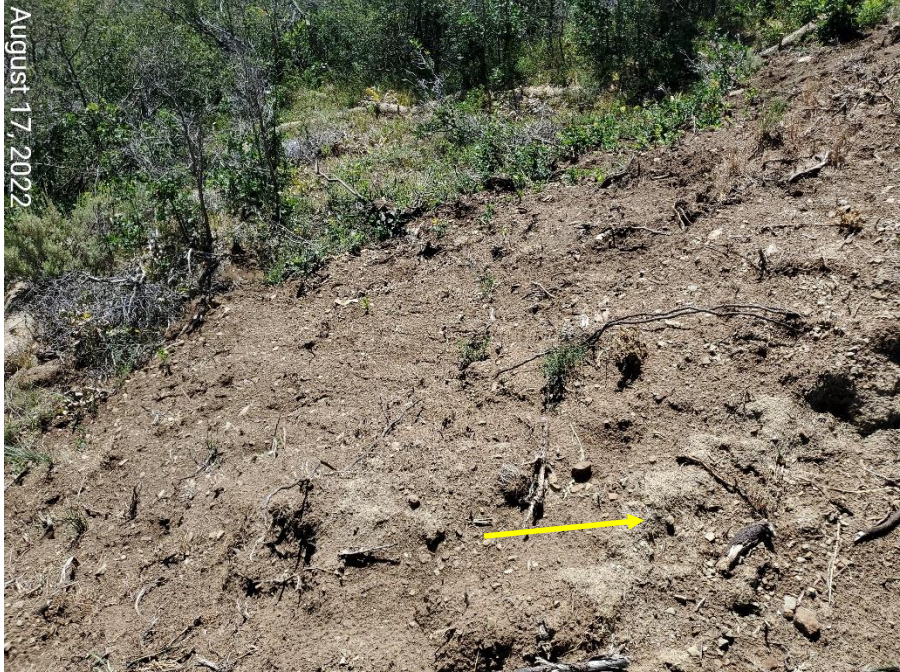
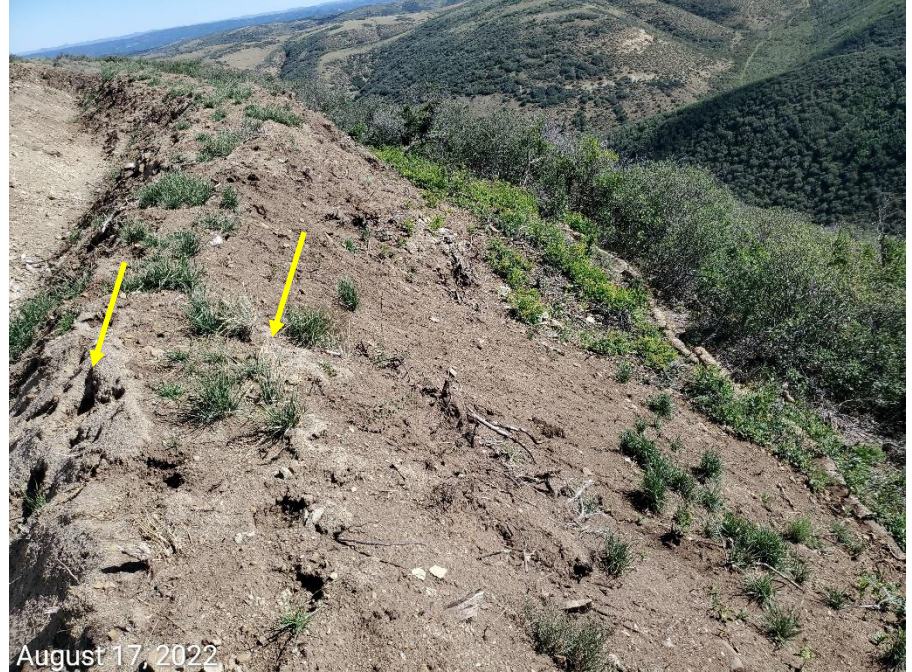
Photo 3: Photos examples showing BMPs to protect the topsoil stockpiles are missing or insufficient; soils at the stockpiles are exposed and at risk to wind and water erosion. Arrow shows areas of hydromulch that had been previously applied; BMP has not been maintained.

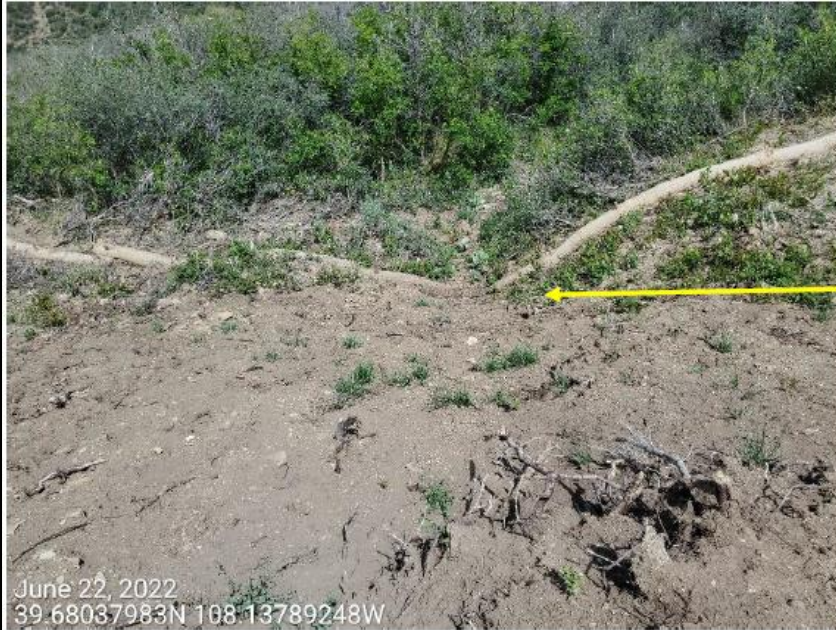
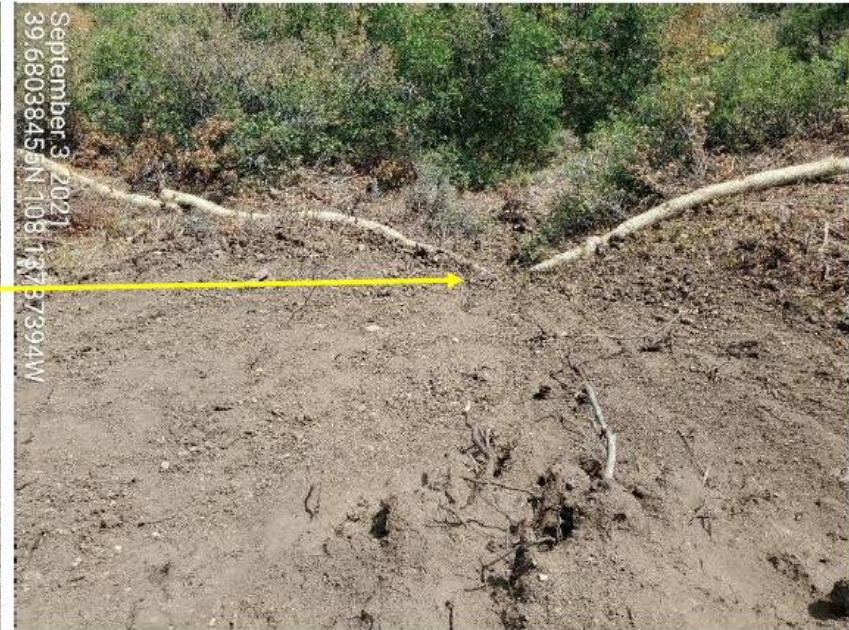
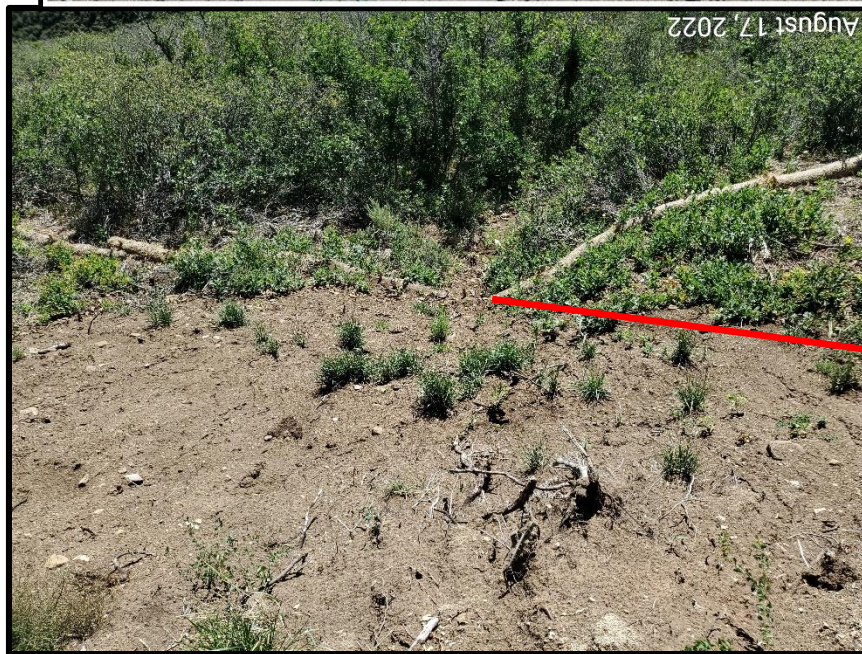
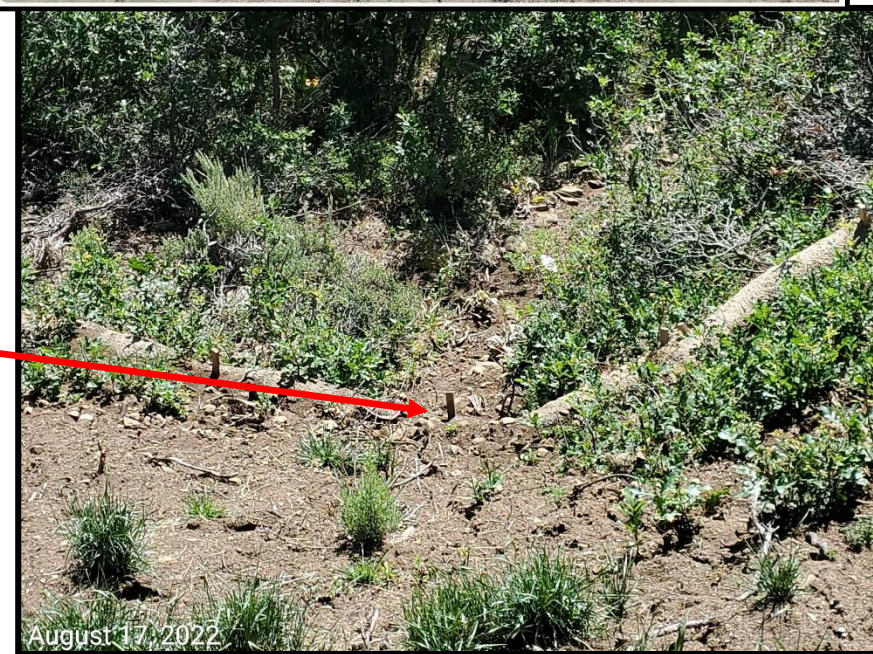
Photo 4: Top photos show areas identified in the 9/3/2021 and 6/22/2022 inspections, where offsite sediment transport from the topsoil stockpiles is evident. Bottom photos from 8/17/2022 show BMPs to protect/stabilize topsoil stockpiles, and to prevent offsite sediment (red arrow) transport remains inadequate and/or have not been maintained.
