Inspection Photos

API: 071-09918

Operator: BNL (ENTERPRISE) INC

Inspection Date: 8/23/2022

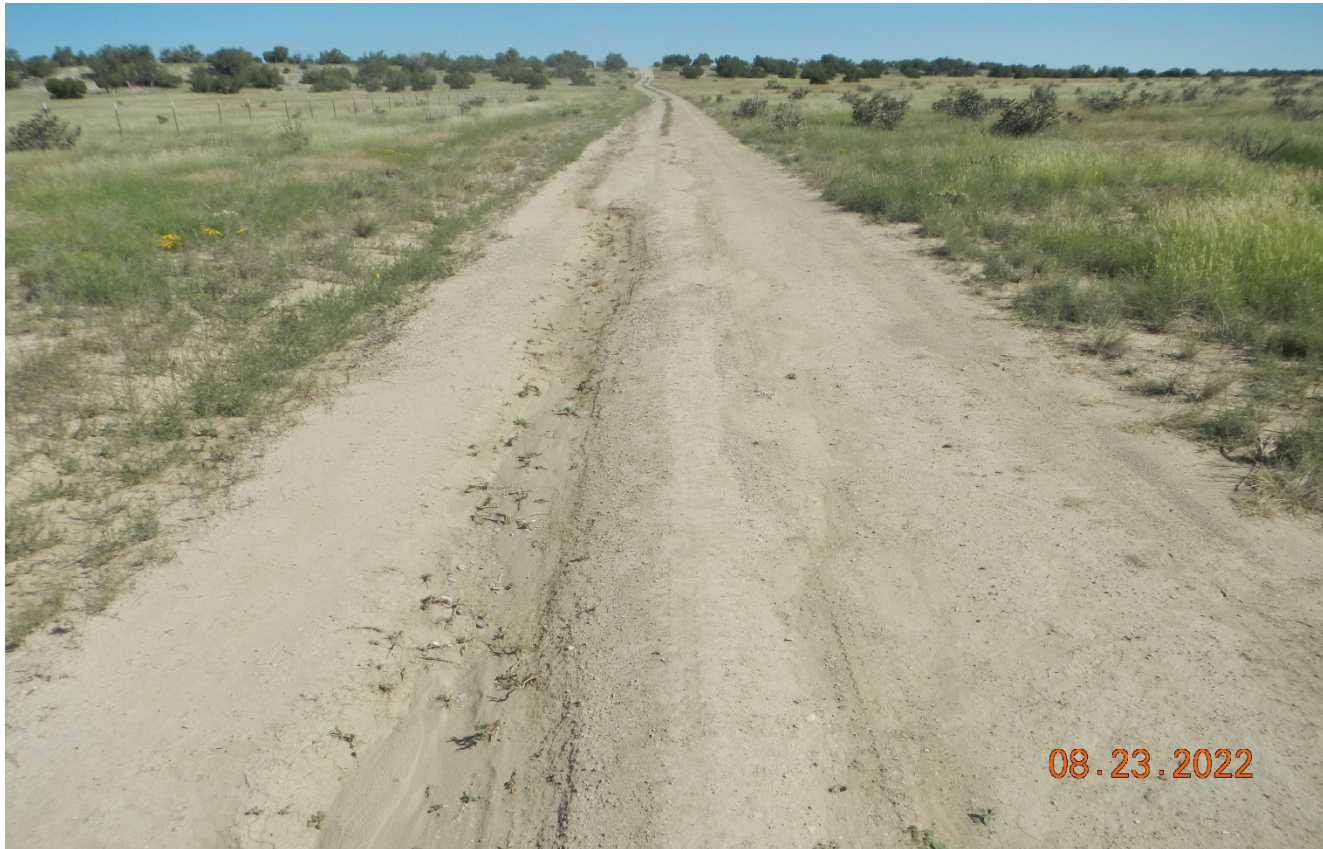
Photo 1. Facing north along the access road. There are signs of erosion along the road that need to be repaired and stabilized.

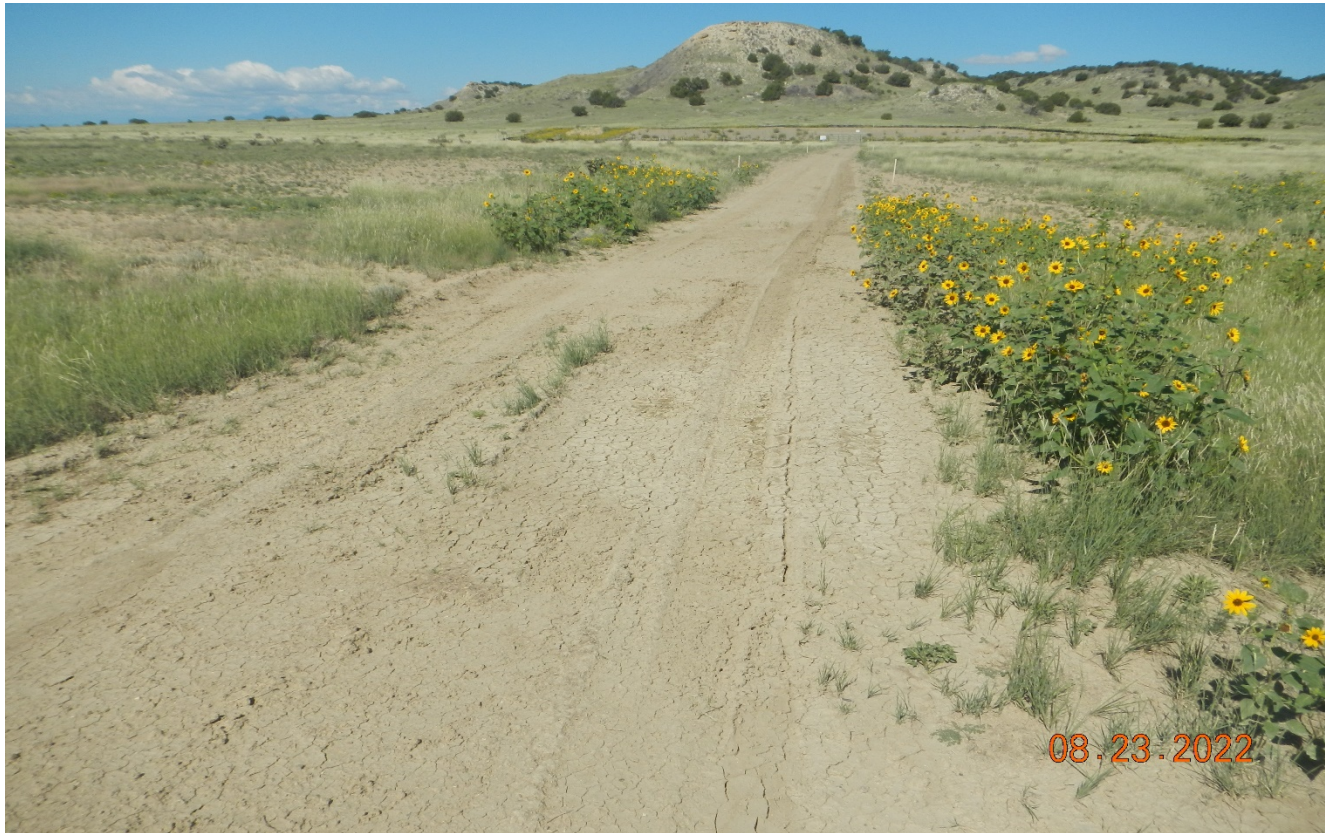
Photo 2. Facing west along the access road. There are signs stormwater is pooling along the road. The road will need to be stabilized with BMP's

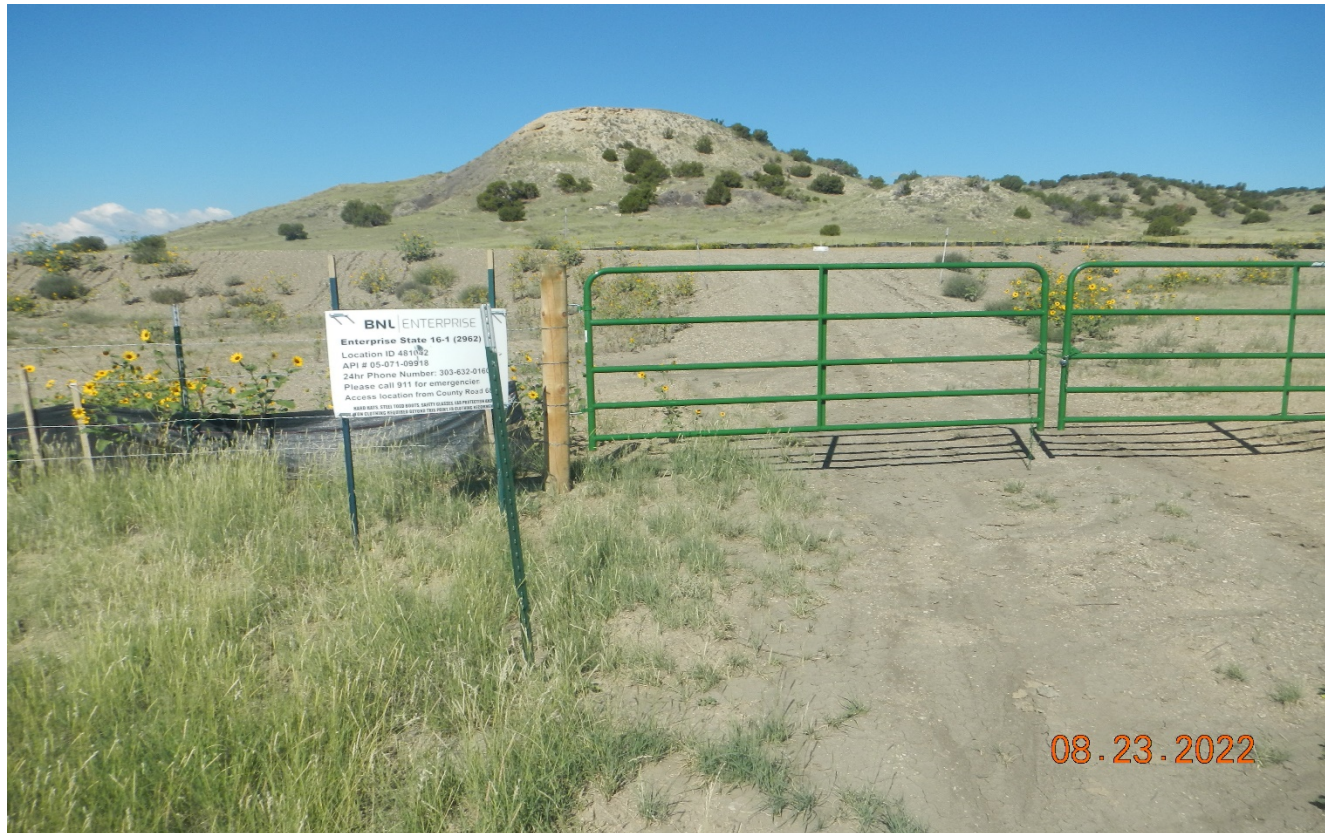
Photo 3. Facing west toward the location.

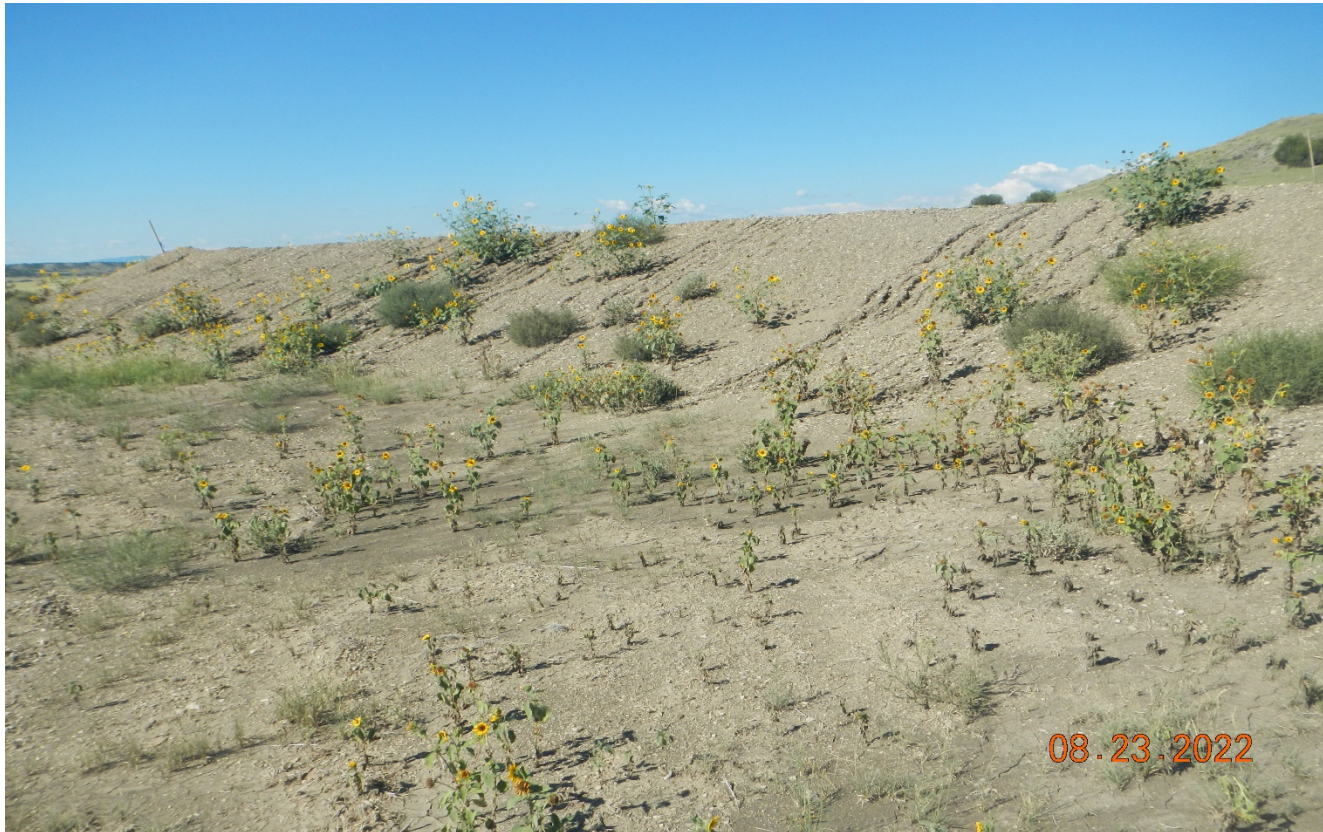
Photo 4. Facing southwest toward the fill slope of the well pad. There is erosion occurring along the fill slope. The fill slope needs to be recontoured and stabilized for interim reclamation.

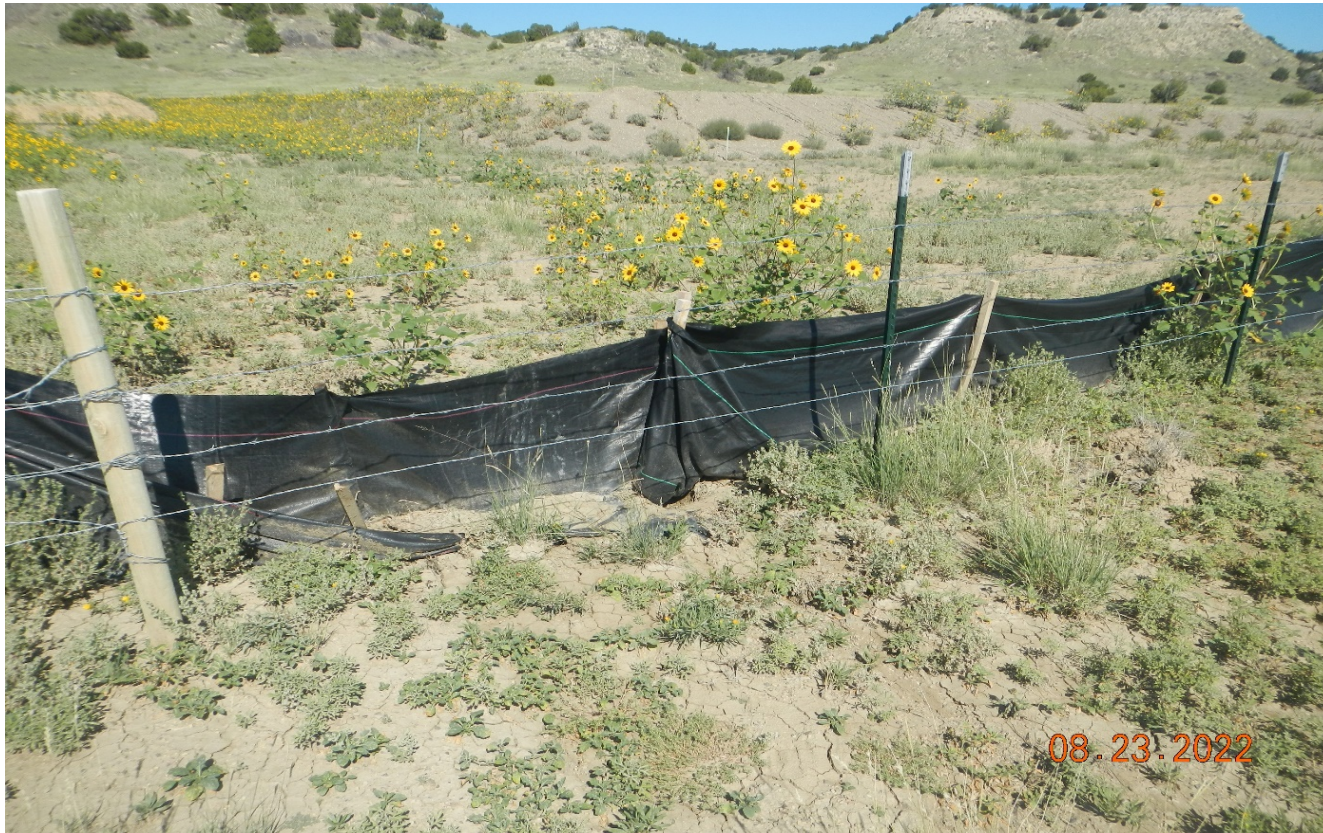
Photo 5. Facing northwest at the southeast corner of the location. Stormwater is being concentrated to this area. The silt fence is not adequate and additional BMP's need to be installed in this area.

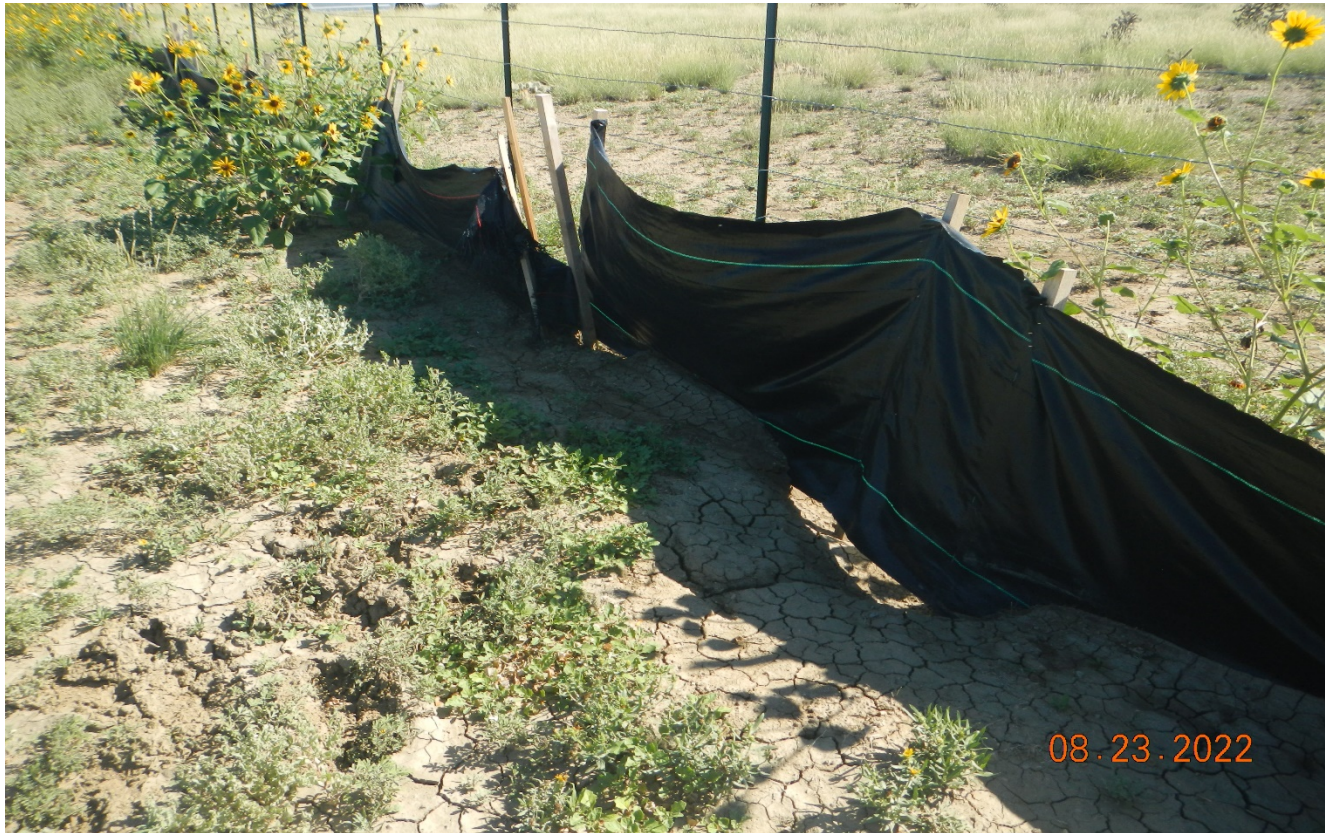
Photo 6. Stormwater is flowing underneath the silt fence in the southeast corner of the location. The silt fence is not adequate and additional BMP's need to be installed in this area. Silt fence is only a temporary erosion control and long term erosion controls need to be installed e.g. sediment trap, rock rip/rap, seeding, vegetation, ect.

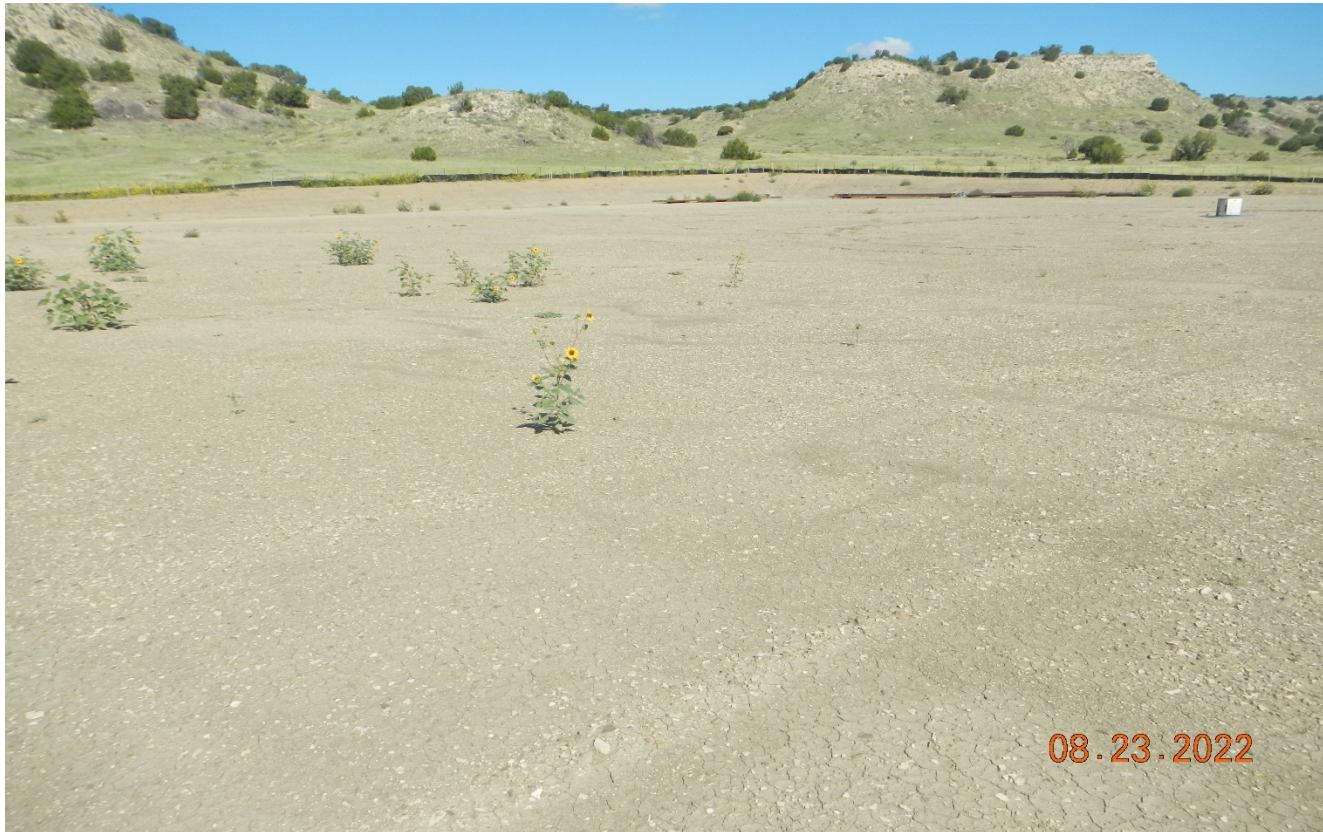
Photo 7. Facing northwest toward the location. The well pad location needs to be recontoured and reclaimed per 1003 Rules.

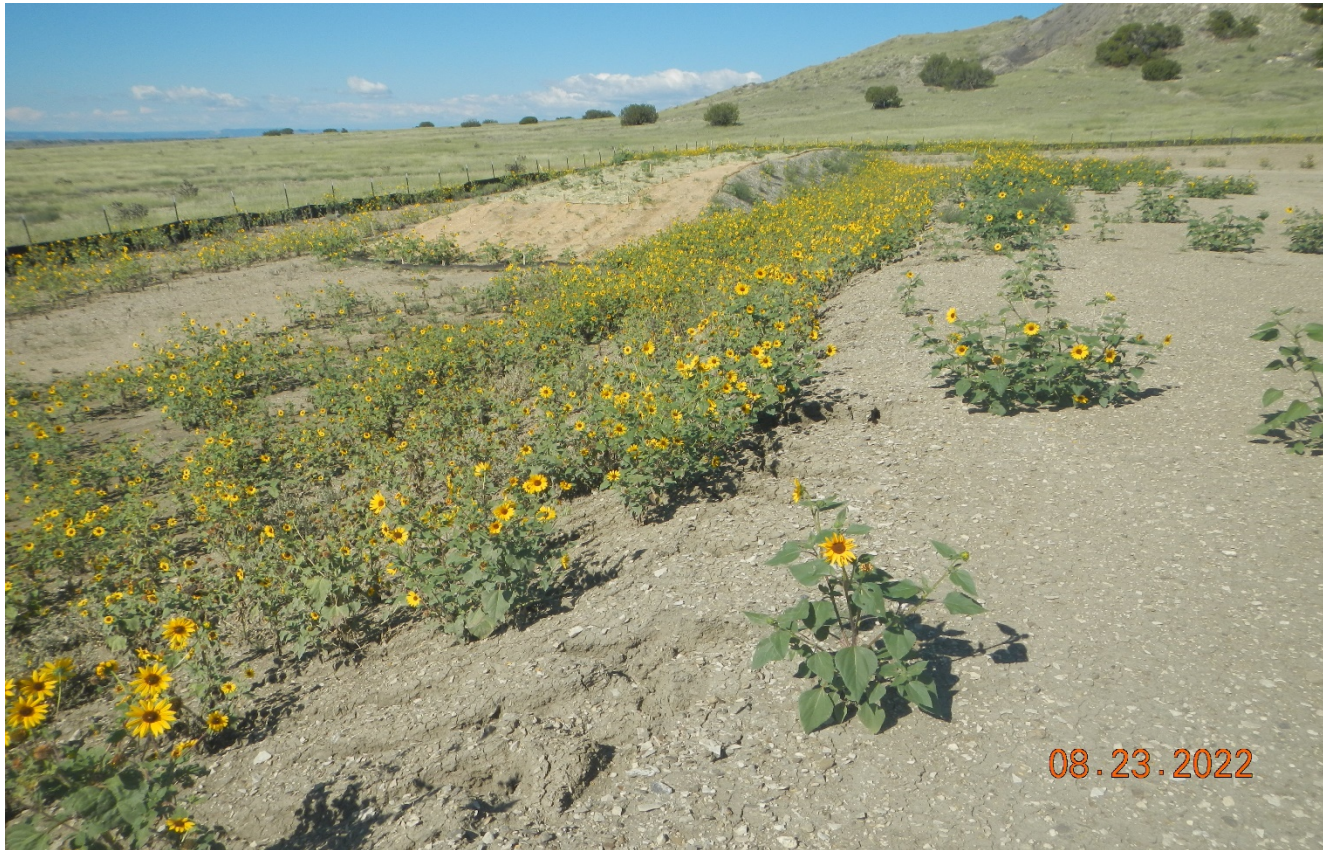
Photo 8. Facing southwest toward the topsoil pile. It does not appear the entire topsoil pile was seeded as vegetation is not establishing. All unused disturbed areas will need to be reclaimed and part of the topsoil will need to be replaced.

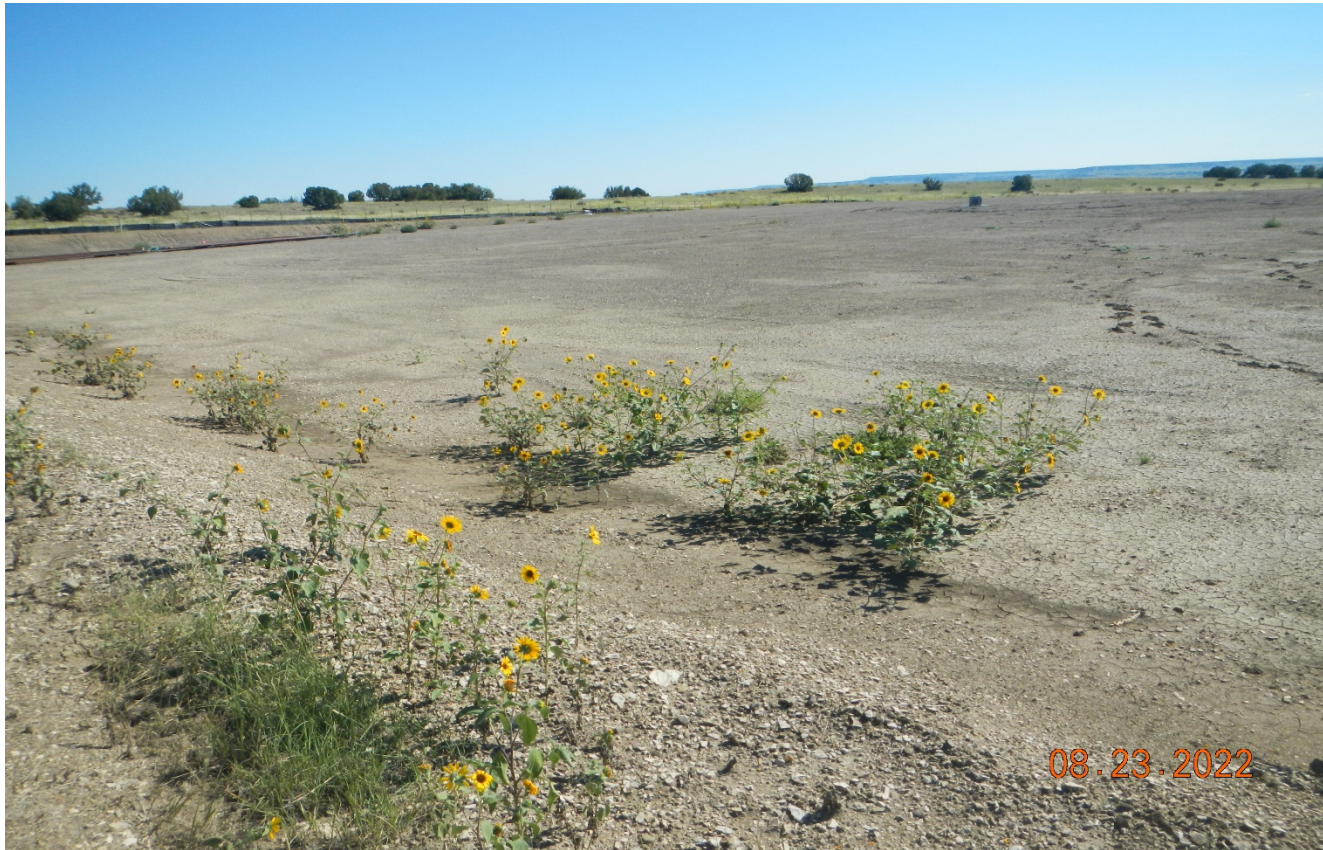
Photo 9. Facing northeast toward the location. The well pad location needs to be recontoured and reclaimed per 1003 Rules.

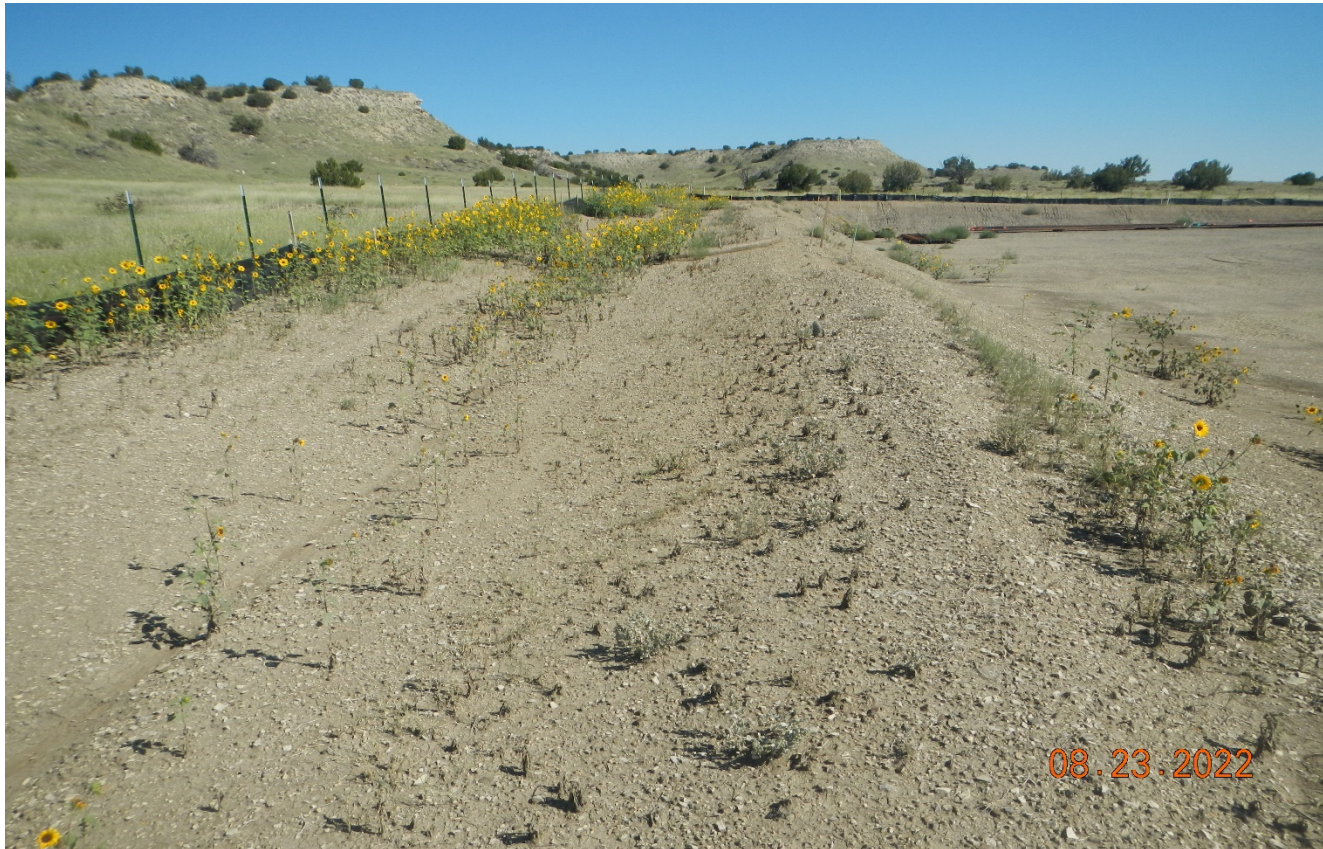
Photo 10. Southwest side of the location facing northwest. There are wattles installed along the perimeter swale. The disturbed soils will need to be reclaimed for long term stabilization.

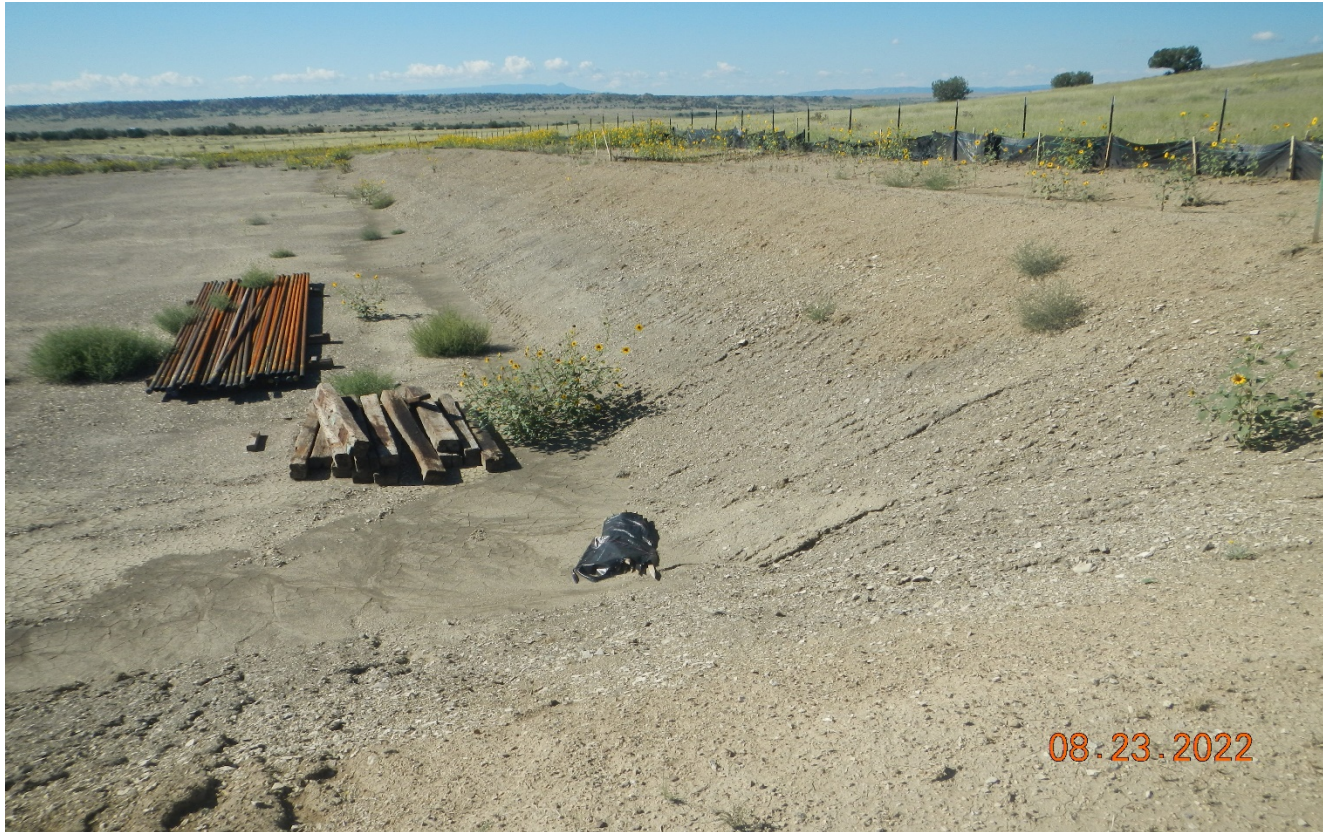
Photo 11. Northwest side of the location facing southwest toward the cut slope. The cut slope needs to be stabilized with interim reclamation. All unused equipment needs to be removed. Drill pipe, wood ties, ect.

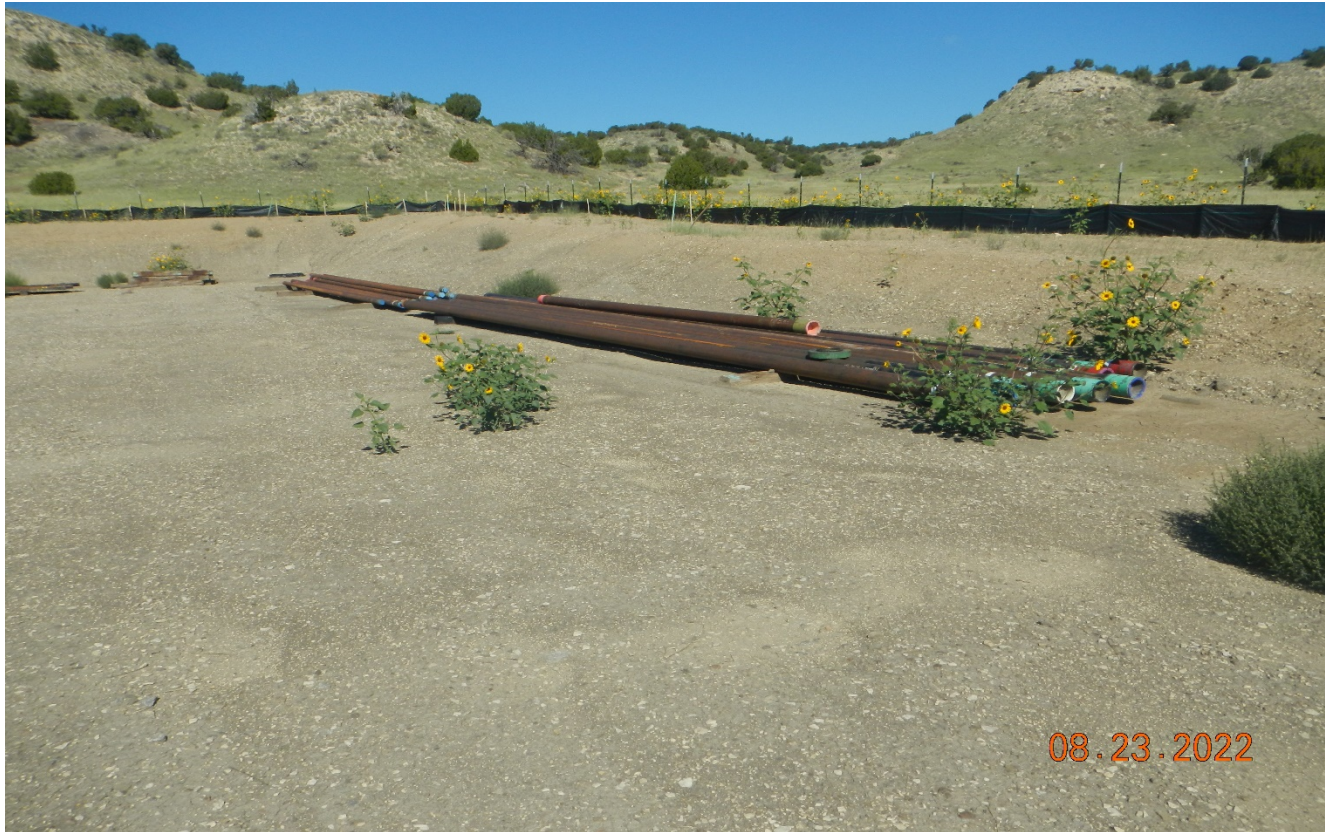
Photo 12. The drilling pipe needs to be remove per rule 606.

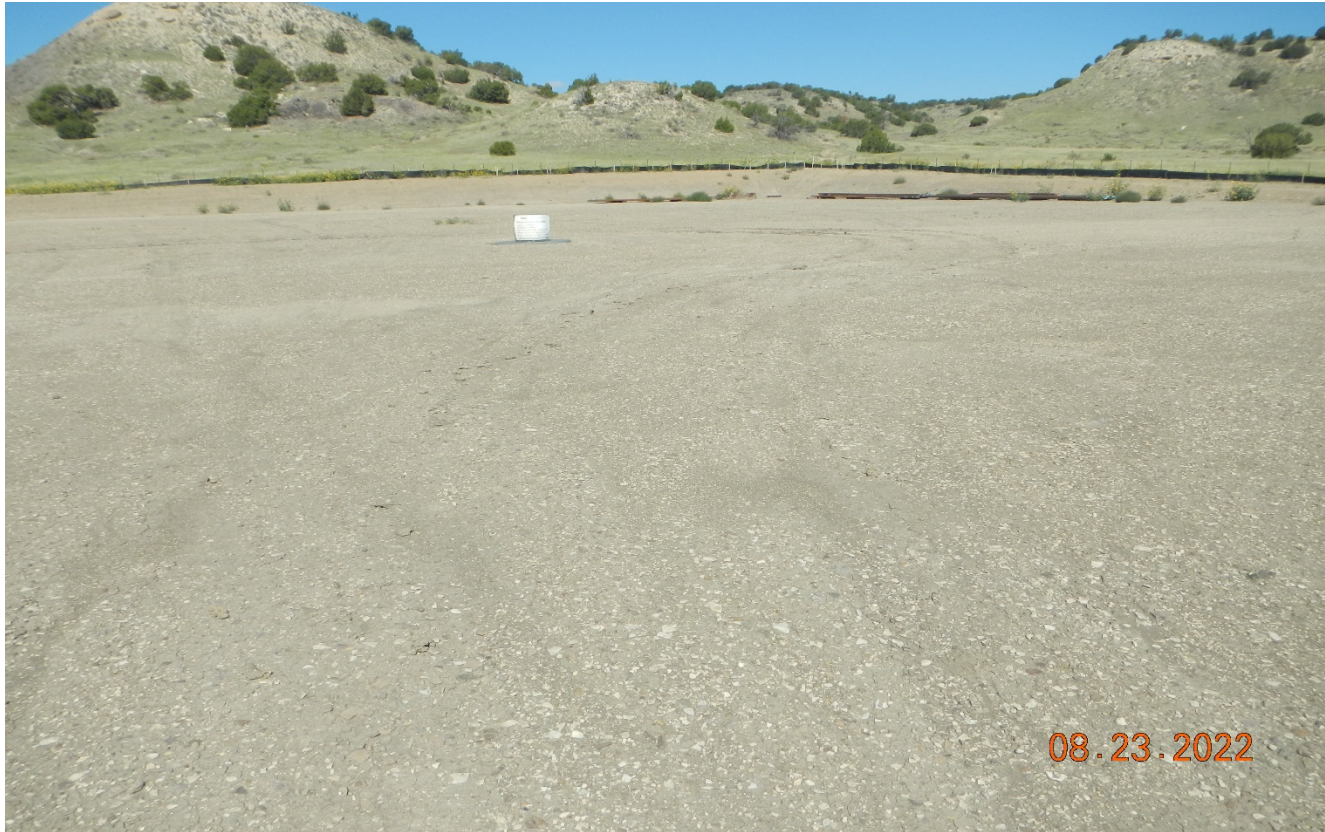
Photo 13. Facing northwest toward the location. The open top tank was removed since previous inspection.
