Final Reclamation Inspection

Operator: PDC ENERGY INC - 69175

Location ID: 323171

Inspection Photos
Location Name: Nadine 1-24
Location ID: 323171

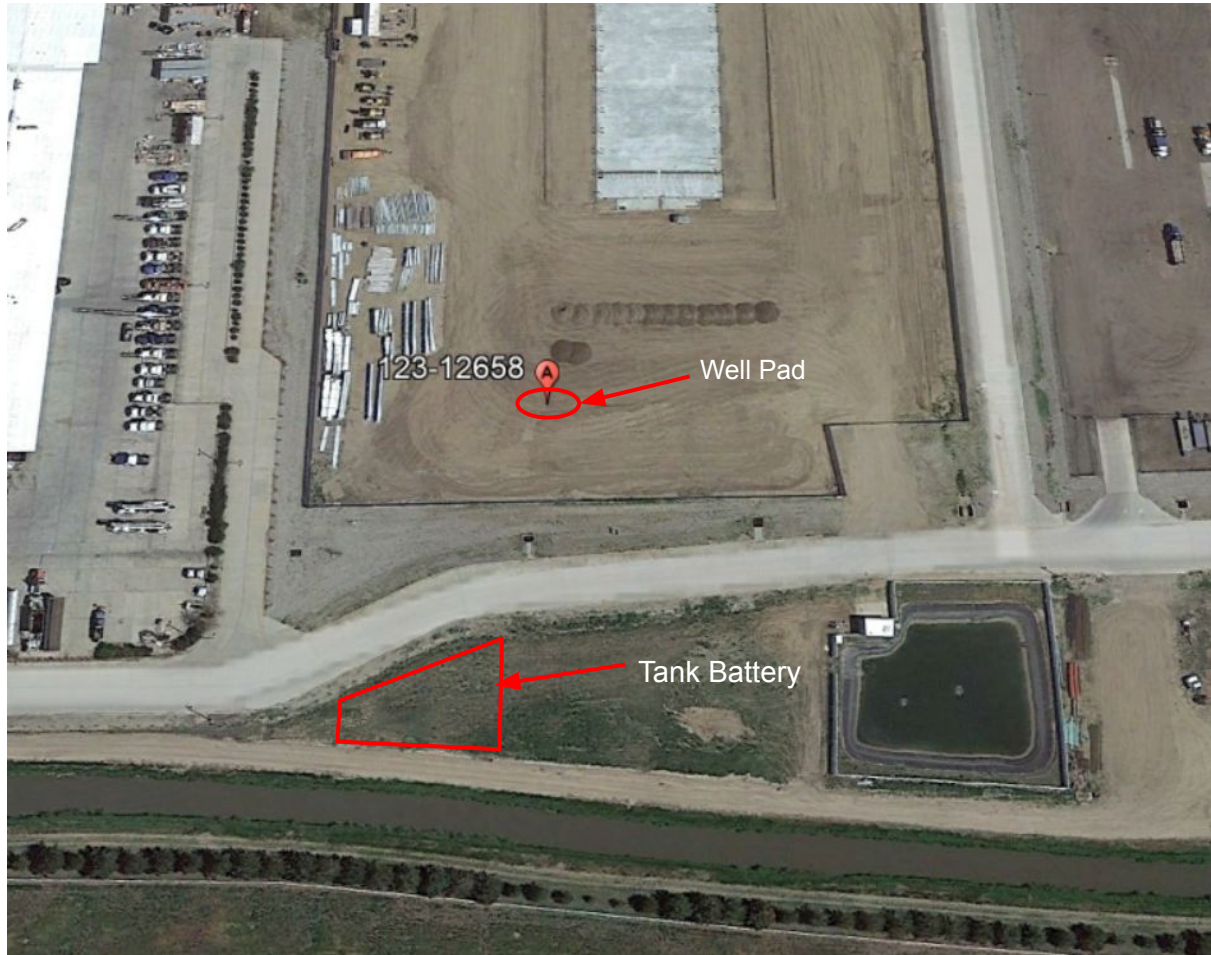
Photo 1. 2021 aerial imagery of the well pad and tank battery. Note: well pad falls within a commercial lot owned by Western Equipment Truck Inc.

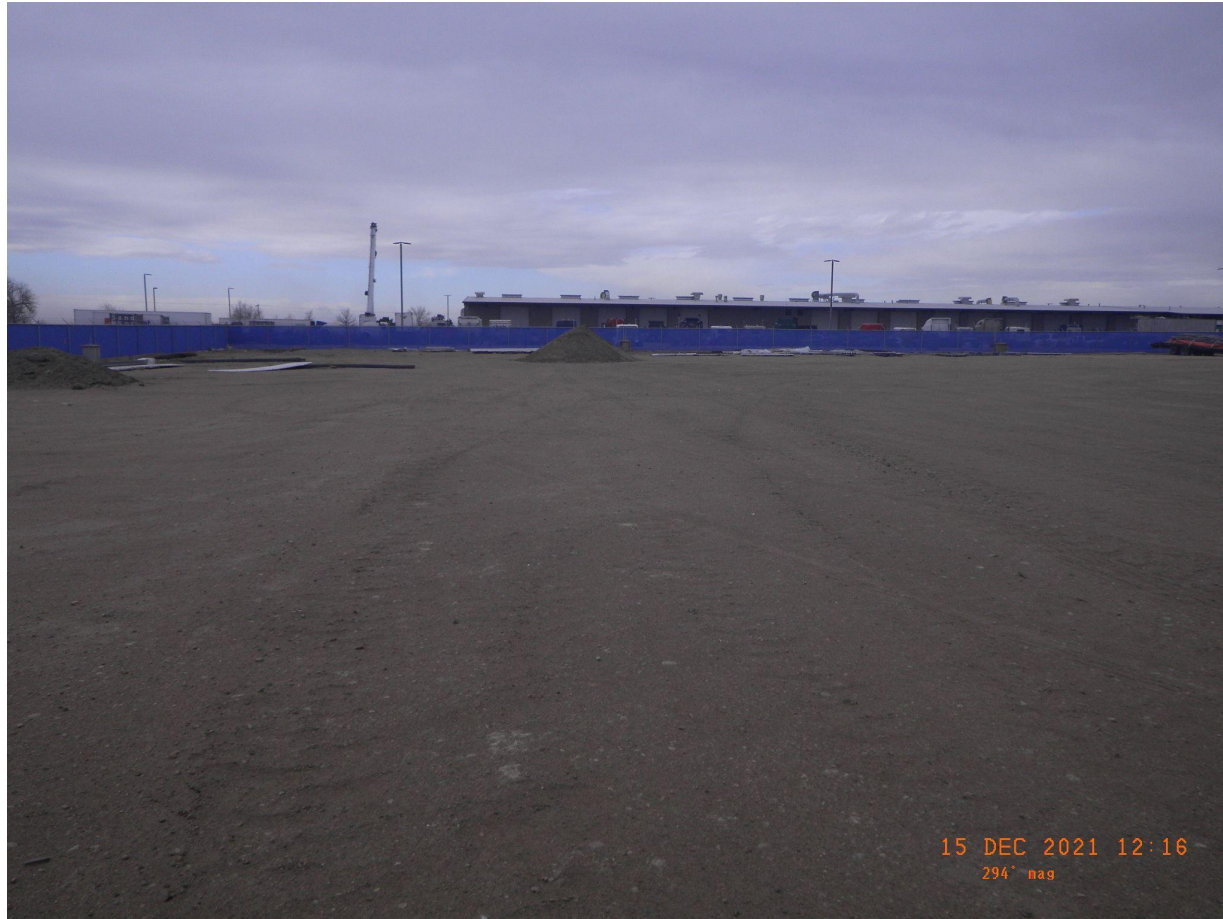
Photo 2. Overview photo of the well pad taken at ground level from the western edge facing east. The well location falls within a developed area and looks similar to the surrounding area.

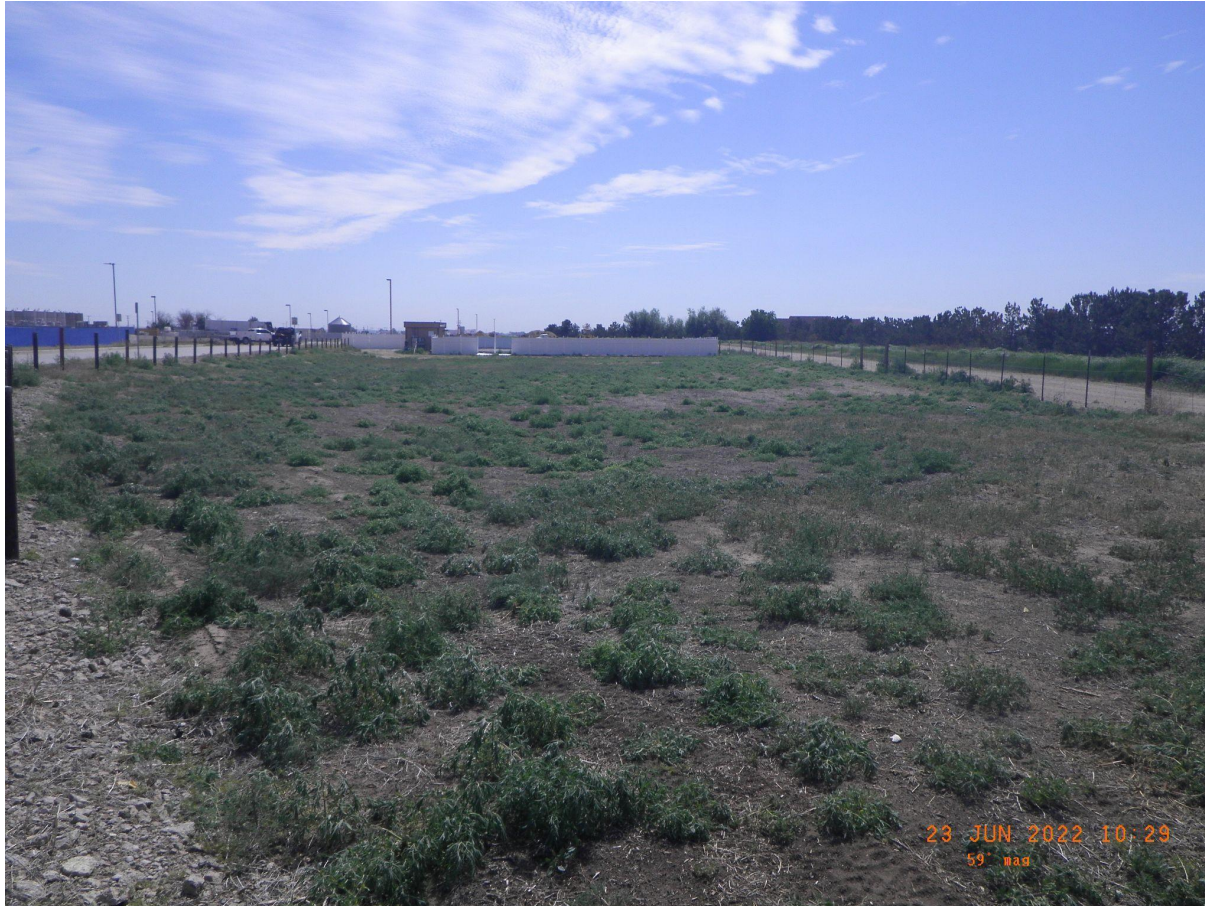
Photo 3. Overview photo of the tank battery taken at ground level from the western edge facing east.

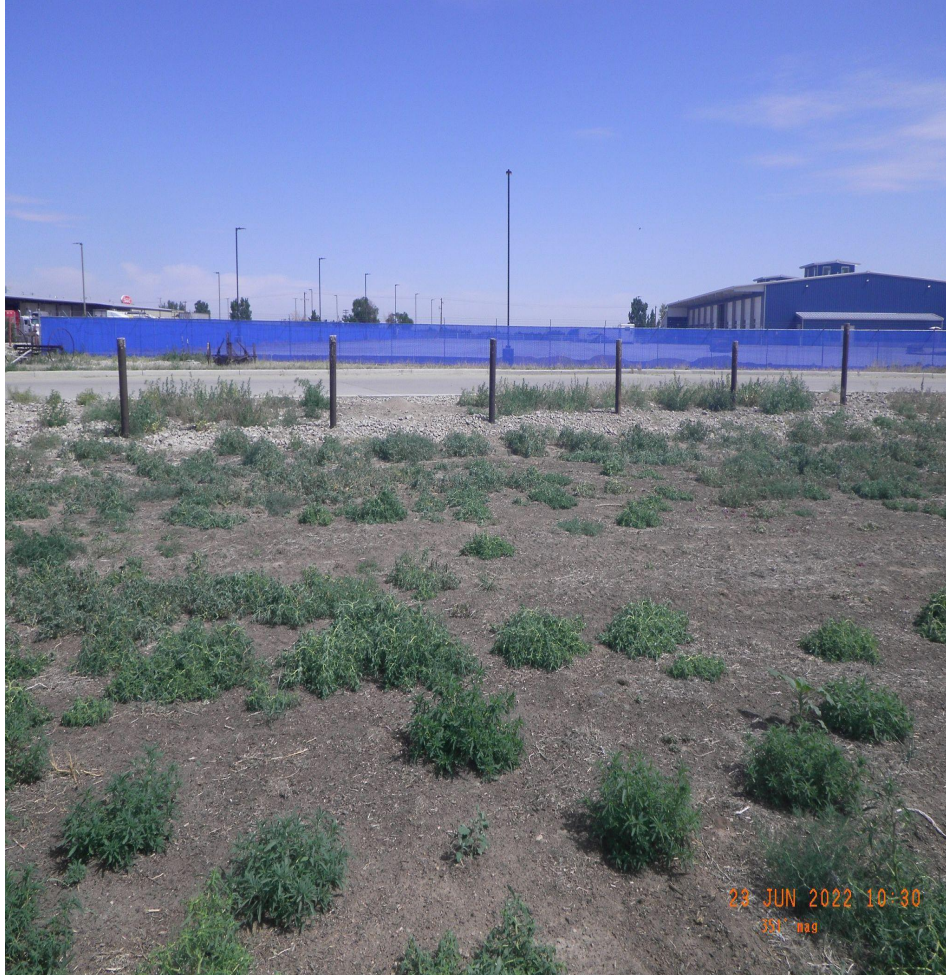
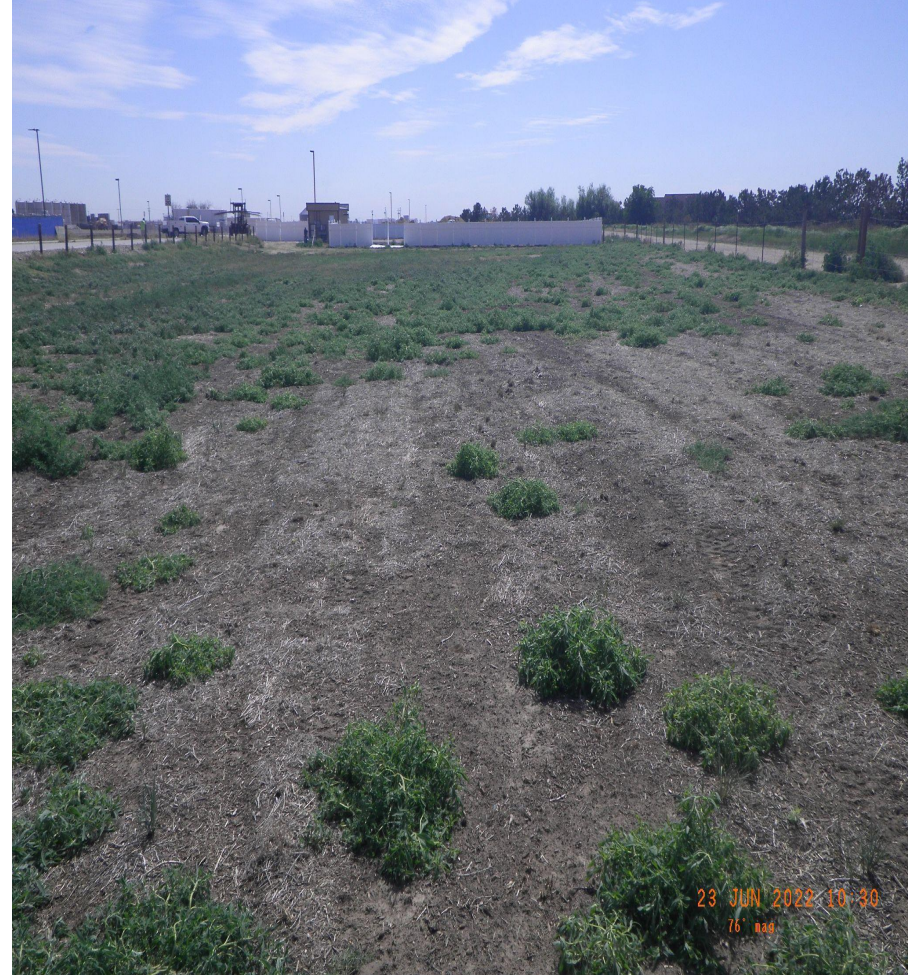
Photo 4. Cardinal photos taken from the middle of the tank battery. Left photo facing north, right photo facing east.
