Inspection Photos

API: 071-09344

Operator: RED RIVER RANCH HOLDINGS LLC

Inspection Date: 8/25/2022

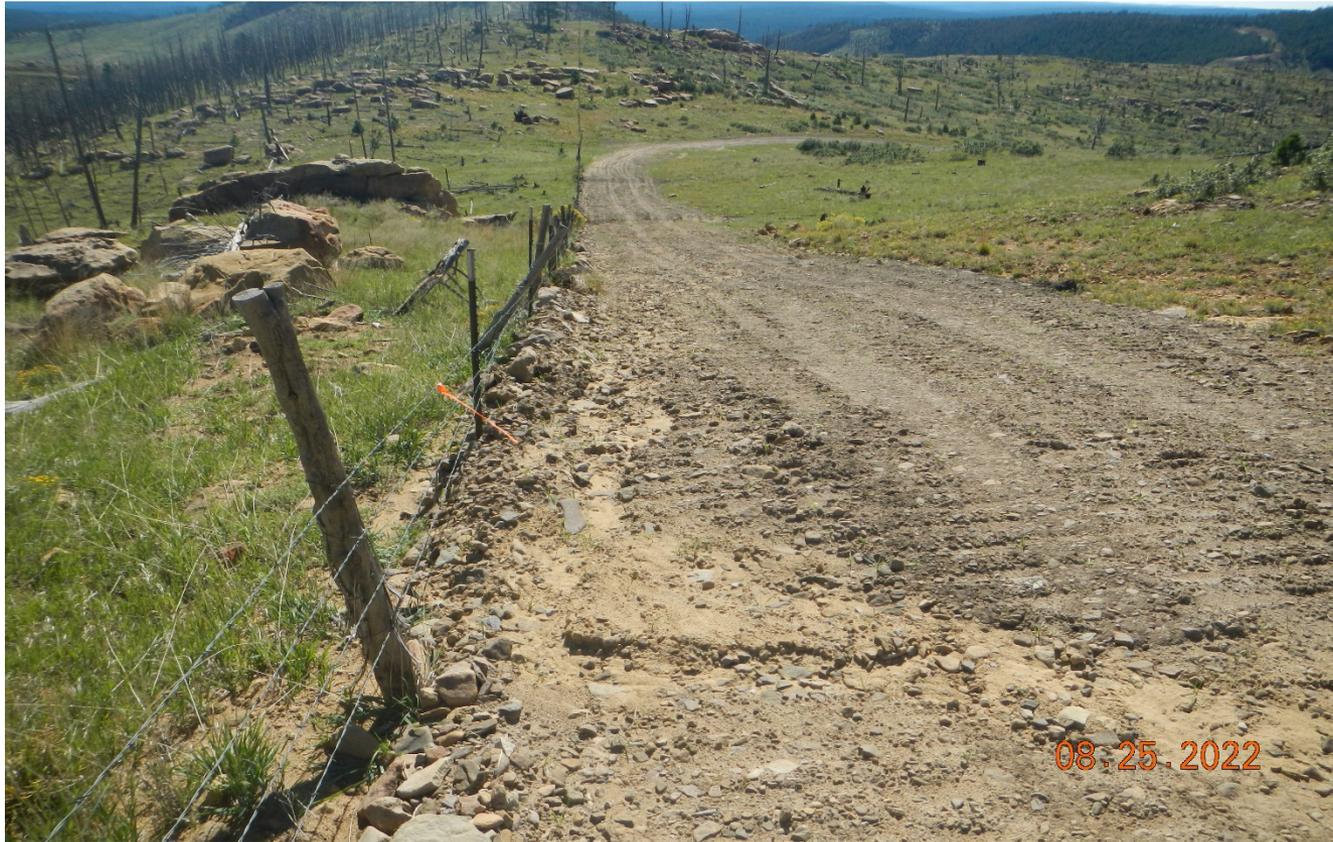
Photo 1. Facing southeast along the pre-existing access road. There are water bars installed along the road however, this area stormwater is overtopping the water bar.

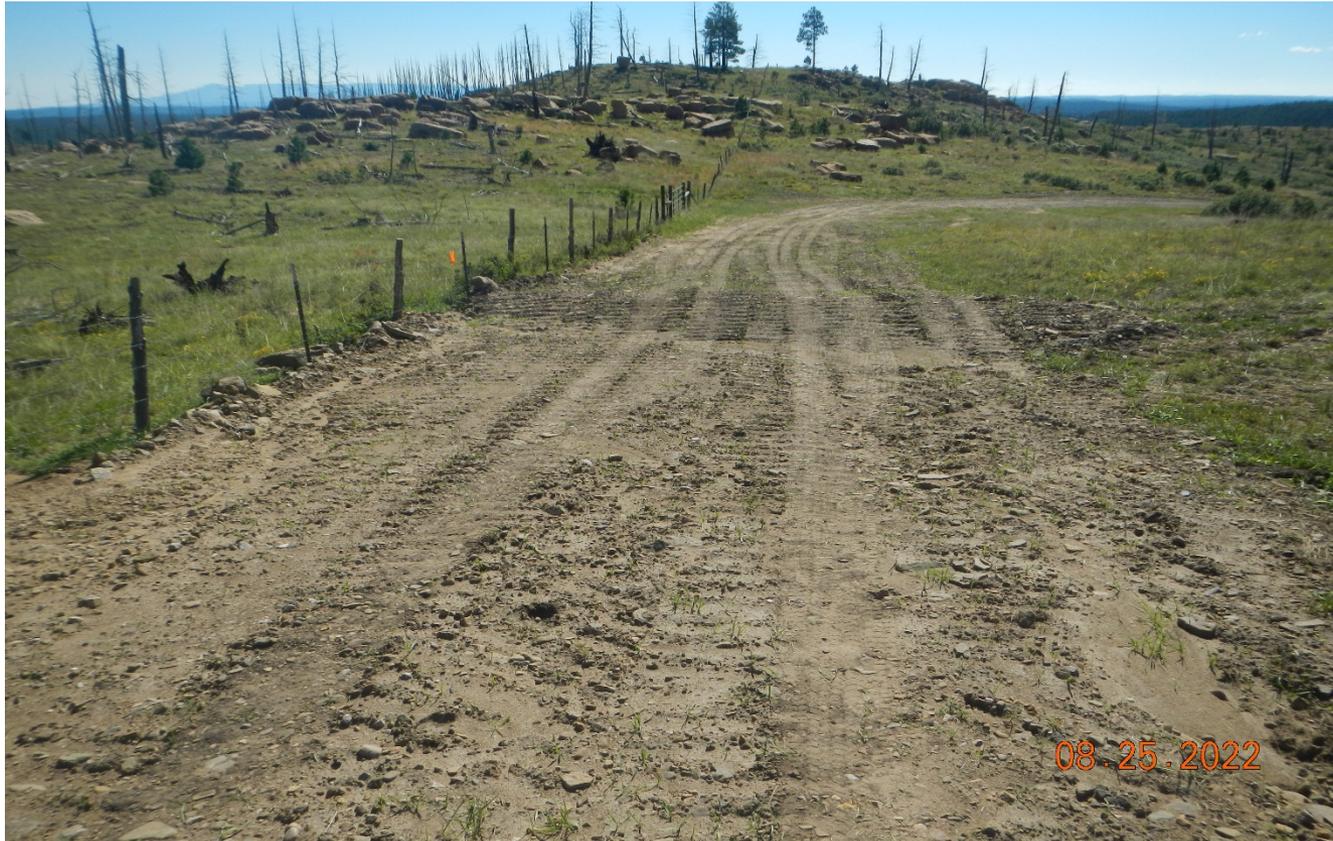
Photo 2. Facing southeast along the pre-existing access road. This area has been reseeded and vegetation is germinating.

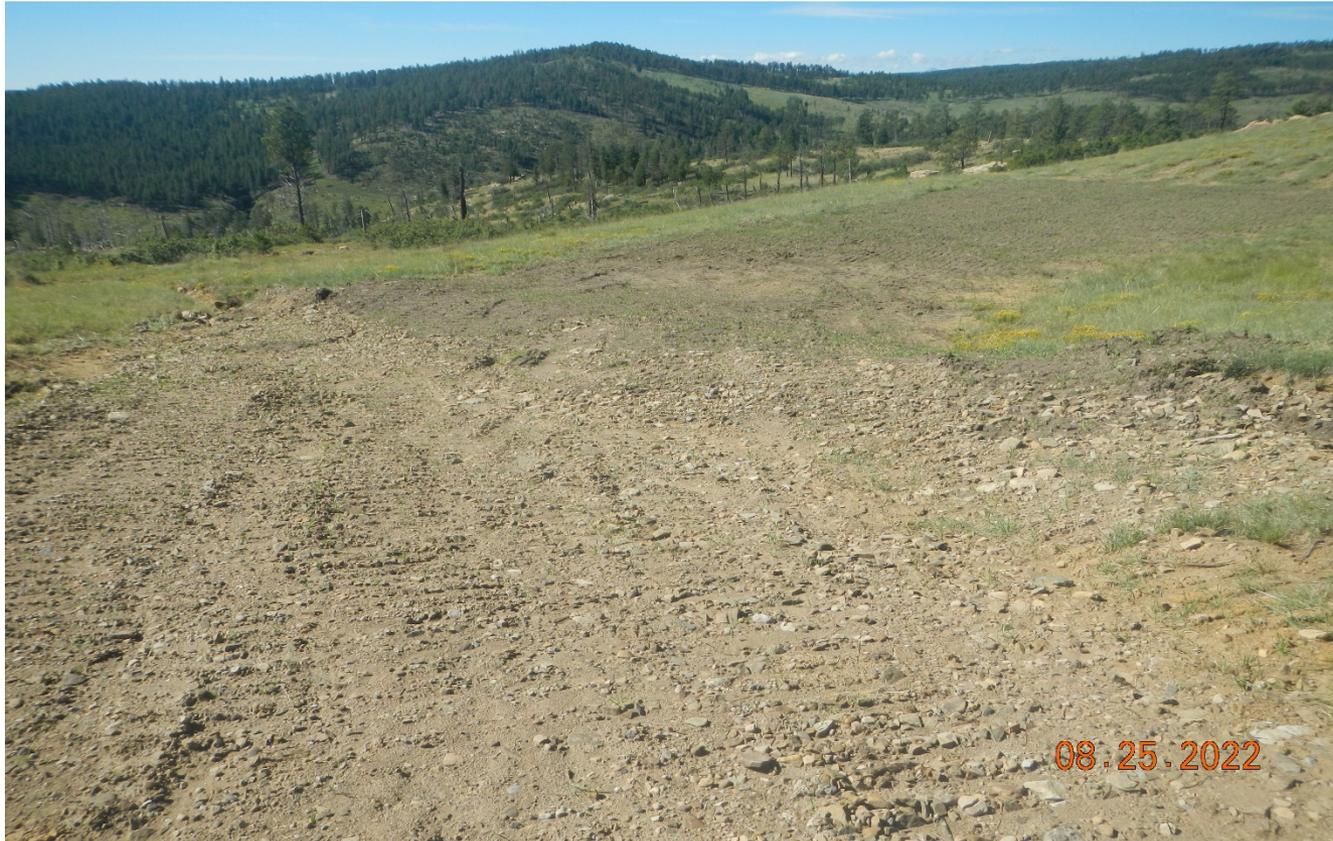
Photo 3. Facing southwest toward the location. The area of previous erosion has mostly been filled in and reseeded.

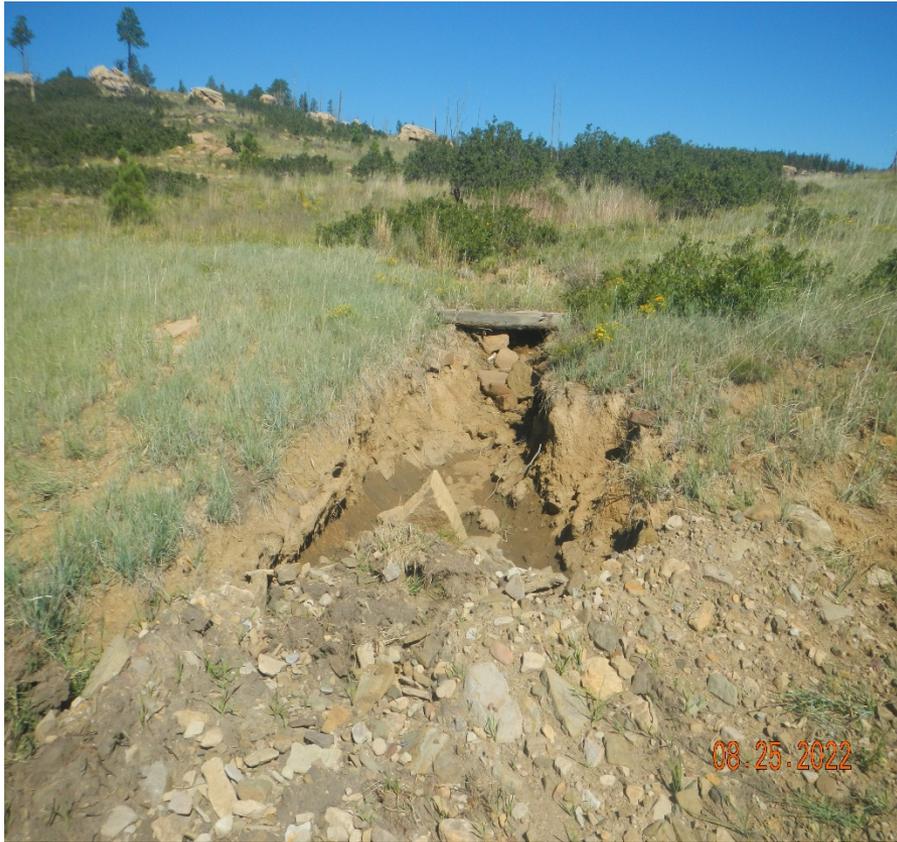
Photo 4. There is still part of the erosion channel that needs to be repaired and stabilized at the north portion of the location.

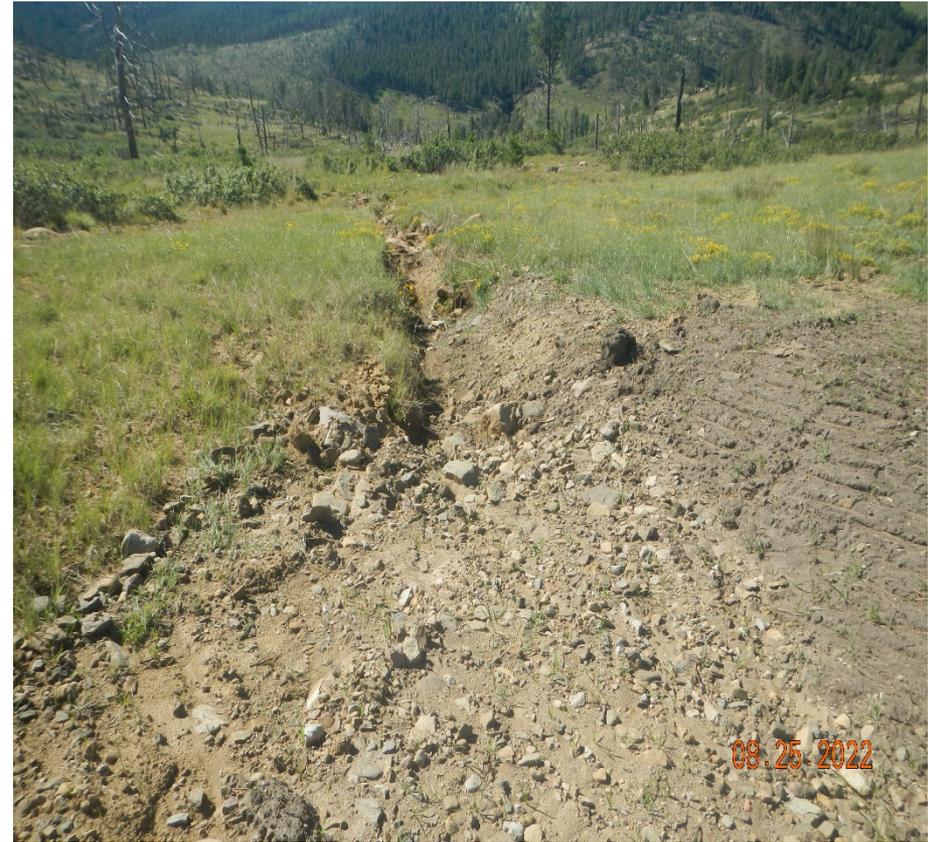
Photo 5. There is still part of the erosion channel that needs to be repaired and stabilized at the southeast portion of the location.

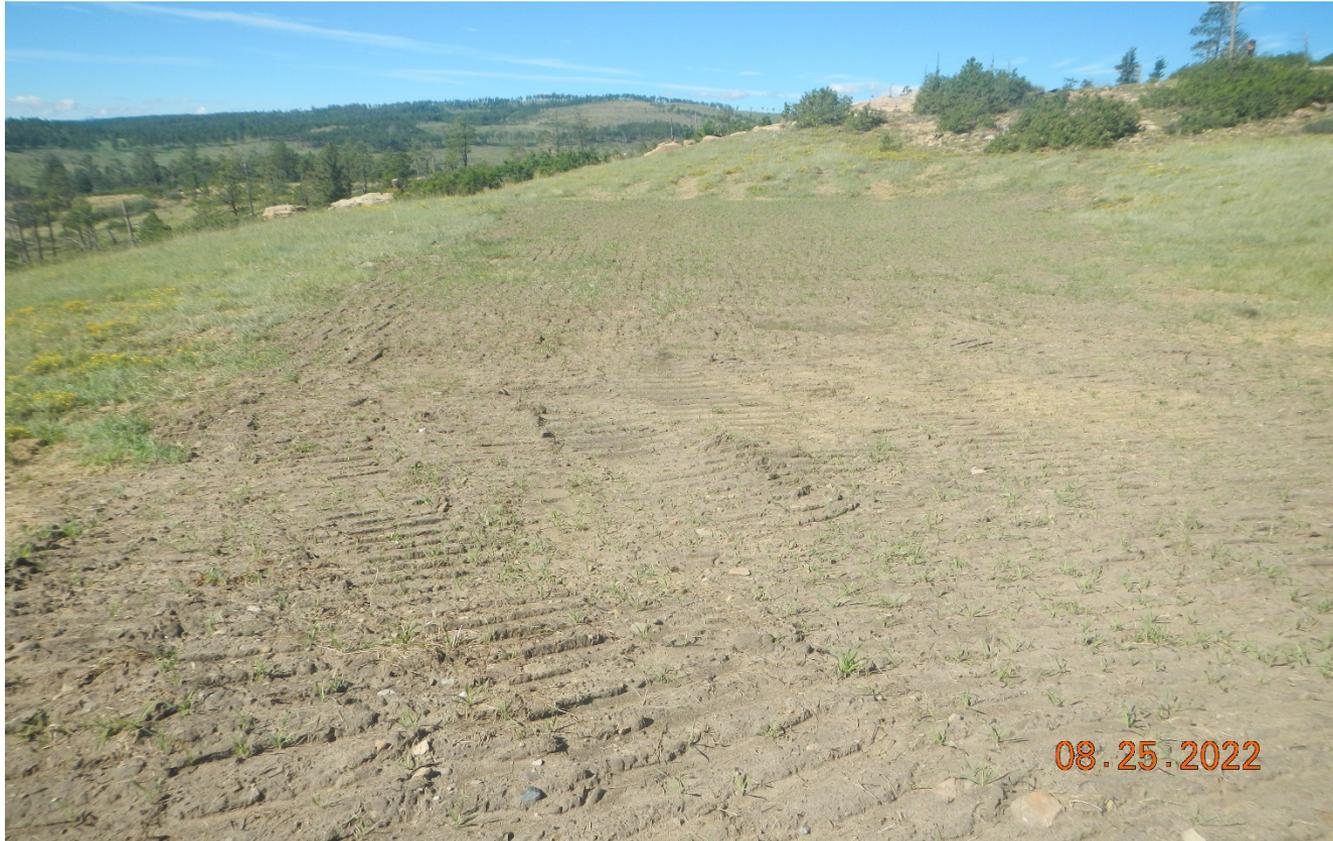
Photo 5. Facing southwest at the location. This area has been regraded and reclaimed.
