Inspection Photos and Issue Report

Operator: UTAH GAS OP LTD DBA UTAH GAS
CORP - 10539

Location #322317
Garfield County, CO

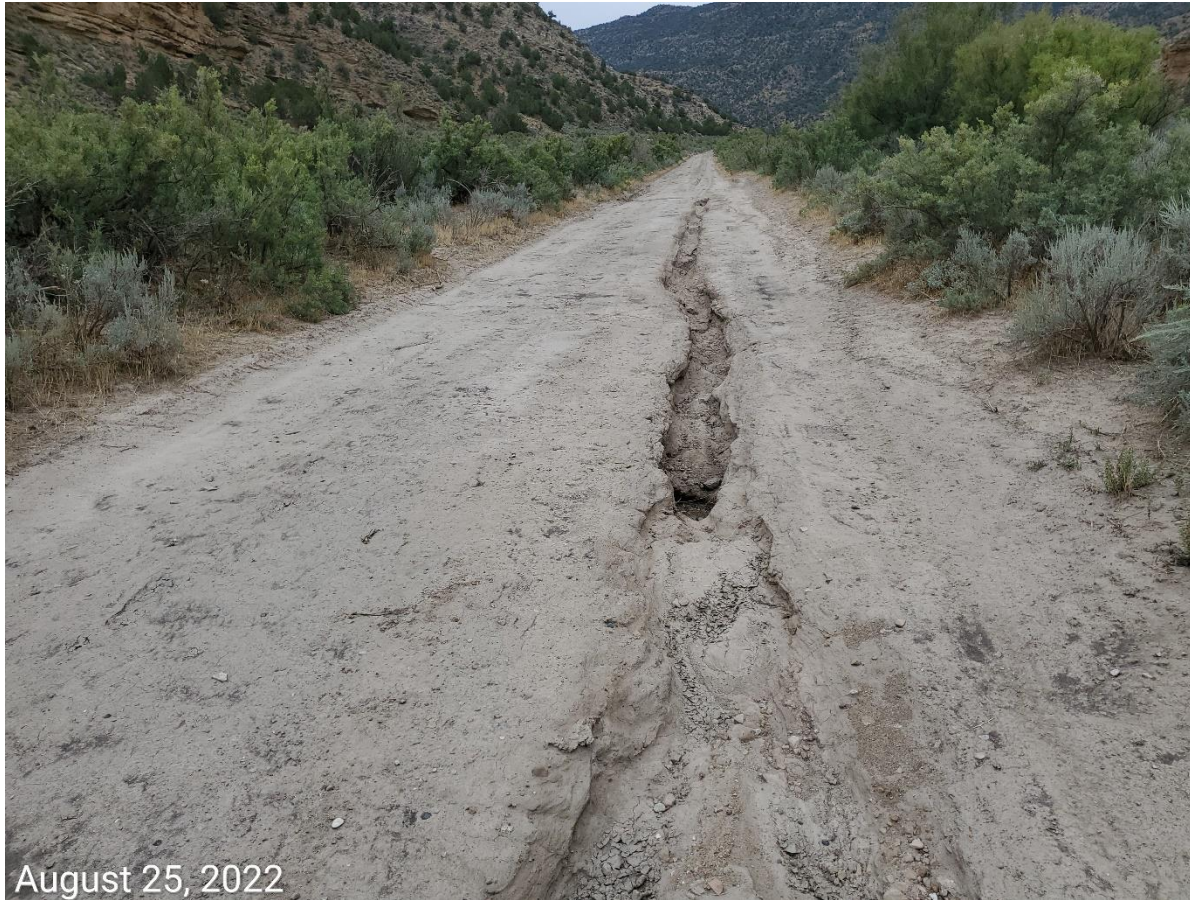
Photo 1: Photo taken from the access road south of Utah Gas Corp's Federal-Carbonera 1-2; access road is shared between two Operators (Utah Gas, Locin). Photo example showing erosion control and stabilization BMPs are missing or insufficient along entire access road- erosion degradation and sediment transport evident.

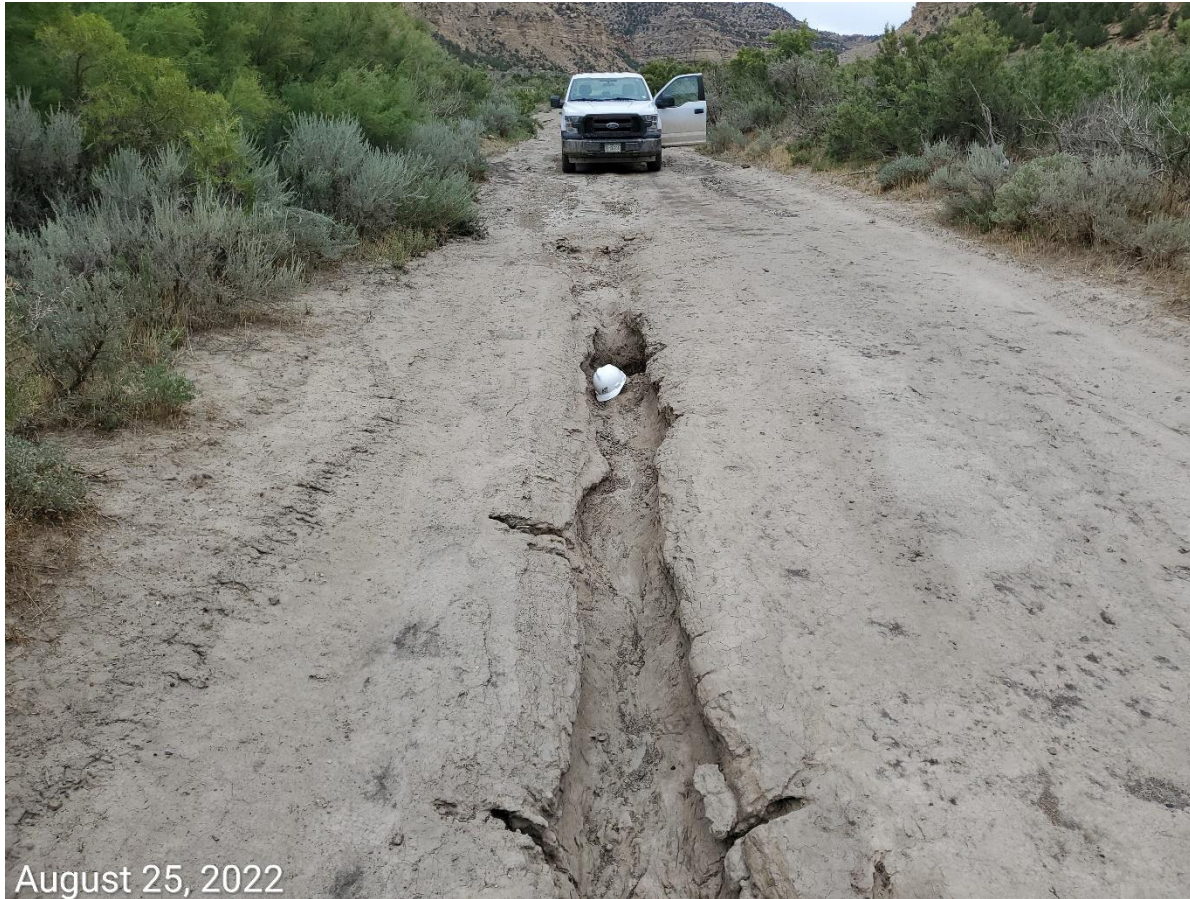
Photo 12: Continued from photo 1. Hard hat in photo for scale/reference.
