Construction and Stormwater Inspection

August 10, 2022

Operator: NOBLE ENERGY INC- #100322

Location ID: 459835

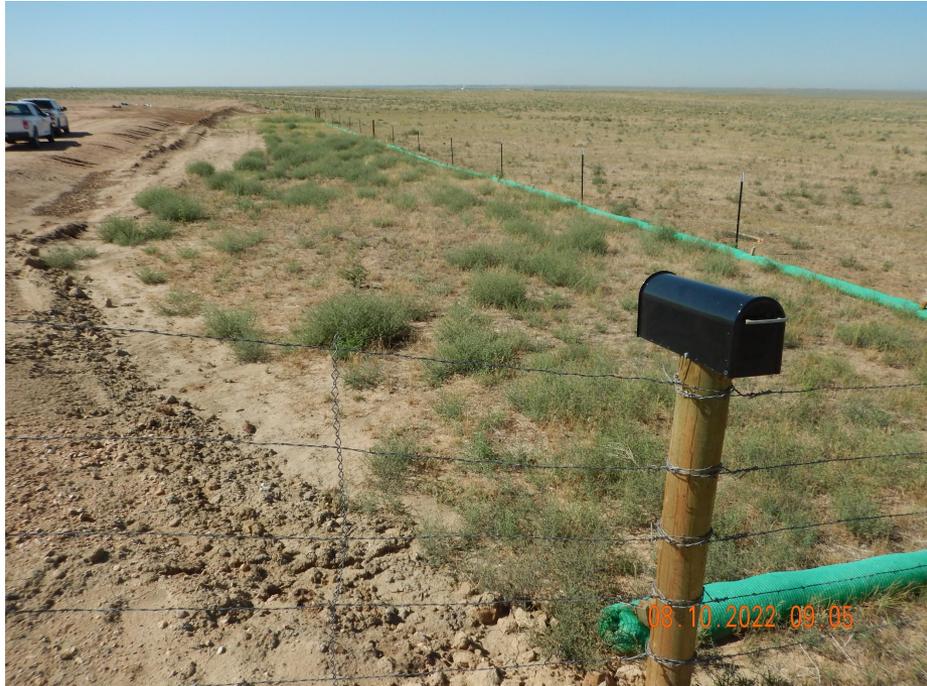
Photo 1. Photo taken from the west entrance of location, facing South. Photo illustrates Operator has installed filter fabric around the entire perimeter of location and the mailbox along the entrance to comply with Rule 406.c.

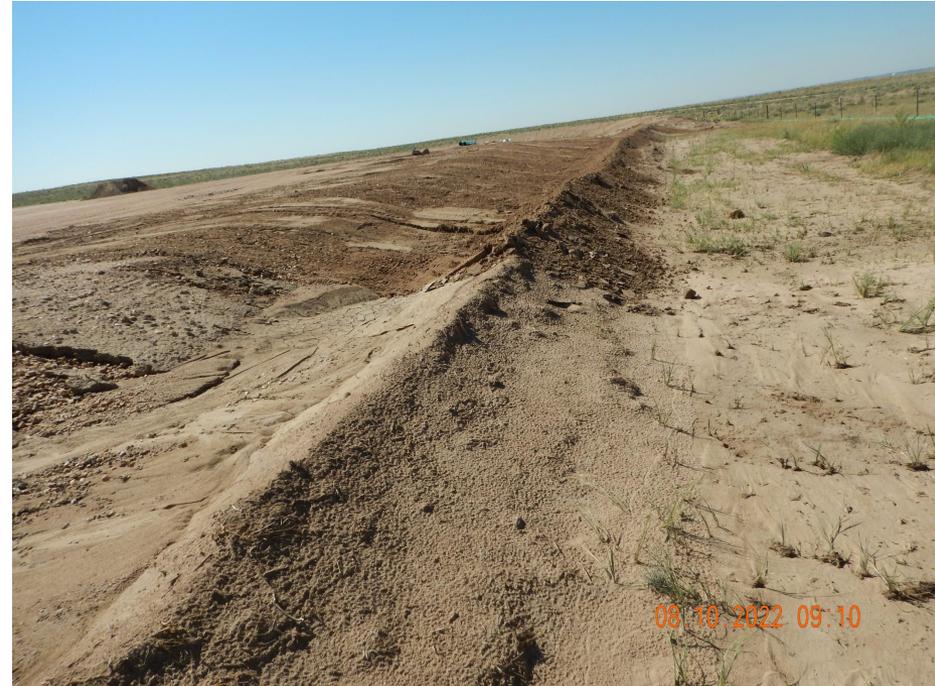
Photo 2. Photo taken from the western location, facing South. Photo illustrates Operator is in process of stormwater repairs along the fill slope and ditch BMP.

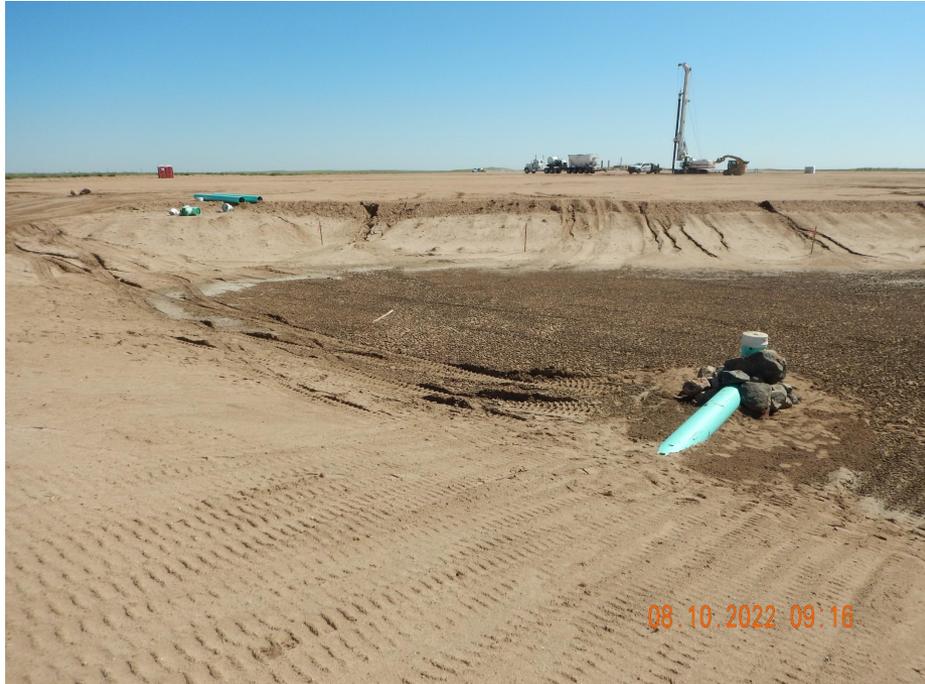
Photo 3. Photo taken from the southwestern location, facing East. Photo illustrates the sediment basin with repairs in need.

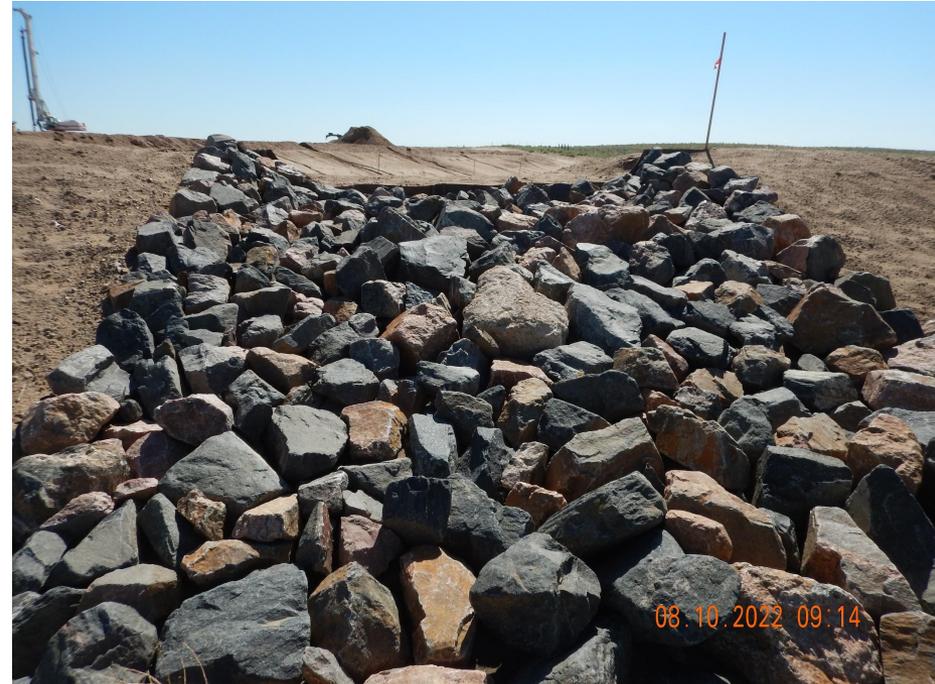
Photo 4. Photo taken from the stabilized outlet area of sediment basin.

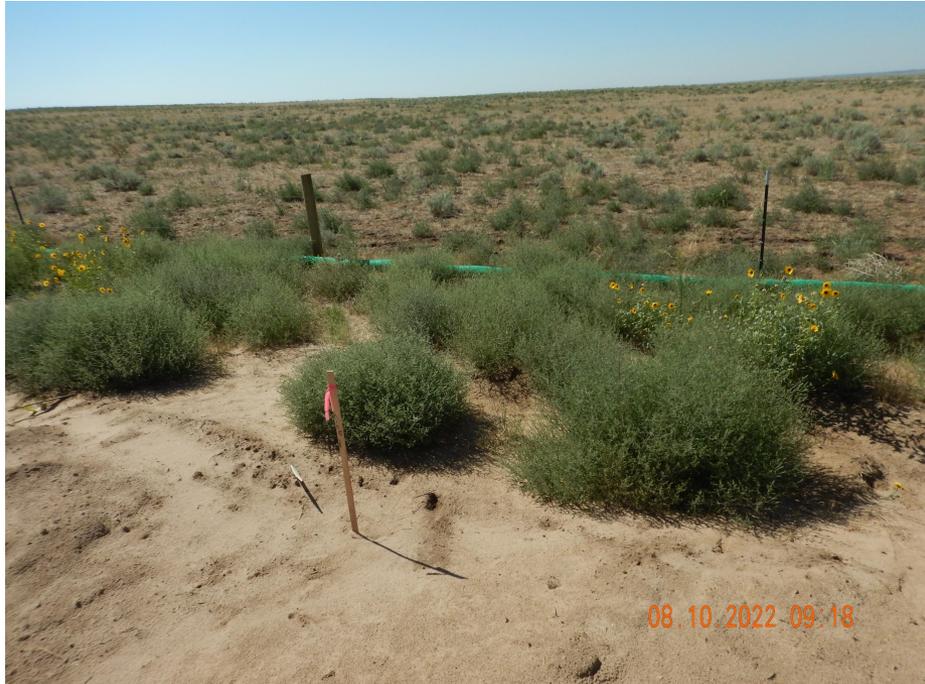
Photo 5. Photo taken from the southwestern location, facing South. Photo illustrates weeds in need of maintenance. Weeds were addressed on a follow up inspection conducted on 8/19/2022.

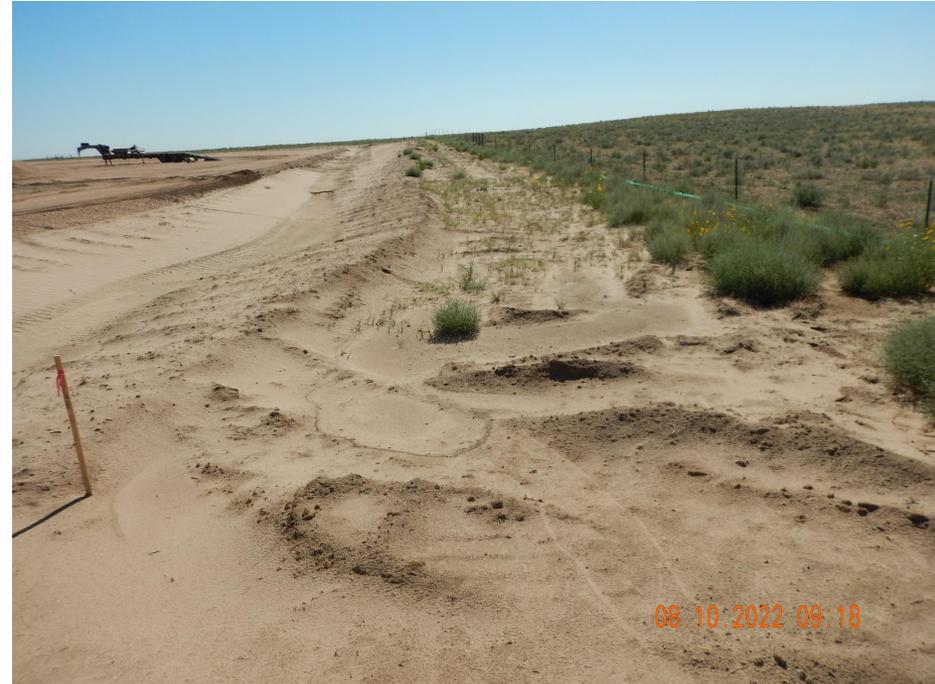
Photo 6. Photo taken from the southwestern location, facing East. See comments under Photo 5. Photo illustrates ditch maintenance is required.

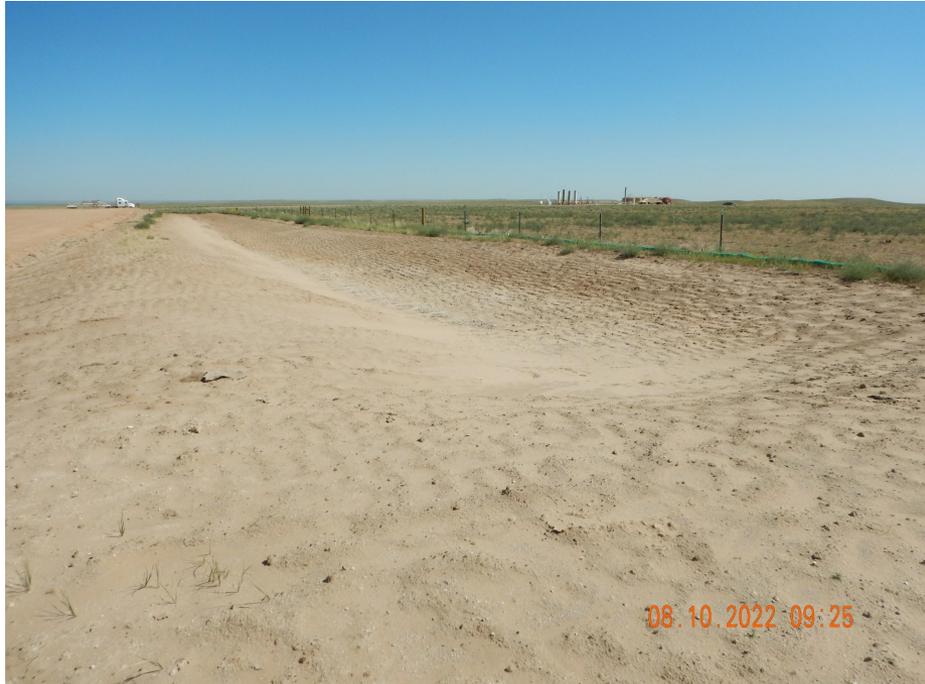
Photo 7. Photo taken from the southeastern location, facing North. Photo illustrates a run-on swale per Weld County requirements.

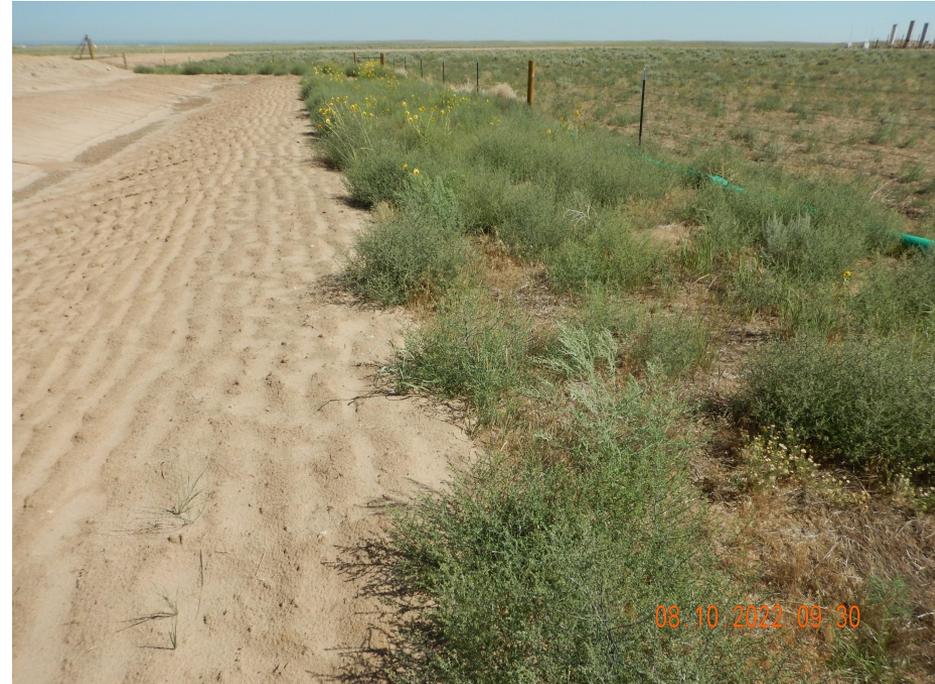
Photo 8. Photo taken from the eastern location, facing North. See comments under Photo 5.

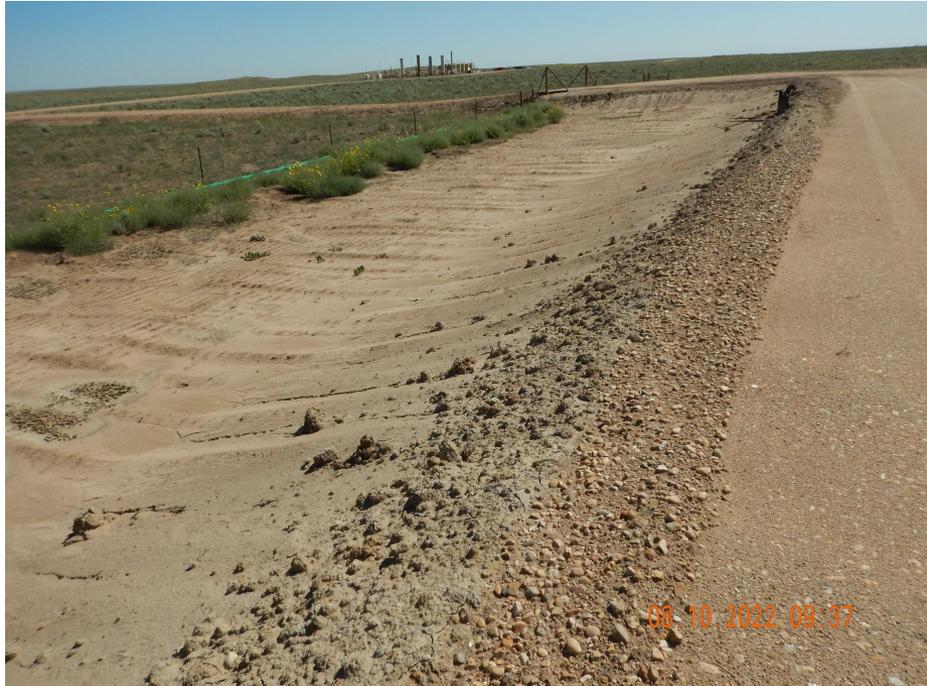
Photo 9. Photo taken from the northeastern location, facing East. See comments under Photo 1.

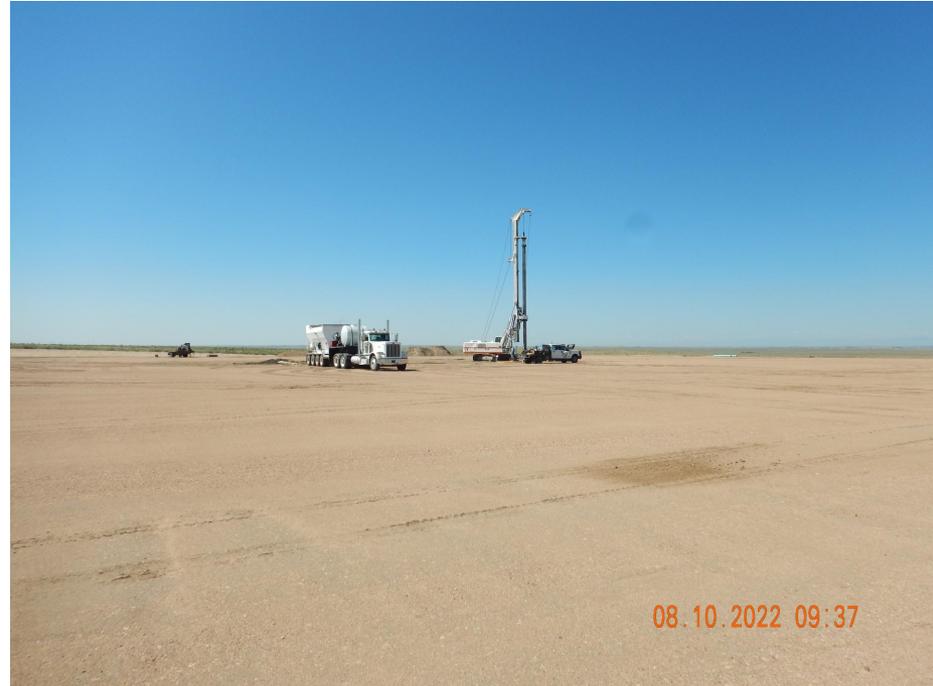
Photo 10. Photo taken from the northern location, facing South. Photo illustrates current operations.
