# Construction and Stormwater Inspection

August 10, 2022

Operator: NOBLE ENERGY INC- #100322

Location ID: 459852

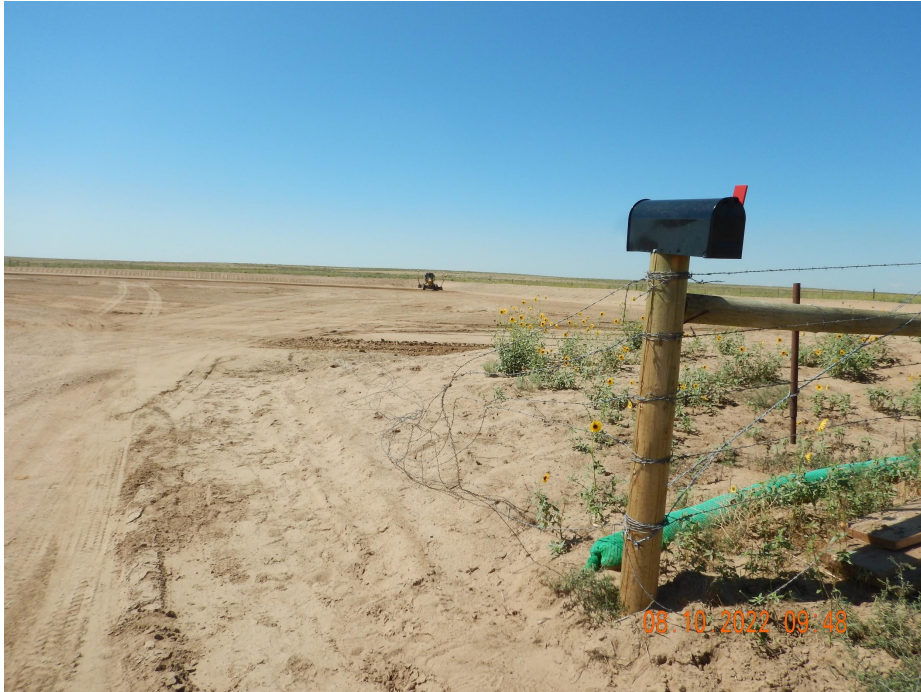
**Photo 1.** Photo taken from the west entrance of location, facing South. Photo illustrates Operator has installed filtrex around the entire perimeter of location and the mailbox along the entrance to comply with Rule 406.c.

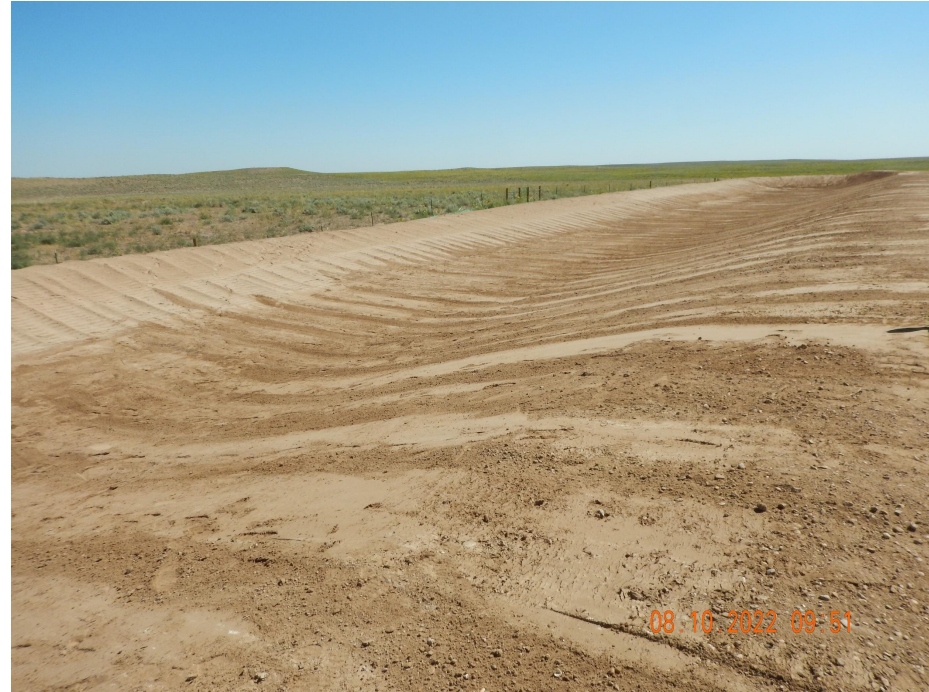
**Photo 2.** Photo taken from the northwestern location, facing Northeast. Photo illustrates the sediment basin.

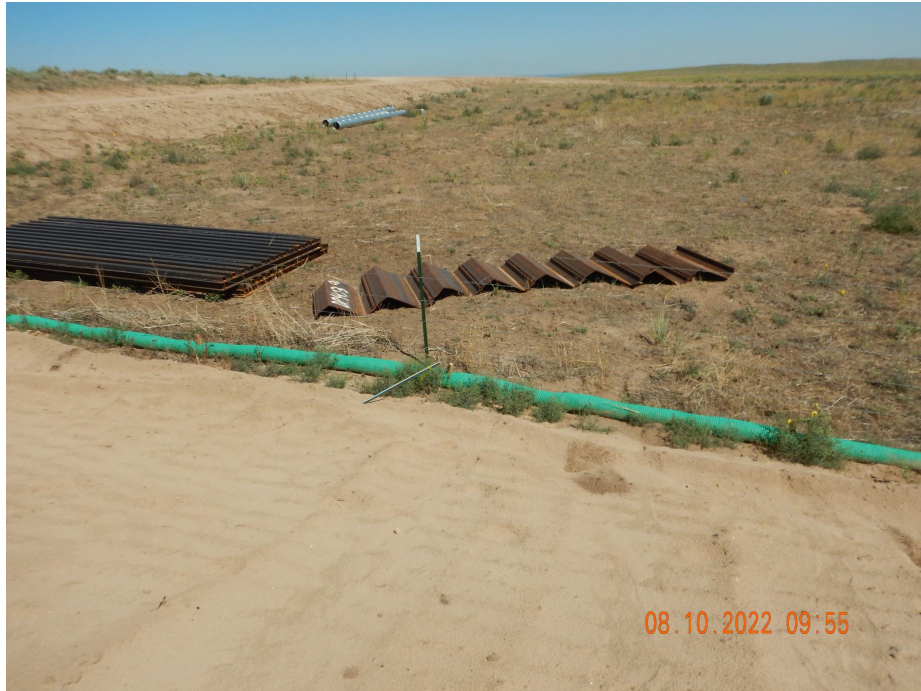
**Photo 3.** Photo taken from the northwestern location, facing North. Photo illustrates the cattle guard VTC to be installed and the weir stormwater BMP to be installed.

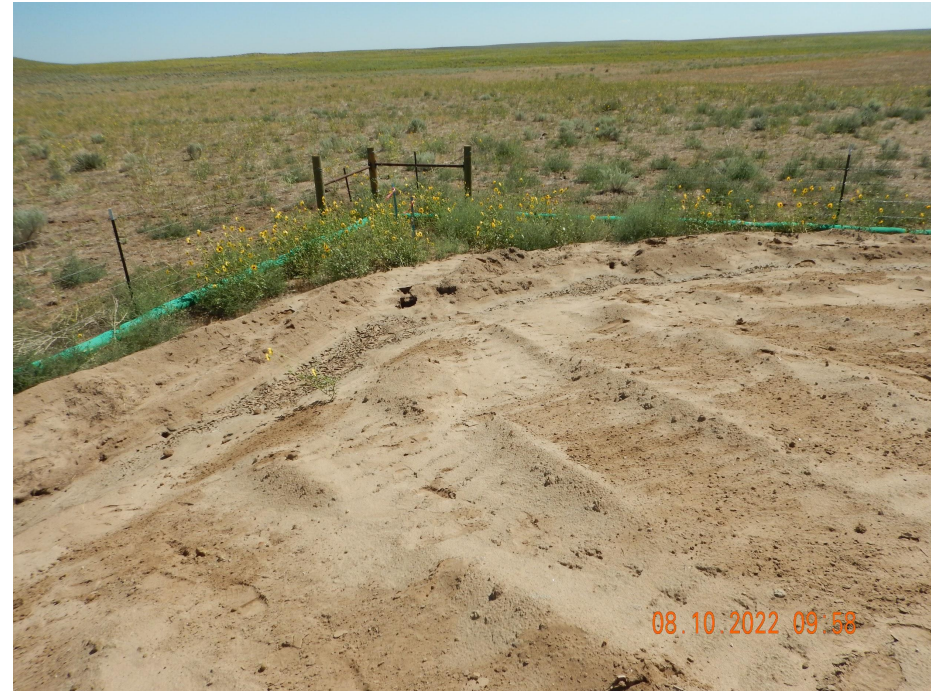
**Photo 4.** Photo taken from the northeastern location, facing East. See comments under Photo 1.

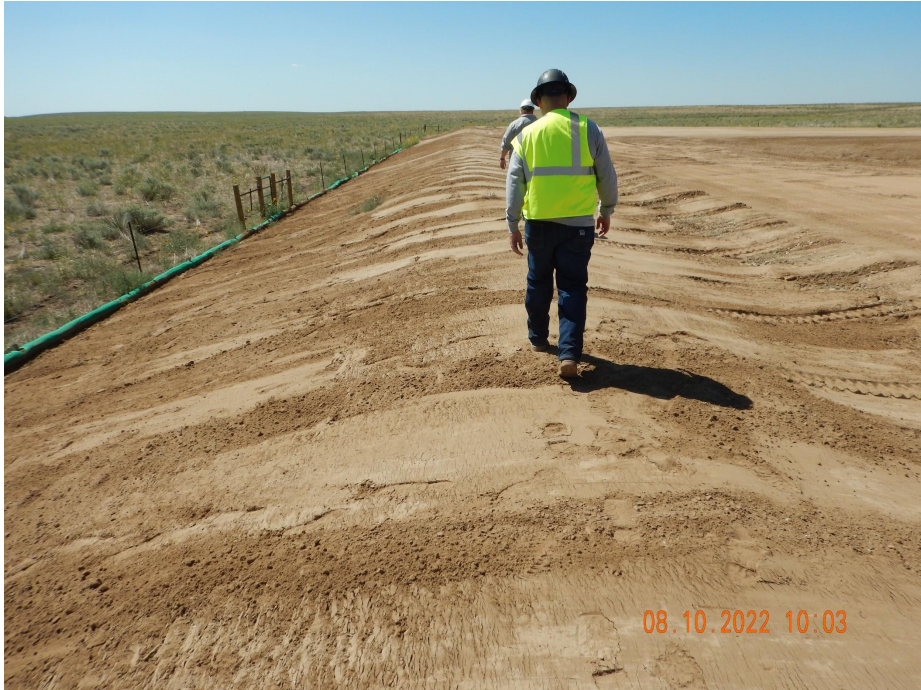
**Photo 5.** Photo taken from the eastern location, facing South. Photo illustrates a swale area that is directed to the sediment basin.

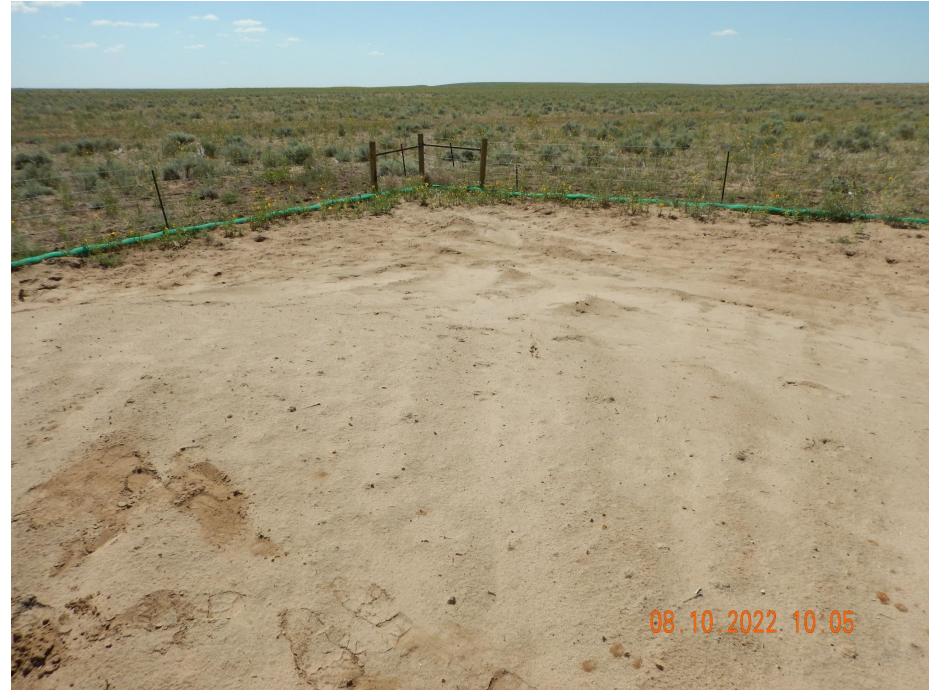
**Photo 6.** Photo taken from the southeastern location, facing Southeast. See comments under Photo 1.

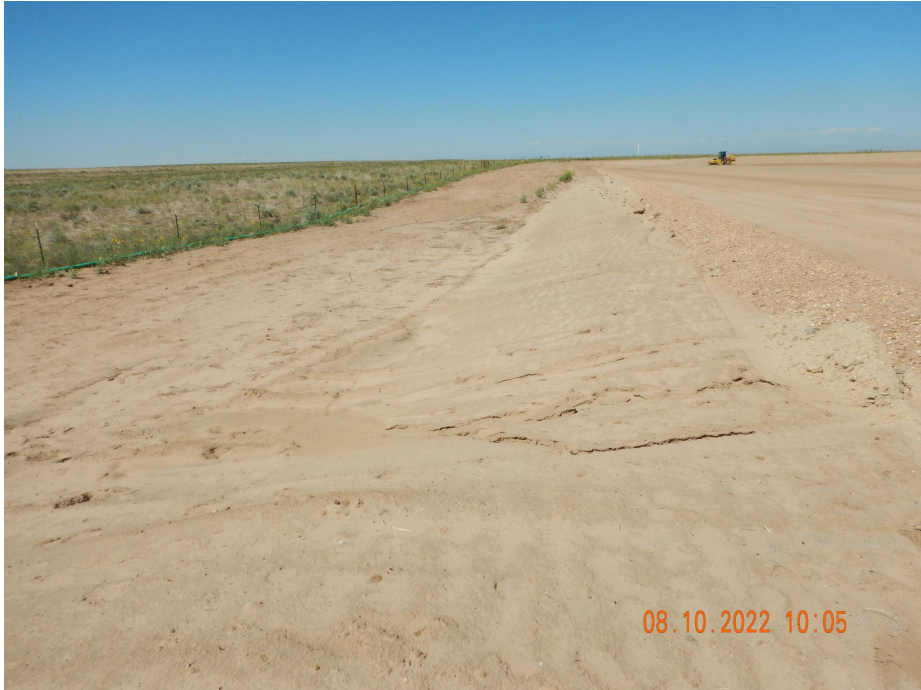
**Photo 7.** Photo taken from the southeastern location, facing West. See comments under Photo 1.

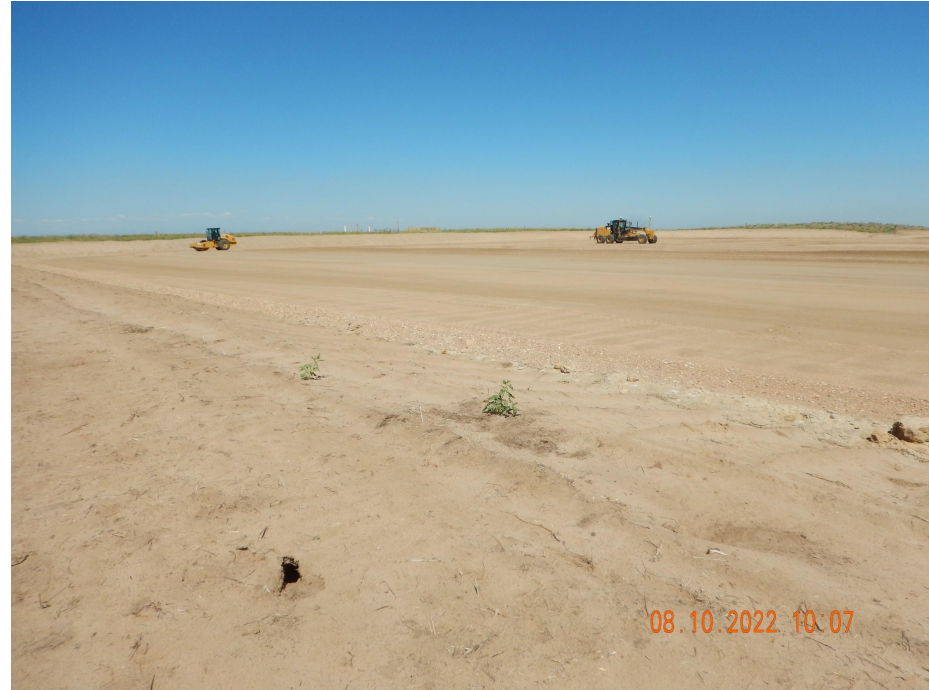
**Photo 8.** Photo taken from the southern location, facing Northwest. Photo illustrates construction and stormwater activities underway.
